Citizens' Oversight Projects (COPs)
771 Jamacha Rd #148
El Cajon, CA 92019
CitizensOversight.org
619-820-5321

August 30, 2018

The NRC announced a "Special Inspection" at San Onofre Nuclear Generating Station to review events surrounding the Aug 3, 2018, fuel-loading "near miss" incident. Through this letter we hope to provide guidance to this investigation by the NRC from our standpoint of providing public oversight, including a request for expanding the scope of your investigation. Please distribute this letter appropriately within the NRC so our concerns will be known by the inspection team.

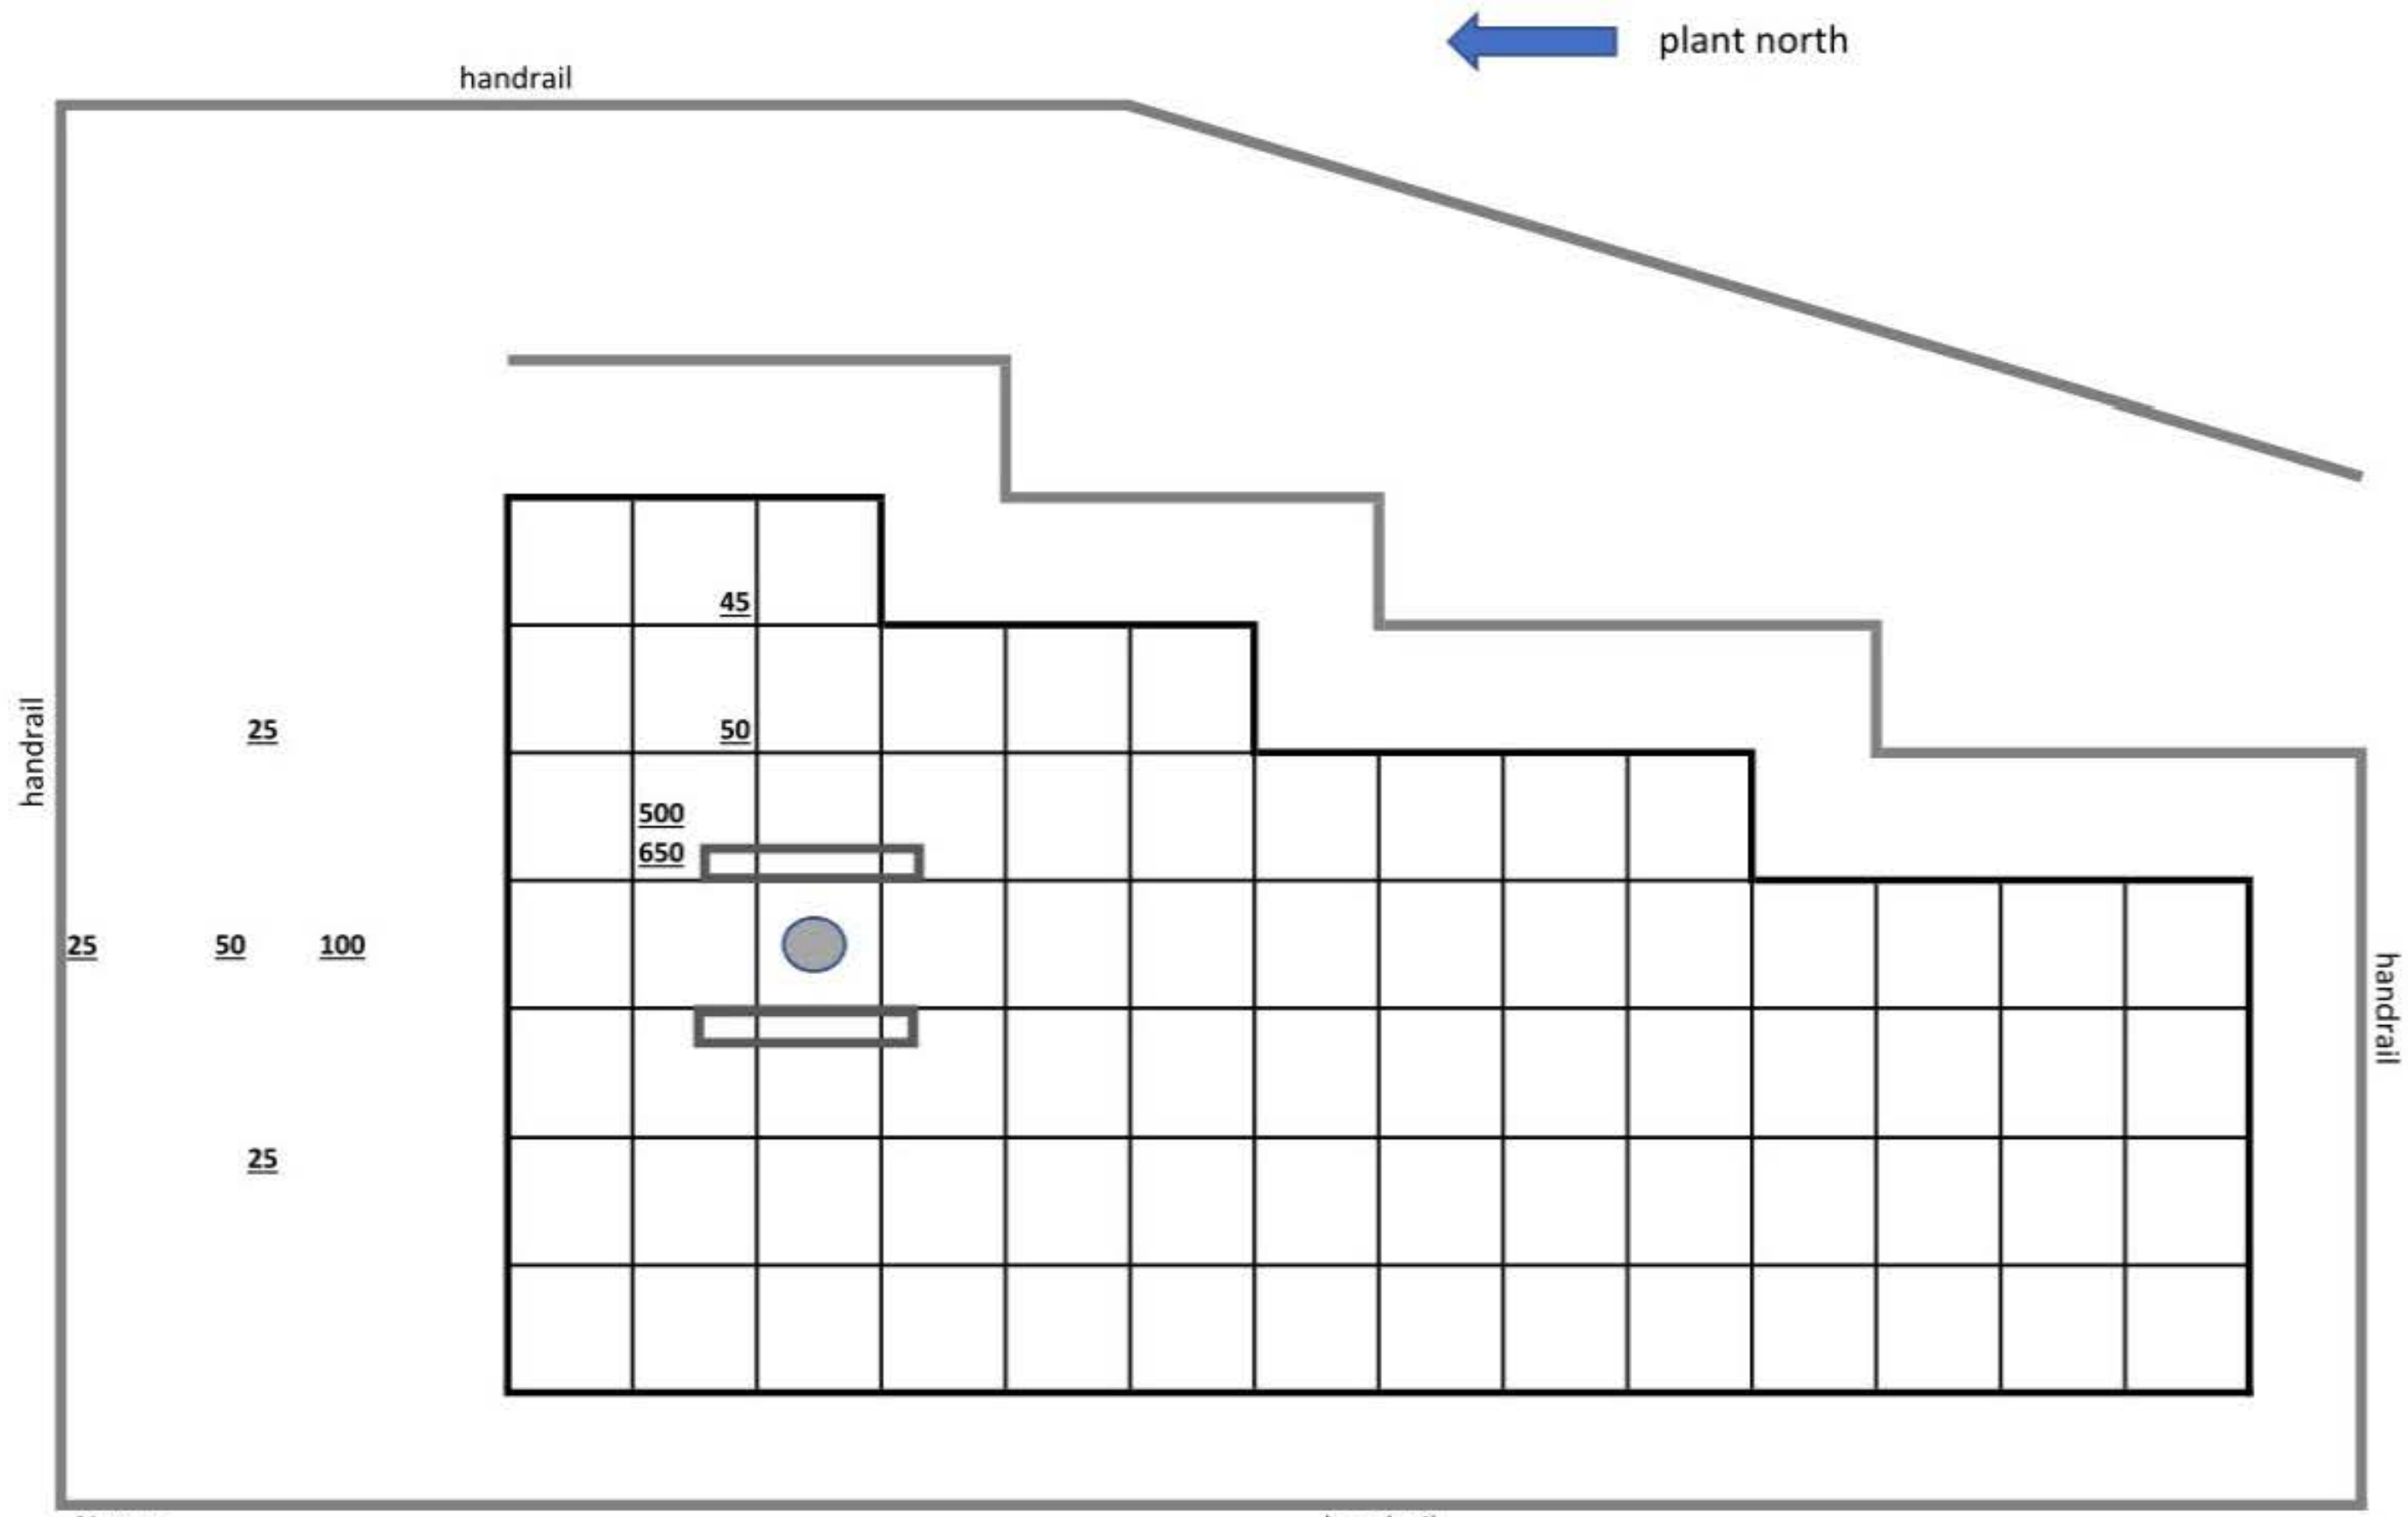
8/3/18 FTO29 VVM22 MEASURED DOSE RATES

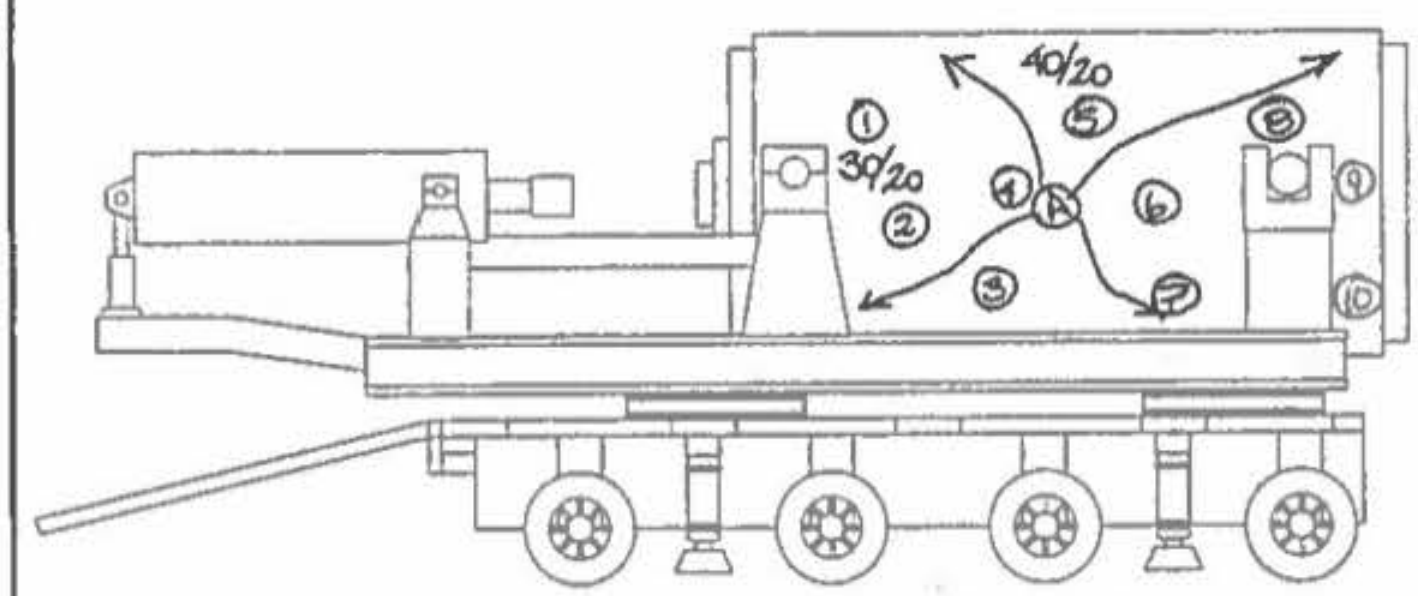
POST DECON: AS PER HP-I-17 ALL DSC SURFACES VERIFIED <1K DPM/100 cm², ≤ 1.5KDPM/LAS FOR PERMISSION TO TRANSPORT FROM U3 FHB CRANE BAY TO ISFSI AS PER HP SUPV. H. PEARSALL AND HPGF R. HERERA

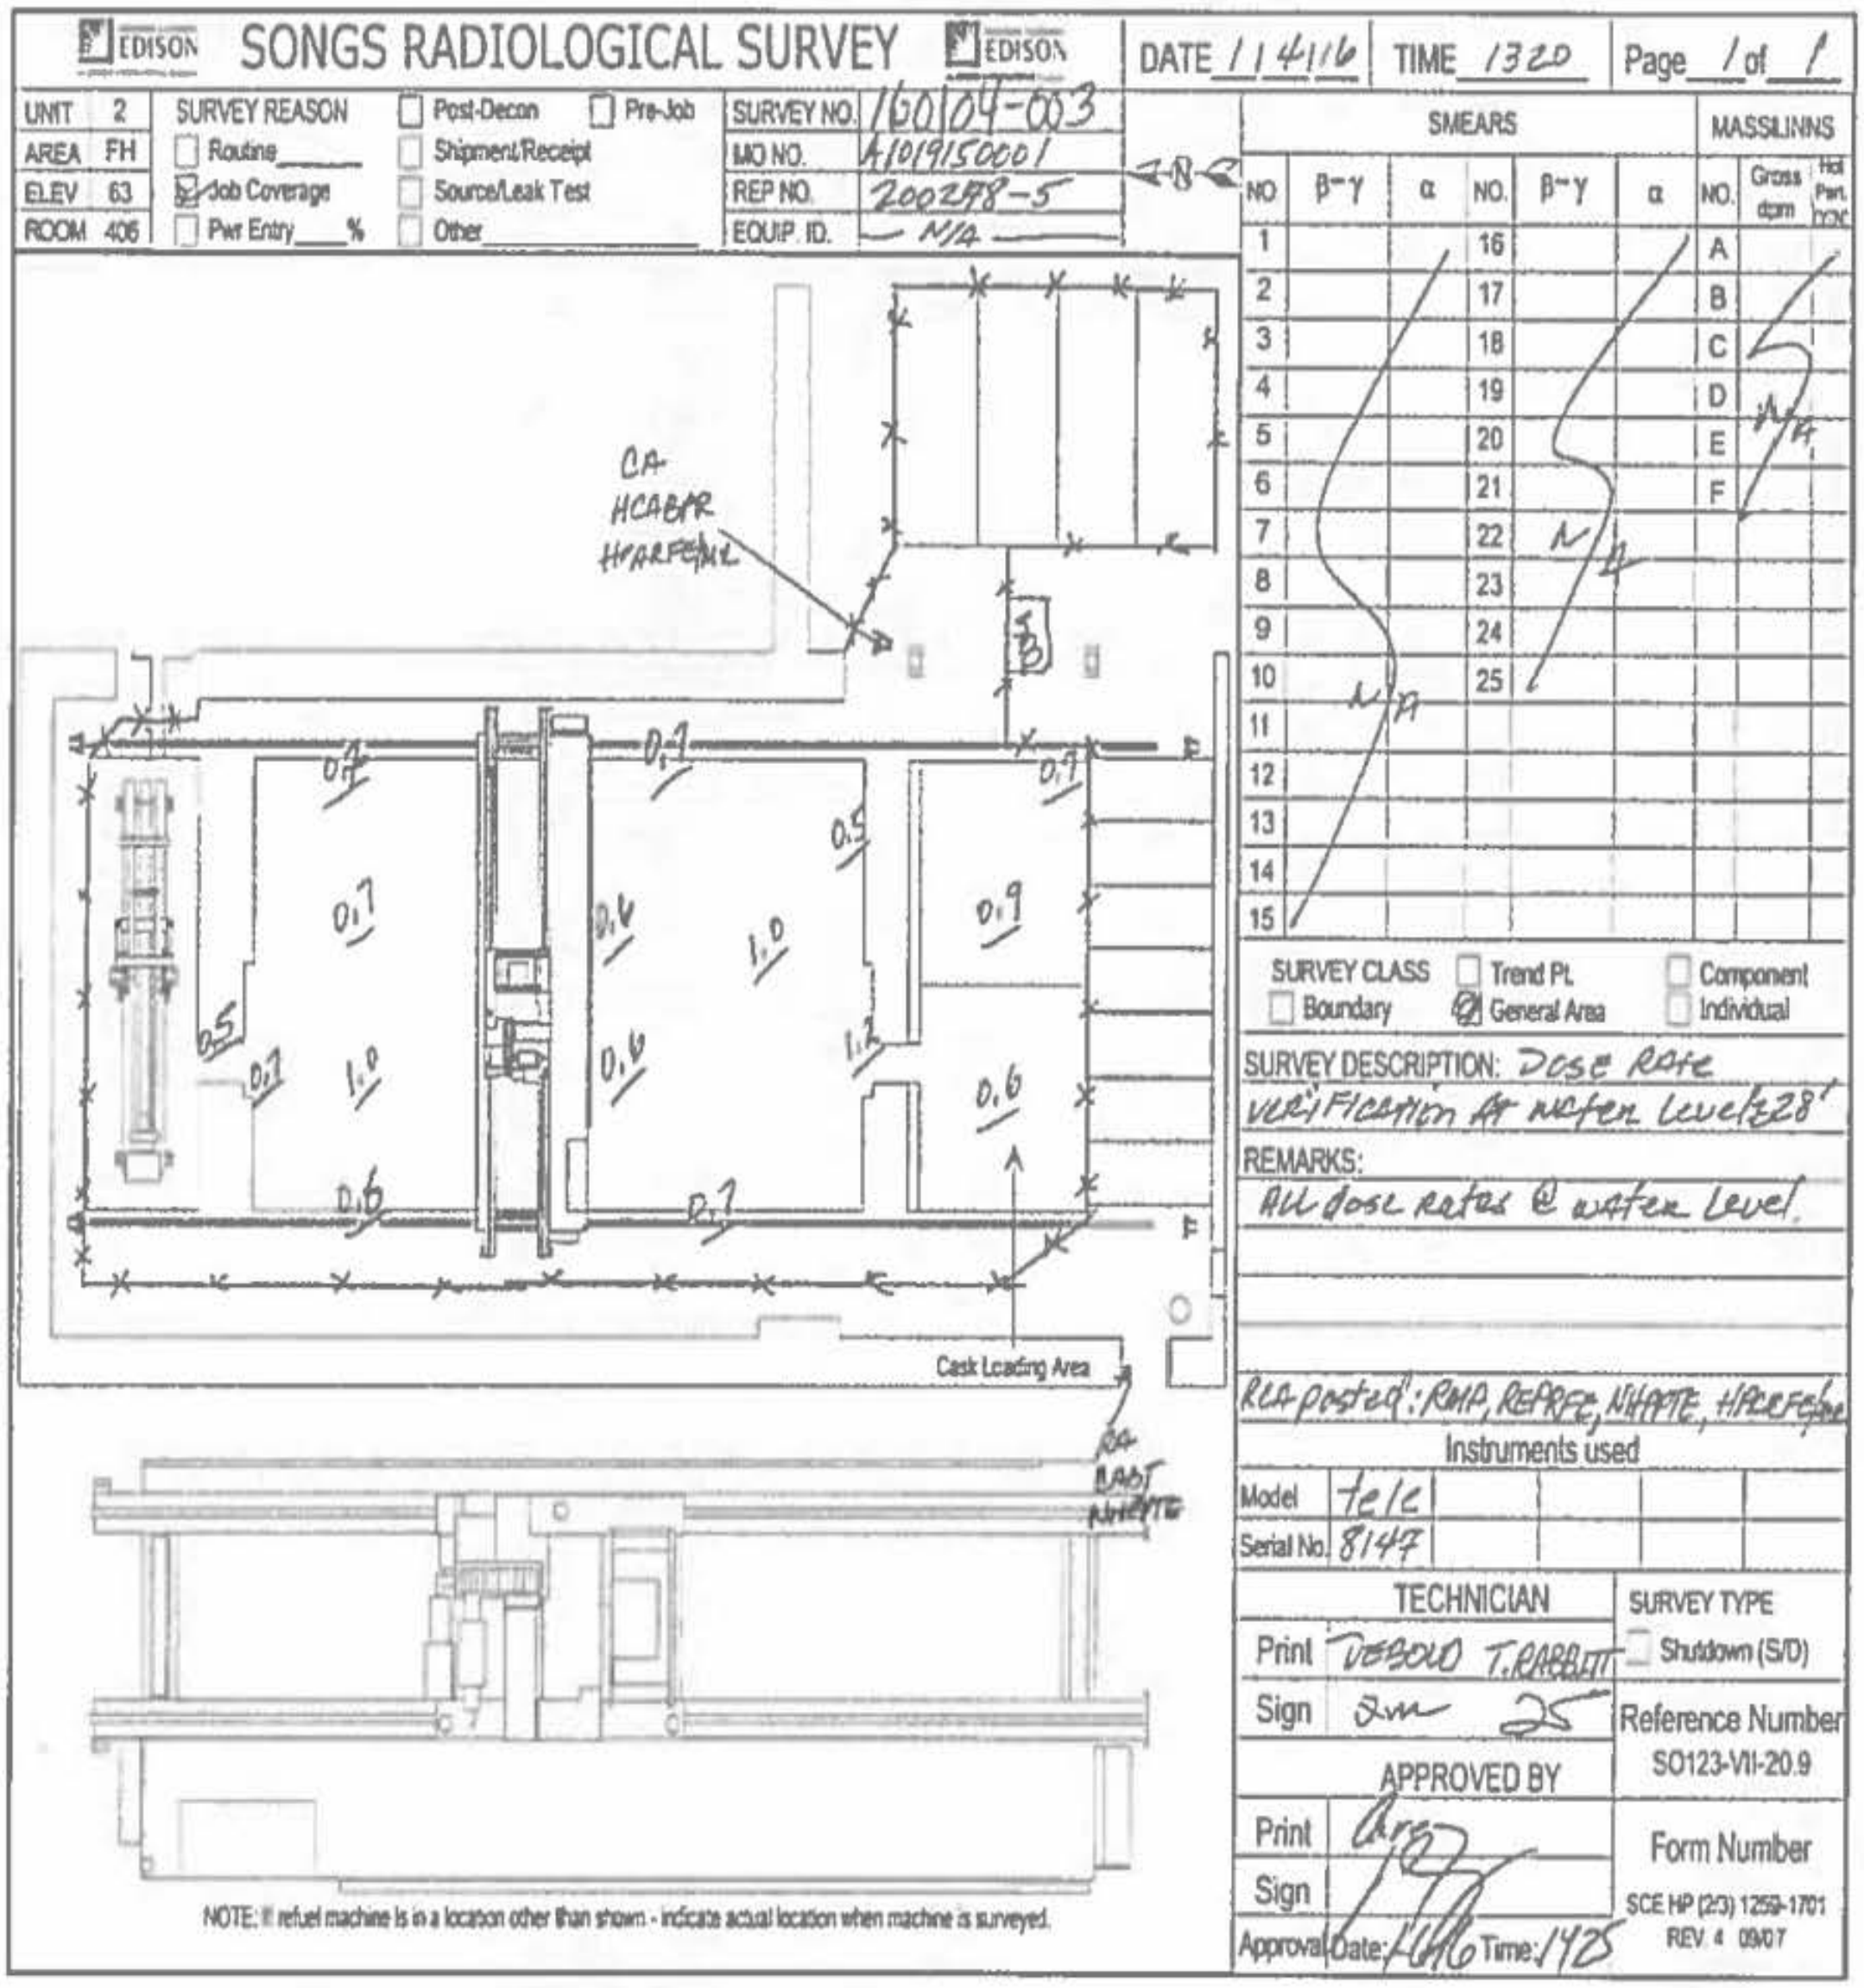
Compare chest high dose rates documented on survey number 170323-002 with pool level dose rates documented on survey number 160104-003. This comparison illustrates that the U2 spent fuel pool activity and dose rates continue to increase over time.

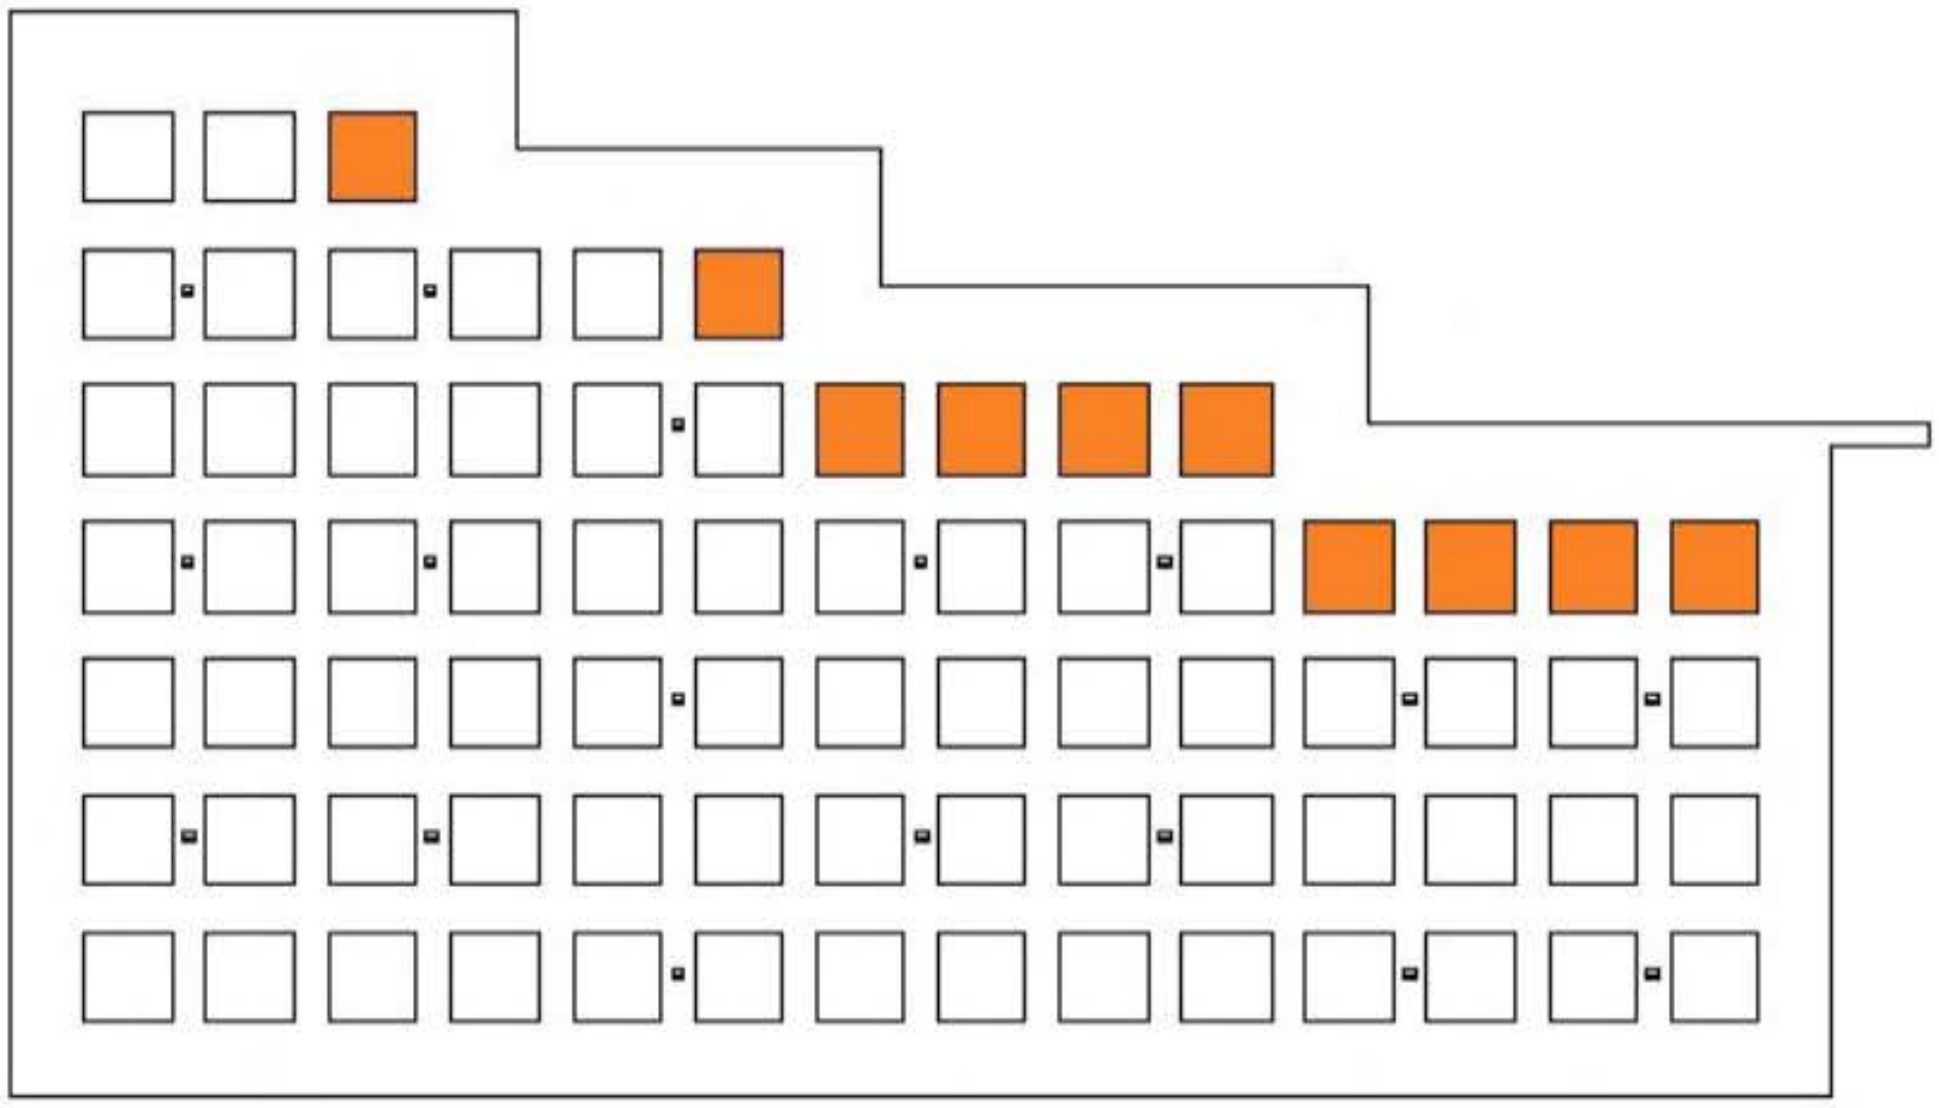
Since delivery of the ten Document Packages, SCE Projects states that they have been reviewed satisfactorily therefore removing any risk to the acceptability of the ten CEC Lids. The diagram below shows the location of the ten CEC Lids.

Since the dual storage requirement for QA Records was met and the remaining issue was the review of the CEC Lid and MPC-37 Document Packages and the waiving of the witness point. At the time of shipping of the last ten CEC Lids and MPC-37, the Document Packages had not been reviewed by SCE's on-site third-party QC personnel (IQC). The review of the CEC Lid and MPC-37 Document Packages was a QC witness point, based on emails from IQC, and as such needed to be formally waived by SCE for the CEC Lids and the MPC to be shipped. It was stated that SCE Engineering waived the witness point and the Lids were delivered to the job site and installed on the respective CECs at risk and the MPC was placed in the Lot 4 Holding area..
