UNITED STATES
NUCLEAR REGULATORY COMMISSION
WASHINGTON, D. C. 20555

May 16, 1980

CRACKING IN LOW PRESSURE TURBINE DISCS

SUBJECT: MEETING WITH GENERAL ELECTRIC RELATED TO TURBINE DISC CRACKS

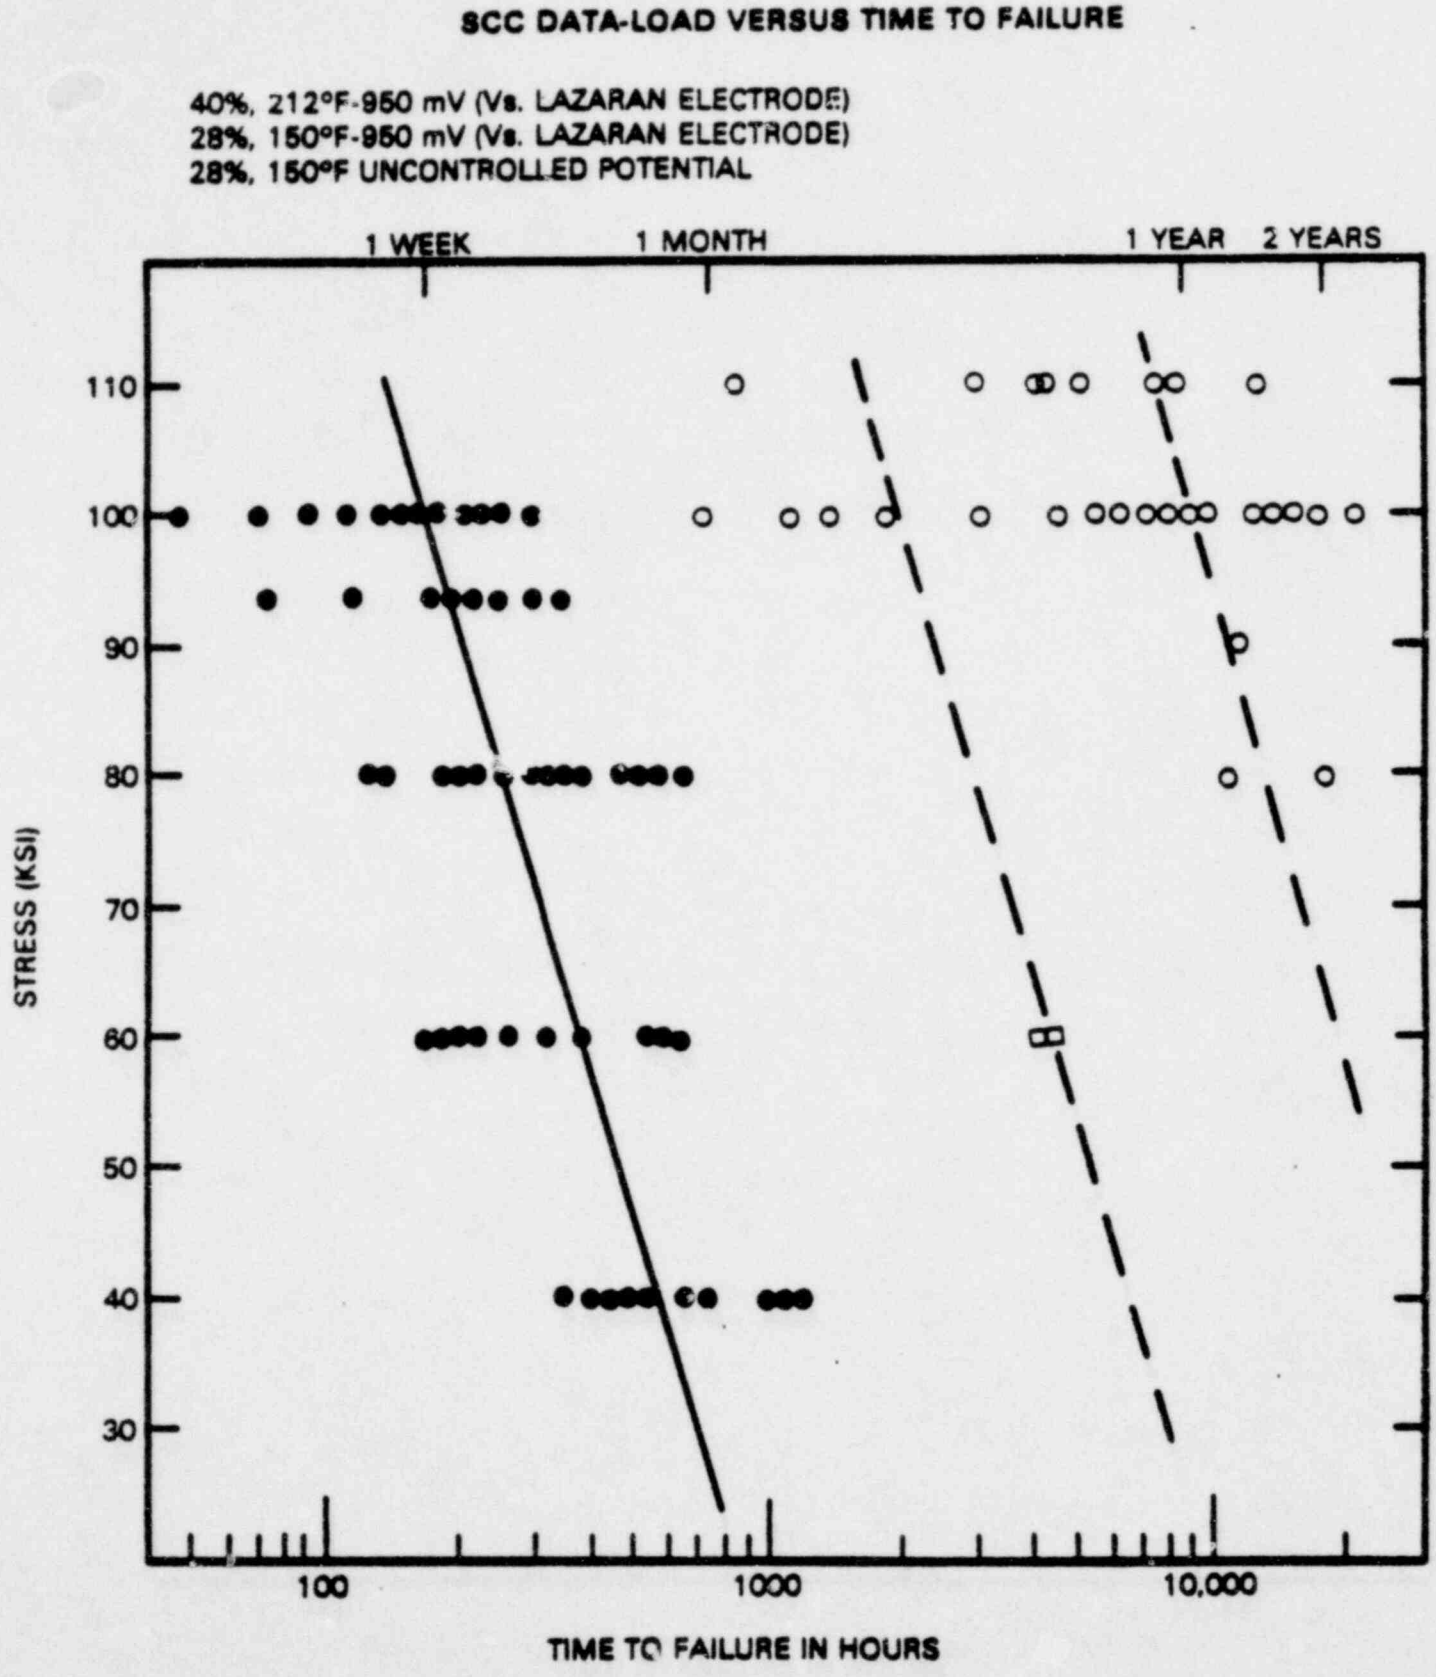
A considerable number of testing procedures have been utilized to investigate the resistance of NiCrMoV steels to stress corrosion cracking. Figure 1 shows results from dead weight load tests performed in caustic solutions under various conditions. Figure 2 illustrates the test apparatus with the environmental container removed so the smooth tensile type specimens can be observed. Scanning electron micrographs of a wheel material tested to failure in caustic are shown in Figure 3.

FIGURE 1. TIME TO FAILURE VERSUS APPLIED STRESS FOR WHEEL MATERIALS IN CAUSTIC. THE SOLID LINE IS THE LEAST SQUARES FIT TO THE 212°F, 40% CAUSTIC DATA. THE DOTTED LINES ARE DRAWN PARALLEL TO THE SOLID LINE AND ROUGHLY THROUGH THE MEAN FOR THE OTHER TWO CONDITIONS TO ILLUSTRATE THE EFFECT OF CHANGING CONDITIONS ON TIME TO FAILURE.

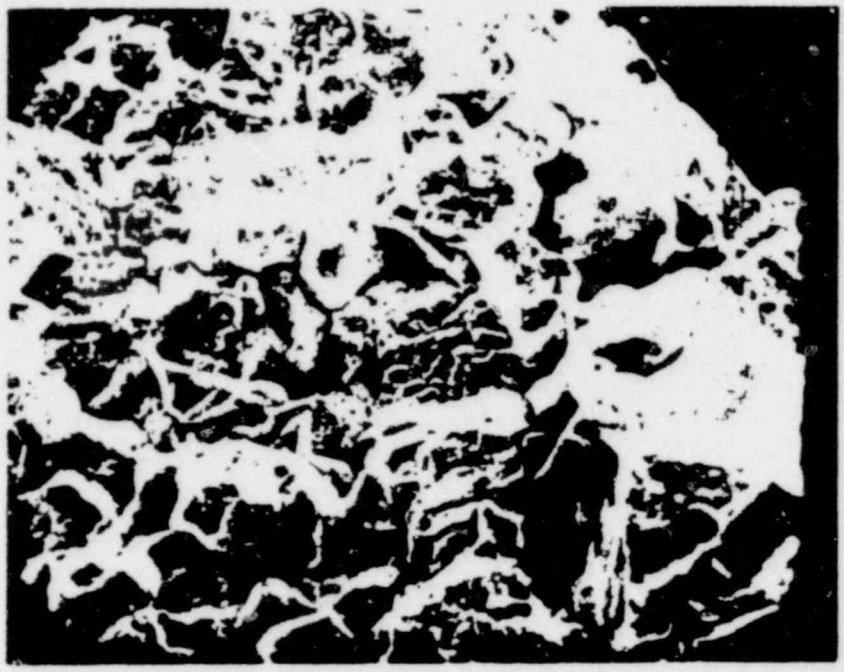
Figure 3: Scanning electron micrographs of NiCrMoV sample. Micrograph (a) shows intergranular SCC near edge. Micrograph (b) shows transgranular tear at center of micrograph (a).

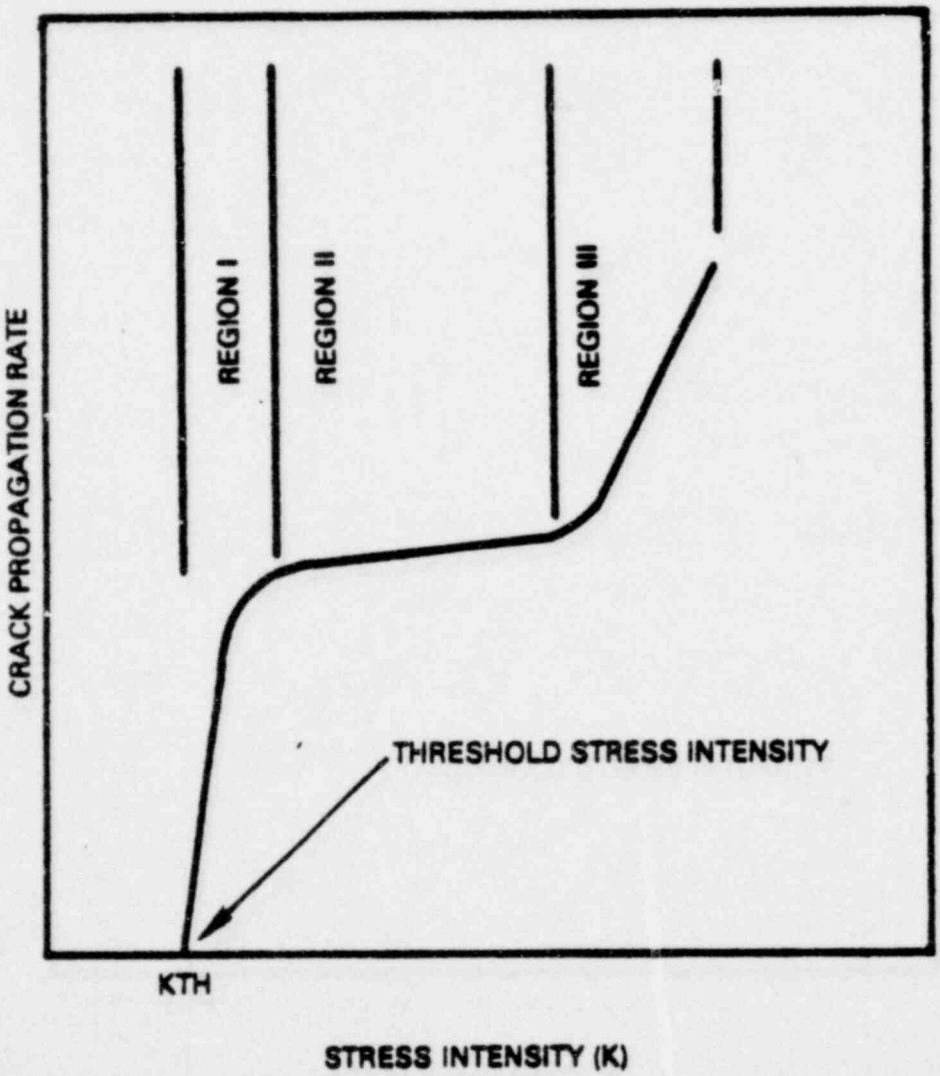
Quantative measurements of the stress corrosion crack propagation rate in wheel alloys have been made using fracture mechanics type specimens (Figure 4). Generally, stress corrosion crack growth rates are depicted by plots of the type shown in Figure 5. The crack propagation rate is plotted versus the crack tip stress intensity factor, which is a function of the applied stress, the crack size and the geometry. A family of such curves are necessary to describe the variation of crack propagation rate with corrosion potential, temperature and caustic concentration.

Of particular interest are the threshold stress intensity (K_{th}), the plateau or second stage, and the third stage of crack growth. The threshold stress intensity is the limit below which stress corrosion cracks will not propagate. The plateau or second stage is the region of relatively stable crack growth, over a range of stress intensity. Crack growth in region 3 is sharply accelerated as the crack tip stress intensity increases. Testing in the laboratory under controlled conditions has indicated that the threshold stress intensity in caustic is low, and in fact may be virtually non-existent. Figure 6 shows the typical range of stage 2 crack propagation rates versus temperature measured on wheel materials in 40% NaOH and maintained near the optimum corrosion potential to accelerate crack growth.

FIGURE 5: STRESS CORROSION CRACK GROWTH CURVE

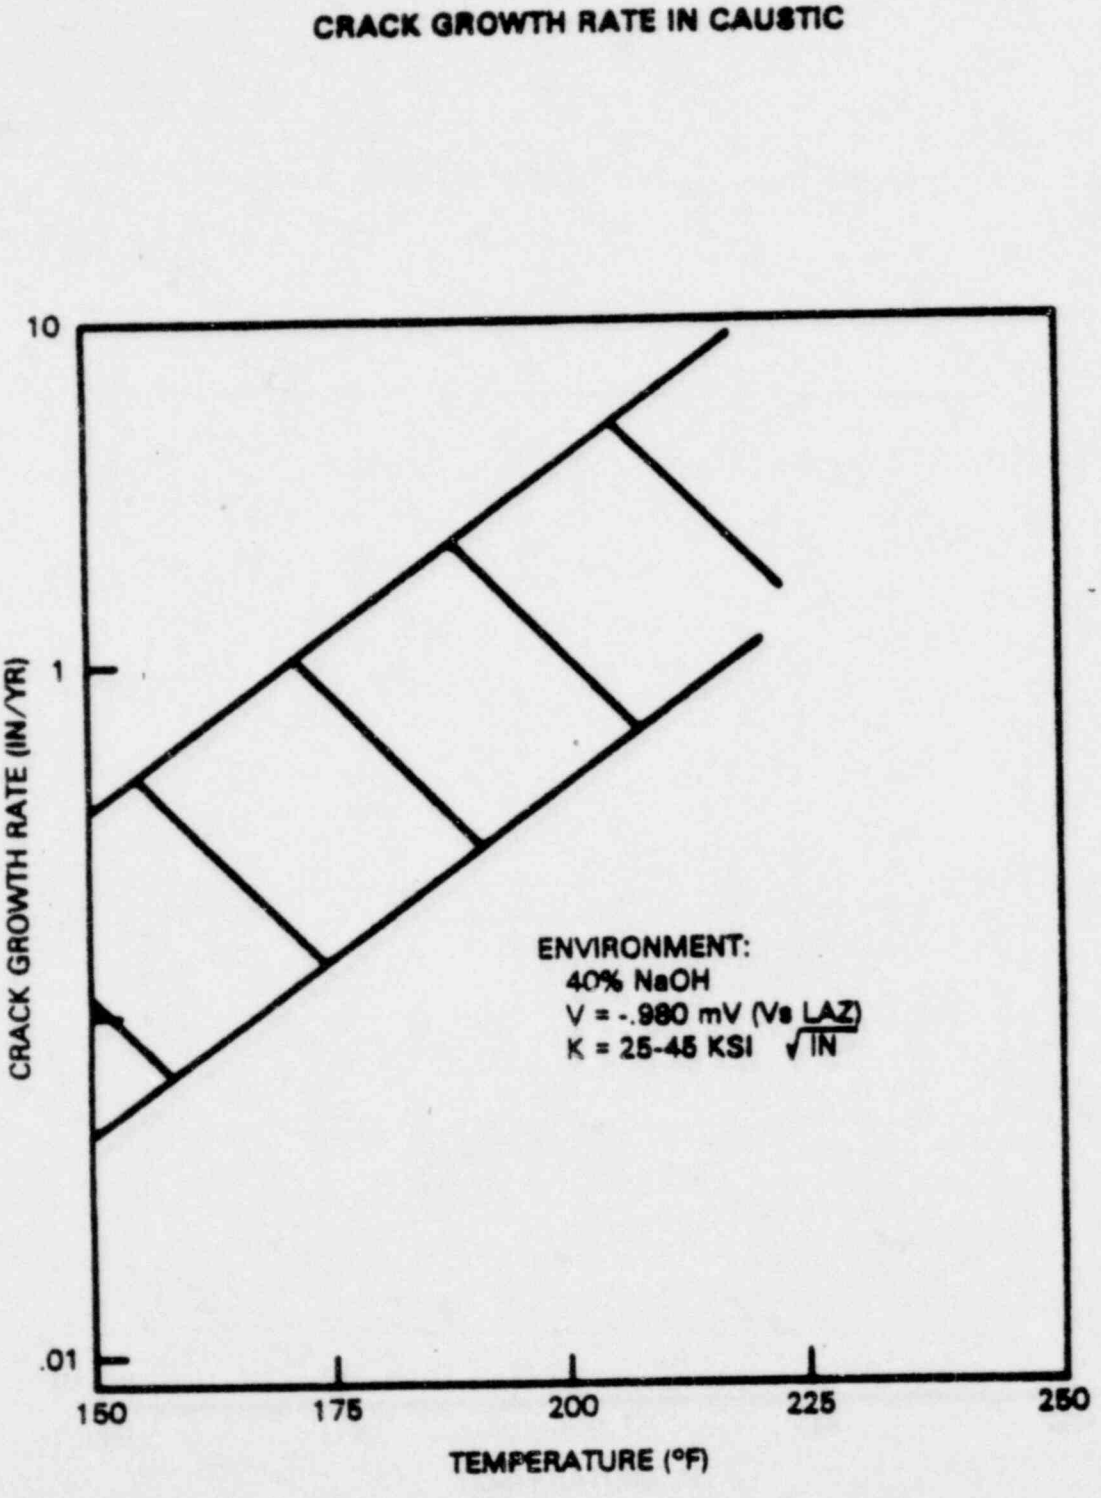
FIGURE 6: MEASURED STRESS CORROSION CRACK GROWTH RATE (REGION II) VERSUS TEMPERATURE FOR NiCrMoV WHEEL MATERIALS. CORROSION POTENTIAL MAINTAINED NEAR OPTIMUM.

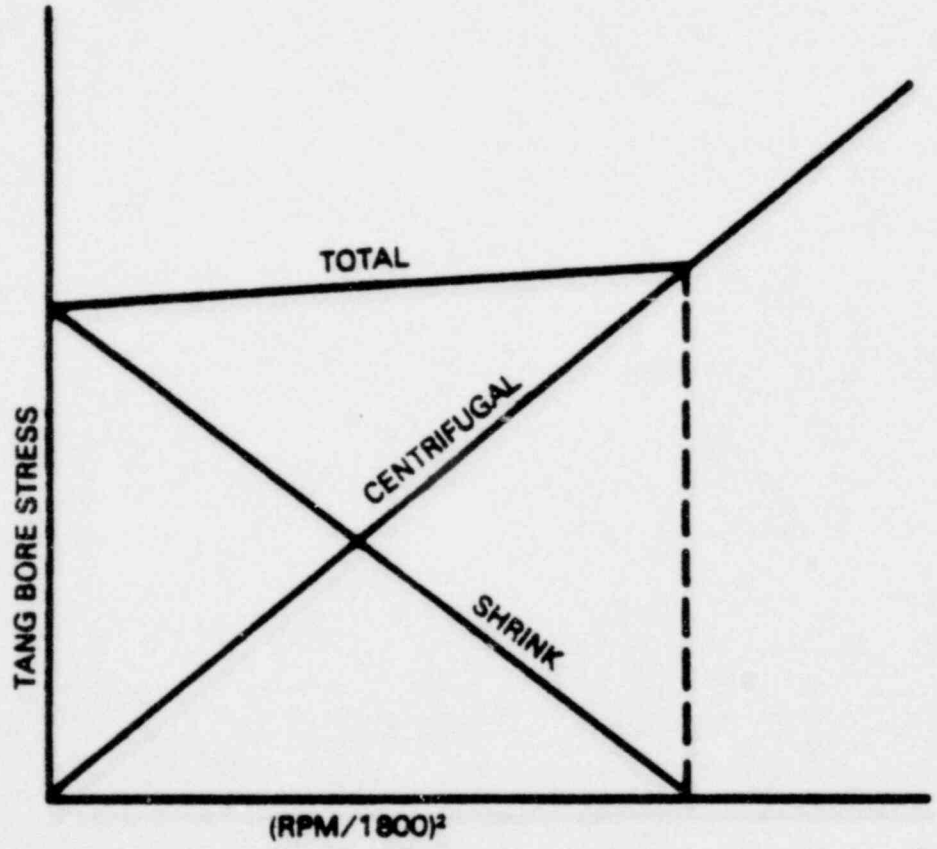
In the bore region of shrunk-on wheels, induced stresses principally result from interference between the wheel and shaft, and the centrifugal forces of the buckets and wheel. Figure 7 shows the variation of tangential bore stress with rotational speed. The total stress, which is the sum of the shrink and centrifugal stresses is reasonably constant up to the speed at which shrink is lost. Centrifugal stresses have been minimized in General Electric wheels by optimizing the wheel shapes and mounting only one row of buckets on each wheel. Reducing centrifugal stresses lowers the magnitude of shaft-to-wheel interference necessary to maintain shrink at normal operating speed. Thermal stresses induced by steady state and transient steam conditions are generally small in comparison with shrink and centrifugal stresses.

FIGURE 7: SHRUNK-ON WHEEL NOMINAL BORE STRESS

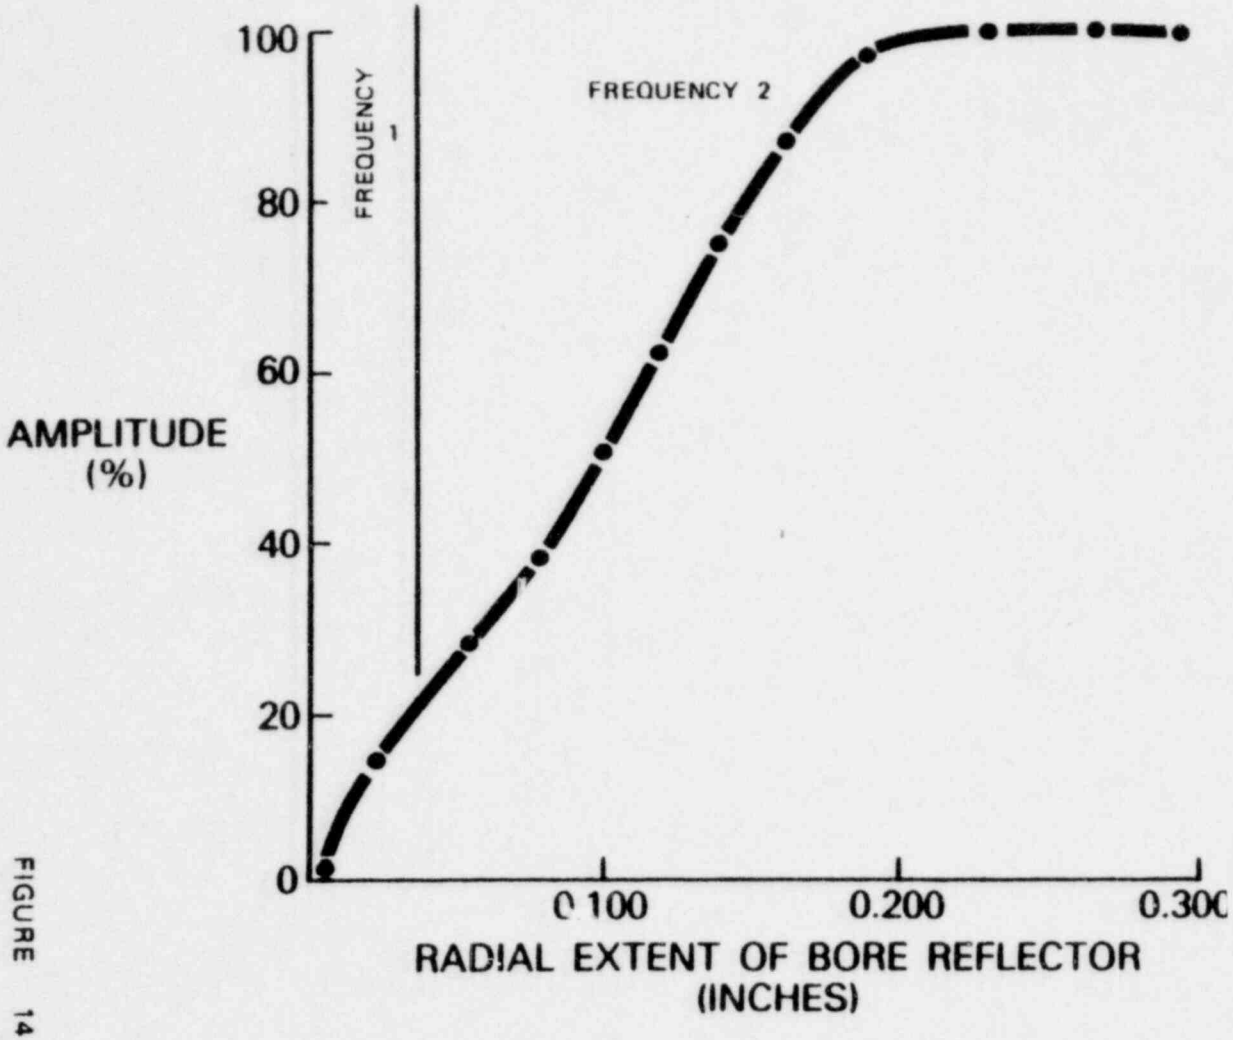
FIGURE 14

While developing this procedure, it was found that score marks which are sometimes produced on wheel boresduring the rotor assembly may produce disproportionately large ultrasonic indication amplitudes. A means of discriminating these signals from crack signals was obviously required. It was found that different test frequencies produced a more proportionate response to flaw size. Consequently, a dual frequency technique was adopted as shown in Figure 14.

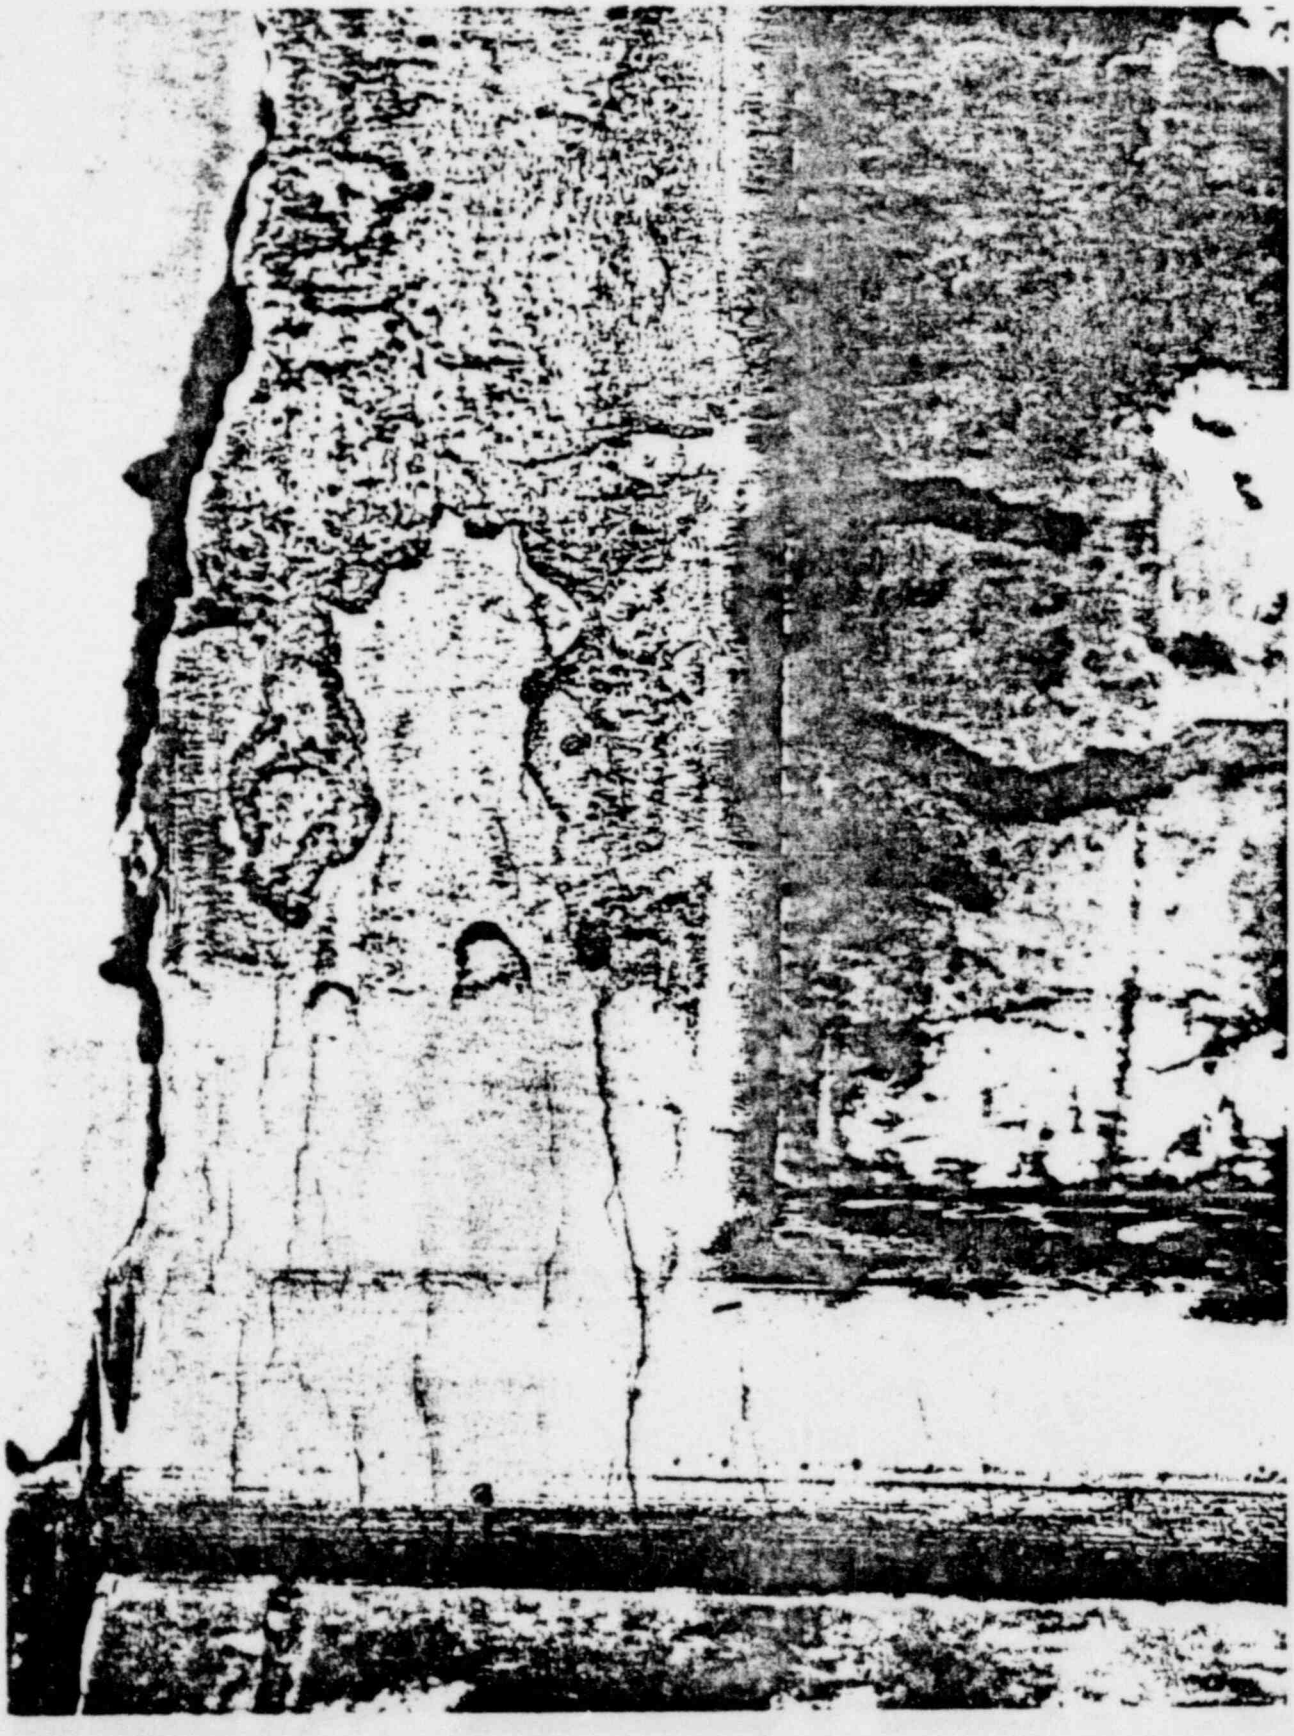
FIGURE 18

To date, a total of three wheels and two large rings have been artifically cracked. The first wheel was exposed to 40% caustic for approximately one year and later broken open (Figure 17 and 18). Ultrasonic indication amplitudes equal to that of the keyway itself were observed from these cracks as shown in Figure 19 and 20. The deepest crack in this wheel was 1 1/4 inch (32 mm). Numerous smaller cracks with approximately 1/4" (6.4 mm) depth were also present near the axial end of the keyway and were detected from the wheel hub.

STRESS CORROSION CRACK IN KEYWAY

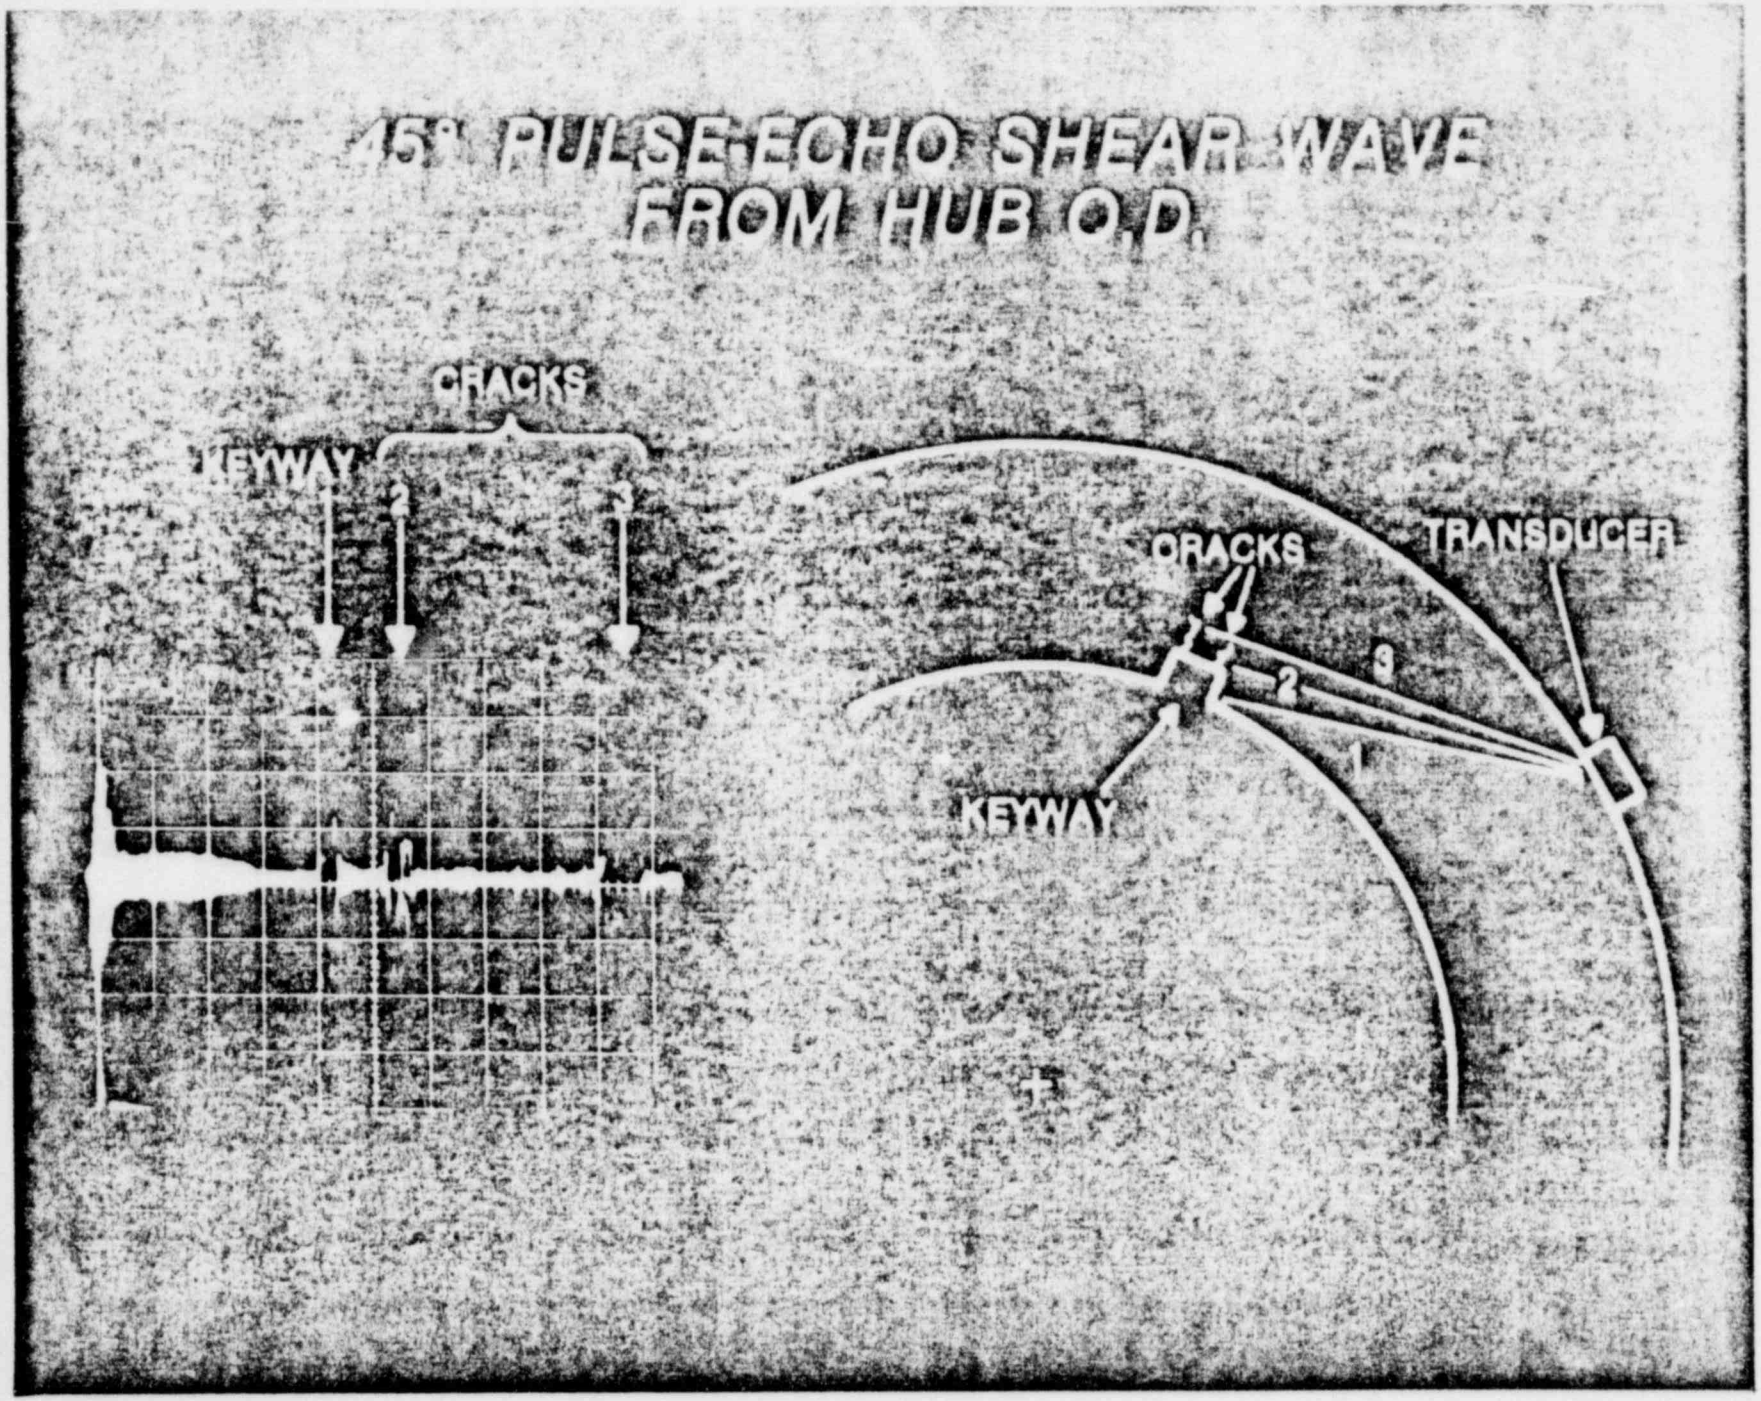
FIGURE 19

45° PULSE-ECHO SHEAR WAVE
FROM HUB O.D.
CRACKS
KEYWAY
CRACKS
TRANSDUCER
KEYWAY

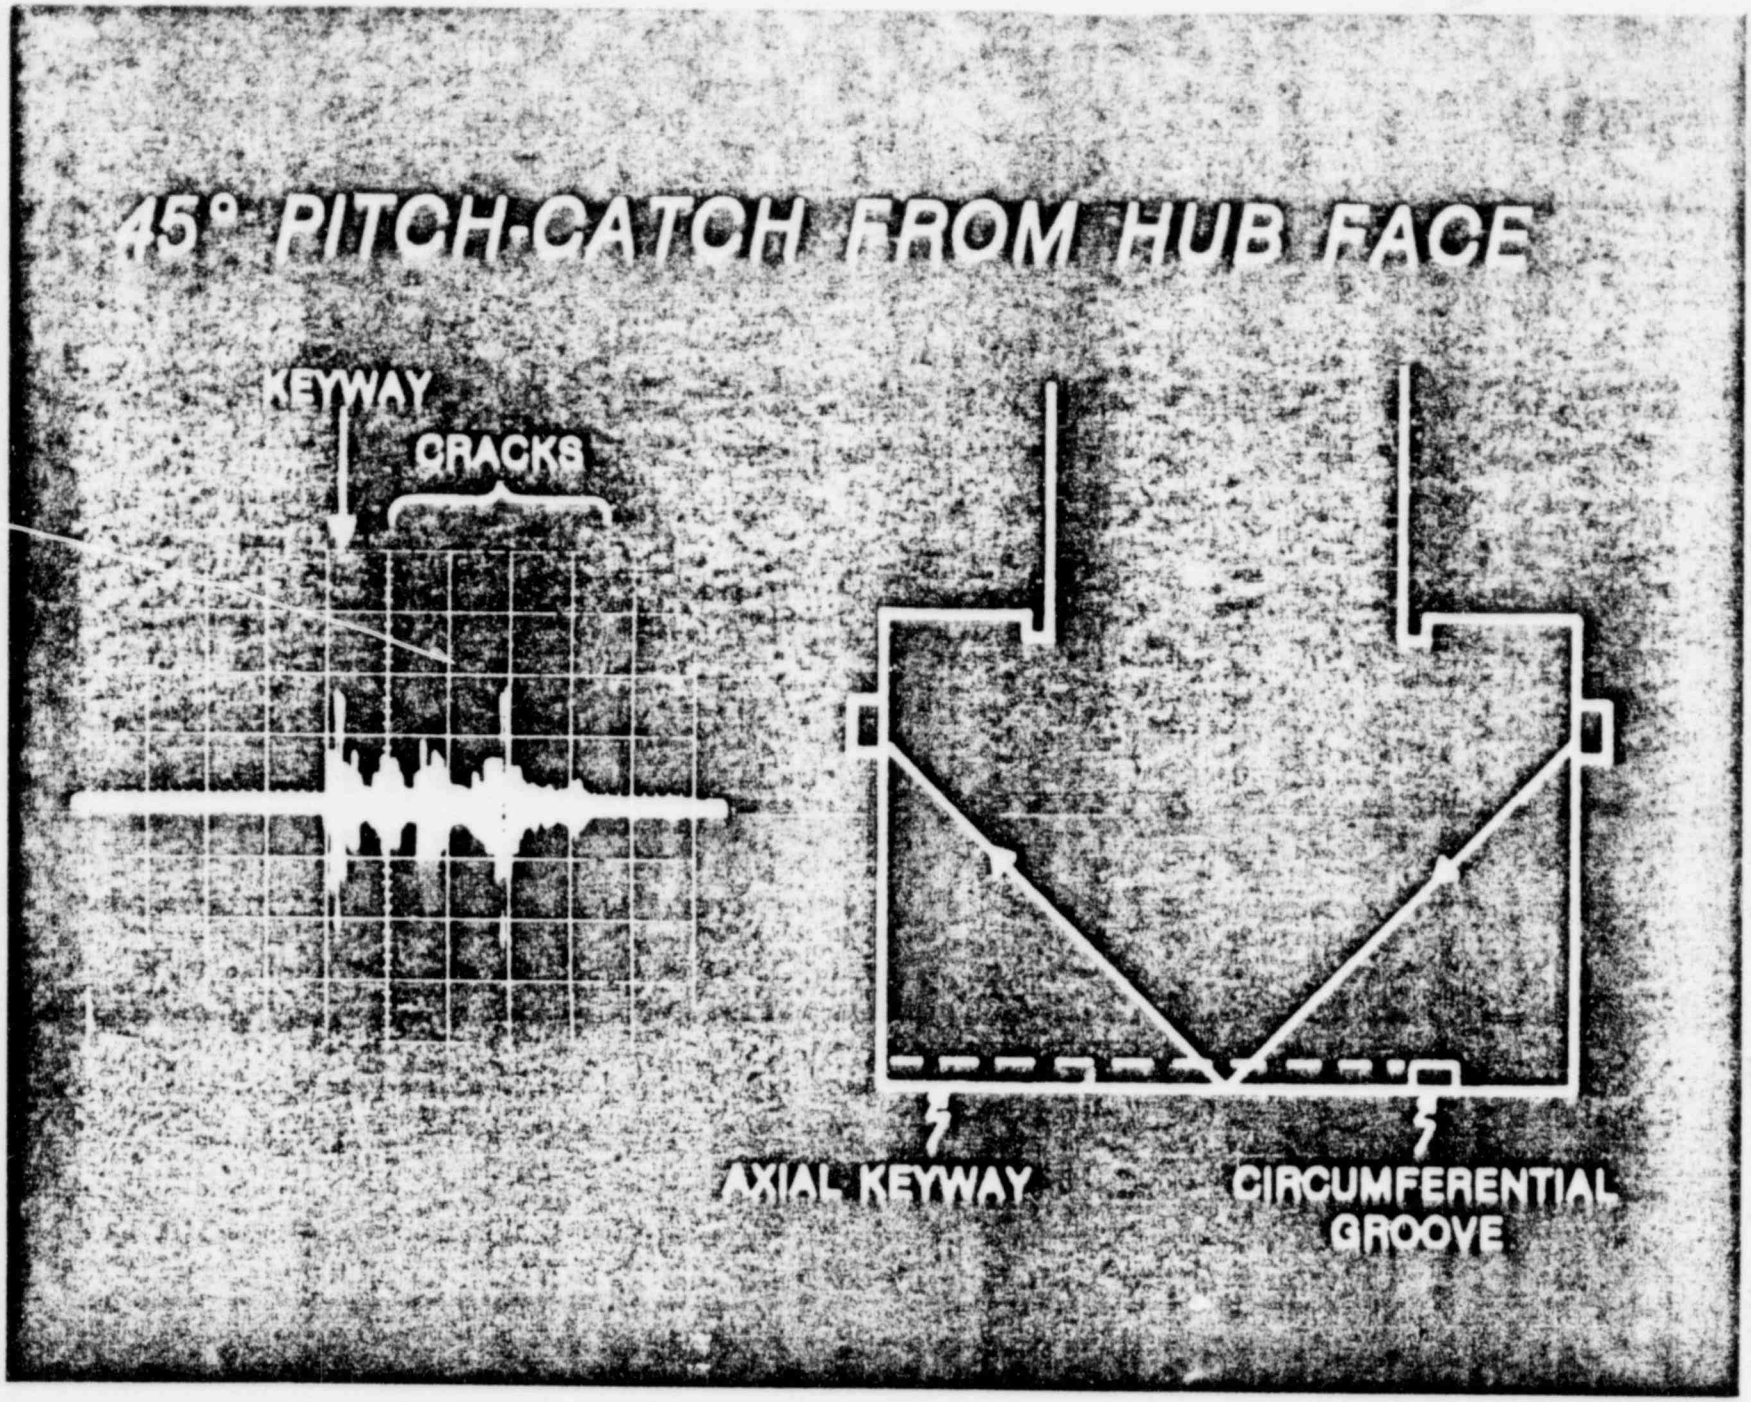
FIGURE 20

45° PITCH-CATCH FROM HUB FACE
KEYWAY
CRACKS
AXIAL KEYWAY
CIRCUMFERENTIAL GROOVE

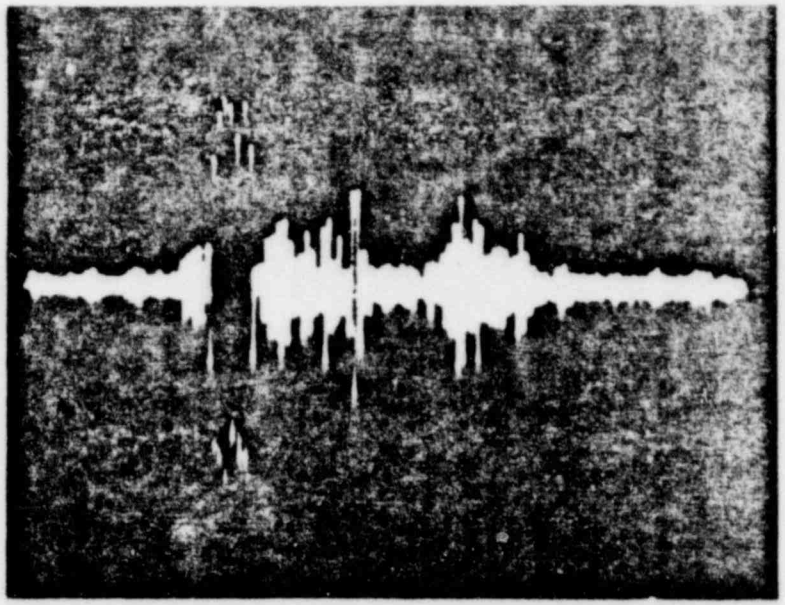
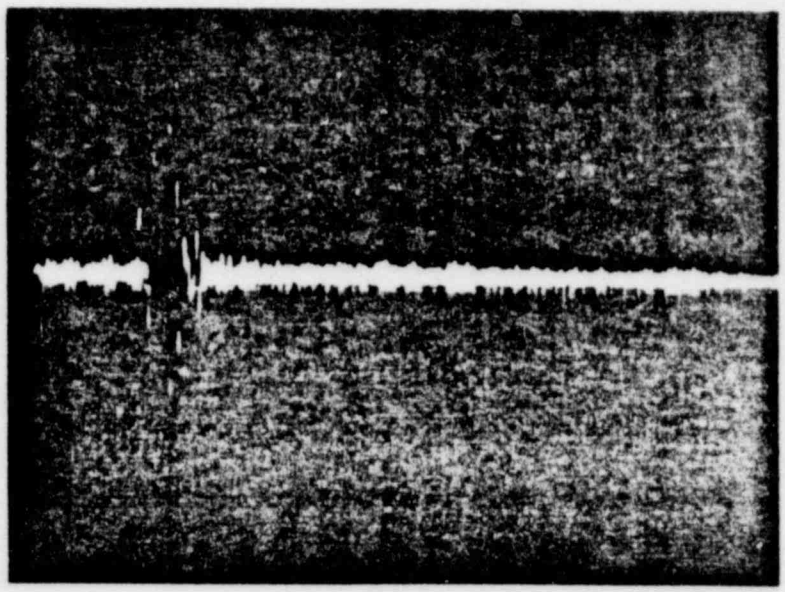
FIGURE 21

exposure, ultrasonic tests of the wheel revealed significant cracking (Figure 21). A section containing the keyway was removed and magnetic particle tested (Figure 22) revealing an extensive network of cracks.

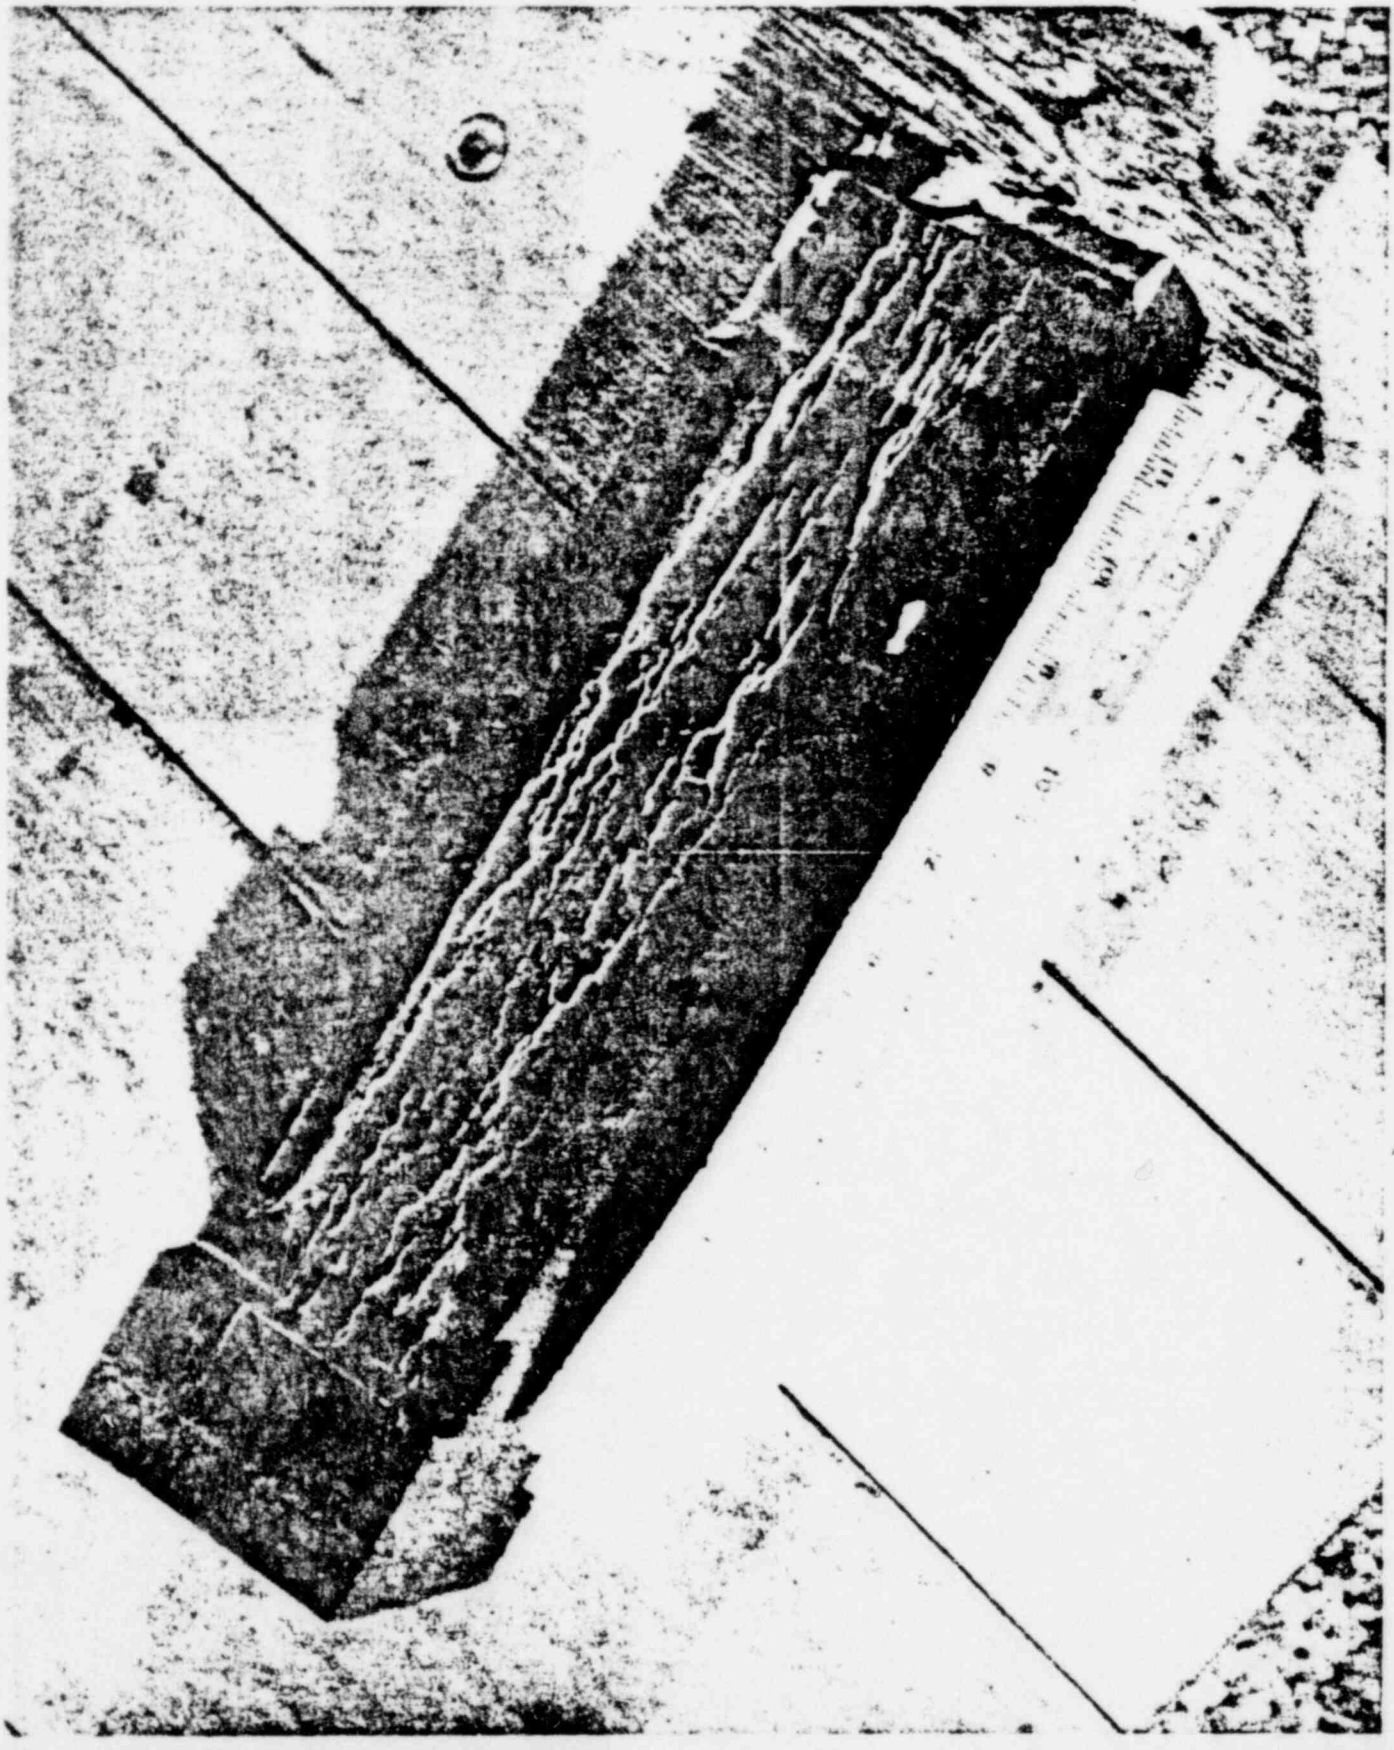
FIGURE 22

STRESS CORROSION CRACKS IN KEYWAY
