UNITED STATES
NUCLEAR REGULATORY COMMISSION
WASHINGTON, D. C. 20555

May 16, 1980

CRACKING IN LOW PRESSURE TURBINE DISCS

SUBJECT: MEETING WITH GENERAL ELECTRIC RELATED TO TURBINE DISC CRACKS

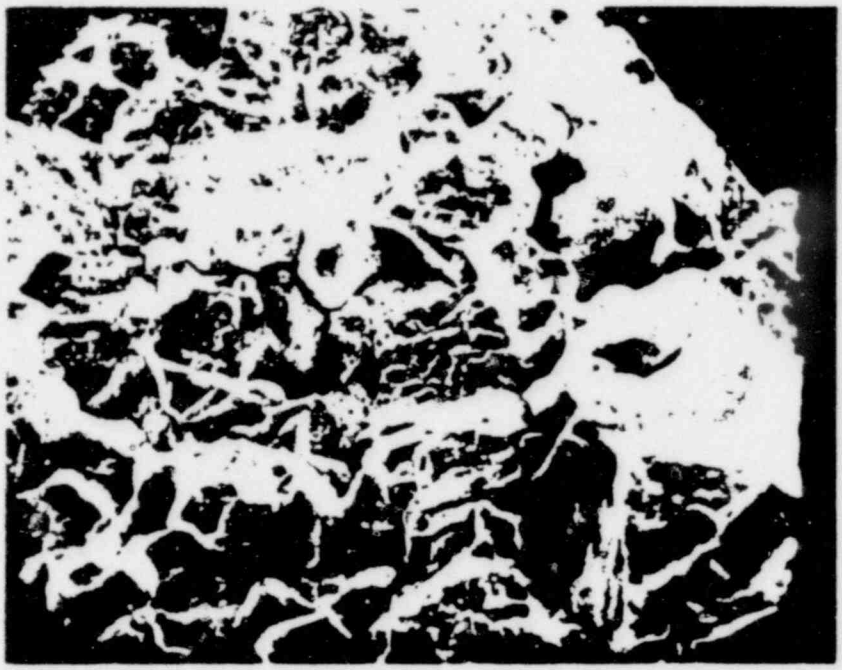
Figure 3: Scanning electron micrographs of NiCrMoV sample. Micrograph (a) shows intergranular SCC near edge. Micrograph (b) shows transgranular tear at center of micrograph (a).

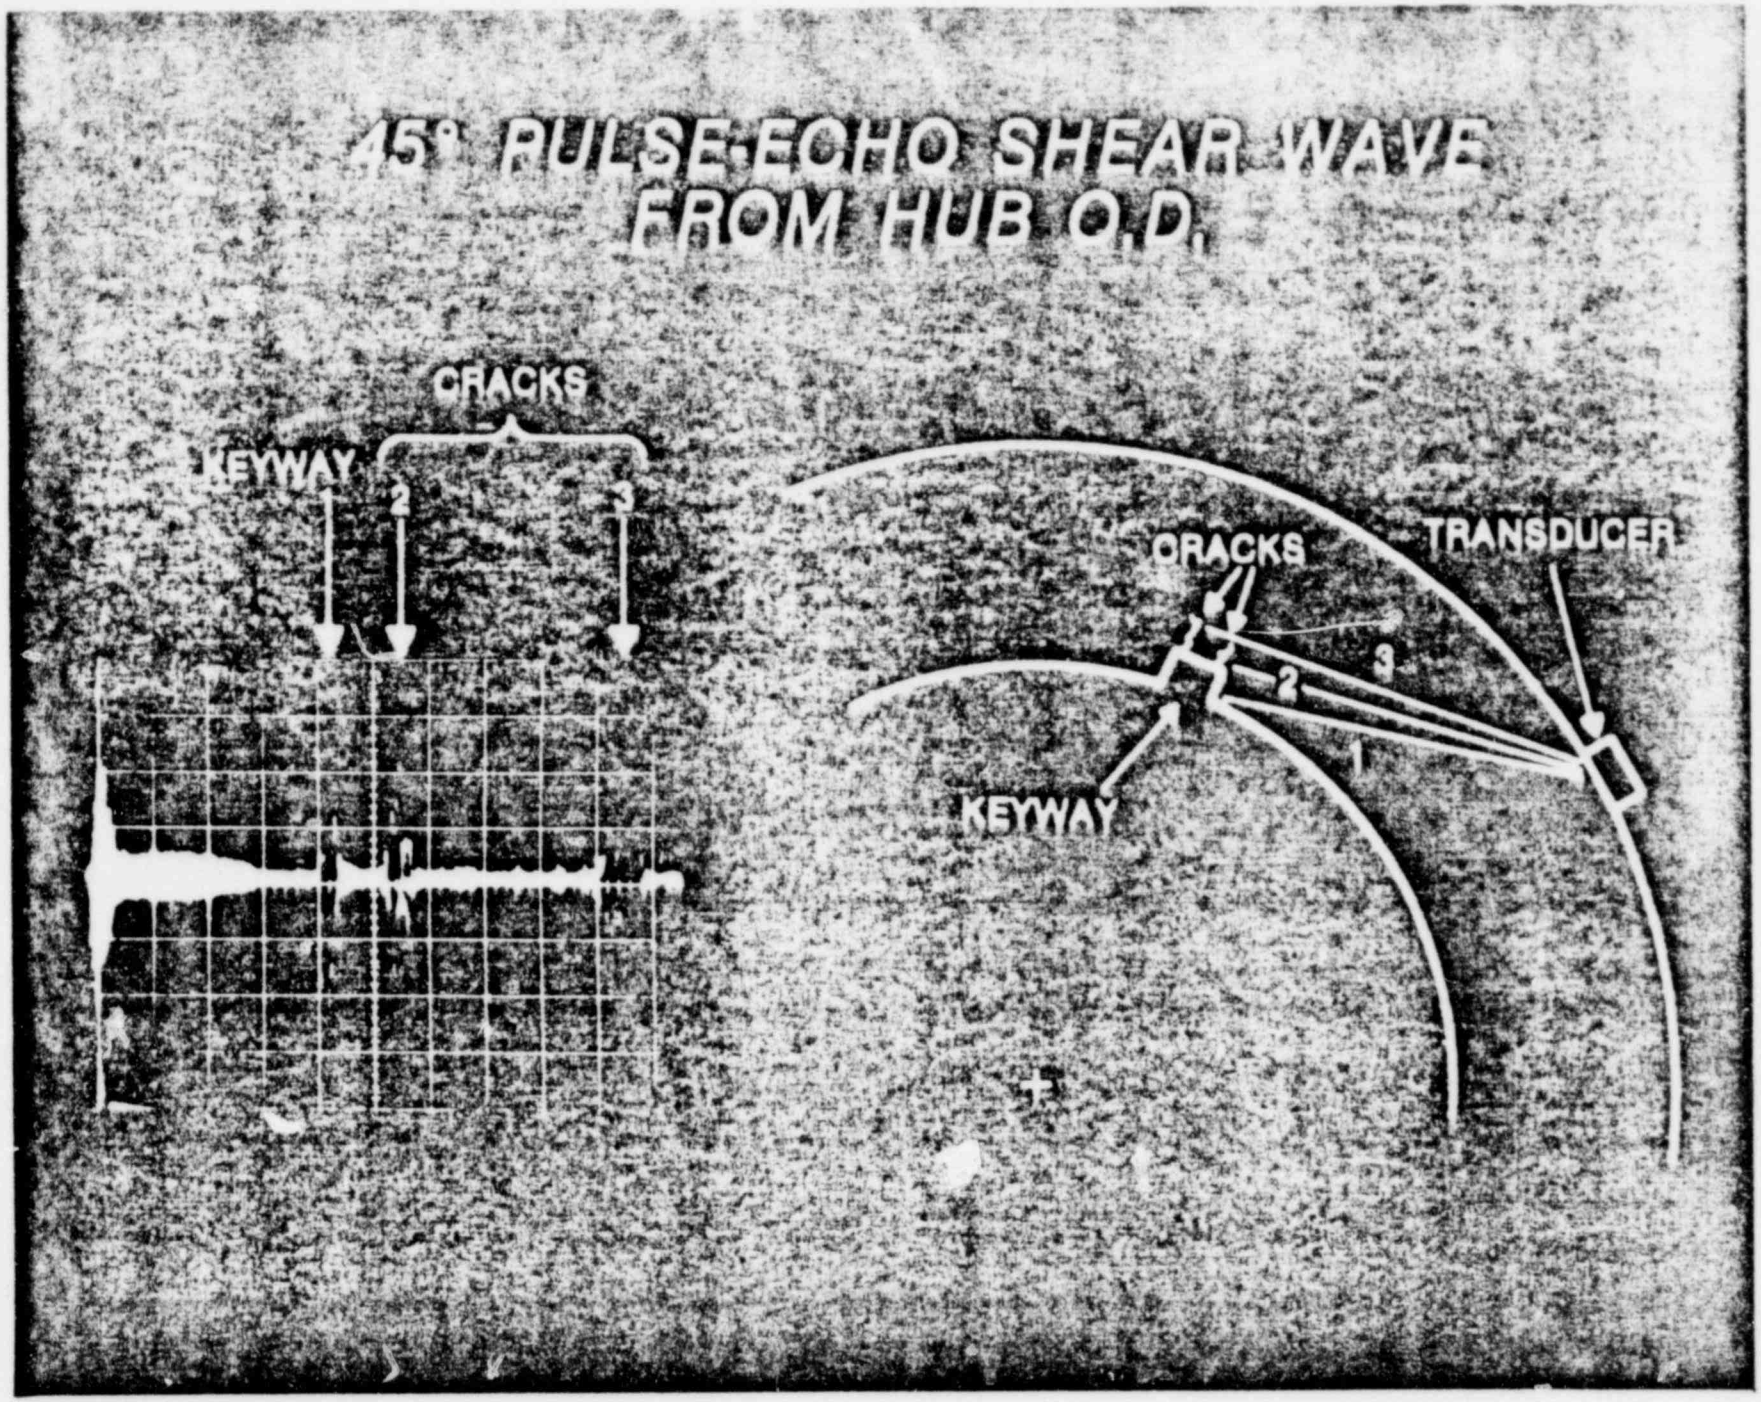
FIGURE 19

To date, a total of three wheels and two large rings have been artifically cracked. The first wheel was exposed to 40% caustic for approximately one year and later broken open (Figure 17 and 18). Ultrasonic indication amplitudes equal to that of the keyway itself were observed from these cracks as shown in Figure 19 and 20. The deepest crack in this wheel was 1 1/4 inch (32 mm). Numerous smaller cracks with approximately 1/4" (6.4 mm) depth were also present near the axial end of the keyway and were detected from the wheel hub.

45° PULSE-ECHO SHEAR WAVE
FROM HUB O.D.
CRACKS
KEYWAY
2
3
CRACKS
TRANSDUCER
3
2
1
KEYWAY

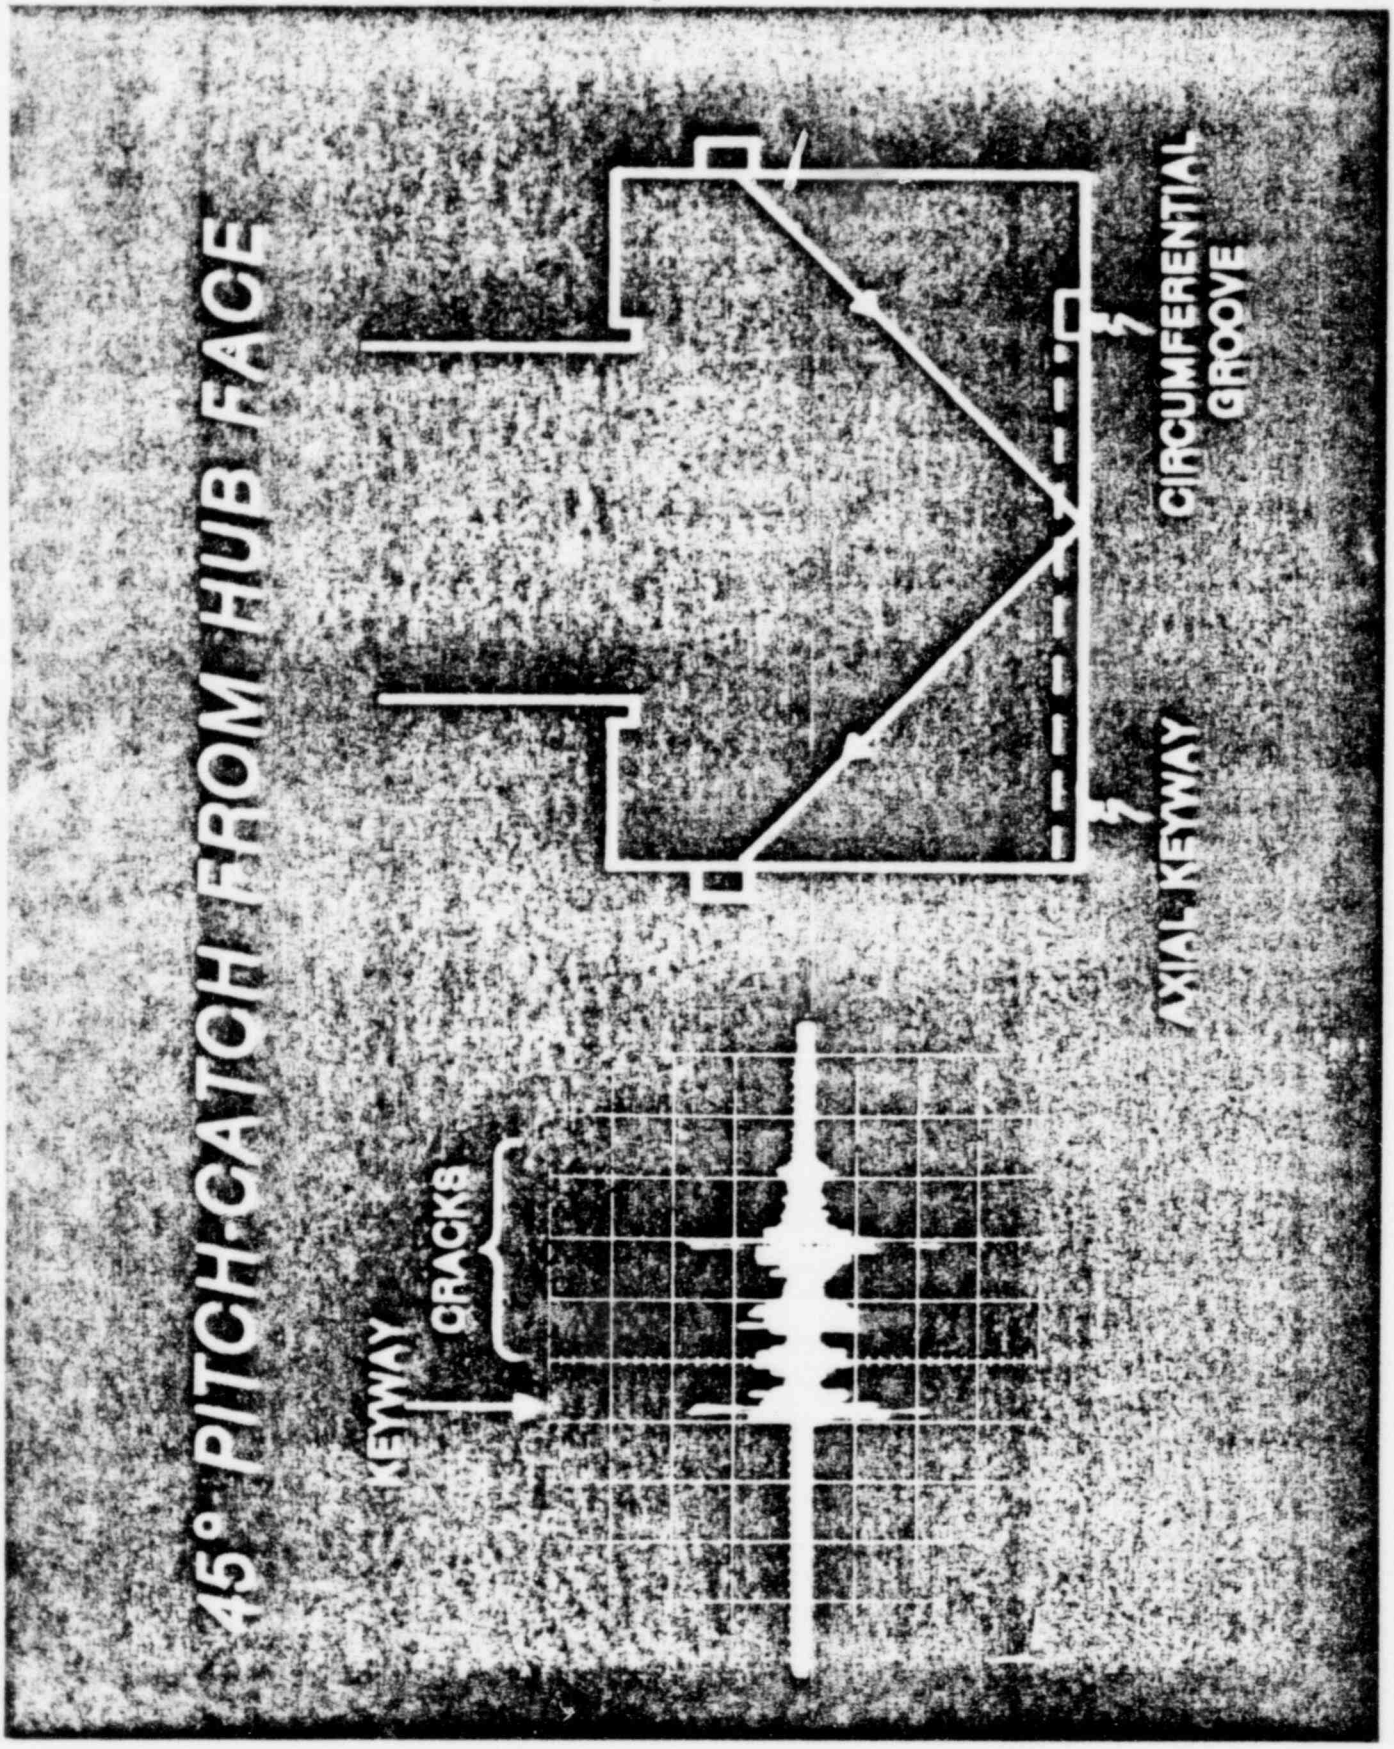
FIGURE 20

45° PITCH CATCH FROM HUB FACE
KEYWAY
CRACKS
AXIAL KEYWAY
CIRCUMFERENTIAL GROOVE

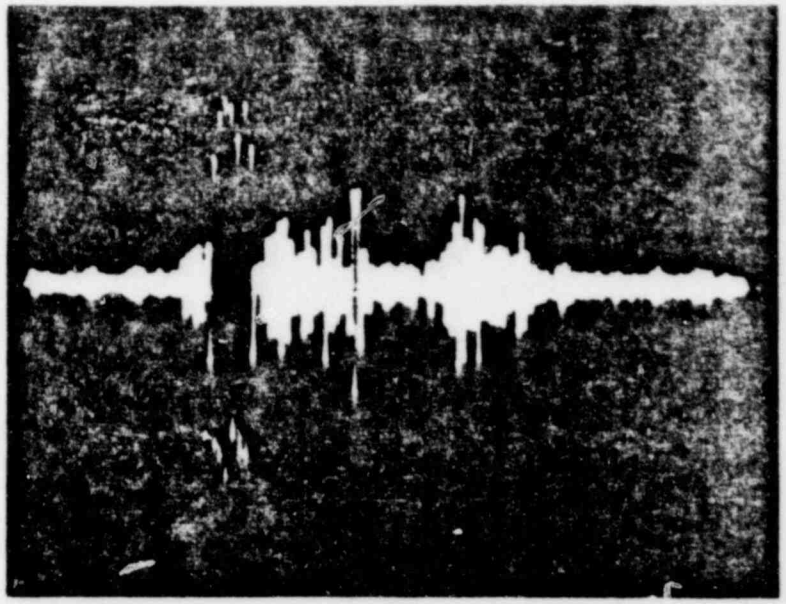
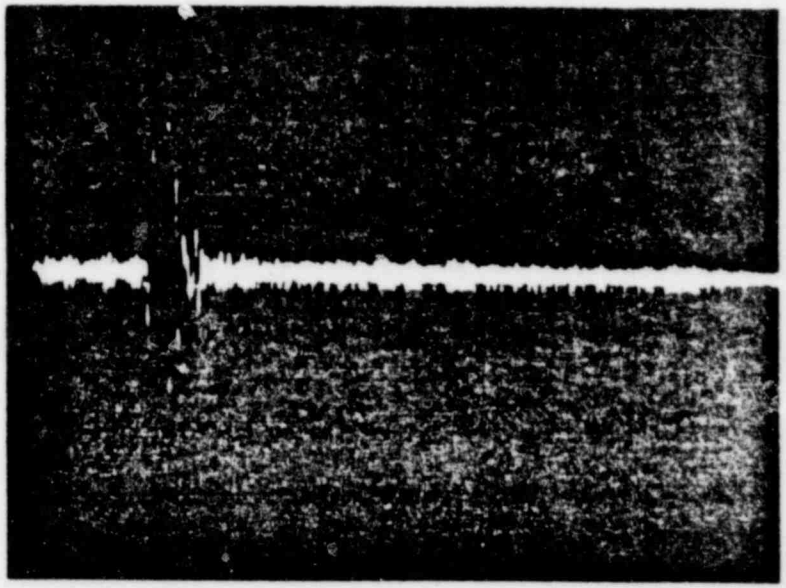
FIGURE 21

exposure, ultrasonic tests of the wheel revealed significant cracking (Figure 21). A section containing the keyway was removed and magnetic particle tested (Figure 22) revealing an extensive network of cracks.

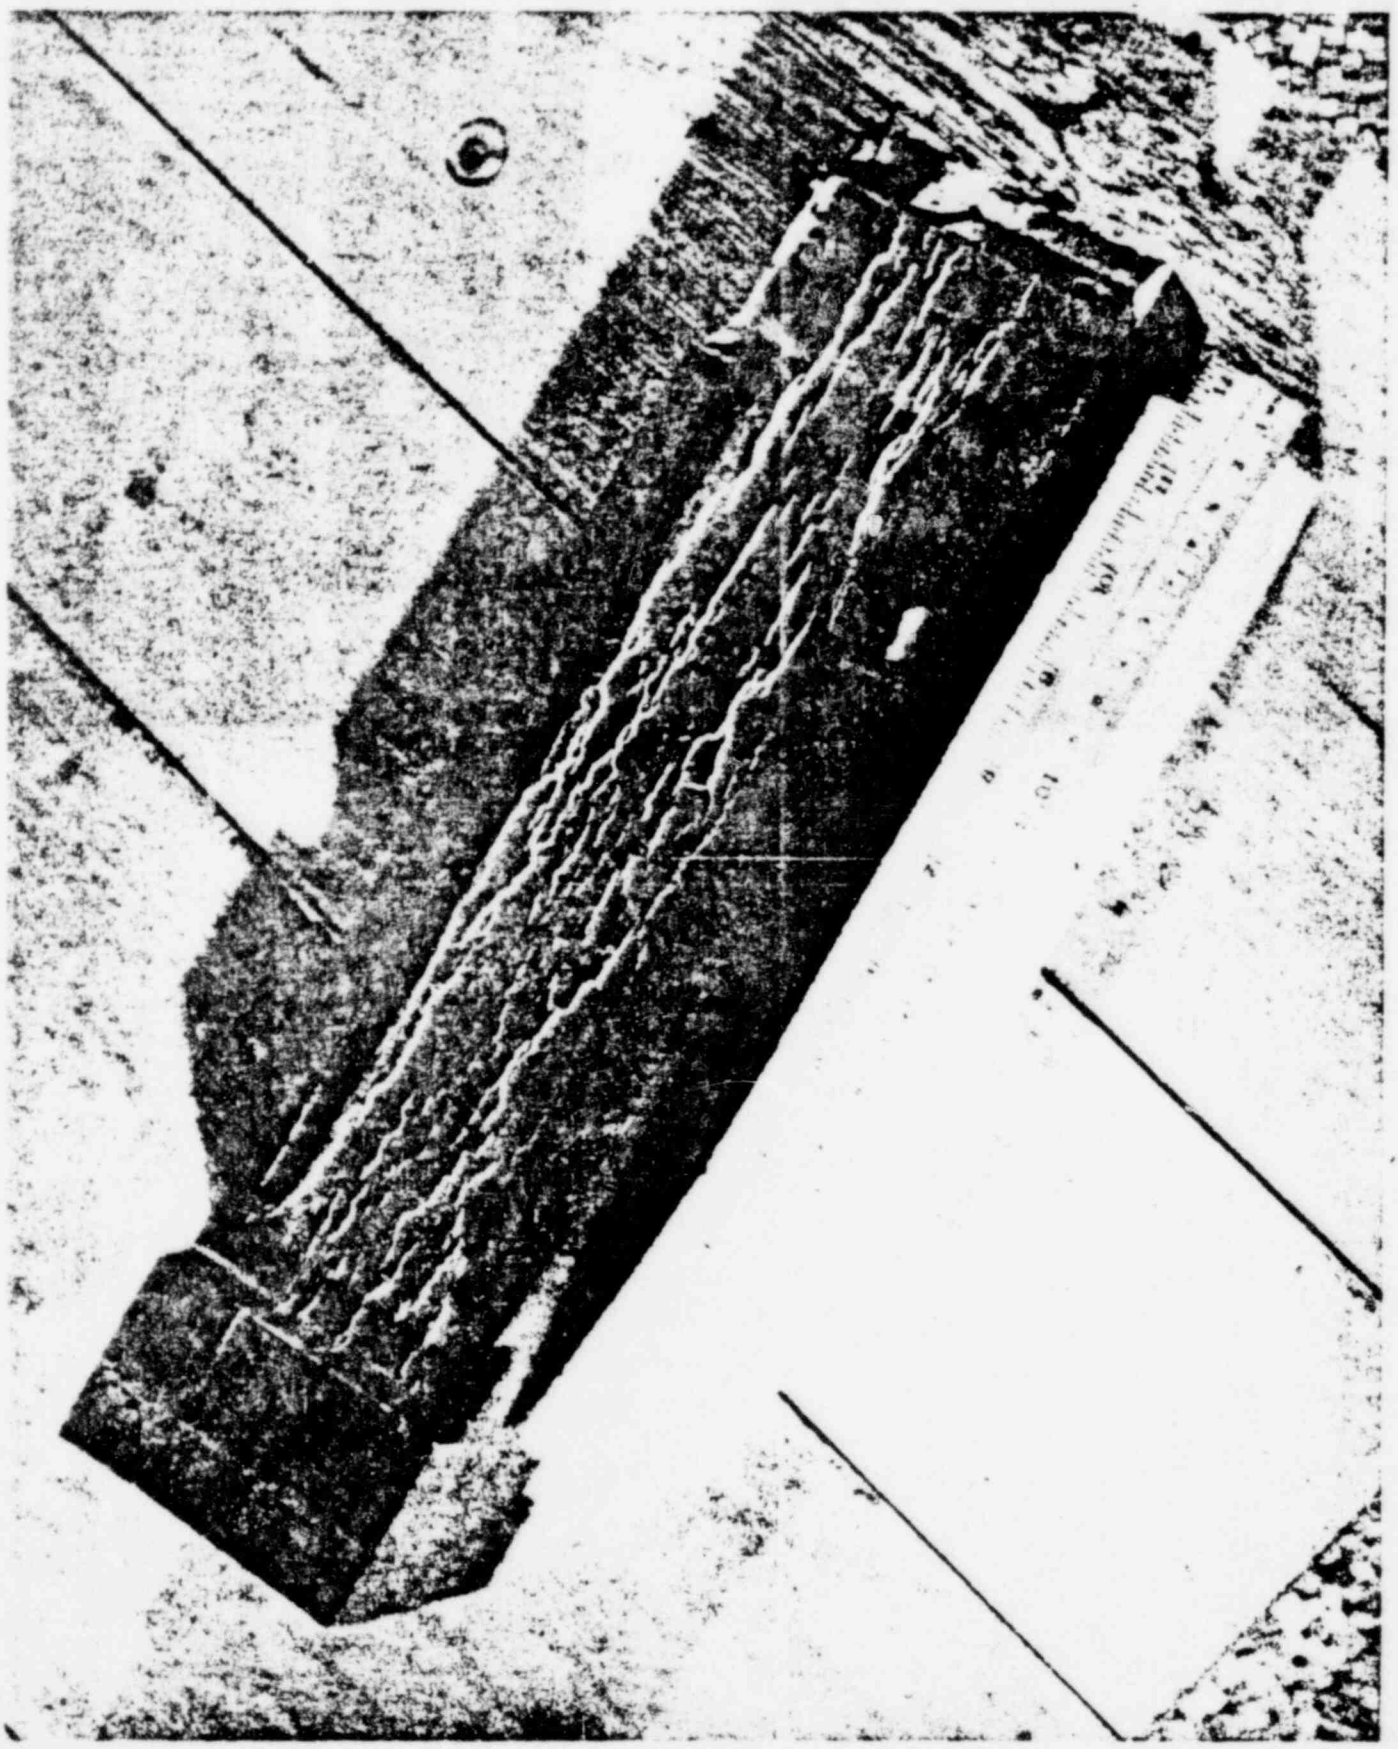
FIGURE 22

STRESS CORROSION CRACKS IN KEYWAY
