SDRC Report No. 11410-R1

SEISMIC QUALIFICATION REPORT
ON
AN ITE SERIES 5600 MOTOR CONTROL CENTER

Prepared for
CINCINNATI GAS & ELECTRIC CO.
COLUMBUS & SOUTHERN OHIO ELECTRIC CO.
DAYTON POWER & LIGHT CO.
P. O. BOX 960
CINCINNATI, OHIO 45201

AUGUST 29, 1982

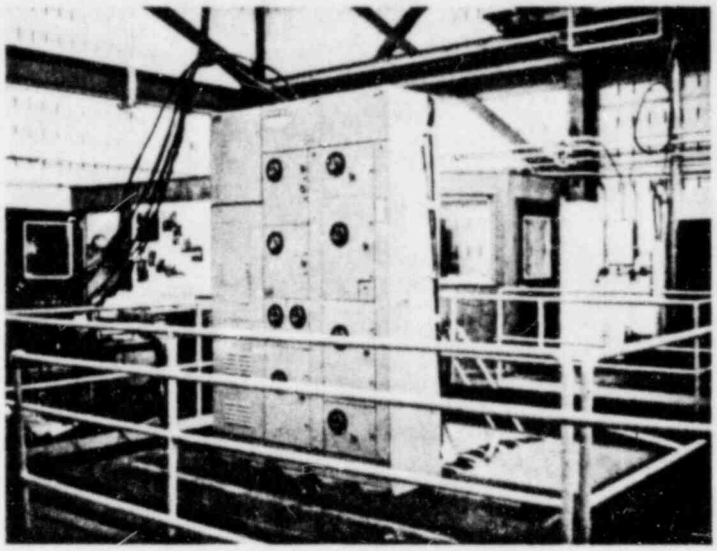
The mounting of the test specimen simulated the actual in-service mounting as closely as was practical. The specimen was mounted to the test table by welding it to a 1" thick plate which was bolted to the shake table. The welding pattern, which represents the as installed in-the-field condition, was 1 1/2 inch long, 3/16 inch leg fillet welds on 12 inch centers. Total number of welds was 12 (6 along front sill and 6 along rear sill). See Figures III.10 and III.11.

Figure III.10
Mounting of the Motor Control Center (MCC)
On the Triaxial Shake Table

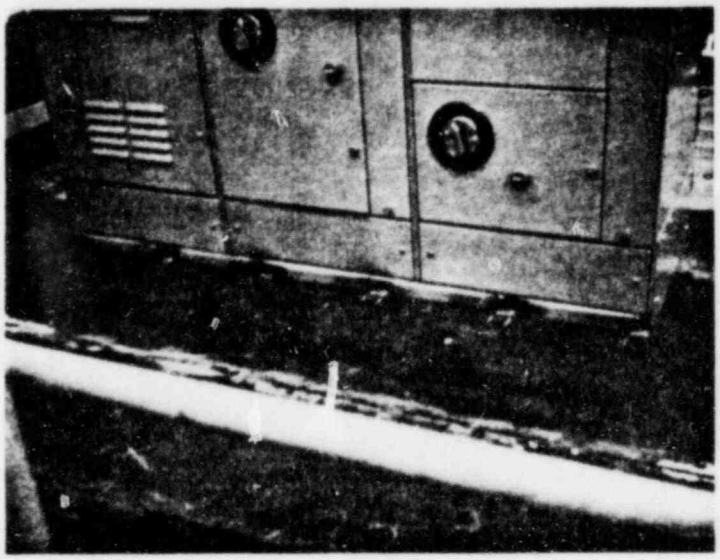
Figure III.11
Weld Pattern Used to Mount the
MCC to the Table

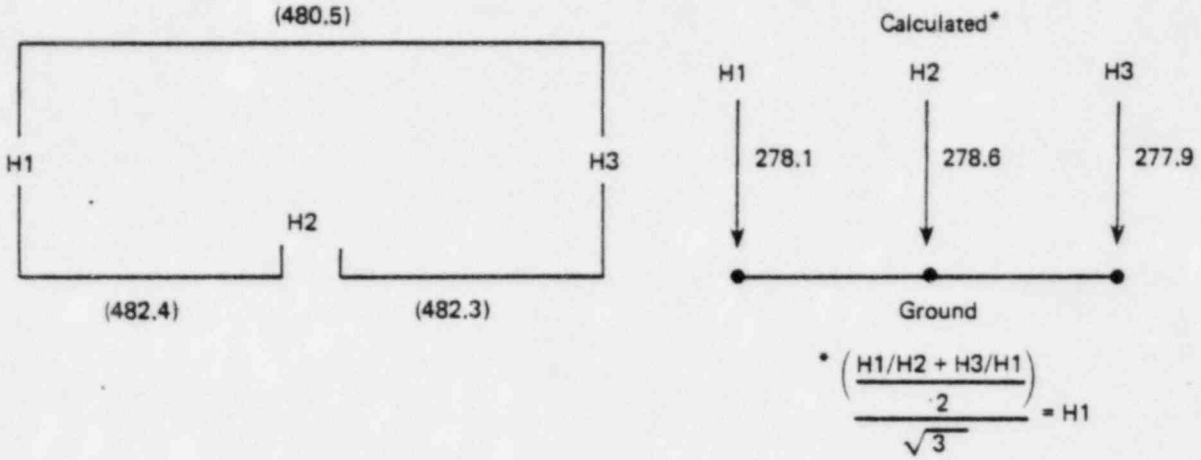
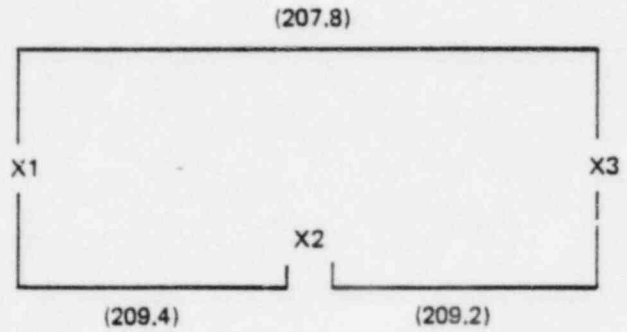
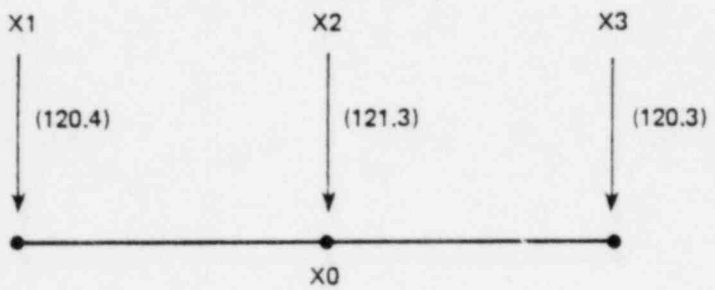
0 to 0 Ratios			0 to Ground Ratios		
H1–H2/X1–X2	H2–H3/X2–X3	H3–H1/X3–X1	H1/X1	H2/X2	H3/X3
2.3	2.3	2.3	2.3	2.3	2.3

Figure IV.12
Pre-Test Distribution Transformer

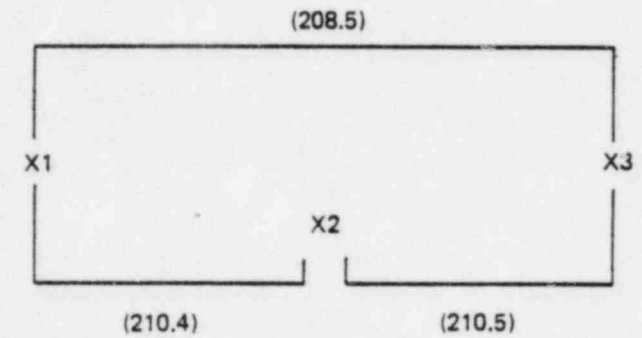
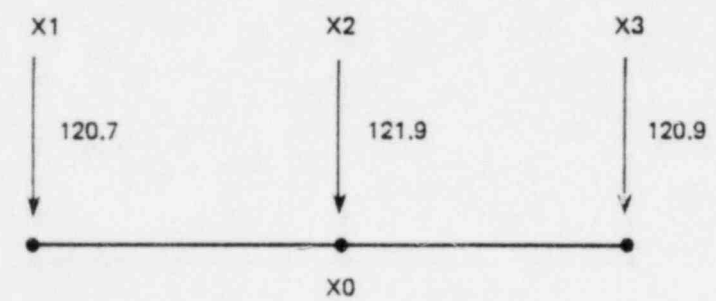
0 to 0 Ratios			0 to Ground Ratios		
H1–H2/X1–X2	H2–H3/X2–X3	H3–H1/X3–X1	H1/X1	H2/X2	H3/X3
2.3	2.3	2.3	2.3	2.3	2.3

Figure IV.13
Post-Test Distribution Transformer

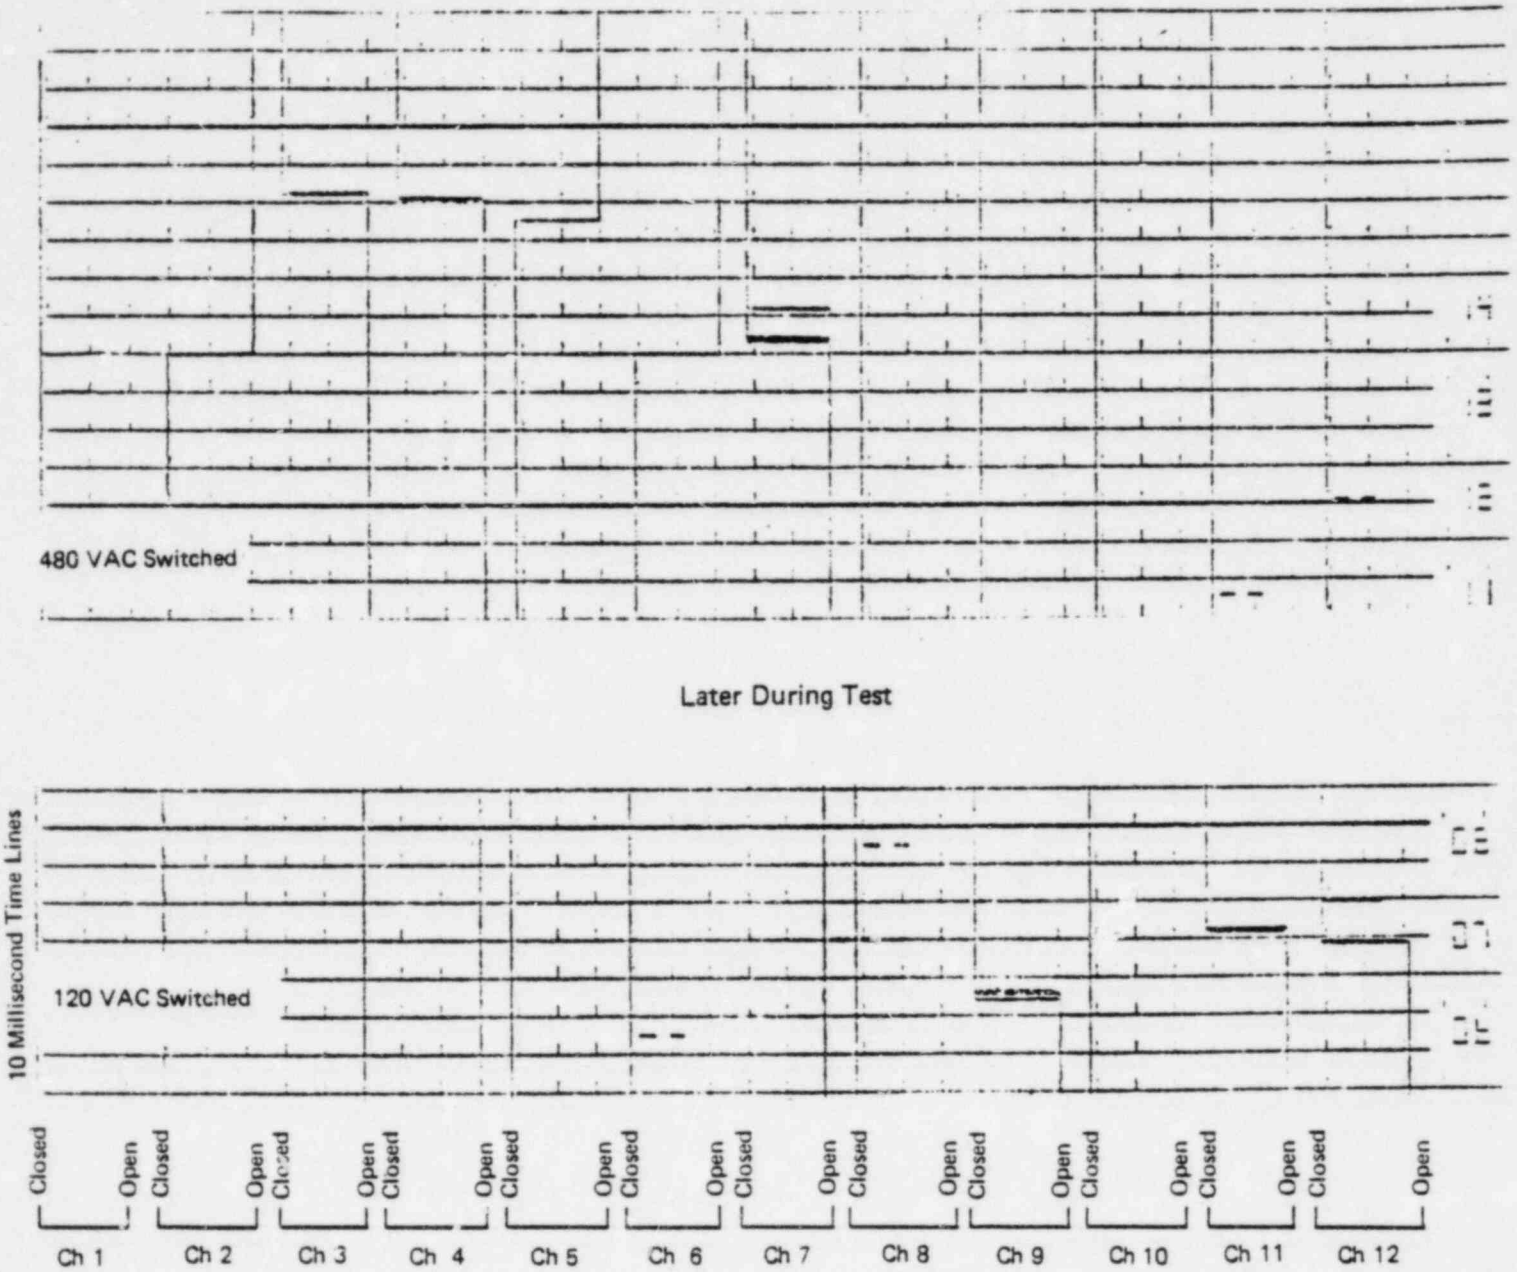
Figure IV.14
Visicorder No. 1 Representative Operation Taken from
Emergency Test (see Section III.5.5 for Channel Identification)

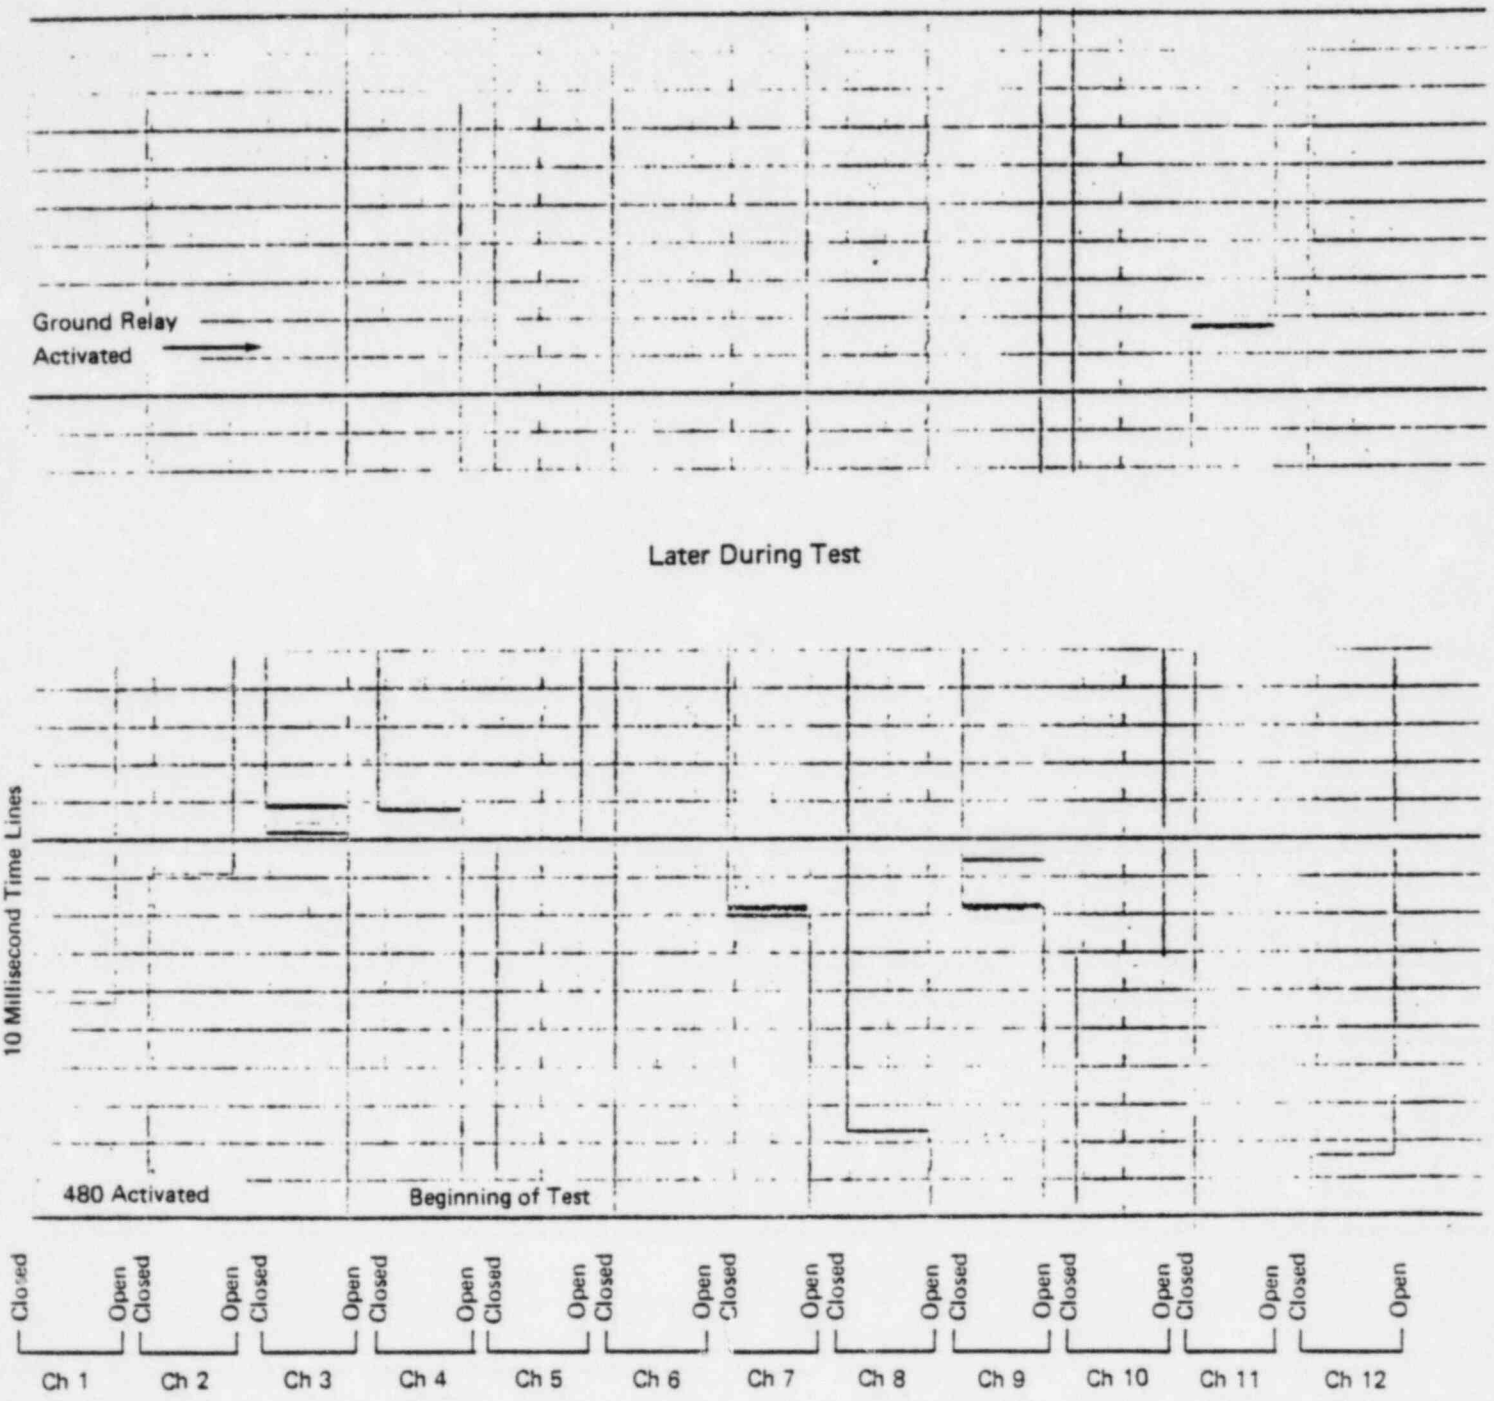
Figure IV.15
Visicorder No. 2 During Emergency Test
(see Section III.5.5 for Channel Identification)

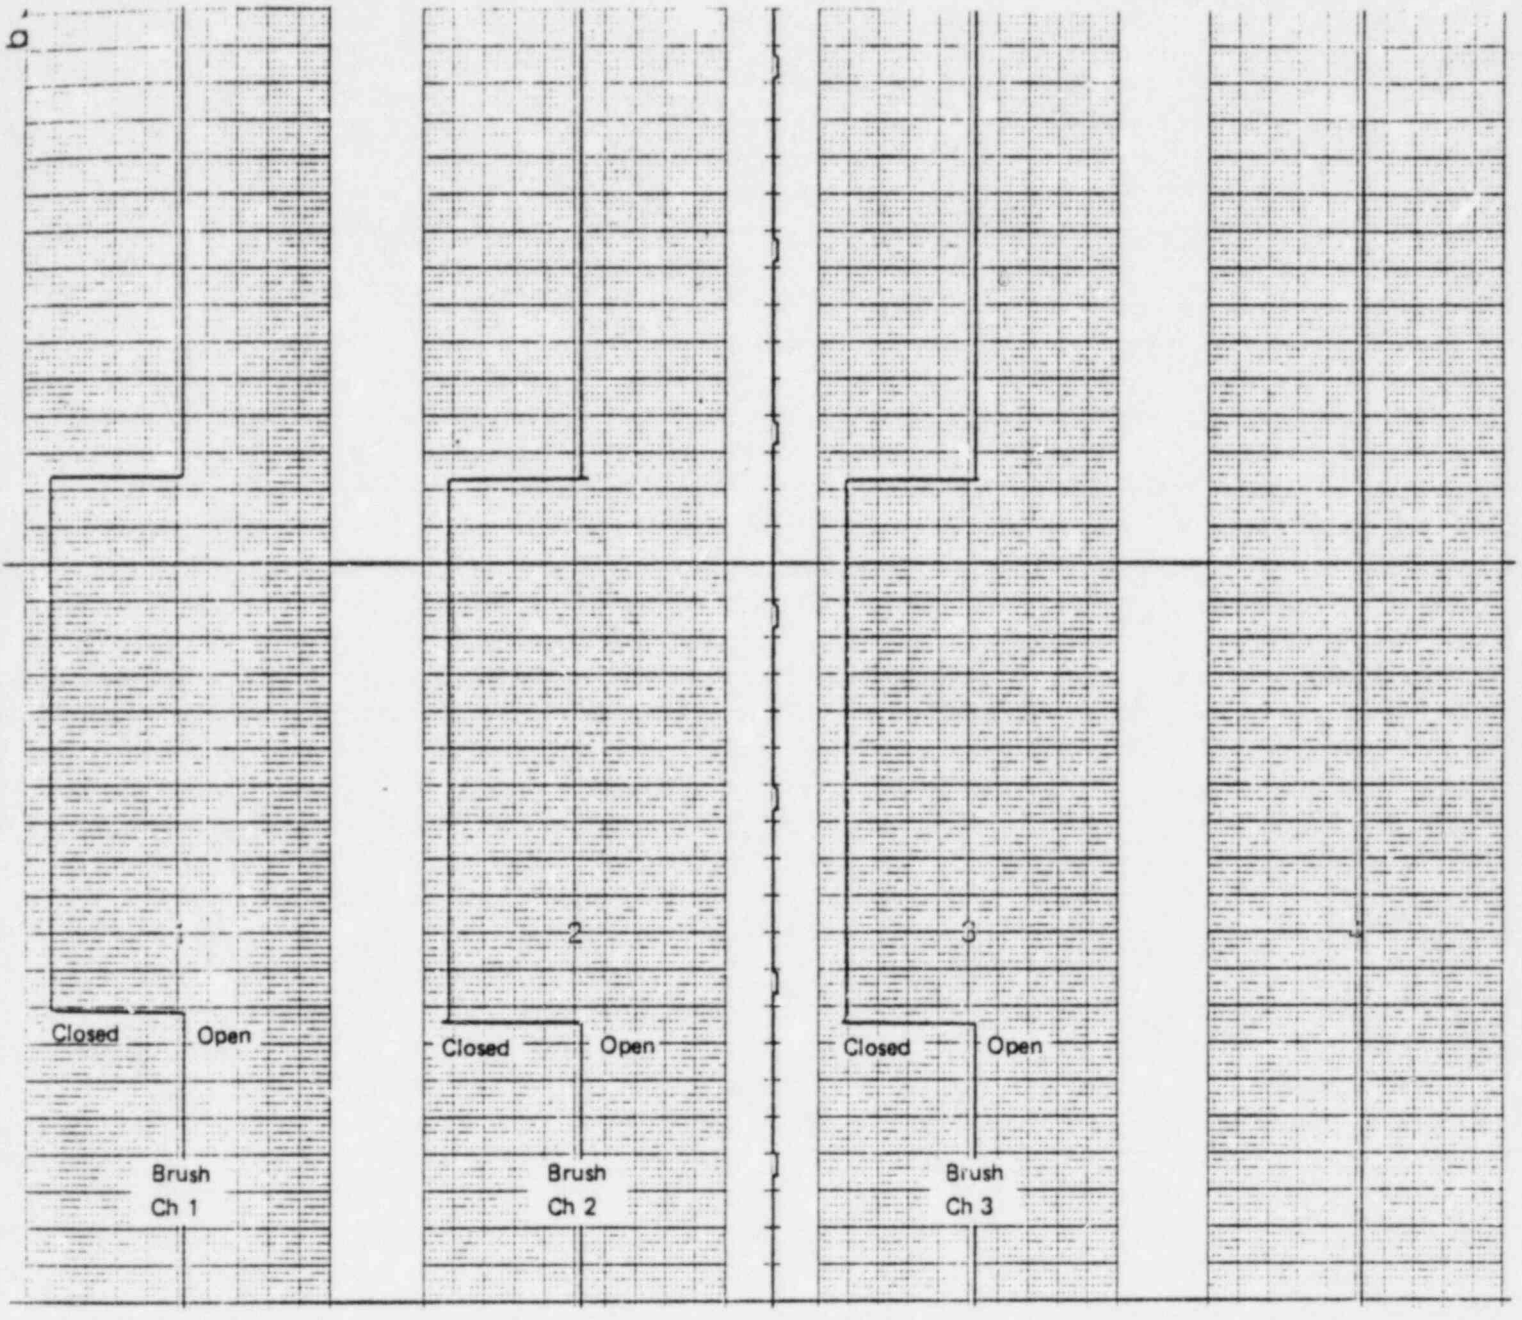
Figure IV.16
Operability As Recorded on the Brush Recorder
During the Emergency Test
(see Section III.5.5 for Channel Description)
