BNL-NUREG-31283
Ginna Restart SER
Appendix A
Limited Distribution

Investigation of Failed Tubes from "B" Steam Generator of the R. E. Ginna Nuclear Power Plant*

Carl J. Czajkowski

May 1982

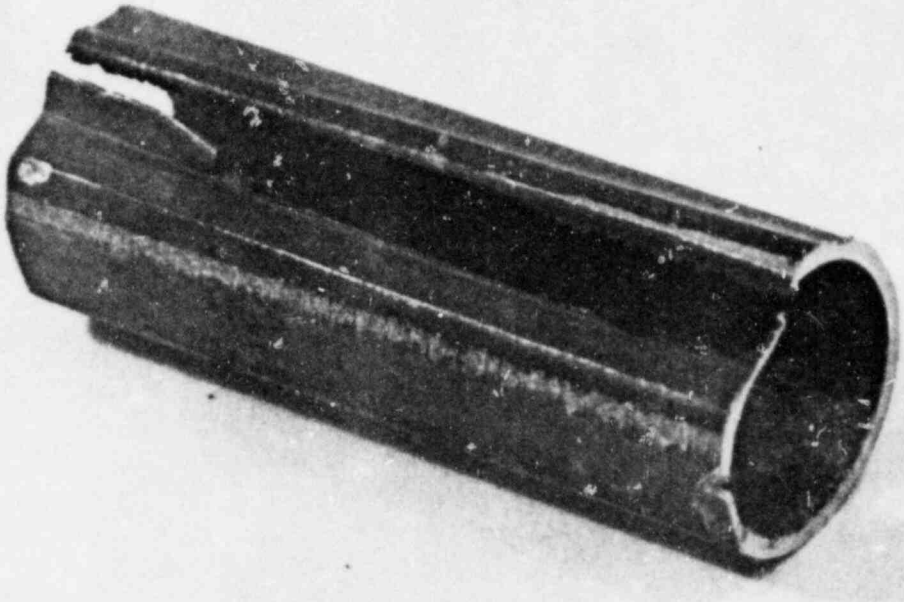
Figure 1 depicts six tube sections received by BNL. The figure gives a good cross section of the types of damage encountered by the steam generator tubing in service. NOTE: the light colored dot, on the specimens, indicates that portion of the tube facing the shell of the steam generator.

Figure 1. Photograph of "as received" ~10" long sections of damaged tubes from Rochester Gas and Electric's (RG&E) GINNA Station

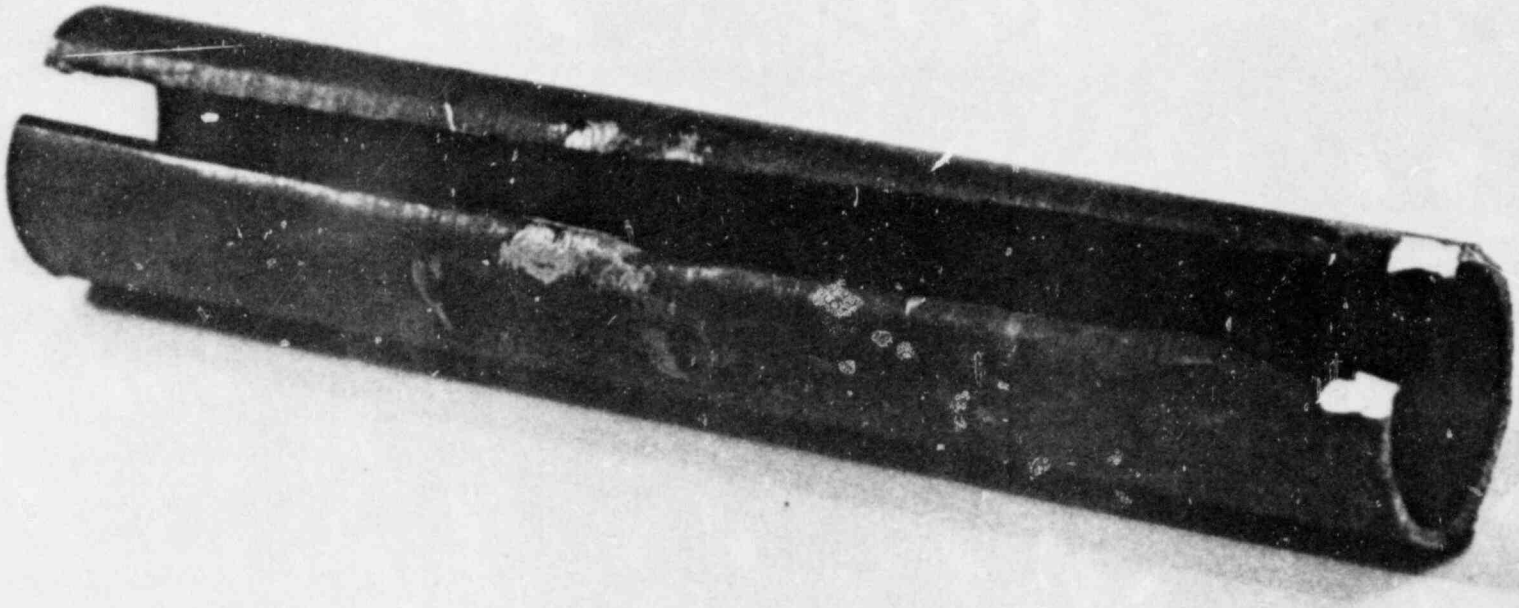
The photographs (Figures 2-6) portray areas of the various tubes which have been worn away by a probable abrasion mechanism. These tubes are on the inner rows of the steam generator (Figure 7) and the longitudinal wear patterns (with circumferential striations) are consistent with two tubes rubbing together for an extended period of time.

Figure 4 . Photograph depicting areas of apparent abrasion on specimen #6 of tube R44-C54 (GINNA)

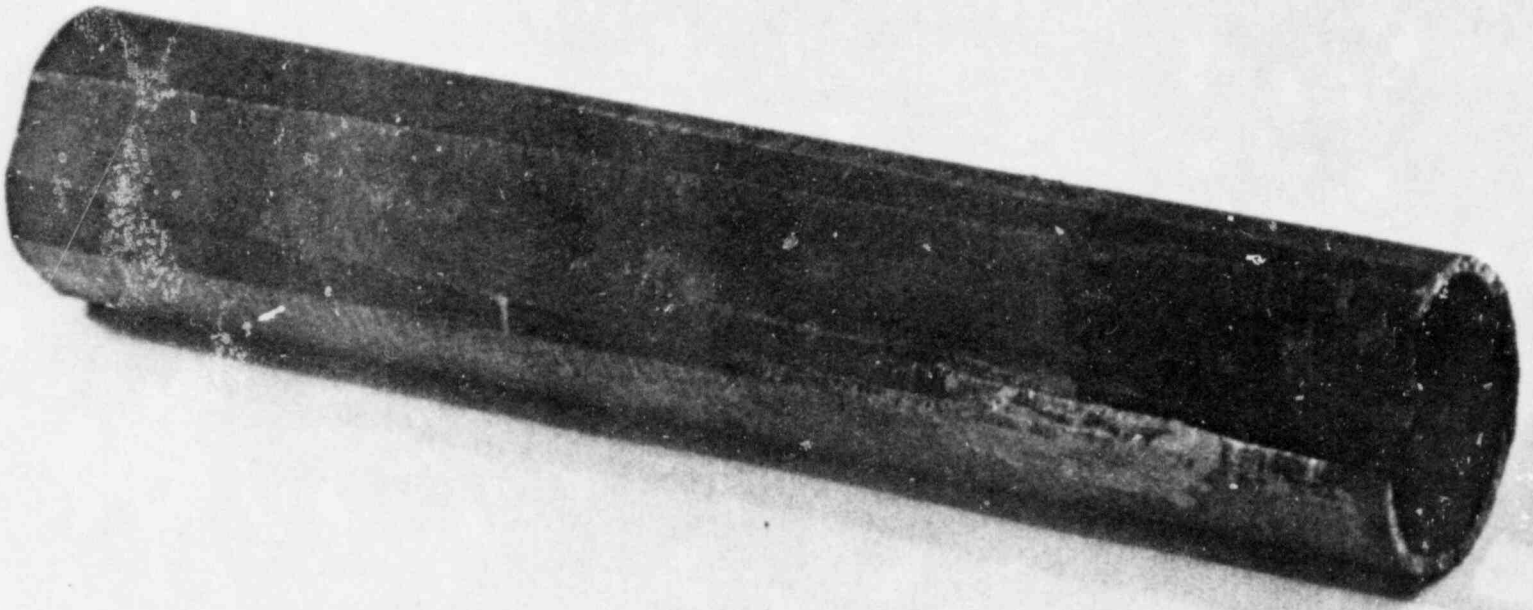
Figure 5. Photograph depicting severely abraded areas "through wall" on tube R43-C56 (GINNA)

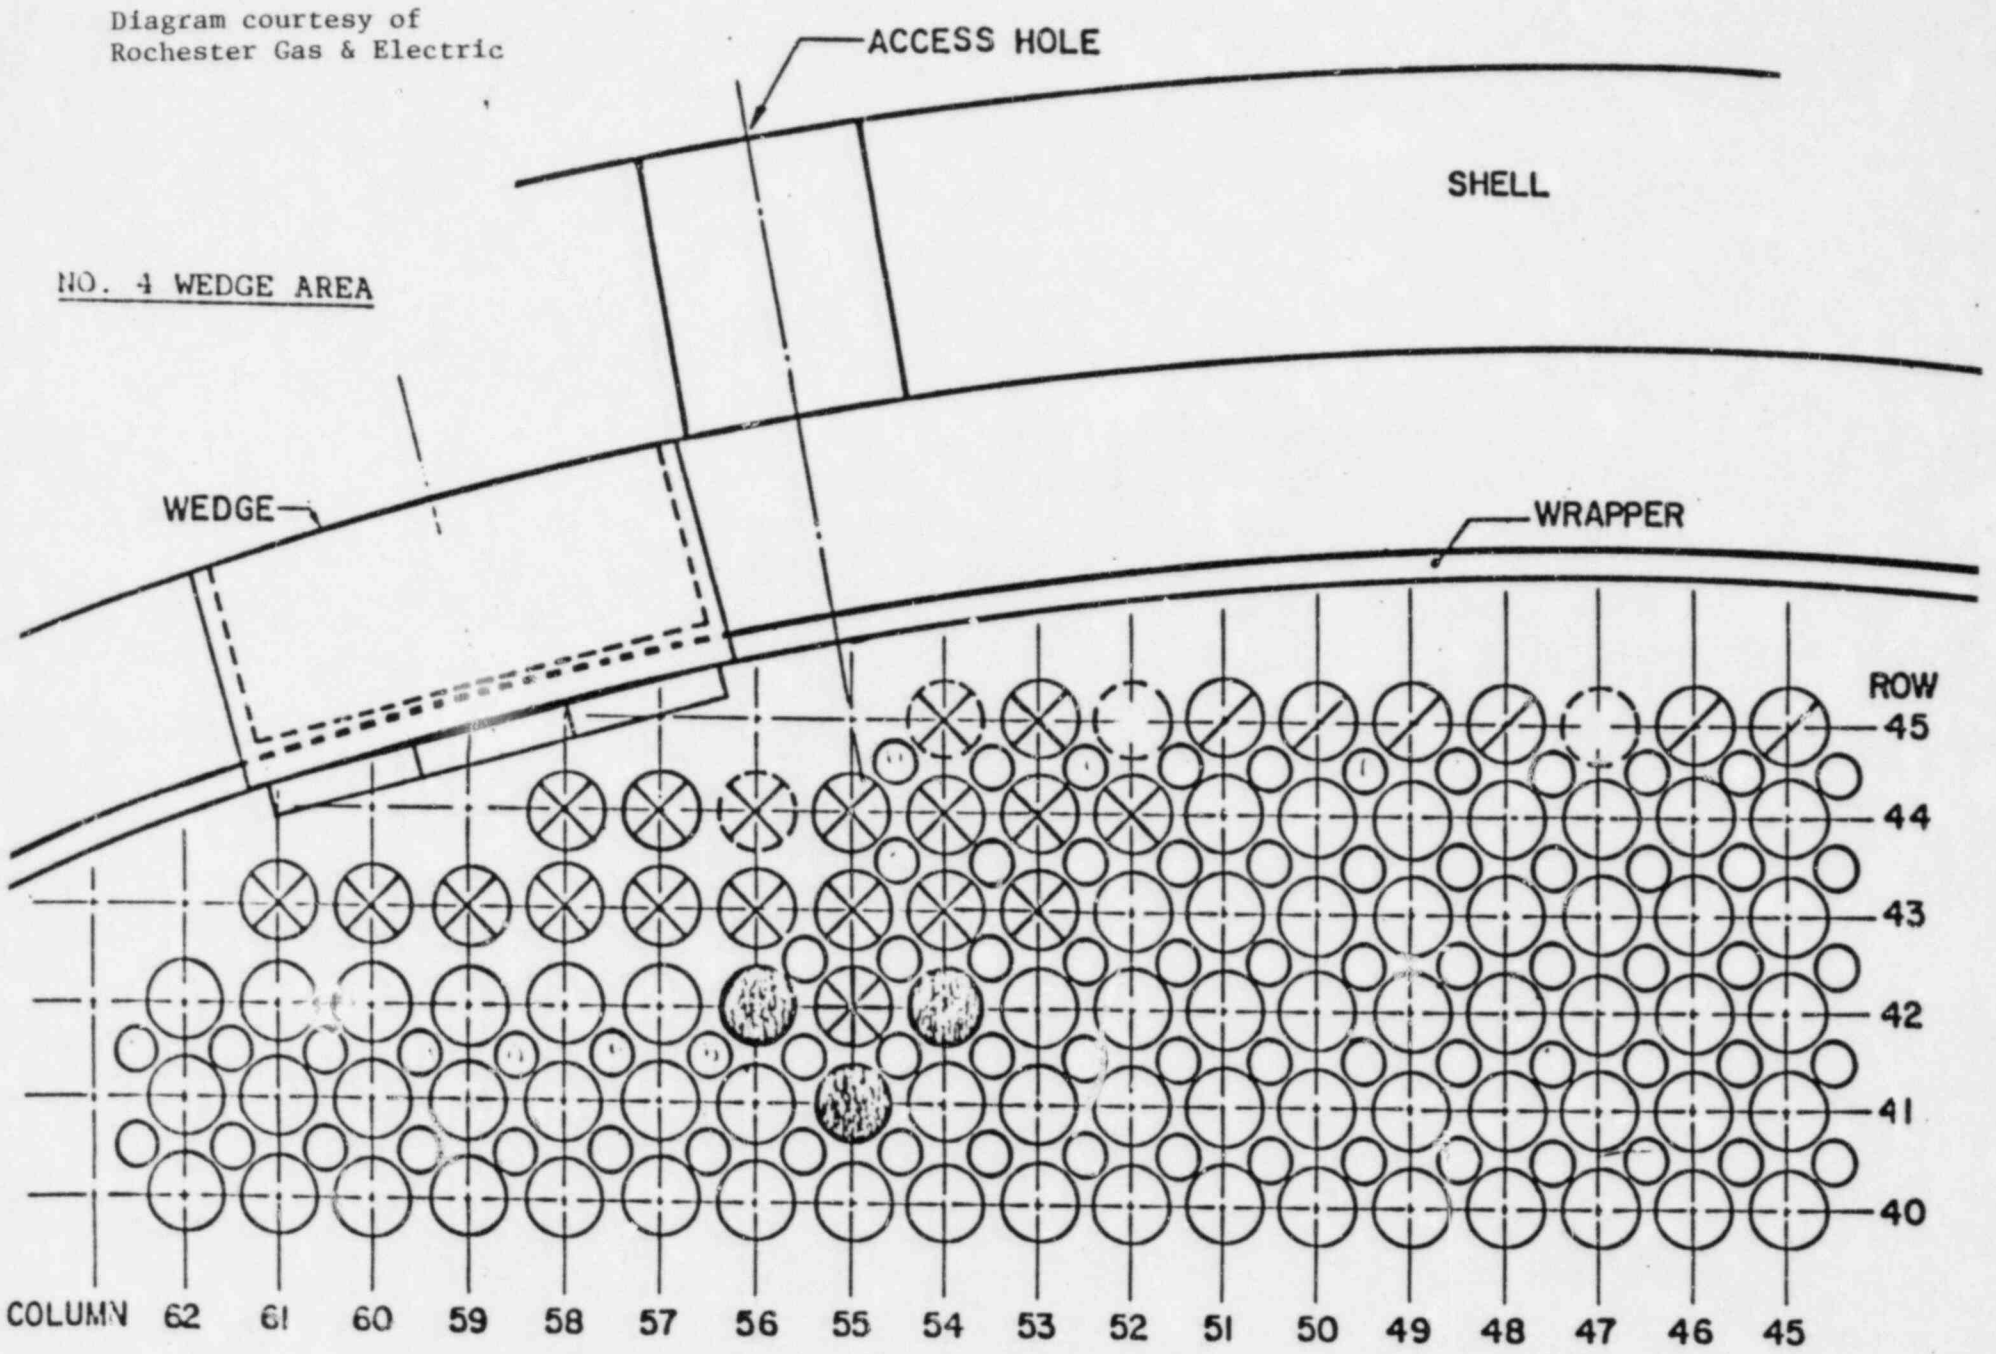
Figure 7. Diagram of Number 4 Wedge Area - Steam Generator "B" Hot Leg Side.

One of the tube sections received (R44-C57), had an area of full collapse in the area of the tube sheet junction (Figure 8). This tube is in the outer periphery of the tube bundle (Figure 7) and the concave portion of the collapse faces the shell of the steam generator. The next two photographs (Figures 9-10) show an impact and wear mechanism which occurred on tubes away from the area of the leak (#4 wedge area) in the #6 wedge area.(Fig. 11) The severest damage occurred on the tube where its circumference faced the steam generator shell. The wear patterns were consistent with the rubbing of one tube by another tube of appoximately 7/8" outside diameter.

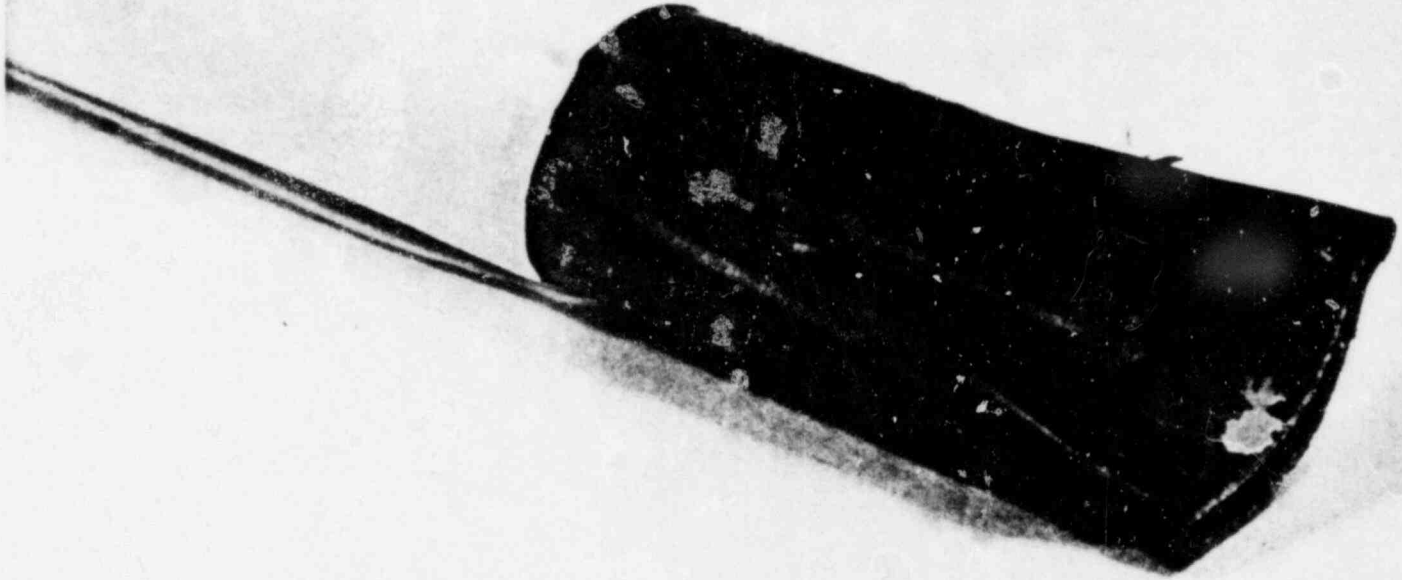
Figure 8. Photograph of collapsed area in tube R44-C57 (GINNA)

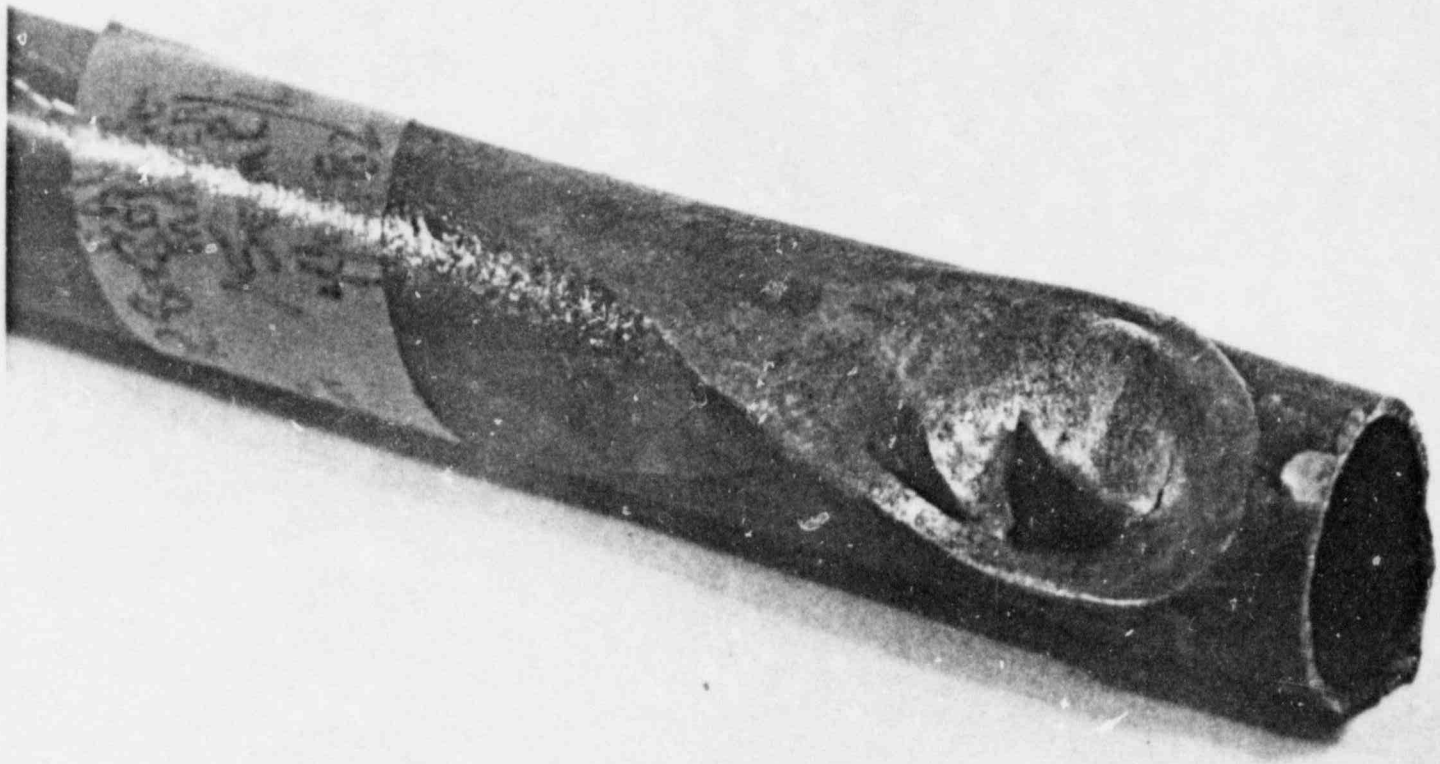
Figure 9. Photograph of apparently rubbed area in tube R8-C92 (GINNA)

Figure 10. Photograph of abraded area in tube R10-C91 (GINNA)

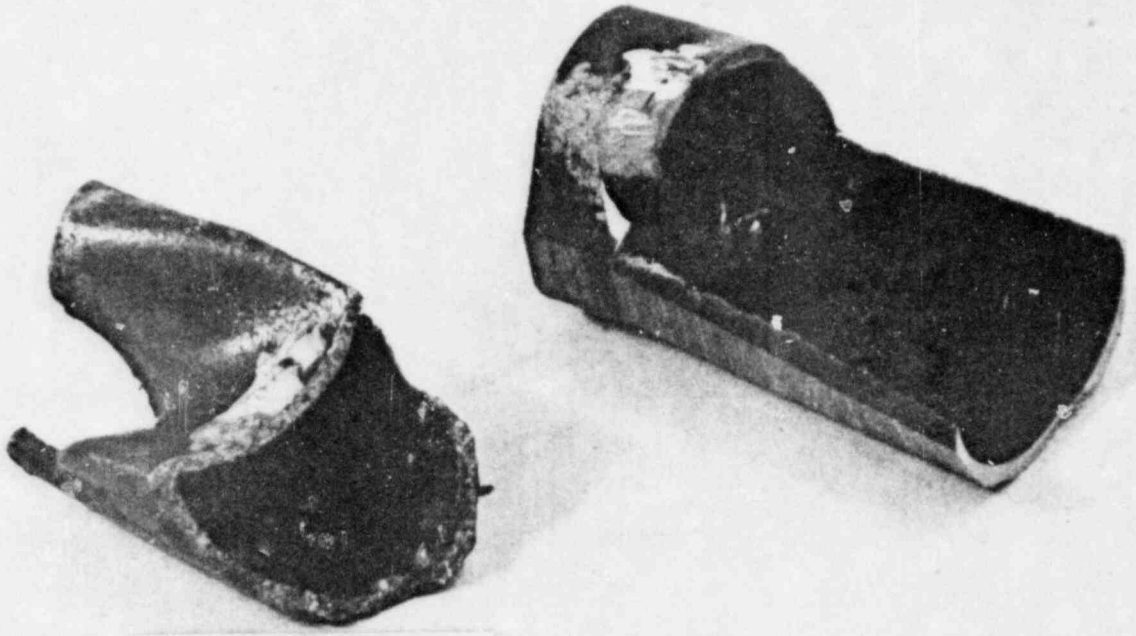
Figure 12 depicts the severe impact damage which occurred on tube R44-C54. Again, it is evident that the most severe deformation occurred on the side of this outer periphery tube facing the shell.

Figure 12. Photograph of two pieces of tube R44-C54 portraying considerable deformation

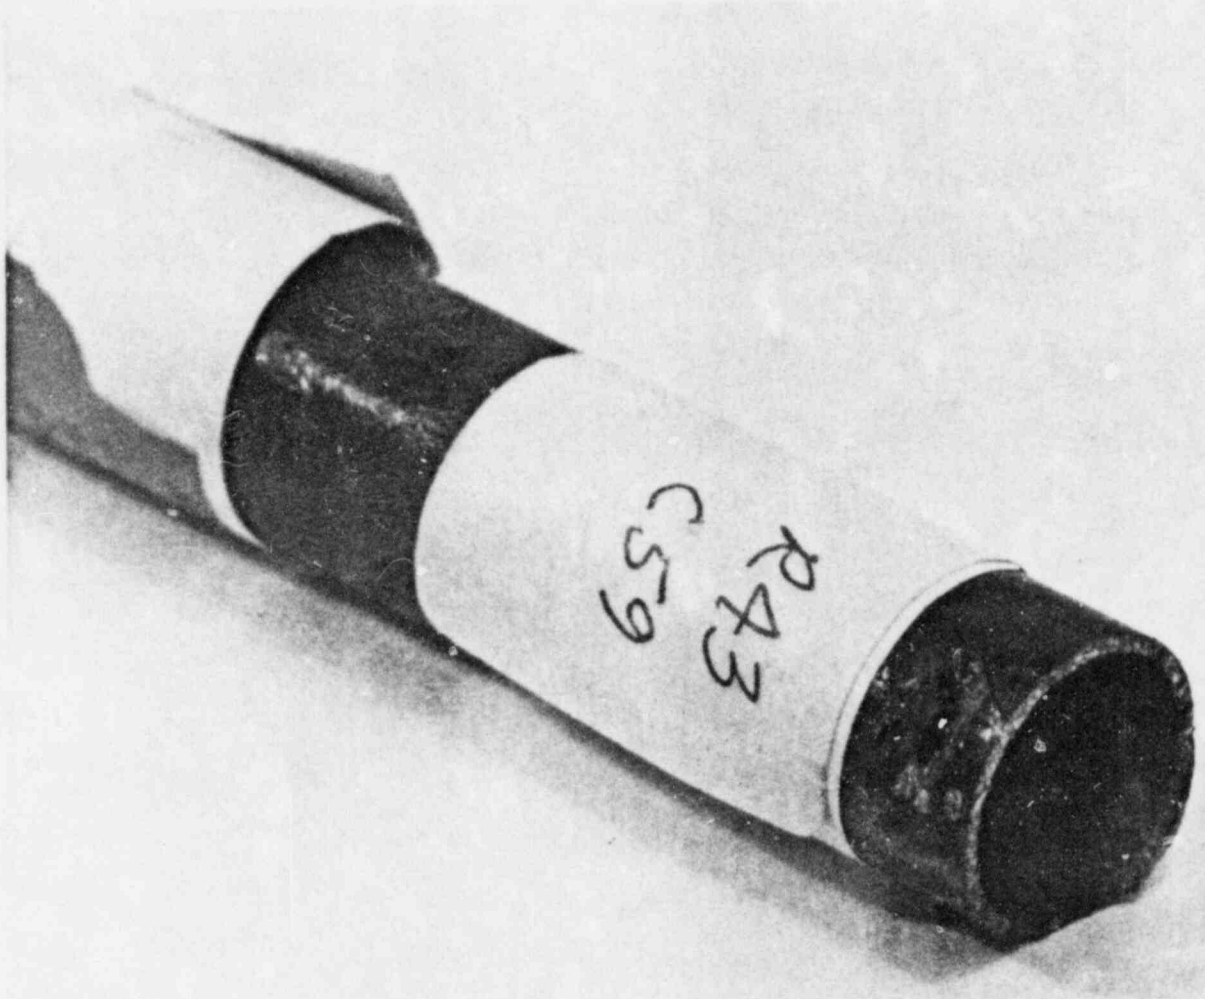
Tube R43-C59 (Figure 14) displayed a chisel-like cut and an impacted area (not shown on photo). The impacted area was approximately 1/2" diameter and hemispherical in shape. It was later determined that the cut was caused by a "miscut" of an electric discharge machining device, which was used to cut the tube section free from the steam generator, and did not occur in service.

Figure 14. Photograph of probable "miscut" of Electric Discharge Machining (EDM) apparatus on tube R43-C59 (GINNA)

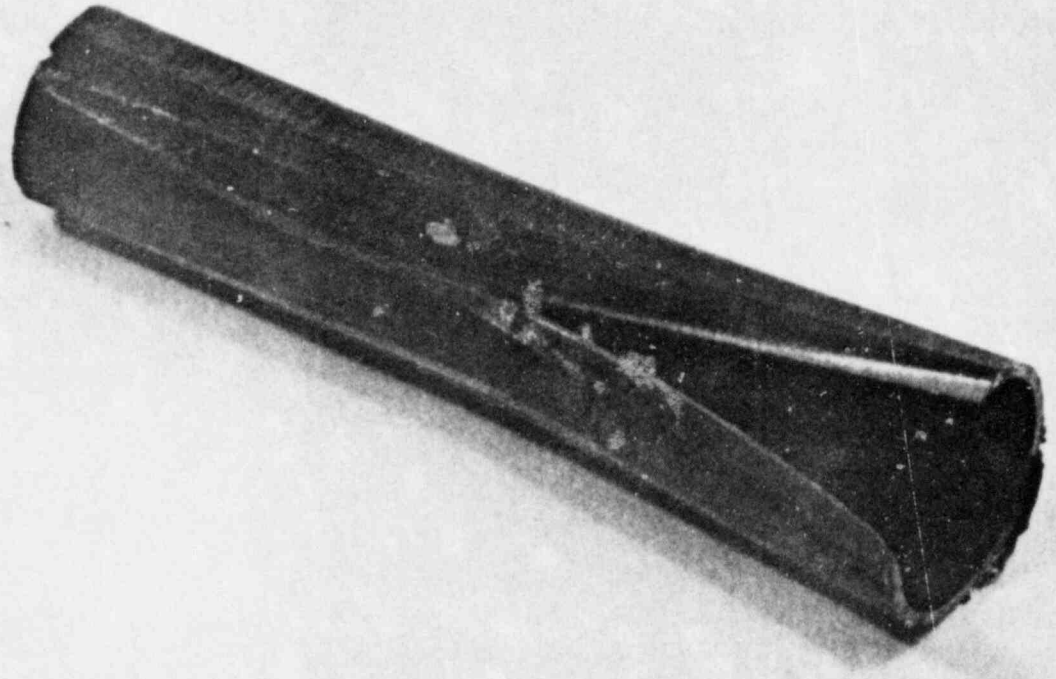
The bottom half of the "fishmouth" fissure (R42-C55) is displayed in Figure 15. Longitudinal wear scars (with circumferential striations) are quite evident in the photograph. These wear patterns are consistent with similar areas found on other inner steam generator tubes. There were no areas of impact evident on this tube.

Figure 15. Photograph of "fish mouth" crack
in tube R42-C55 (GINNA)

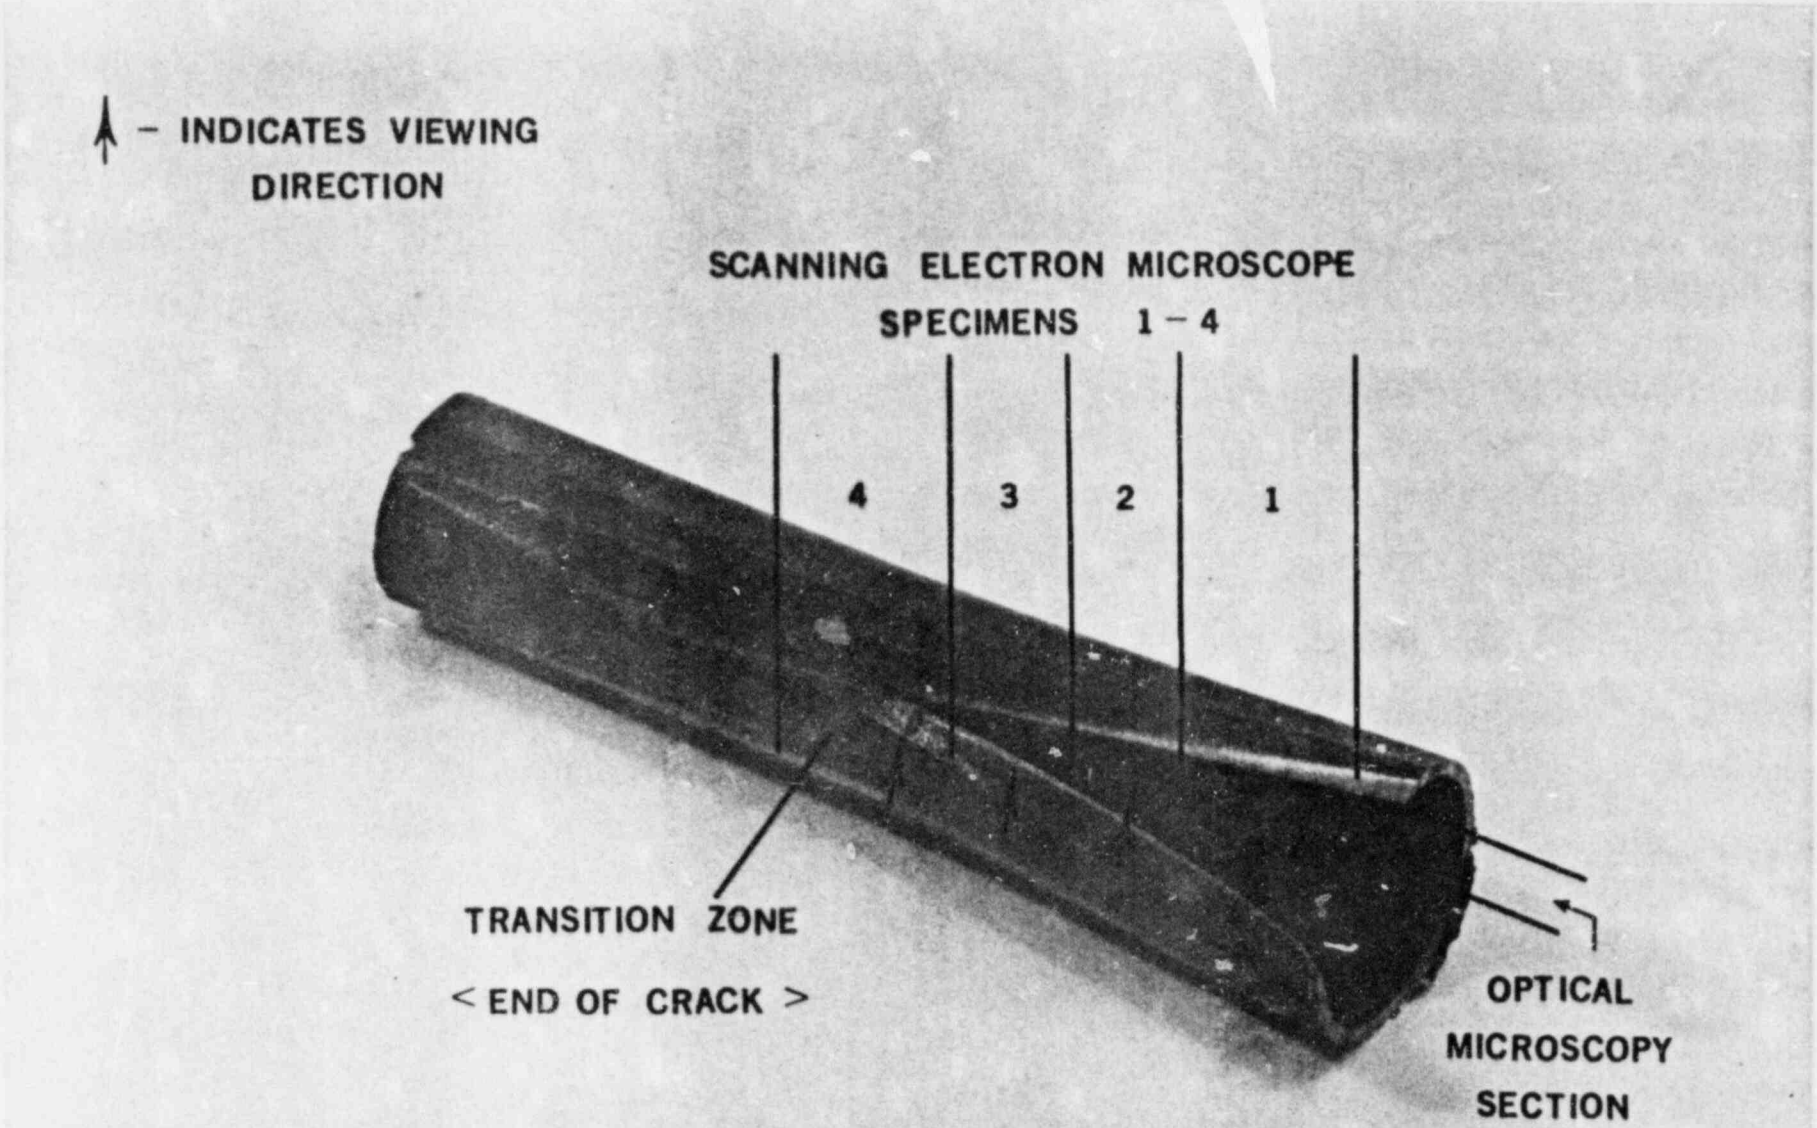
FIGURE 16. OVERLAY DEPICTING THE SECTIONING OF R42 – C55 < GINNA >

The "fishmouth" fissure on tube R42-C55 was sectioned (Figure 16) for both SEM and optical examinations. Figures 17-24 are typical SEM photographs of the face of the "knife edge" fissure starting near the center of the "fishmouth" and moving along its length to the crotch of the crack. It is clearly seen in Figures 17 and 18, that the mode of failure was a ductile overload mechanism. The normally circular dimples (if a uniaxial tensile test were performed) are somewhat elongated, which is evidence of a pipe bulge prior to break. The elongated dimpled structure of the fracture disappeared the farther away the "fishmouth" was scanned from the center of the fissure, as seen in Figures 19-22. An impacted area was noted in specimen #3 (Figure 21), which appeared to have occurred after the tube failed. This occurrance would be consistent with the postulation that loose objects were present in the steam generator at the time of failure. Figures 23 and 24 are SEM photographs of the transition zone (end of crack) in specimen #4. It is evident by the photographs, that the end of the crack also displayed ductile overload features with no evidence of fatigue contribution.

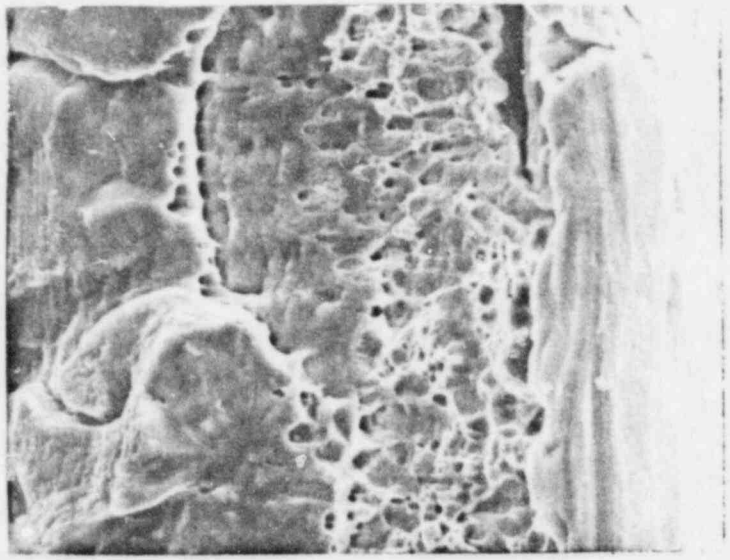
Figure 17. SEM photo of knife edge on R42-C55. Typical of "bulging" prior to ductile overload specimen #1

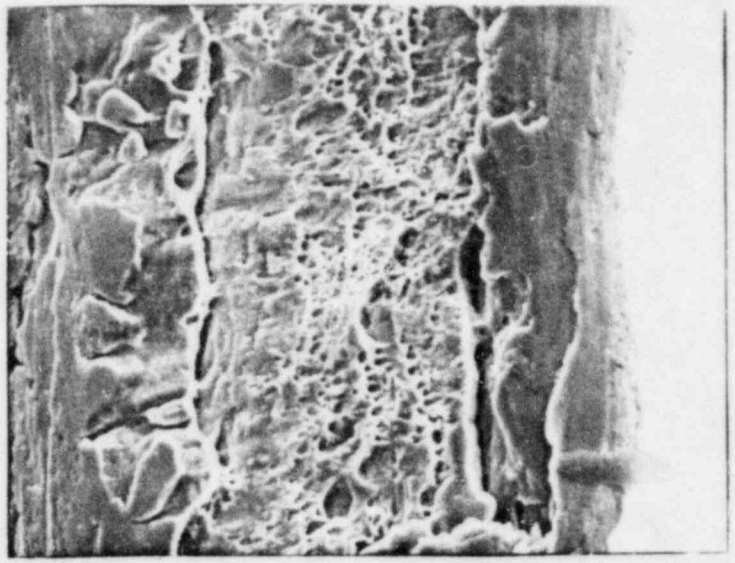
Figure 18. SEM photo of knife edge on R42-C55. Elongation of dimples less pronounced. Specimen #2

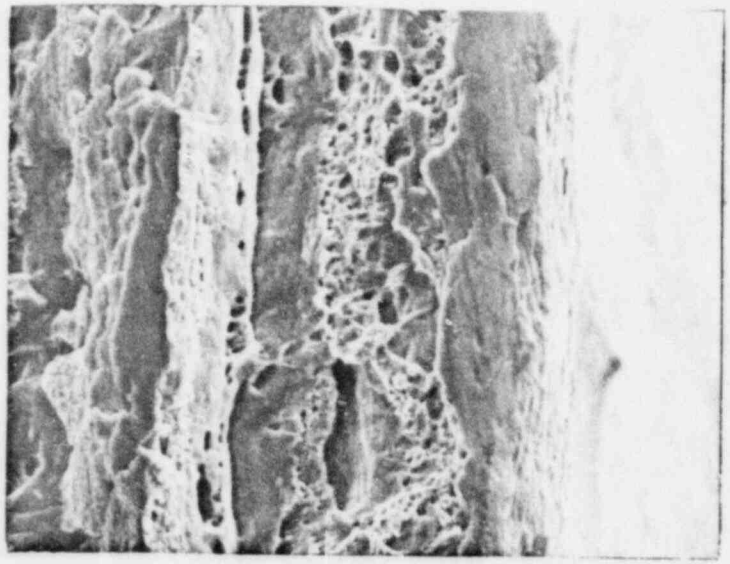
Figure 19. SEM photo of knife edge on R42-C55. Higher magnification. Specimen #2.

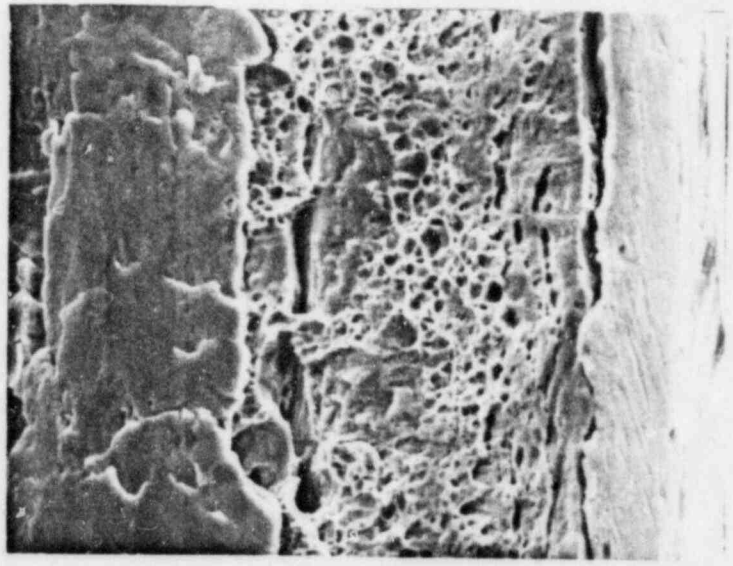
Figure 20. SEM photo of knife edge on R42-C55. Specimen #3

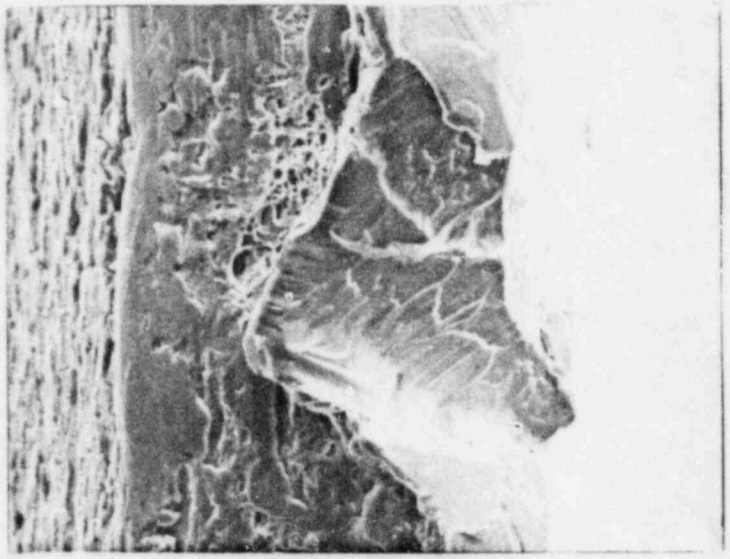
Figure 21. SEM photo of knife edge on R42-C55 depicting impact after break. Specimen #3

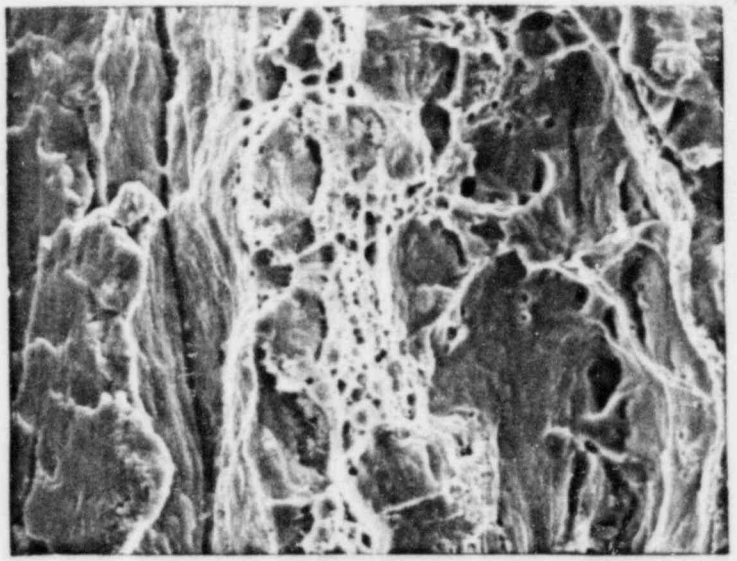
Figure 22. SEM photo of knife edge on R42-C55. Specimen #4

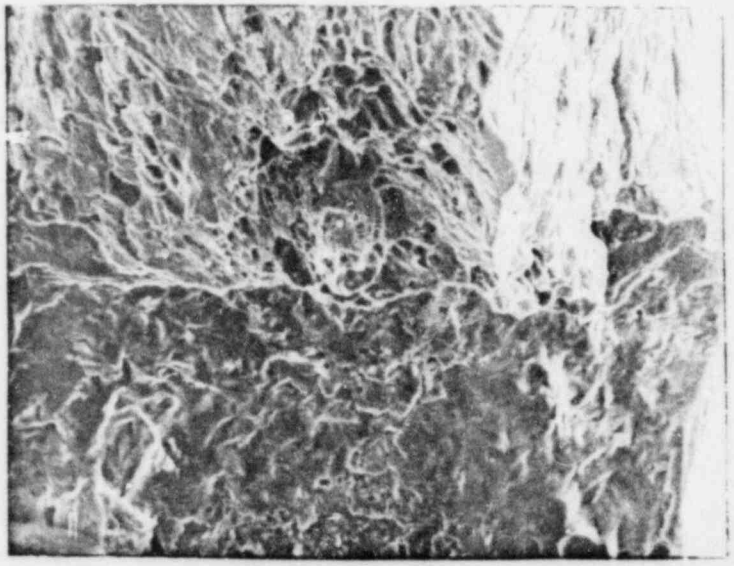
Figure 23. SEM photo of transition of knife edge on R42-C55. Specimen #4

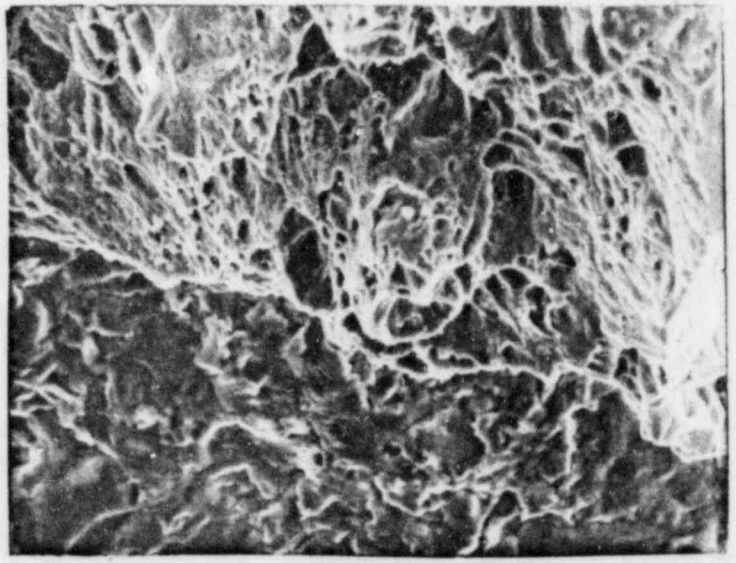
Figure 24. SEM photo of transition of knife edge on R42-C55. Specimen #4

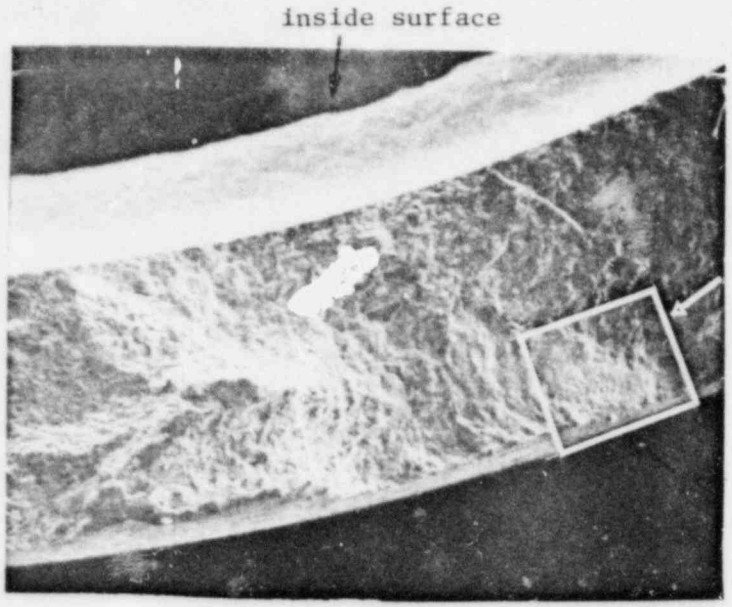
A section of tube R44-C56 was also examined by SEM. This tube had been collapsed and broken at the tube sheet and had also been severed by the tube support plate. The section viewed was the cross section of the tube, where it was severed just below the tube support plate. The majority of the fracture face was featureless and had a tamped appearance. One interesting feature was noted on the specimen, however, shown in Figures 25-27. Chevron marks were evident (Figure 25) on the surface of the fracture, which led to a cyclically fatigued area on the specimen (Figures 26 and 27). This type of structure would be consistent with a tube breaking by the tube sheet and then "whipping" about in a turbulent flow, causing a fatigue type failure of the tube by the upper tube support plate.

Figure 25. SEM photo of "chevron" marks (indicative of fatigue failure) on Tube R44-C56 (top) near tube support plate

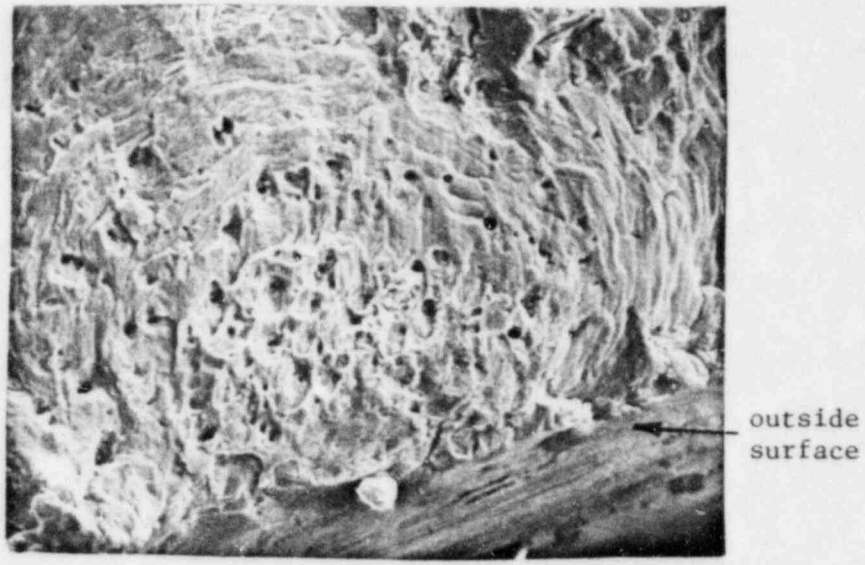
Figure 26. SEM photo of probable initiation site for cyclic fatigue failure of tube R44-C56

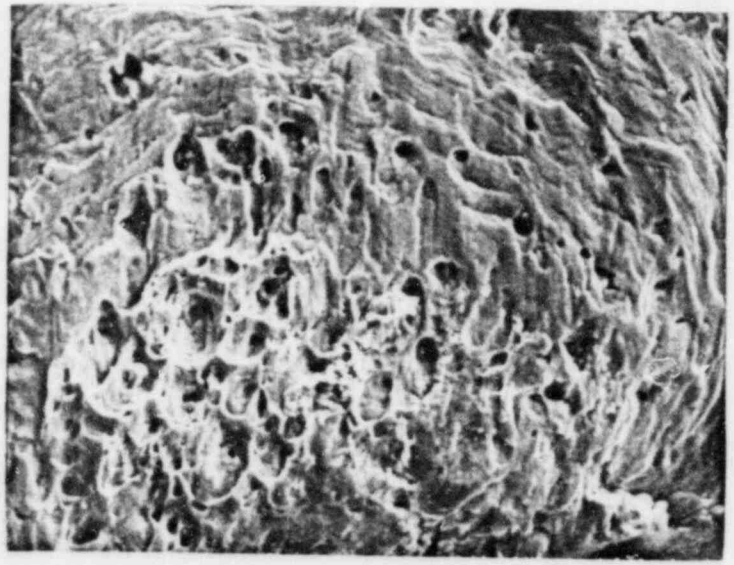
Figure 27. Higher magnification SEM photo of "initiation site" - Tube R44-C56

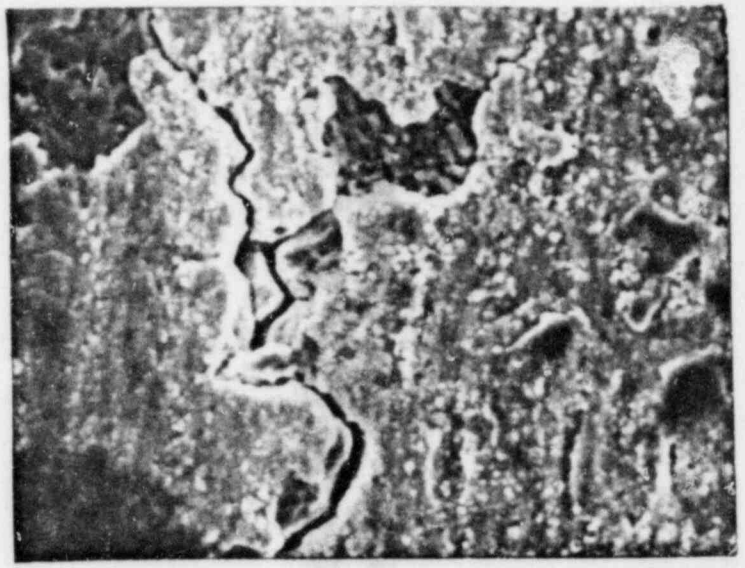
An examination of the inside surface of tube R43-C59 showed one area, which initially appeared as an intergranular type crack in the tube (Figures 28 and 29). The crack-like indication found on this tube was later

determined to be associated with a prior pickling process (see EDS section).

Figure 29. Higher magnification SEM photo of inside surface of tube R43-C59

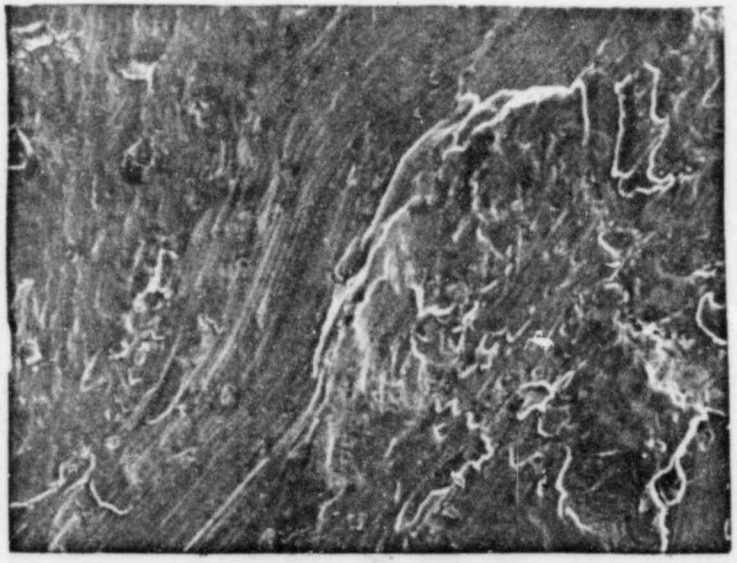
Figure 30 is an SEM photograph of a typically abraded and impacted section of tube R11-C91. Although some wear lines are evident, the section has no predominant distinguishing features.

Figure 30. SEM photo of outside surface of abraded tube R11-C91

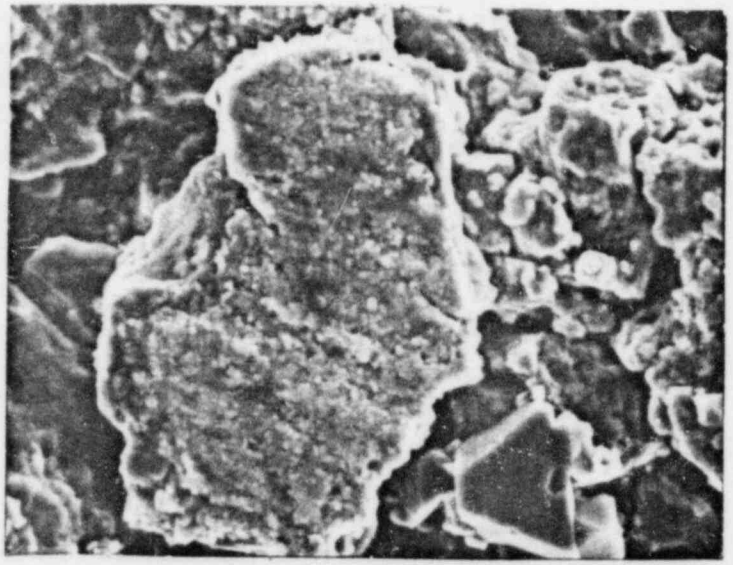
Various EDS scans were performed on the outside surface of the impacted specimens of tubes, and on the inside surfaces of the impacted sections (adjacent to any breaks in the tube), in the hopes of obtaining information on the composition of the impacting object. Figures 31 and 32 are typical of the scans encountered on tube R8-C92 and are representative of the majority of scans taken.

Figure 31. SEM photo of particle on inside surface of tube R8-C92 near rubbed area

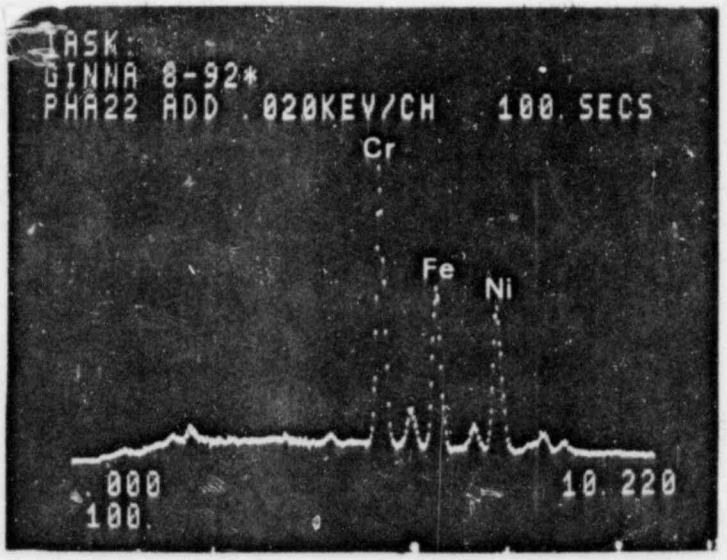
Figure31a. EDS scan of particle on inside surface of tube R8-C92 for constituents

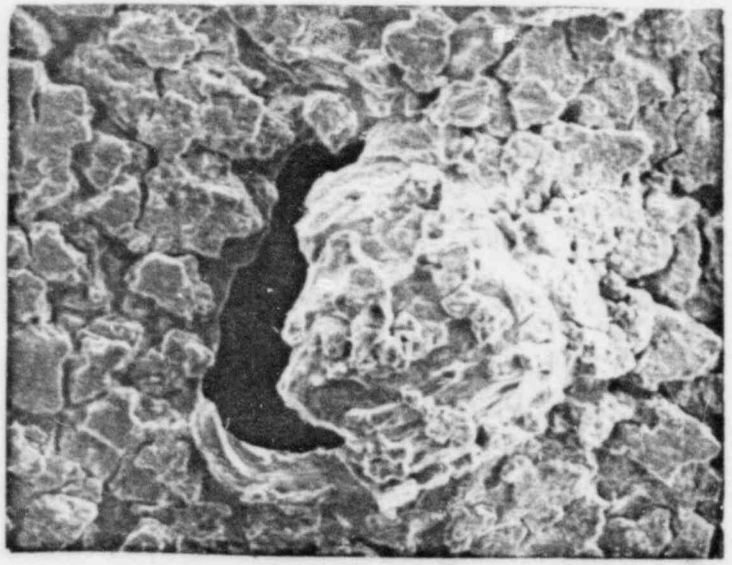
Figure 32. SEM photo of inside surface of tube R8-C92 depicting area of wall collapse

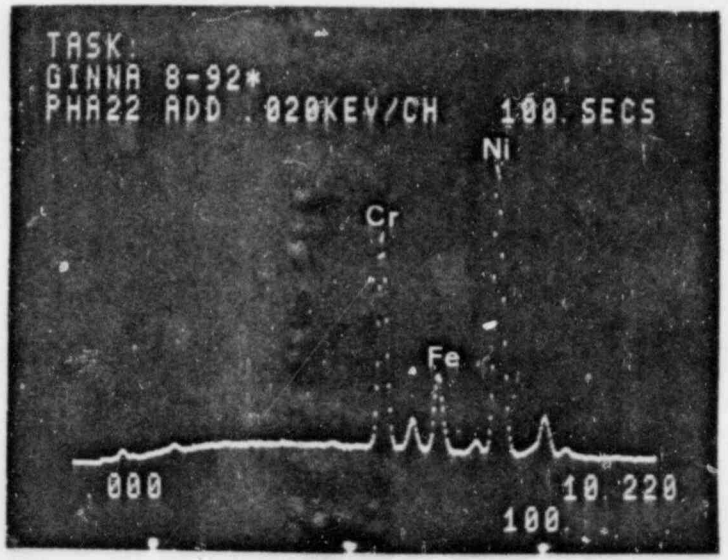
Figure 32a. EDS scan of inside surface of tube R8-C92 near collapse for constituents

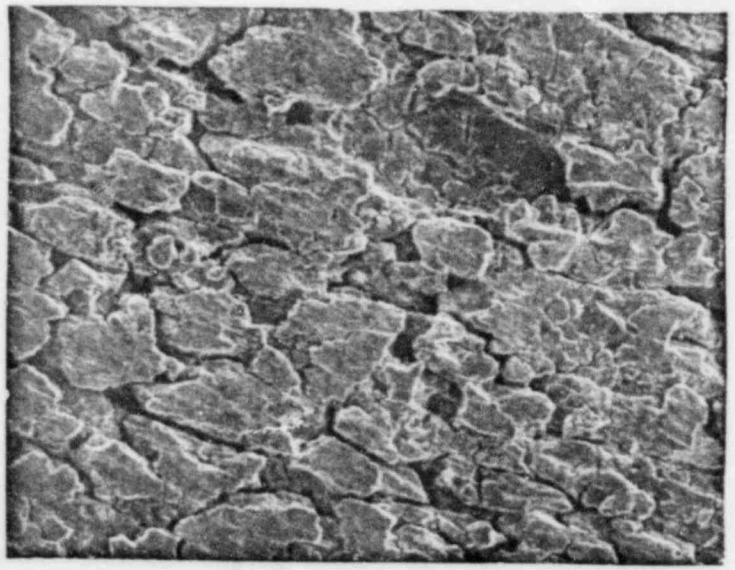
Figure 33 is representative of the type of "etched" structure found on the inside surface of tube R8-C92. This structure was much more prevalent on this tube than the one area found on tube R43-C59. It was probably the result of pickling done on the tubes prior to their installation.

Figure 33. SEM photo of inside surface of tube R8-C92 depicting "etched" structure

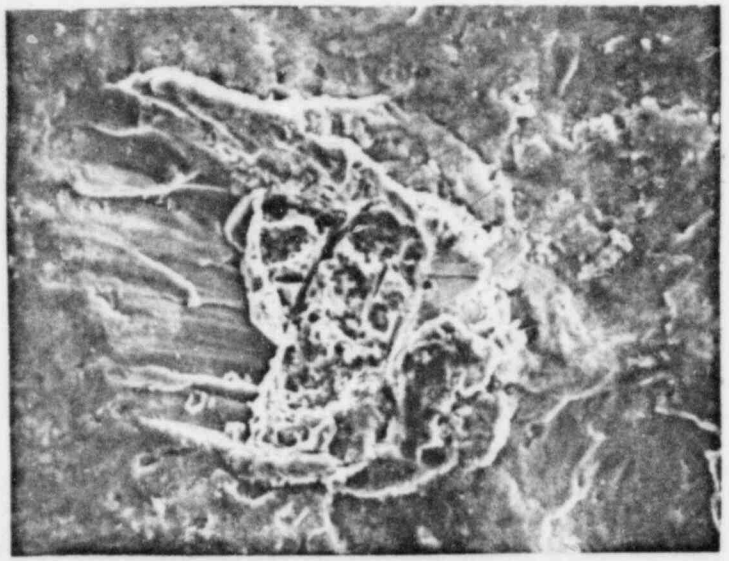
The last set of EDS scans (Figures 34, 35, and 36) display the constituents found on two smears on an impacted area on the outside surface of tube R43-C59. The scan (Figure 34a) is typical of that found on both of the smears and shows an extremely high peak of iron (Fe) relative to chromium and nickel. Since tube R43-C59 is an outer periphery tube, this finding appears to corroborate the hypothesis that the outer periphery tube damage occurred as a result of impact with a carbon steel foreign object.

Figure 34. Imbedded particle found on outside surface (O.D.) of R43-59

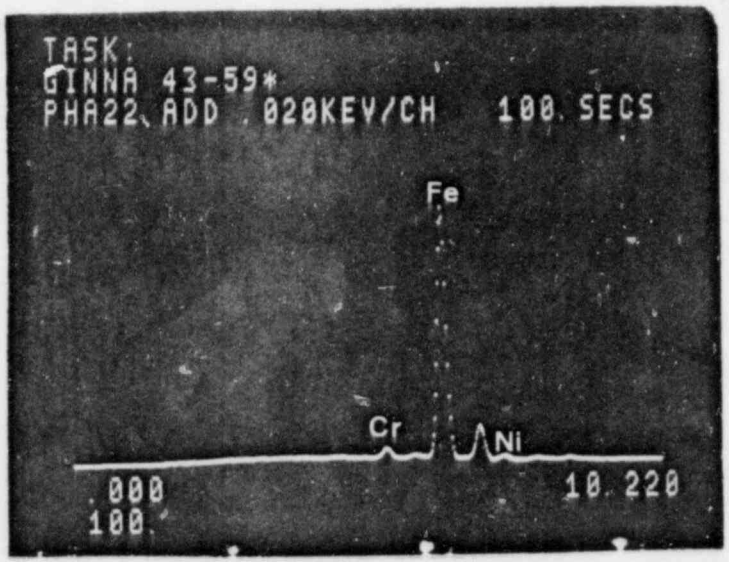
Figure 34a. EDS scan of imbedded particle found on R43-59

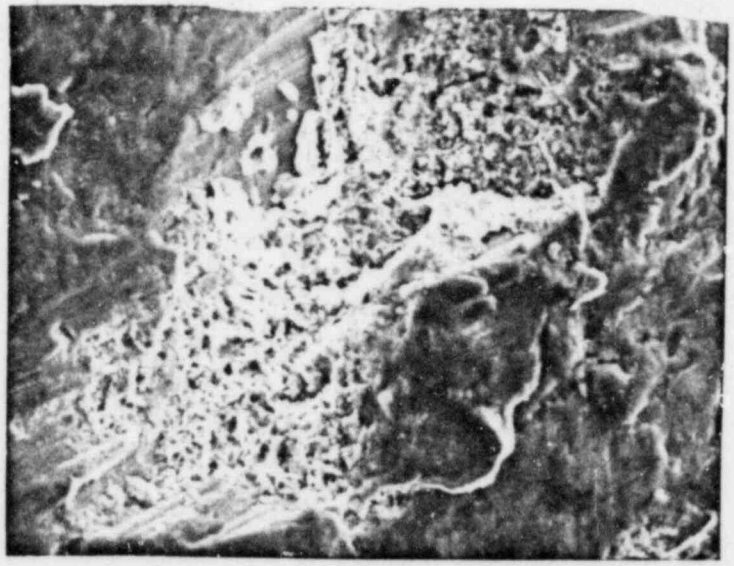
Figure 36. SEM photo of another "smear" of iron (prior EDS scan is typical) found on outside surface of R43-59
