BNL-NUREG-31283
Ginna Restart SER
Appendix A
Limited Distribution

Investigation of Failed Tubes from "B" Steam Generator of the R. E. Ginna Nuclear Power Plant*

Carl J. Czajkowski

May 1982

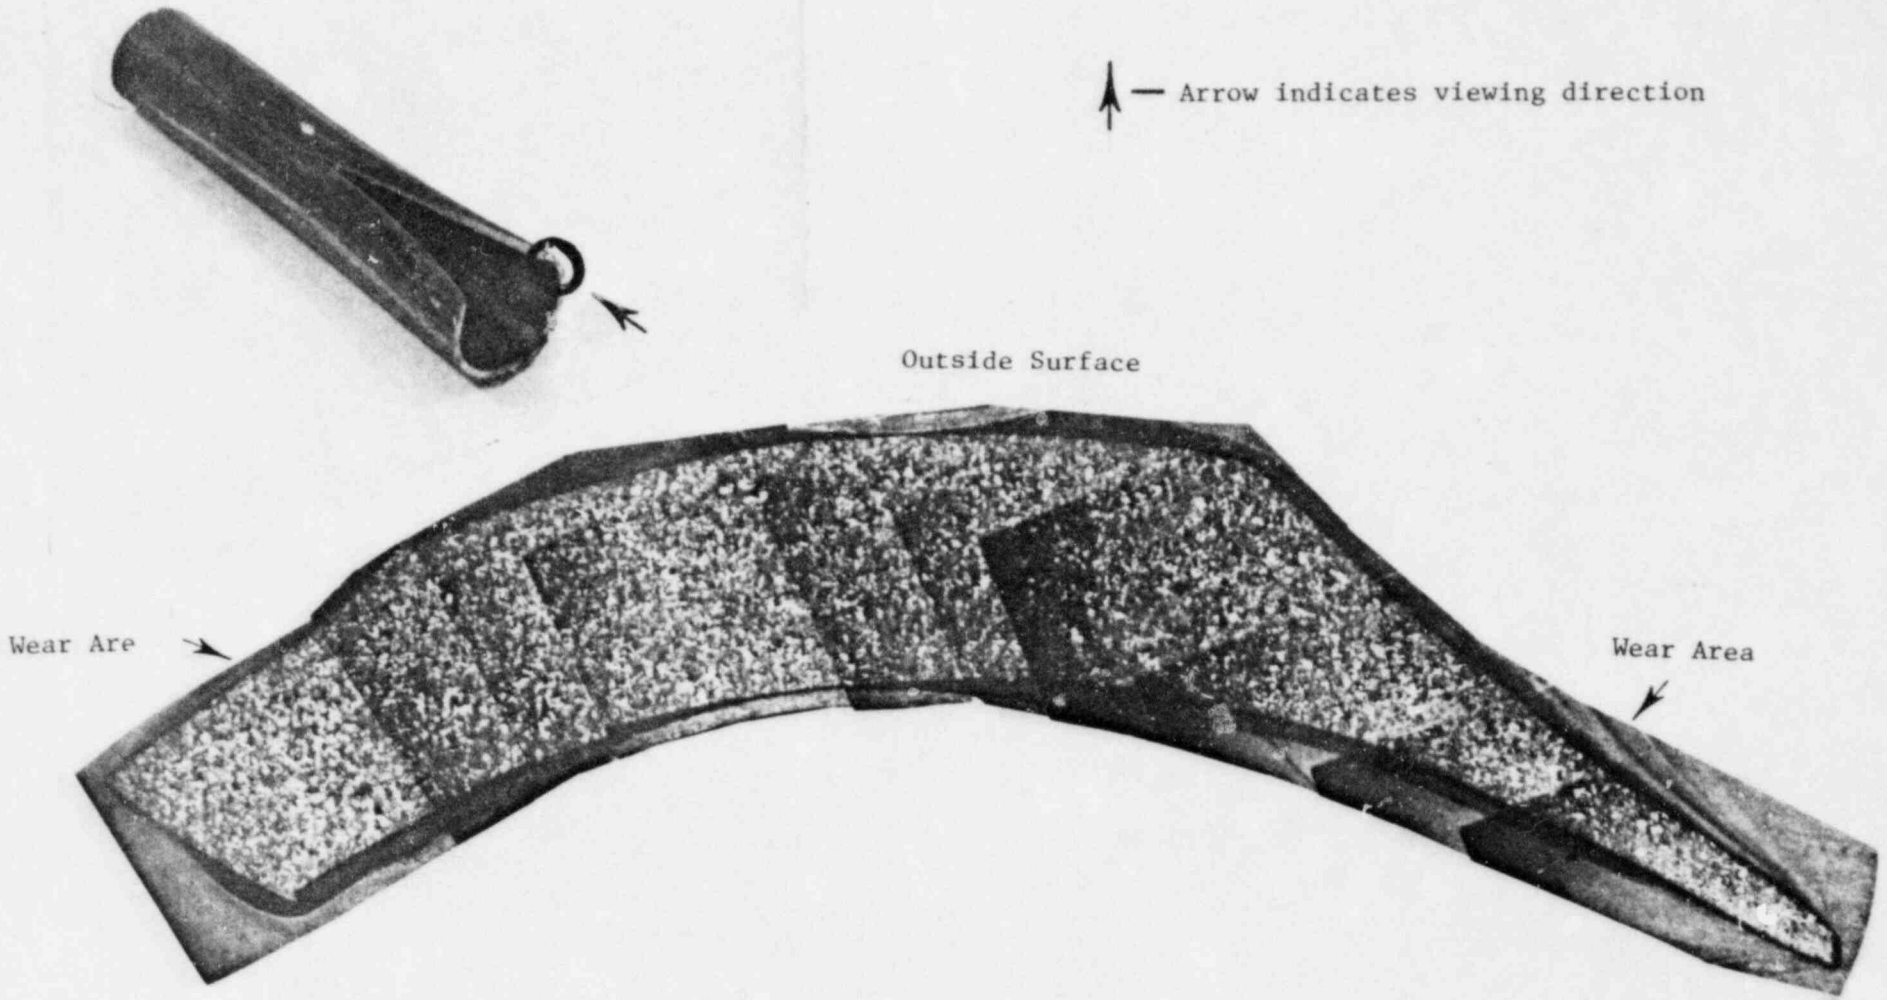
A cross sectional metallurgical mount was made of the number 1 area of the "fishmouth" fracture on tube R42-C55. It was etched with a 10% bromine + methanol etch for 20 seconds (Figure 37). There was no real evidence of cold work on this section, even though the wear patterns on the cross section are quite distinguishable. This type of wear would be consistent with a fretting corrosion mechanism, which would have reduced the tubes cross section by slow grinding over a long time period, coupled with oxidation of the freshly created surface.

Figure 37. Optical photomicrograph of cross section of "Fishmouth" fracture (tube R42-C55) also shown is area of section relative to fracture. (Note: photomicrograph is optically reversed.

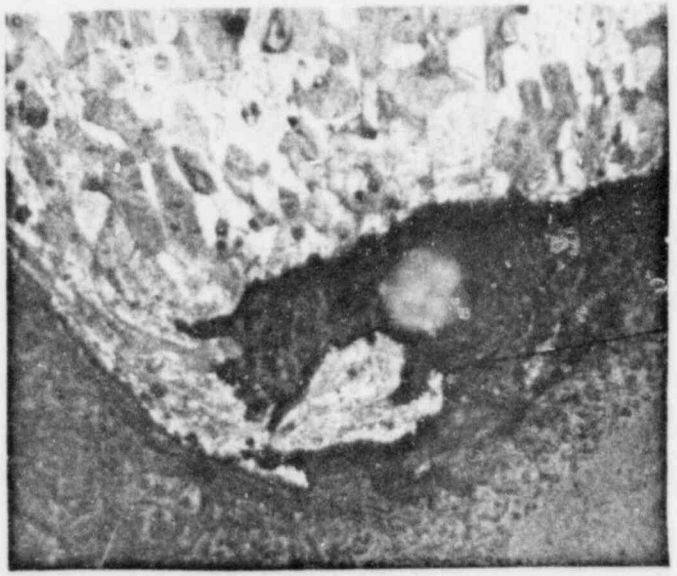
Cold work was in evidence on cross sections of tubes R10-C91 and R8-C92 in small amounts and is depicted on Figures 38 and 39. The most significant areas of cold work were found on tube R44-C57 on a cross section of the collapsed area. Figures 40 and 41 give a good representation on the amount of repetitive cold work that this tube endured. Figure 42 is a full cross section of the tube displaying the amount of structural damage that the tube received prior to the plants shutdown. It is significant to note that cold work was primarily found on the outer (periphery) tubes, with the inner row tubes displaying a fretting corrosion microstructure.

Figure 38. Optical photo depicting area of cold work on tube R8-C92.

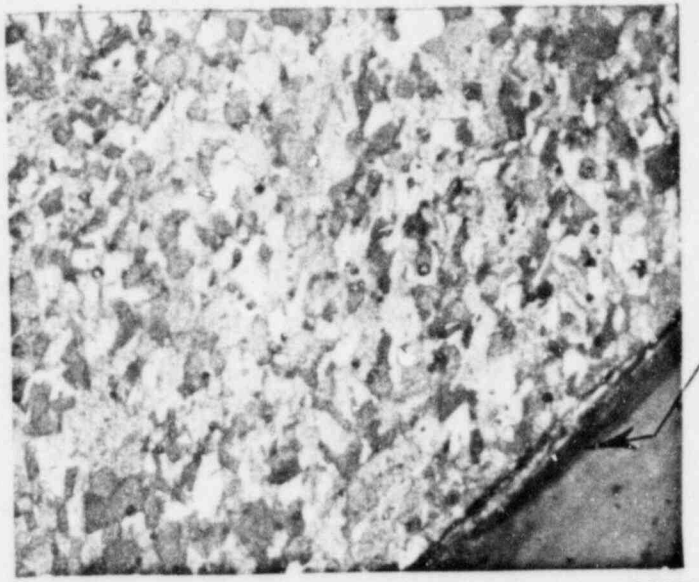
Figure 39. Optical photo displaying area of cold work on tube R10-C91.

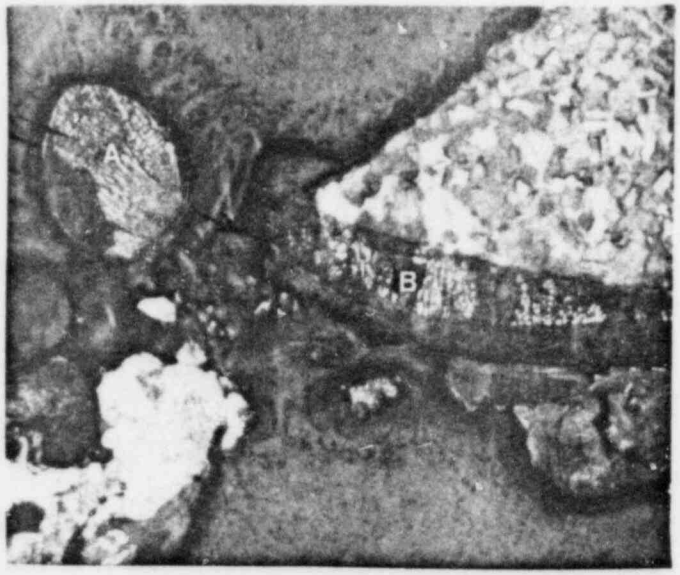
Figure 40. Low magnification photo of cold work on collapsed tube R44-C57.

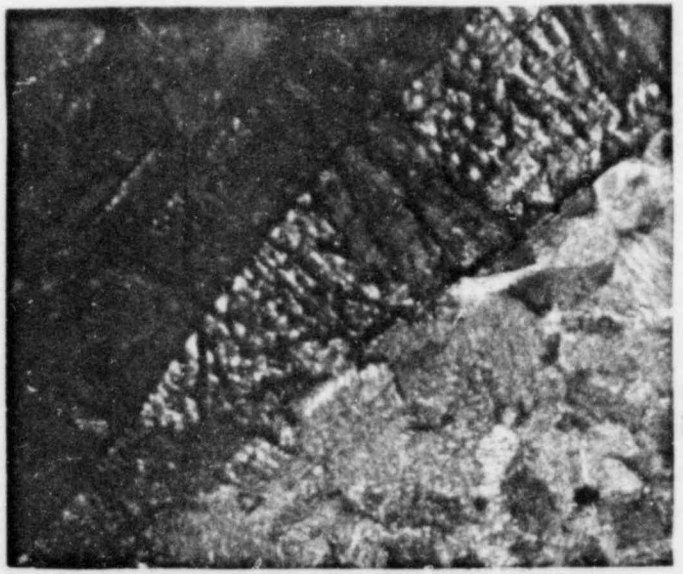
Figure 41. Higher magnification photo of cold work on tube R44-C57(Area B).

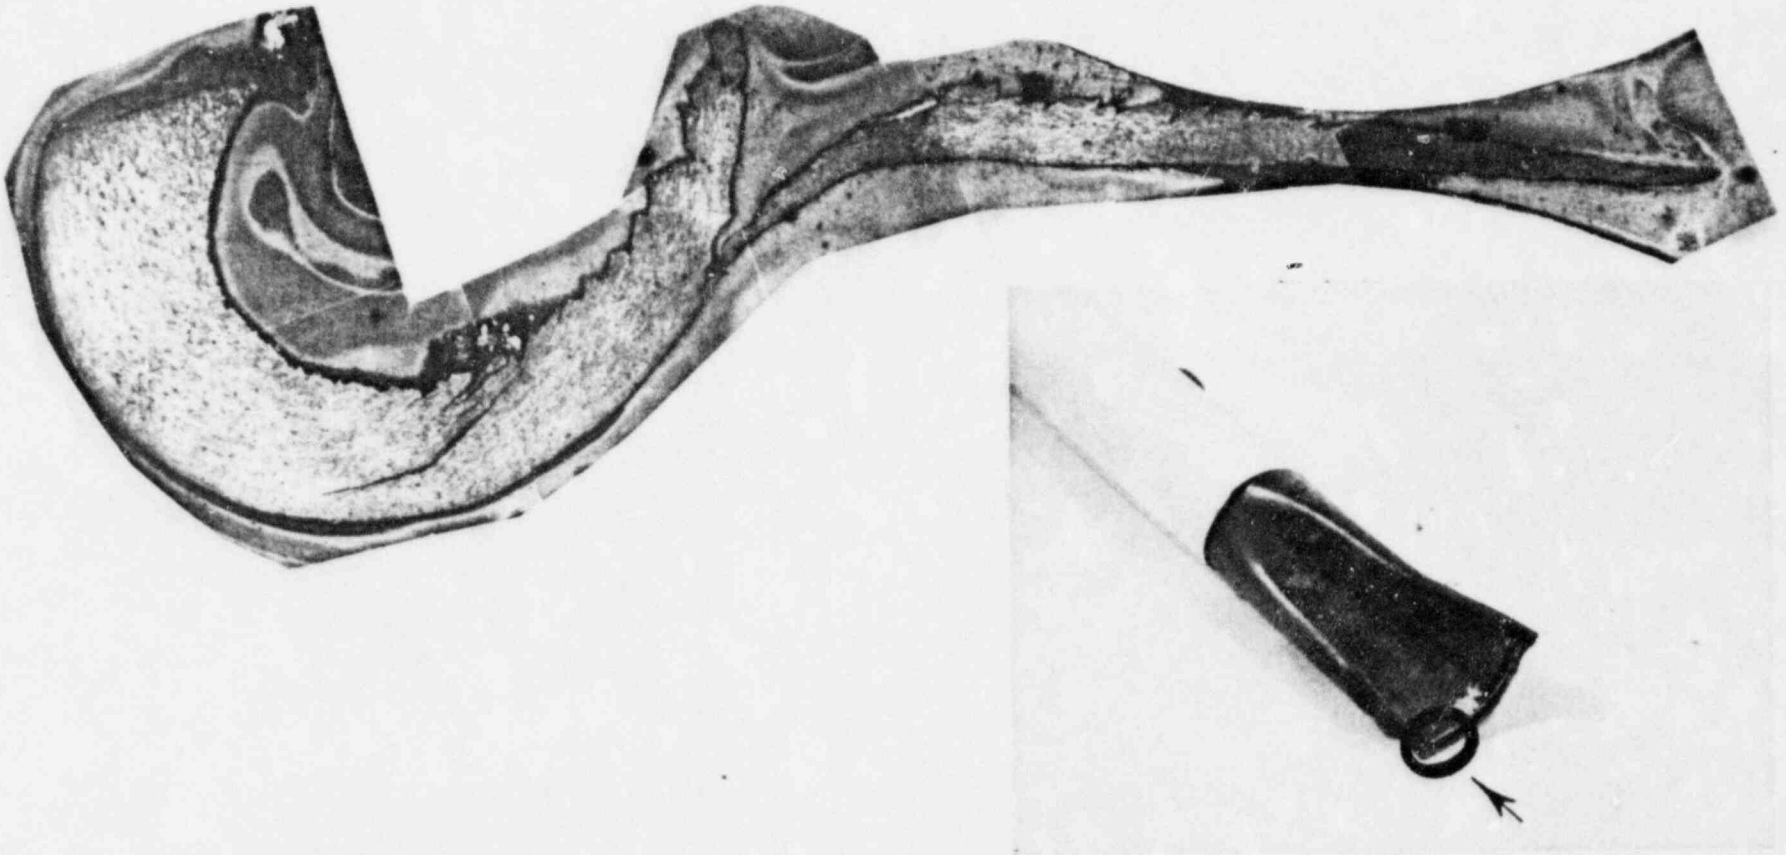
Figure 42. Cross sectional photomicrograph showing extent of damage endured by tube R44-C57. Also shown is area of section taken relative to collapse area.

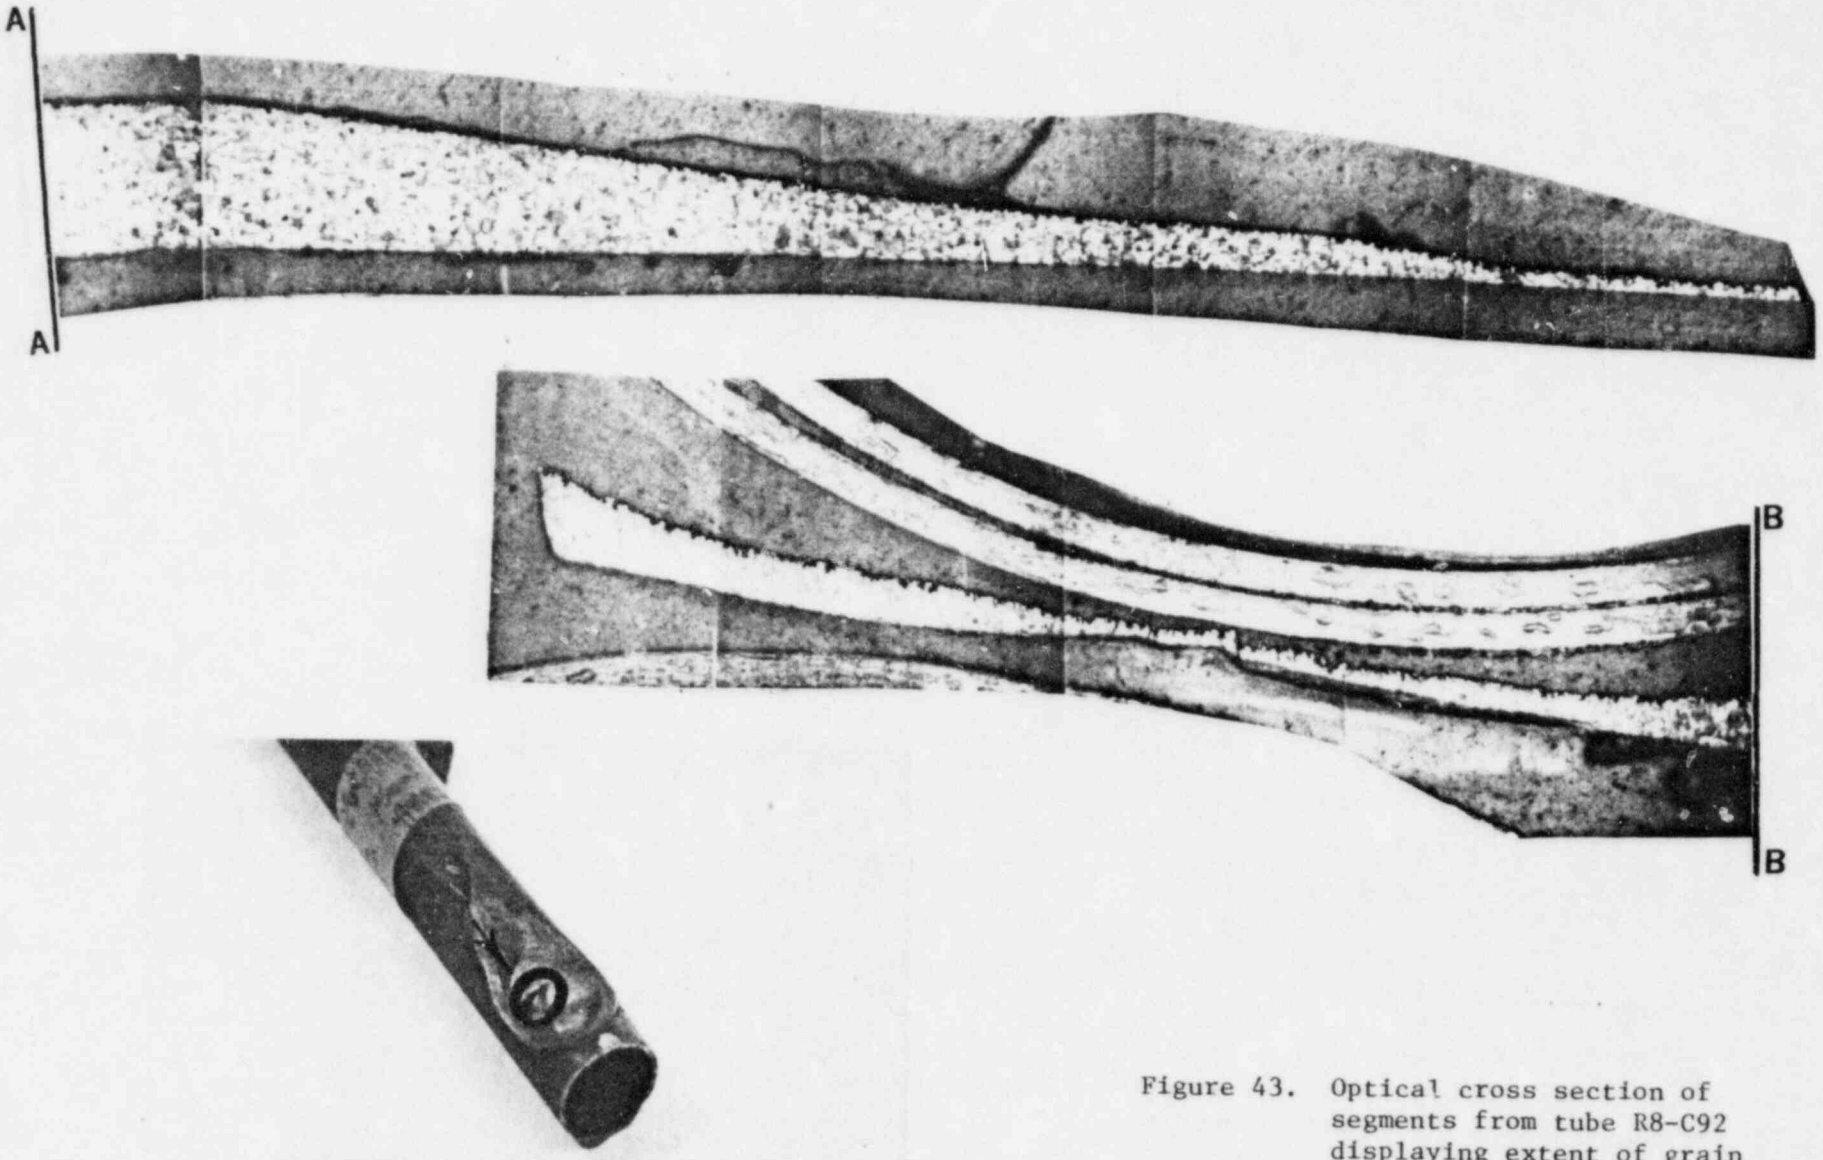
Since a grain boundary "etching" was noticed during SEM examination, an optical mount was made of tube R8-C92. As can be seen on Figure 43, the extent of grain boundary etching is only a few grains deep (approximately .001") which is consistent with the suggestion that this attack was caused by

pickling prior to plant operations and deceptively appears significant only on severely degraded areas of the section.

Figure 43. Optical cross section of segments from tube R8-C92 displaying extent of grain boundary etching.
