BEDROCK DEFORMATION IN THE
COOLING WATER SYSTEM
INTAKE TUNNEL, PERRY NUCLEAR POWER PLANT
NORTH PERRY TOWNSHIP, OHIO

PERRY NUCLEAR POWER PLANT – UNITS 1 AND 2

BEDROCK DEFORMATION IN THE

COOLING WATER SYSTEM INTAKE TUNNEL

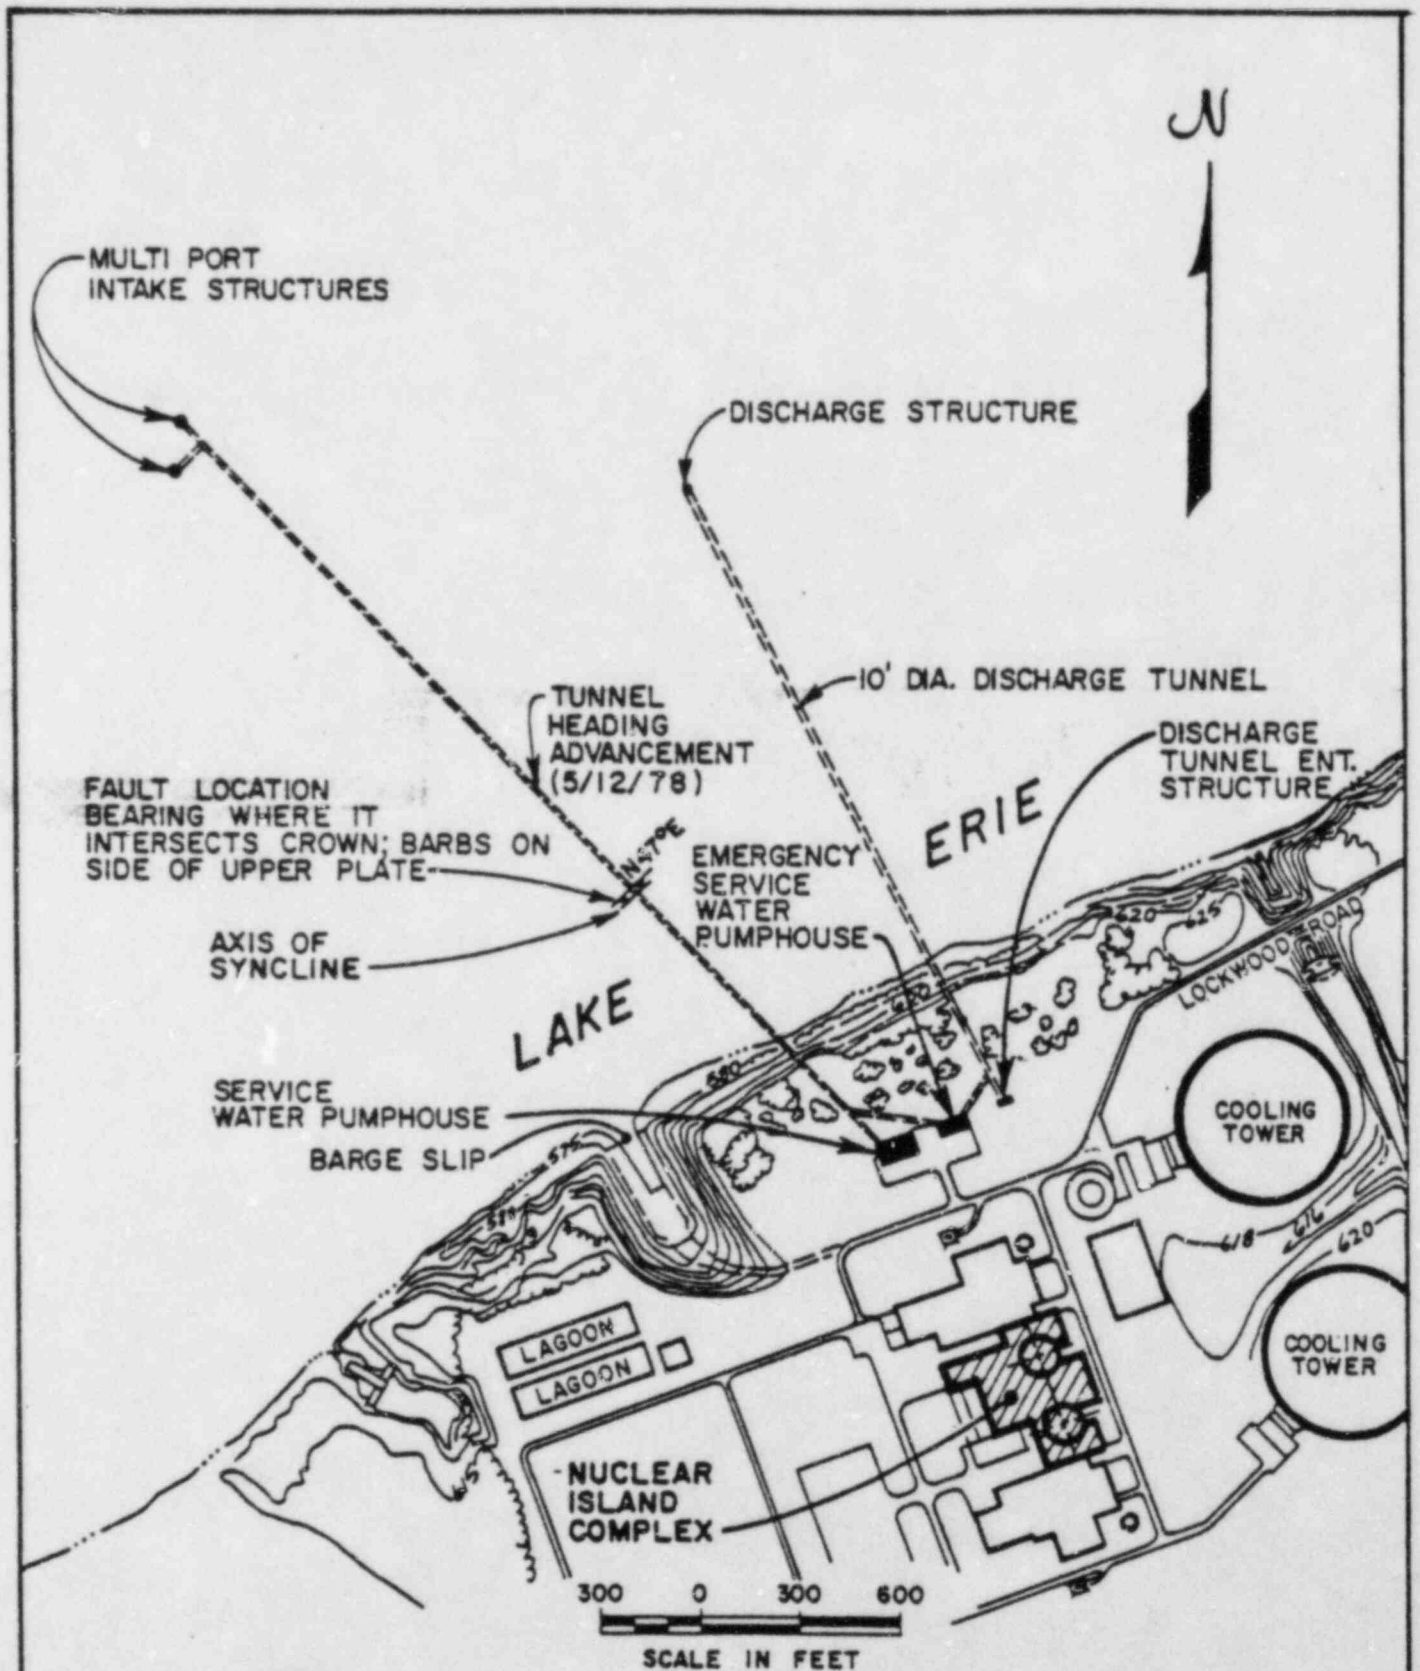
FIGURE I. PLOT PLAN OF INTAKE AND DISCHARGE STRUCTURES
SHOWING LOCATIONS OF BEDROCK DEFORMATION
PERRY NUCLEAR POWER PLANT
NORTH PERRY, OHIO.

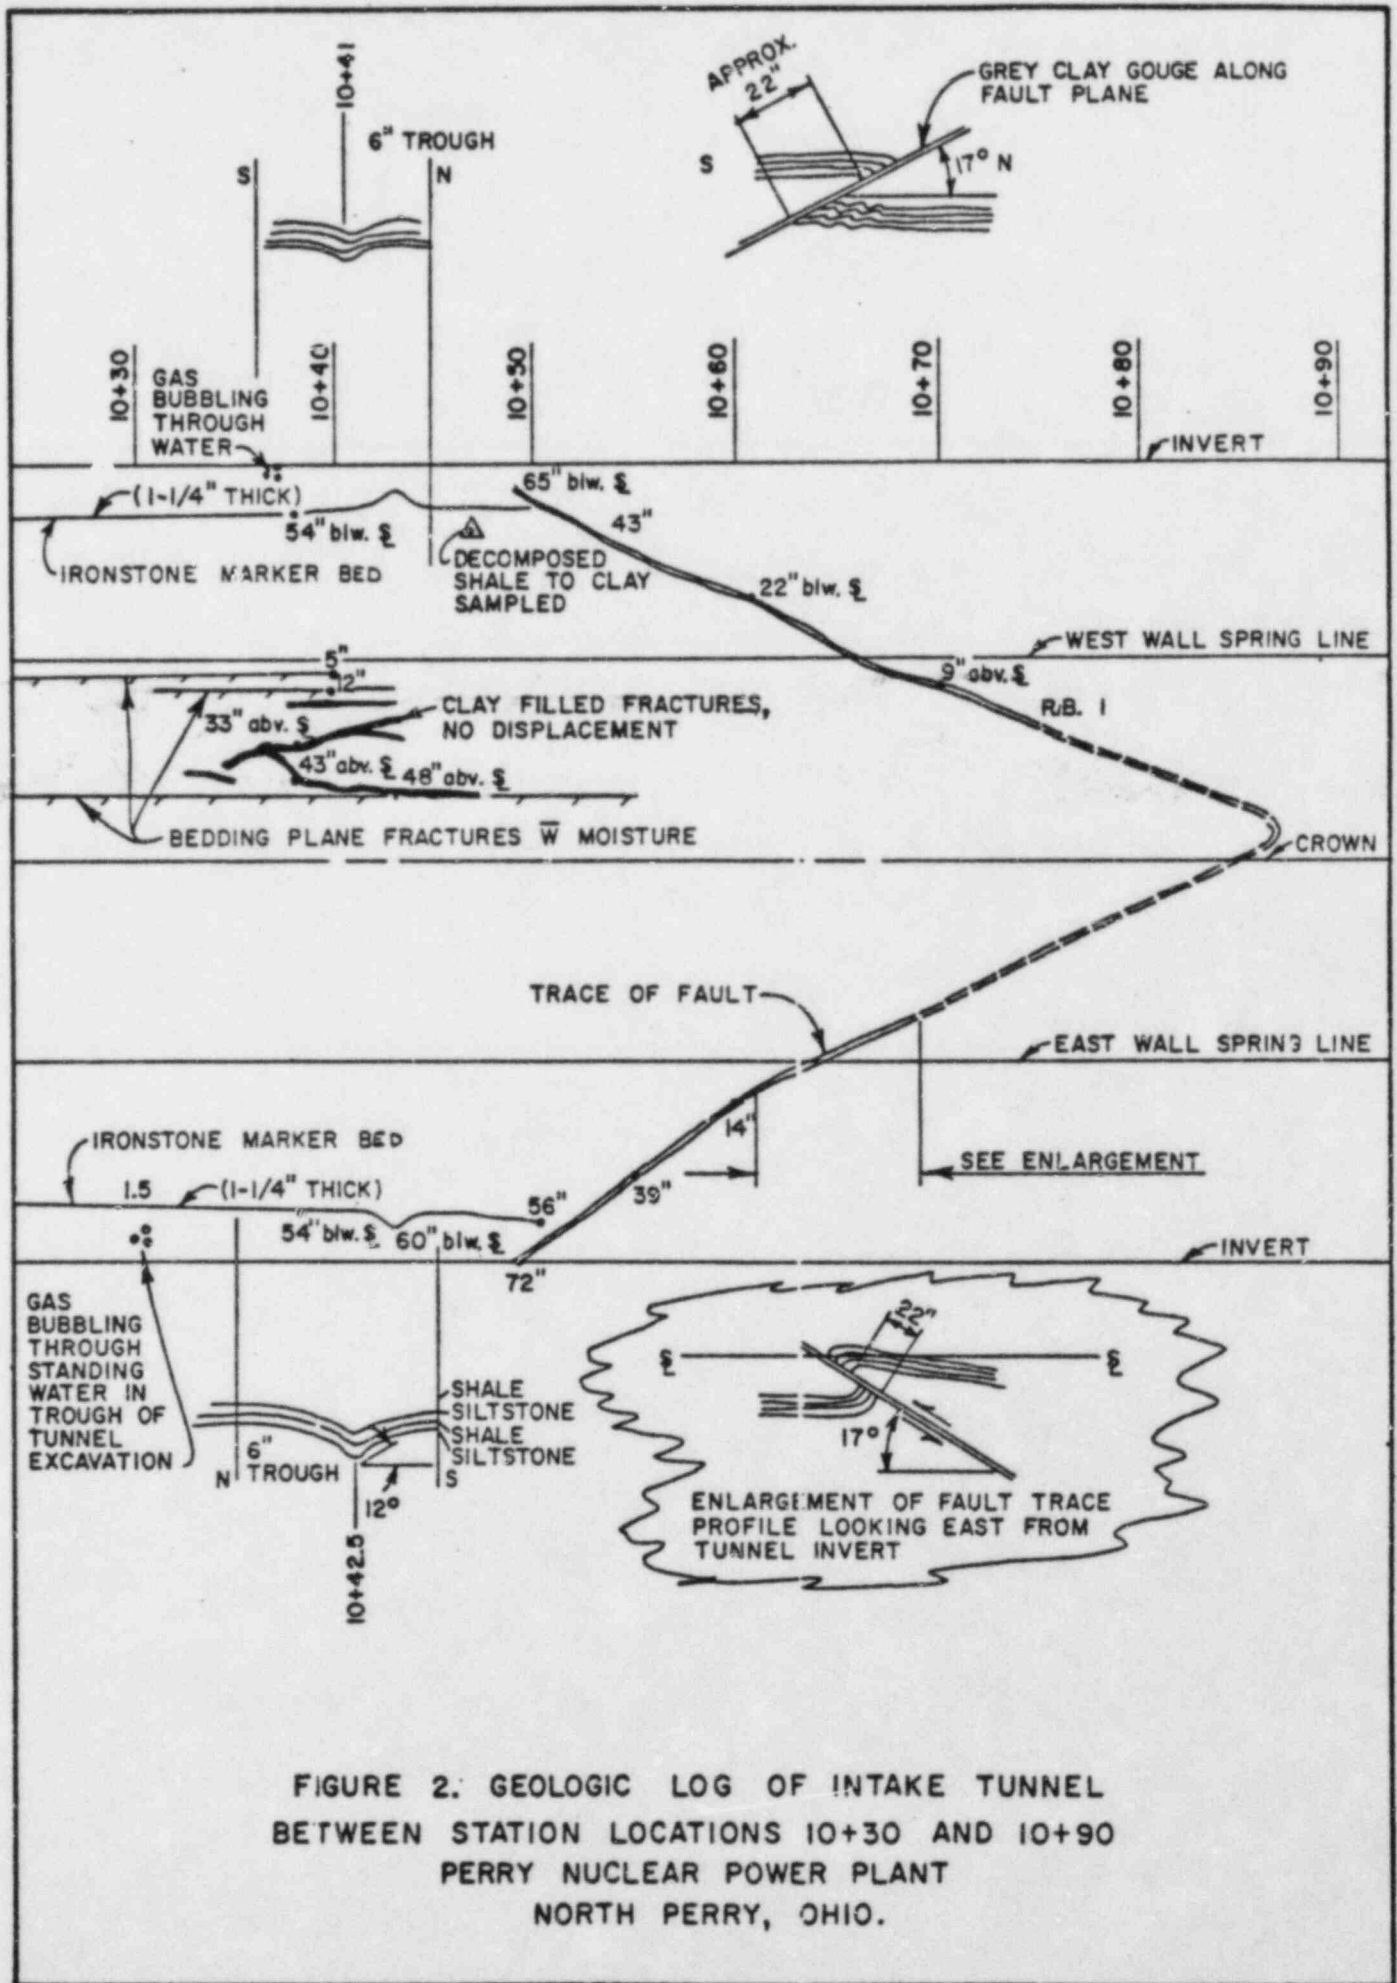
FIGURE 2. GEOLOGIC LOG OF INTAKE TUNNEL
BETWEEN STATION LOCATIONS 10+30 AND 10+90
PERRY NUCLEAR POWER PLANT
NORTH PERRY, OHIO.

APPROX. 22"

GREY CLAY GOUGE ALONG FAULT PLANE

ENLARGEMENT OF FAULT TRACE PROFILE LOOKING EAST FROM TUNNEL INVERT

adjacent to the fault plane and probable marker bed correlations are interpreted as rather substantial evidence of a low-angle reverse or thrust fault. Maximum apparent displacement was measured on the west wall at station location 10+61 to be approximately 22 inches accompanied by 12 and 18 inches of throw and heave respectively.

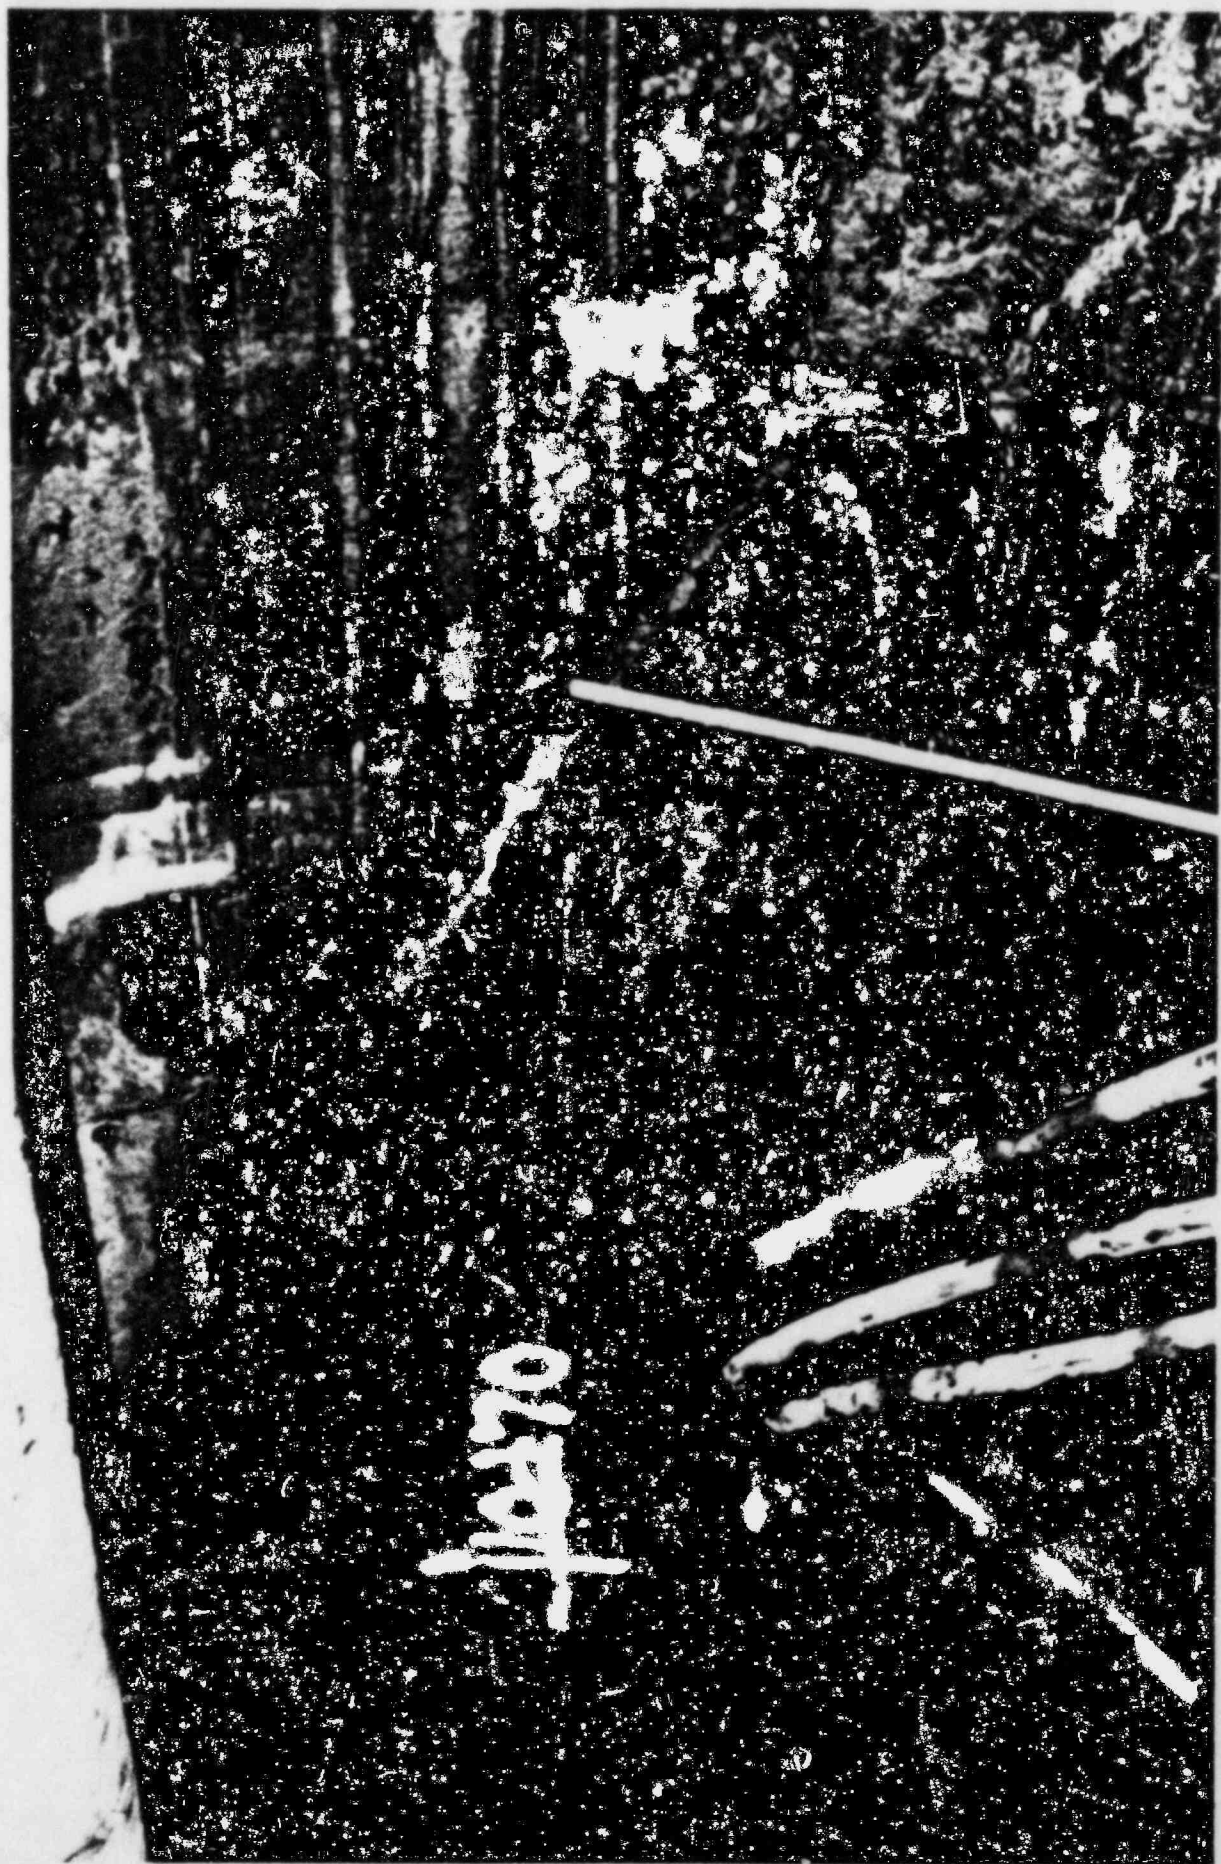
FIGURE 3. CORRELATION OF STRATUM ON EAST WALL INTAKE TU
RE DISPLACED ALONG FAULT; APPROXIMATE STATION LOCATION I
NOTE FLAT-LYING STRATUM ABOVE AND BELOW FAULTED INTERV

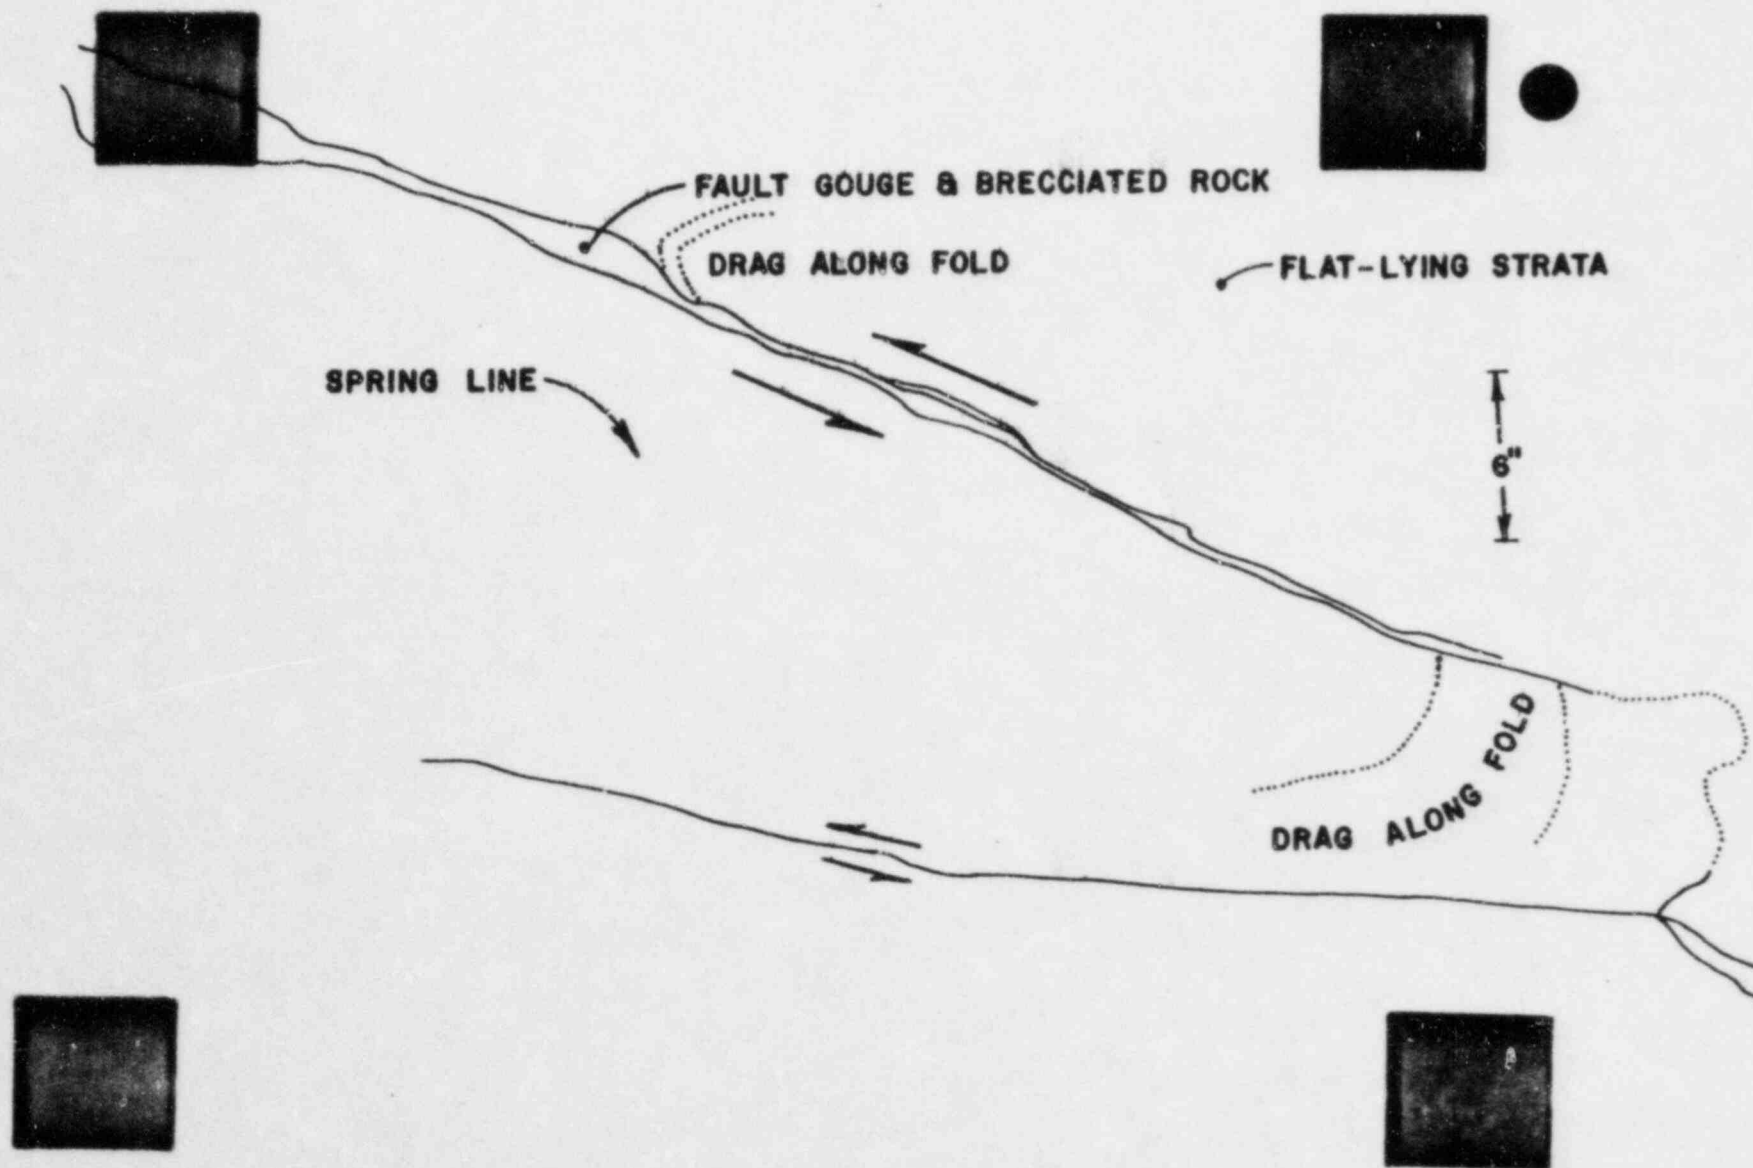
FIGURE 4. EAST WALL OF INTAKE TUNNEL WHERE FAULT
CROSSES SPRING LINE AT STATION 10+65.

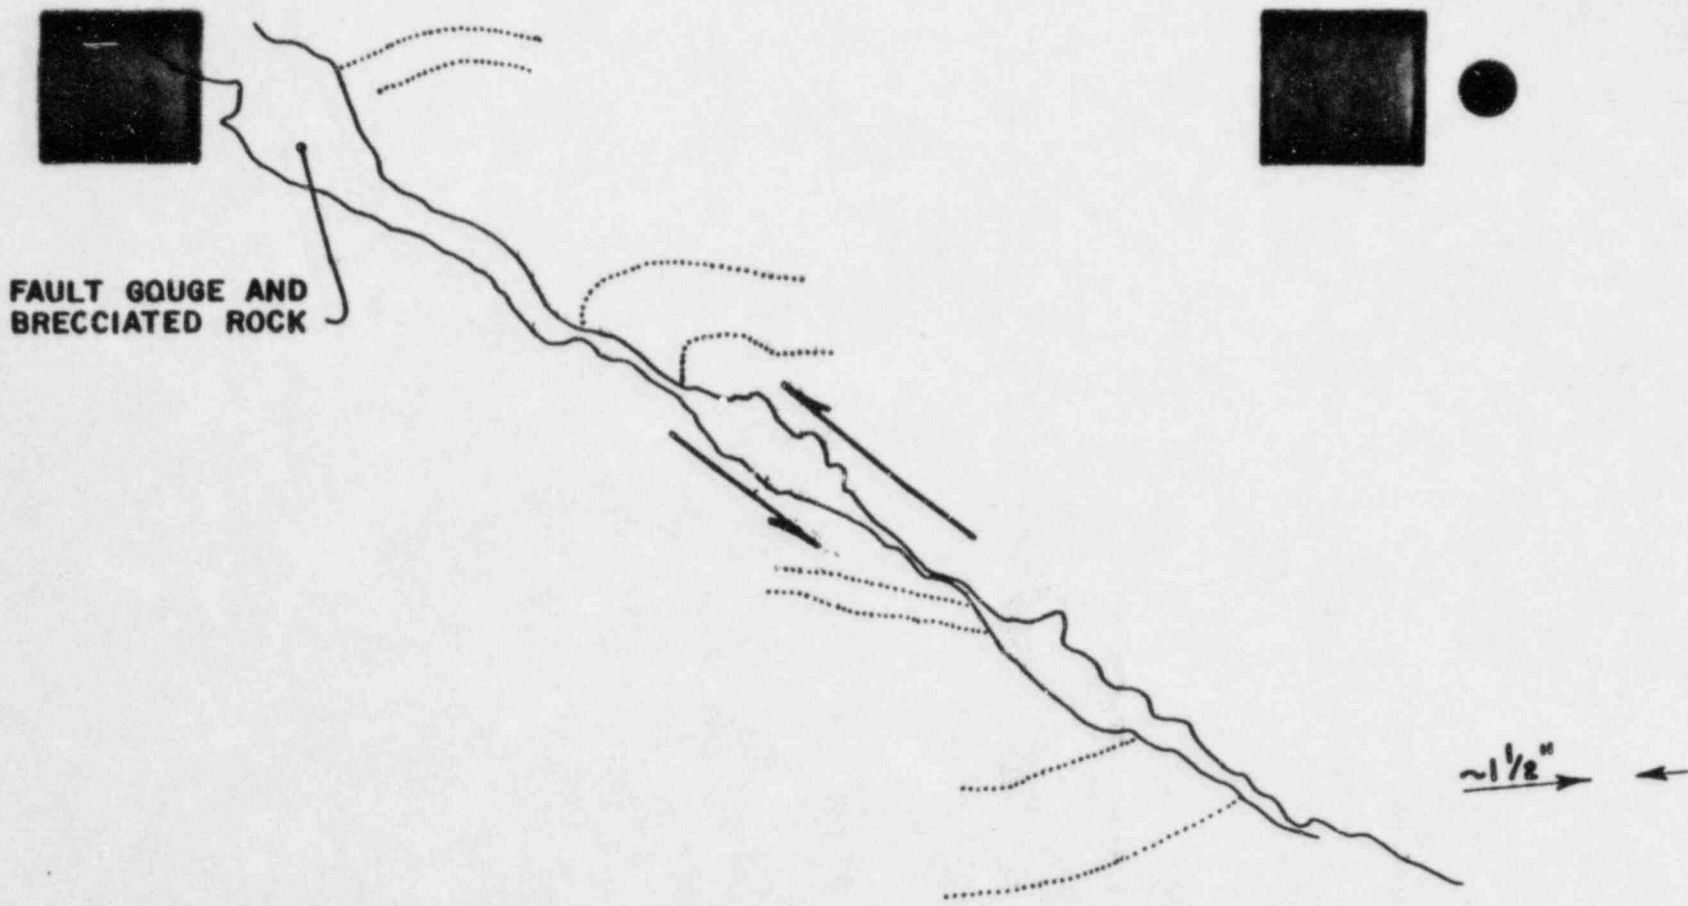
TRACE OF BEDDING PLANE
SHOWING EFFECTS OF DRAG

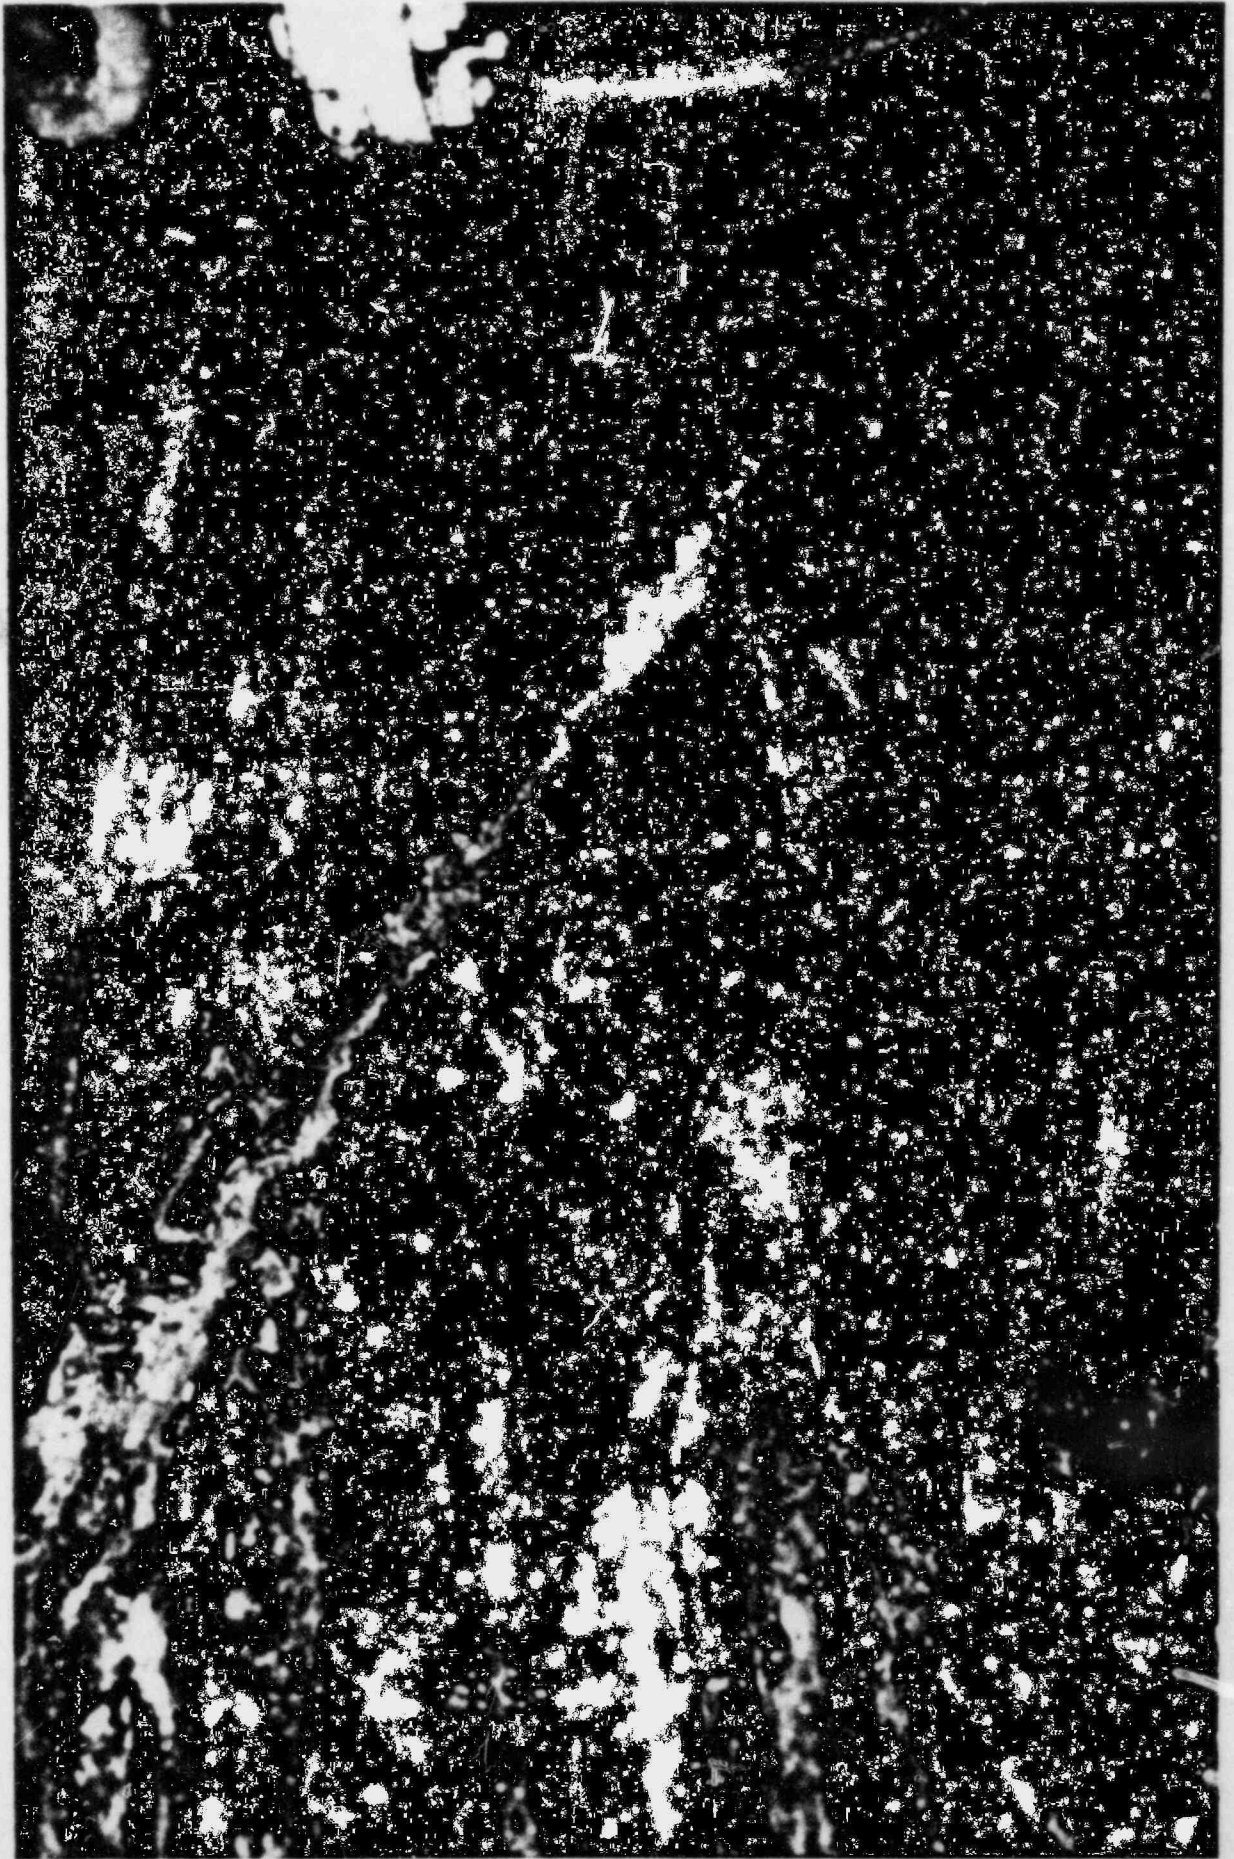
FAULT GOUGE AND
BRECCIATED ROCK

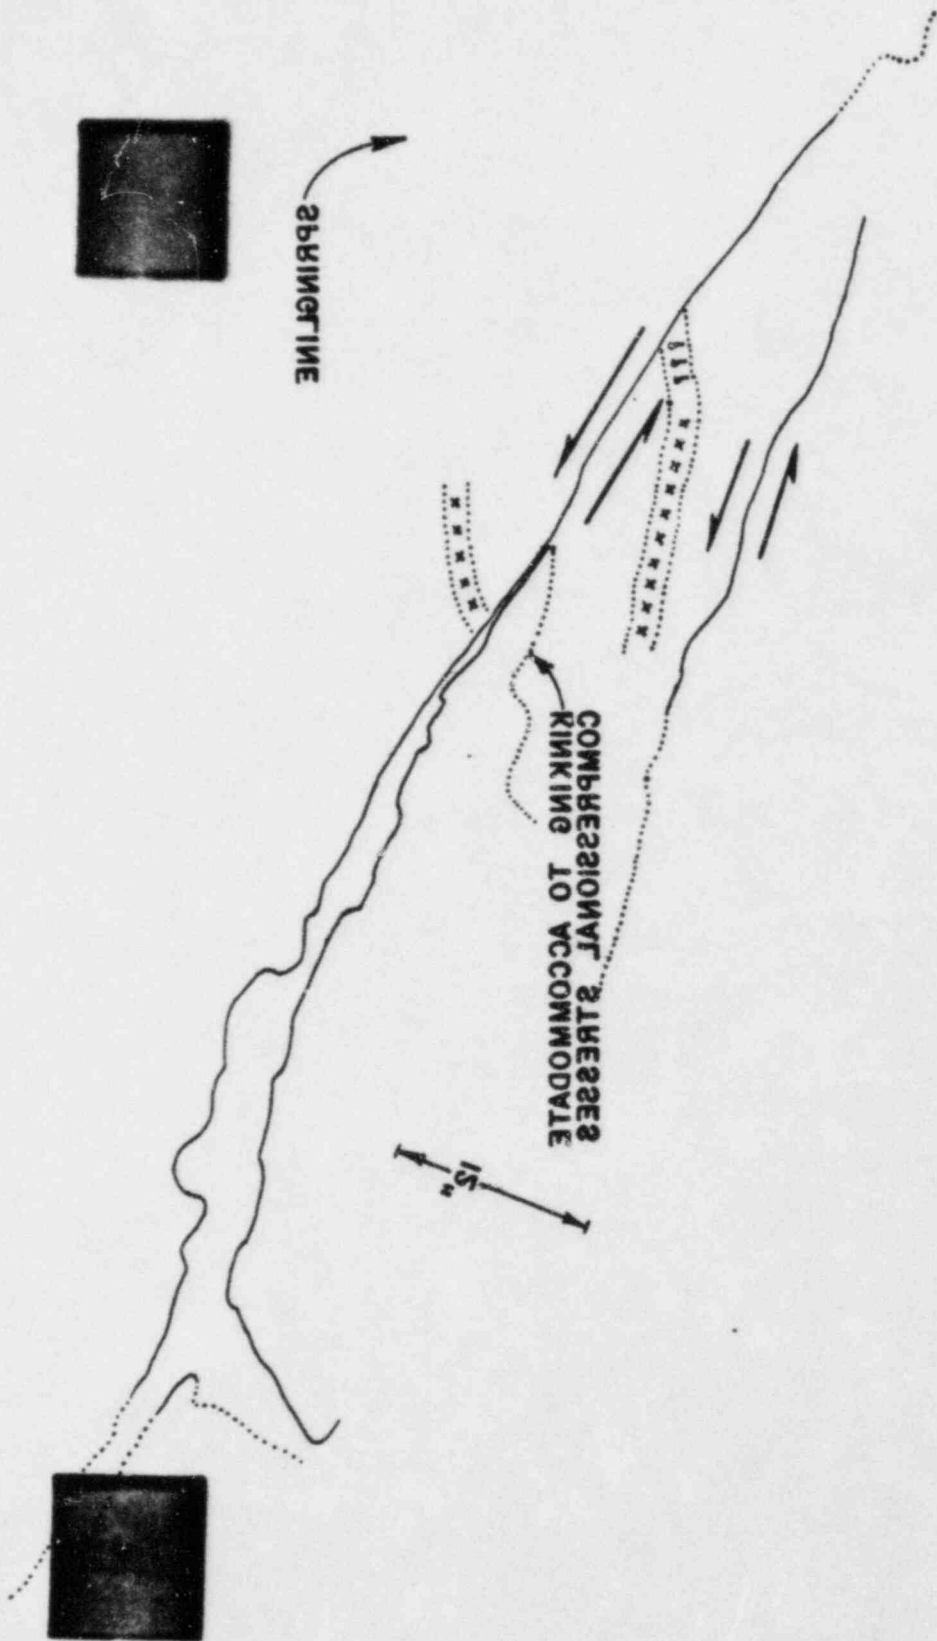
The fault plane varies in width from 1/2 to 18 inches, although the latter is more indicative of gently flexed and/or abruptly kinked or otherwise simply fractured rock. Typically, a gray-clay gouge of tough leathery consistency containing small angular shale fragments occupies the fault zone separating adjacent hanging and foot walls. As shown on several photographs there is a slight splaying of the fault resulting in a subparallel fracture ranging up to three feet in length with an apparent displacement on the order of a few inches (see Figs. 3, 4, 5, 7 and 8).

KINKING DUE TO
COMPRESSIONAL
STRESSES

FIGURE 8. FAULT ON WEST WALL OF INTAKE TUNNEL.

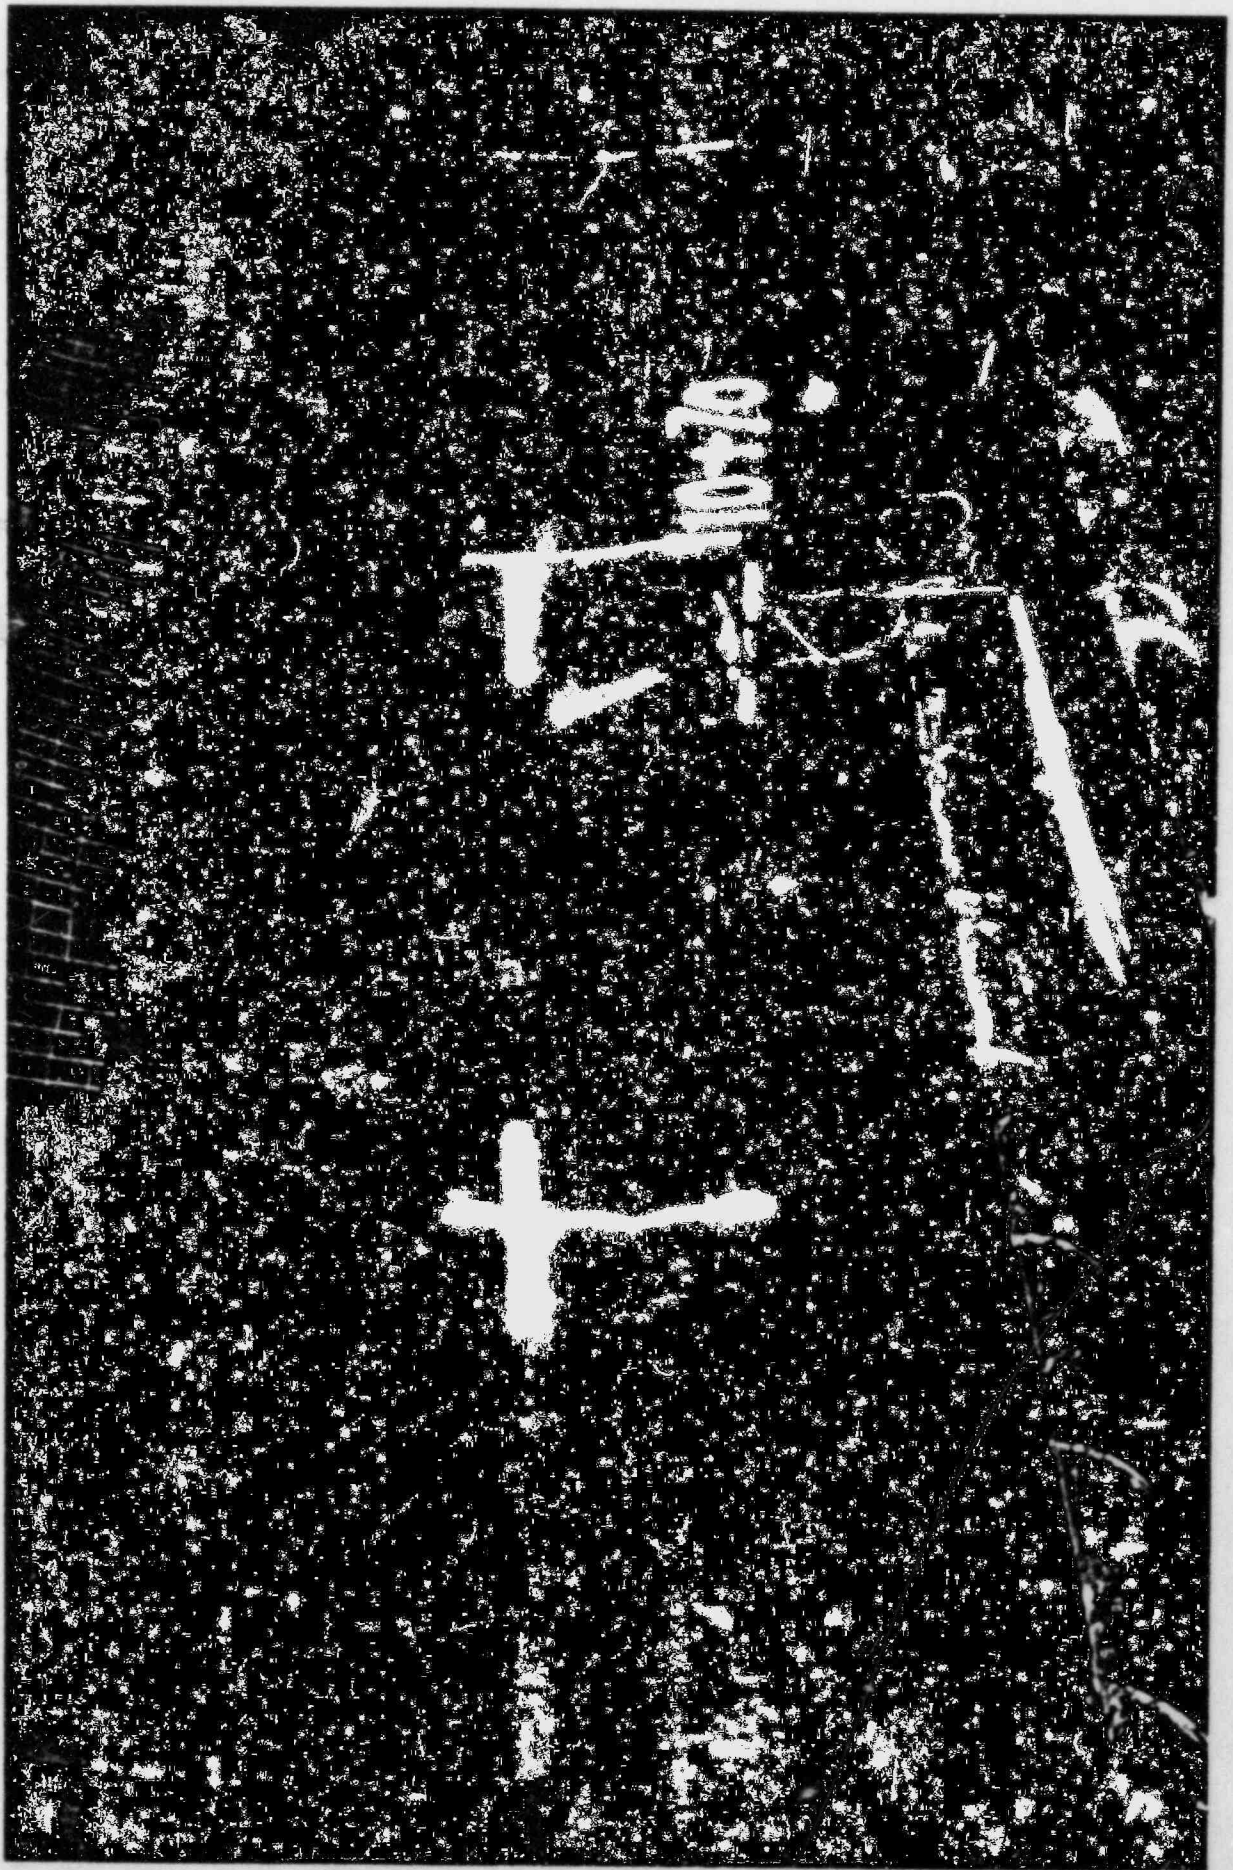
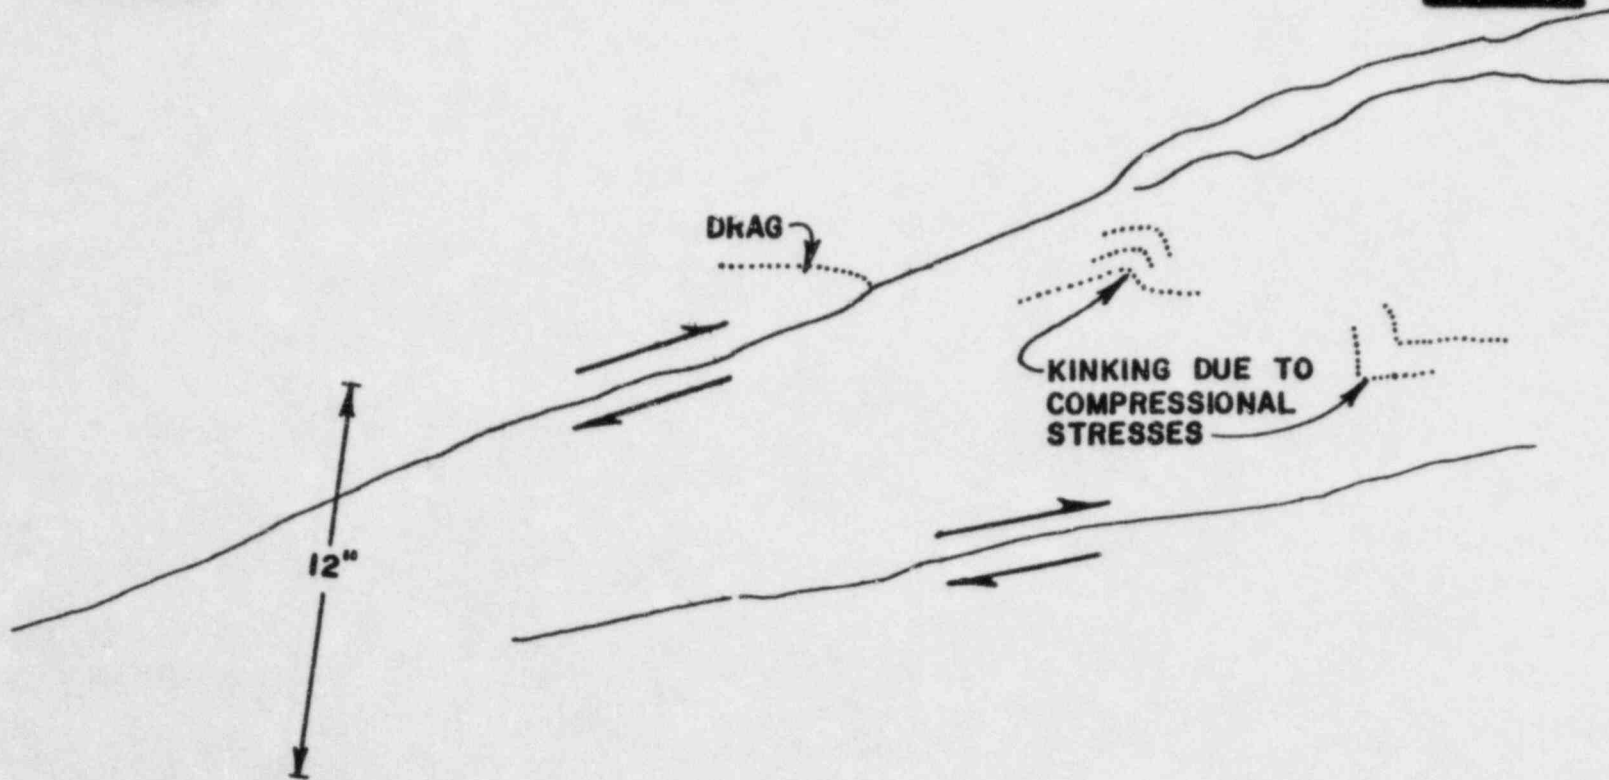
A general sense of symmetry between the east and west tunnel wall is quite good for most fault features discussed above except for kinking (see Figs. 7 and 8). Presumably, kinking of the bedrock is limited laterally. Nonetheless, it is considered representative of

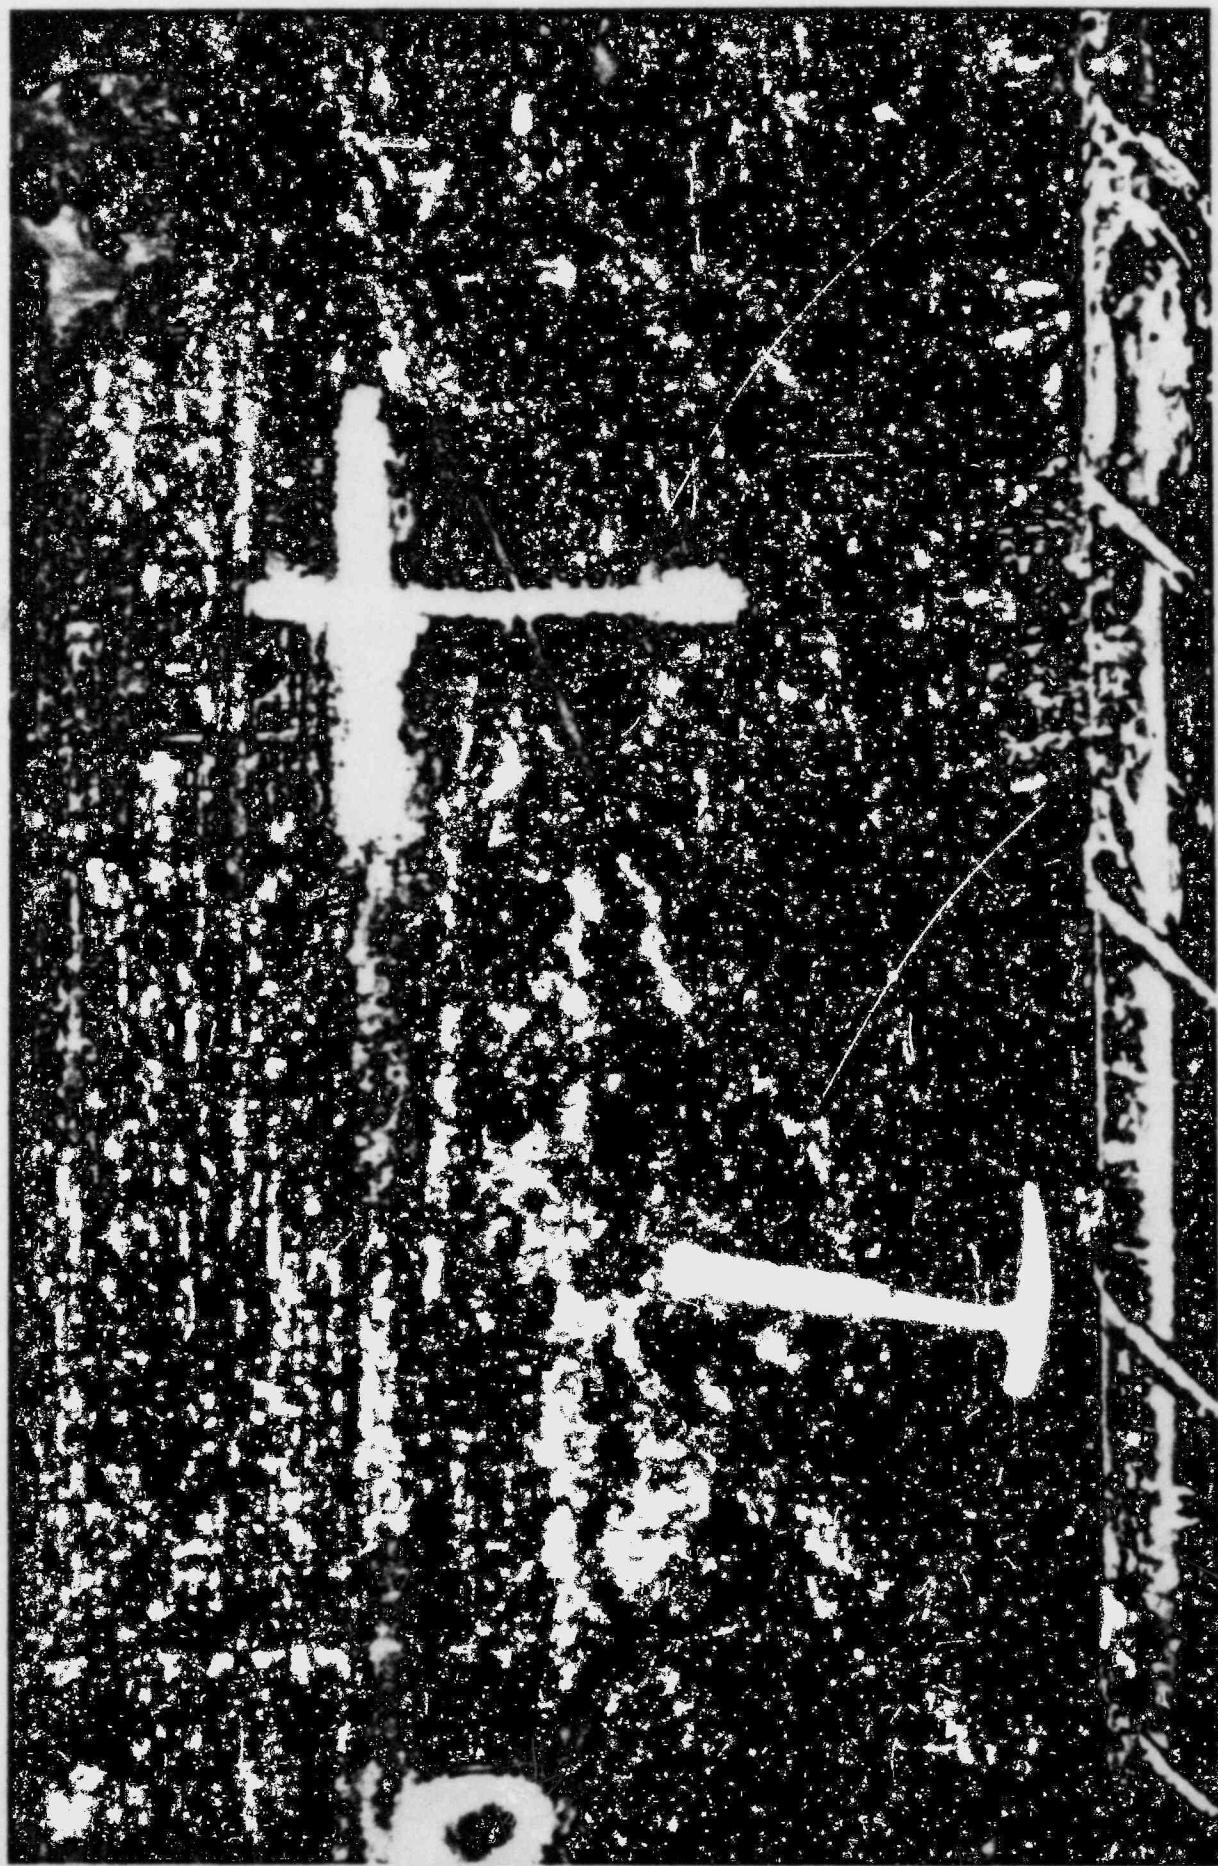
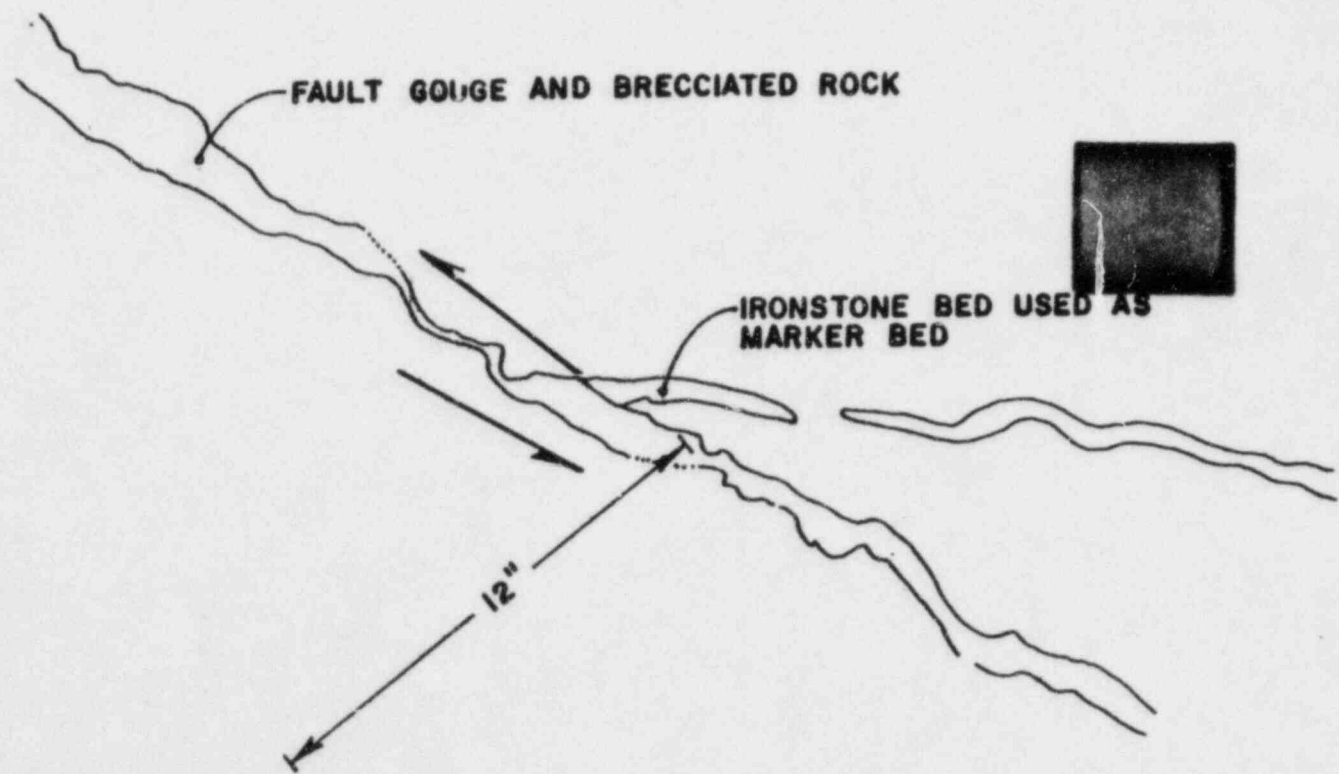
IRONSTONE BED USED AS
MARKER BED

IRONSTONE BED (OXIDIZED) ALONG EAST WALL INTAKE TUNN
WHERE IT INTERSECTS FAULT.
