ENGINEERING REPORT NO. HE-05-1991

STARTING AIR VALVE INVESTIGATION

NOVEMBER 25, 1991

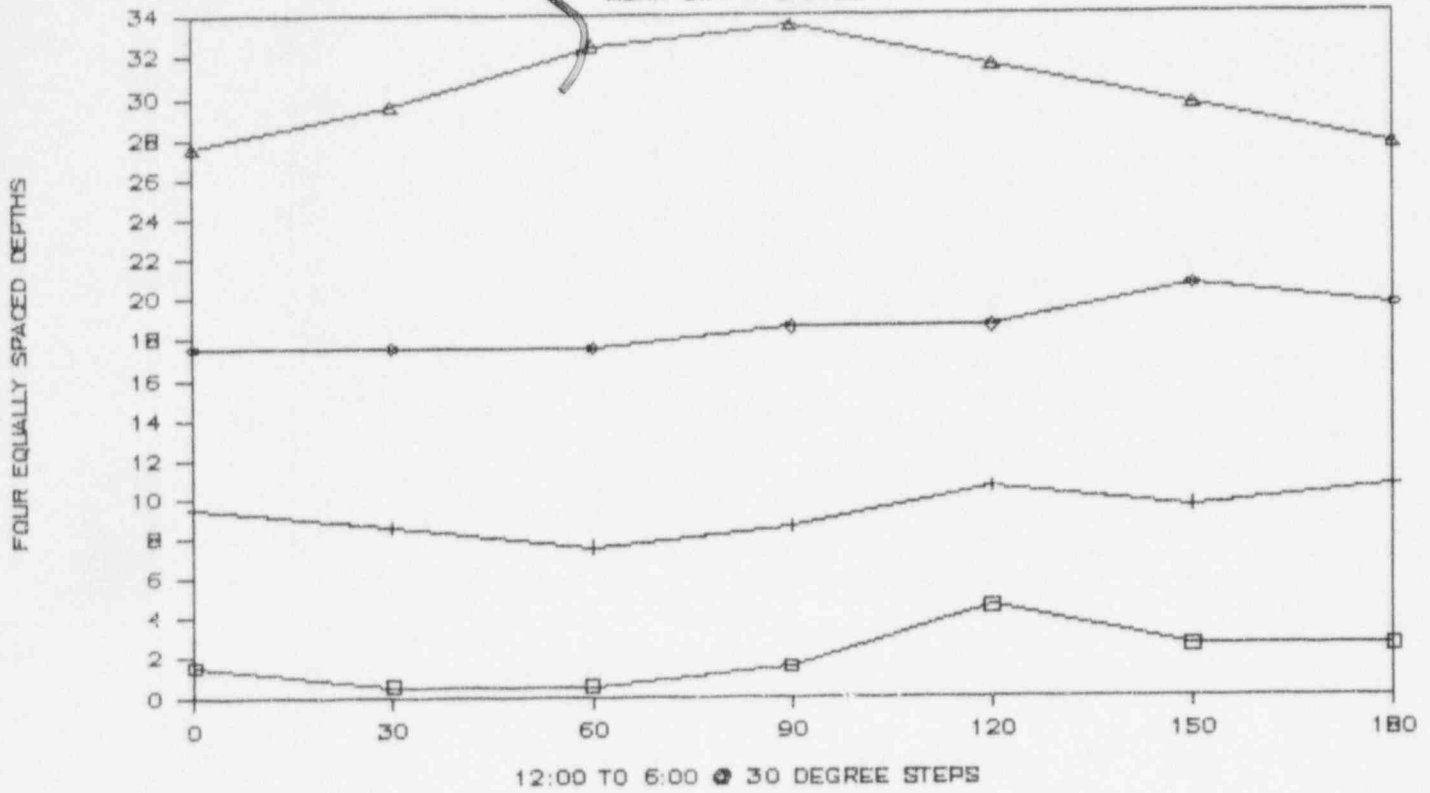
AIRCAP L1
MEAN DIA. = 2.24994

Graphical representation of the bore measurements is shown in *Attachment II*. The linear graphs trace the deviation from the mean diameter at each 30° interval from bolt hole flange to bolt hole flange. The four measurement depths are shown equally spaced from the bottom of the bore to the bore lip. Measurements are in 1/10 mils. In general the bores appear to be slightly elongated along the axis coincident to the bolt hole flanges. Some exceptions to that are the measurements taken at the lip of cap bores L1, L3 and L8. Those measurements show the bores at that location to be slightly longer in the direction perpendicular to the bolt hole flanges.

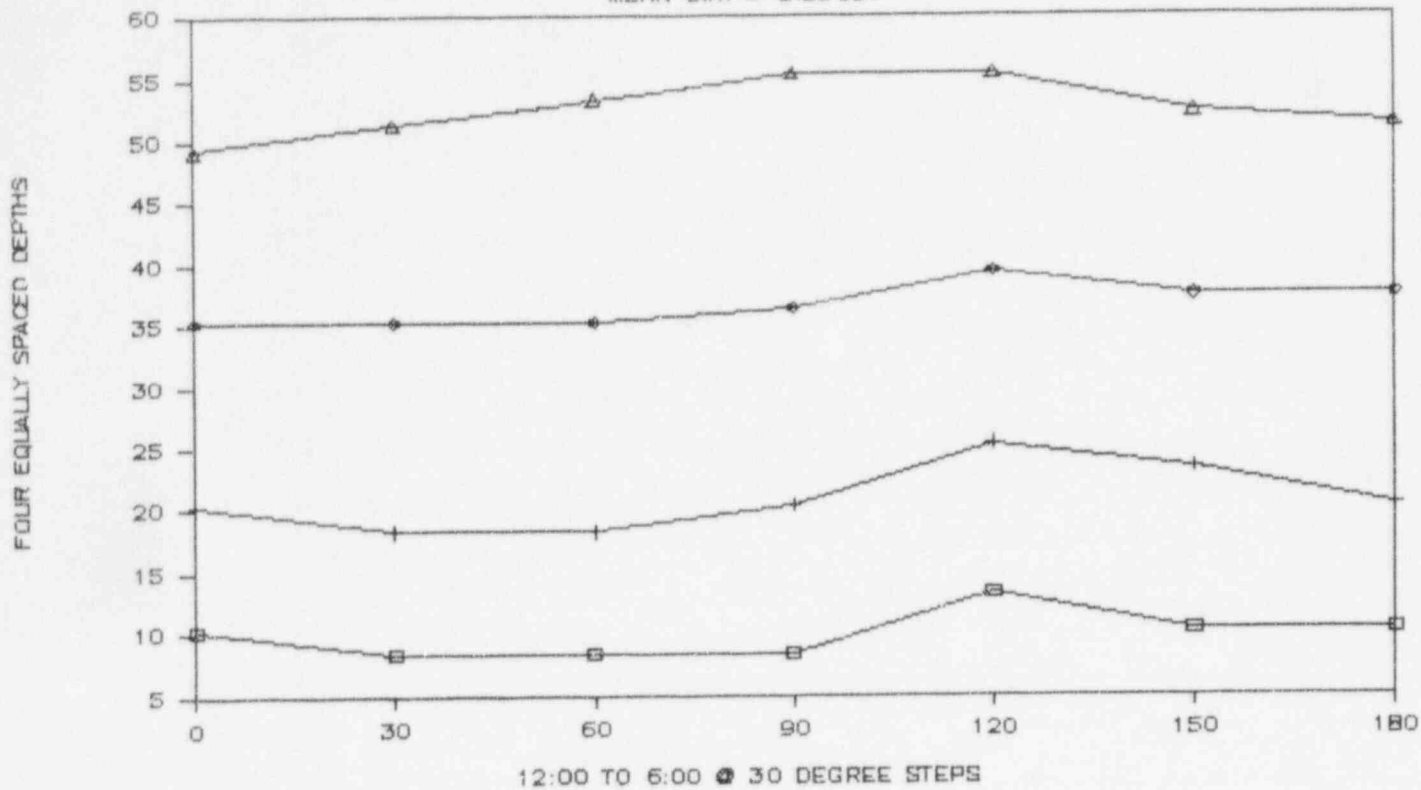
AIRCAP L5
MEAN DIA. = 2.25057
FOUR EQUALLY SPACED DEPTHS
12:00 TO 6:00 @ 30 DEGREE STEPS

Several comments can be made regarding the results. Firstly, all of the cap bores conformed to the design specification of 2.2495"/2.2505" with the exception of cap L5. Measurements of that bore were found to be as much as 1.9 mils over nominal diameter along the bottom depth. Diametral deviation was no greater than the other caps at that location and the remaining depths were measured within specification. No reasons for that nonconformance were visibly apparent but it should be noted that those measurements were taken as close as possible to the 3/32" re-entrant fillet at the bottom of the bore. A slightly oversized fillet, chamfer, or taper could have attributed to the unexpected bore measurements. Additionally, the oversized bore at that location would not induce piston seizure.

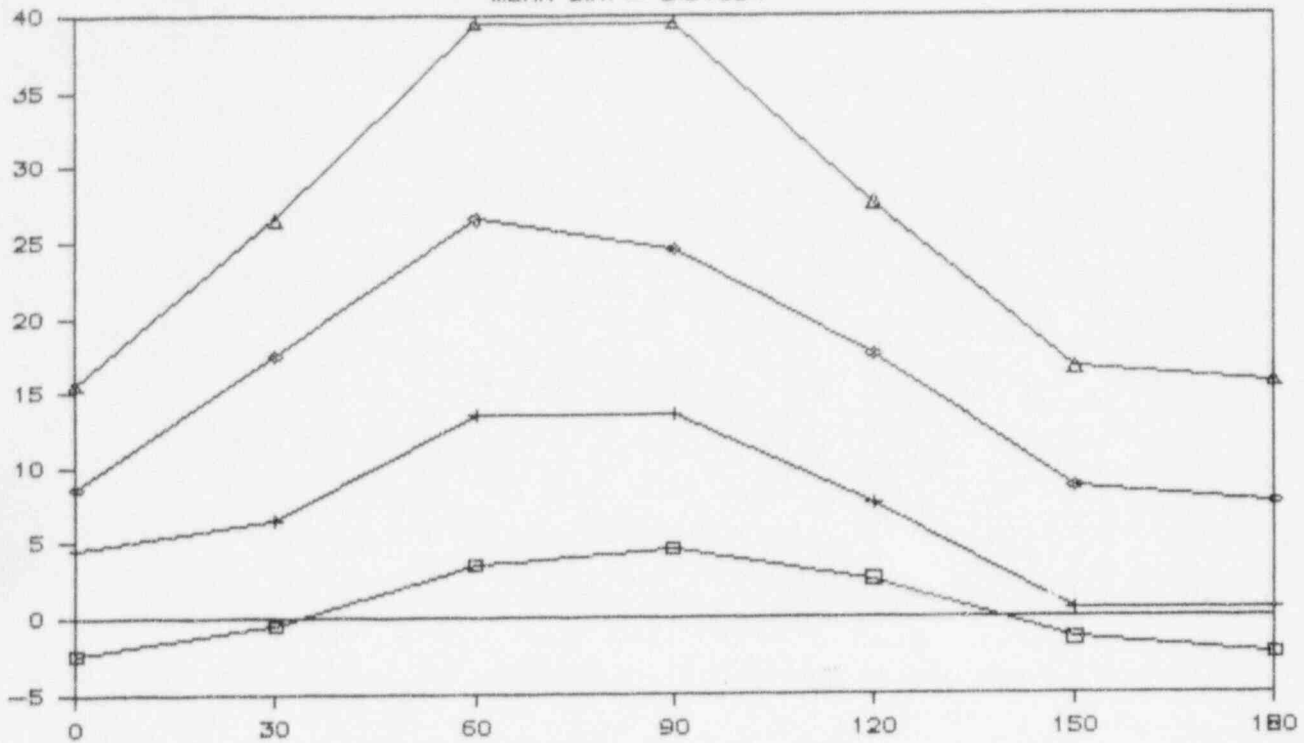
AIRCAP L1
MEAN DIA. = 2.24994

The cap bores were remeasured while chucked in a lathe at the bolt hole flanges to simulate the forces imparted by the hydraulically operated v-chucks that were at one time used during cap manufacturing. These measurements and the corresponding graphs are shown in *Attachments III* and *IV*. Although I was not able to chuck the caps to produce round bores, the plots show that material did deform and cause the bores to elongate in the direction perpendicular to the bolt hole flanges. A comparison of the chucked and unchucked measurements shows the Georgia Power caps to be out of round in the direction one would expect if excessive clamping force was applied to the bolt hole flanges during machining.

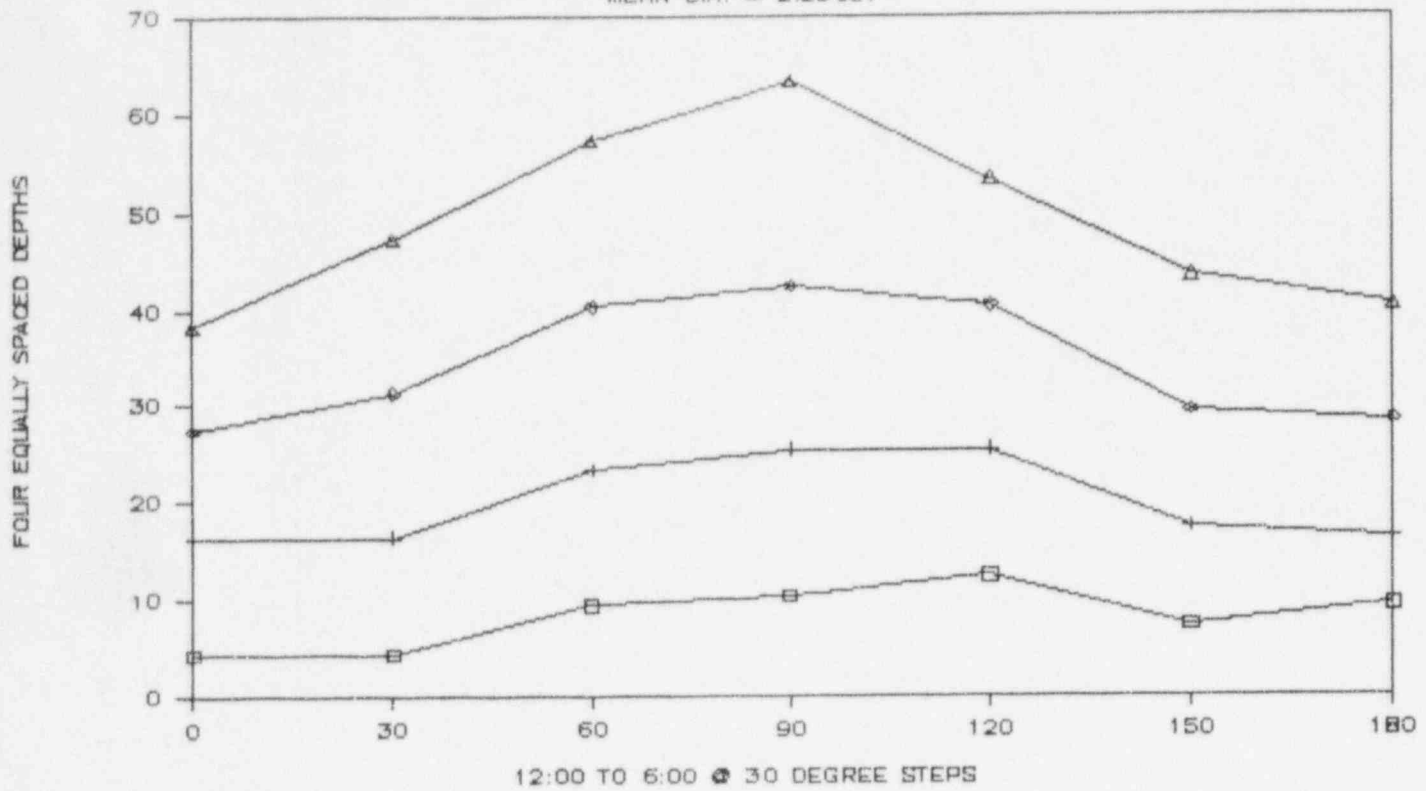
AIRCAP L6

MEAN DIA. = 2.24972

FOUR EQUALLY SPACED DEPTHS
