WCAP-13139

FARLEY UNITS 1 AND 2

STEAM GENERATOR TUBE/ TUBE SUPPORT PLATE ELEVATION ALTERNATE PLUGGING CRITERION SUMMARY

DECEMBER 1991

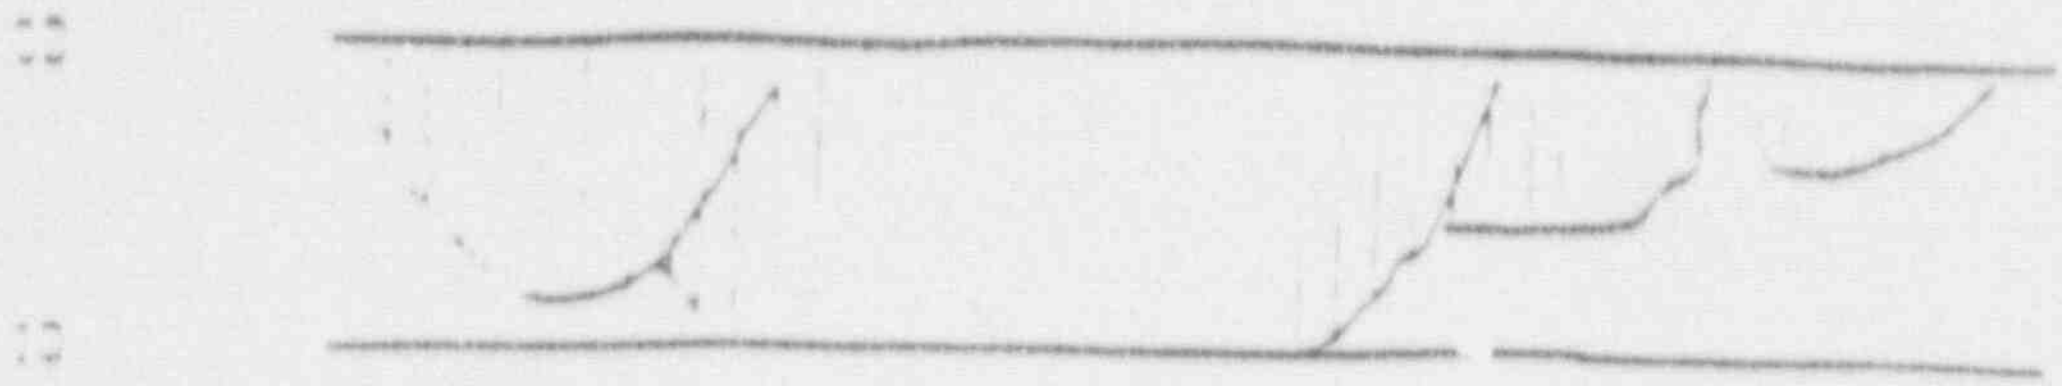
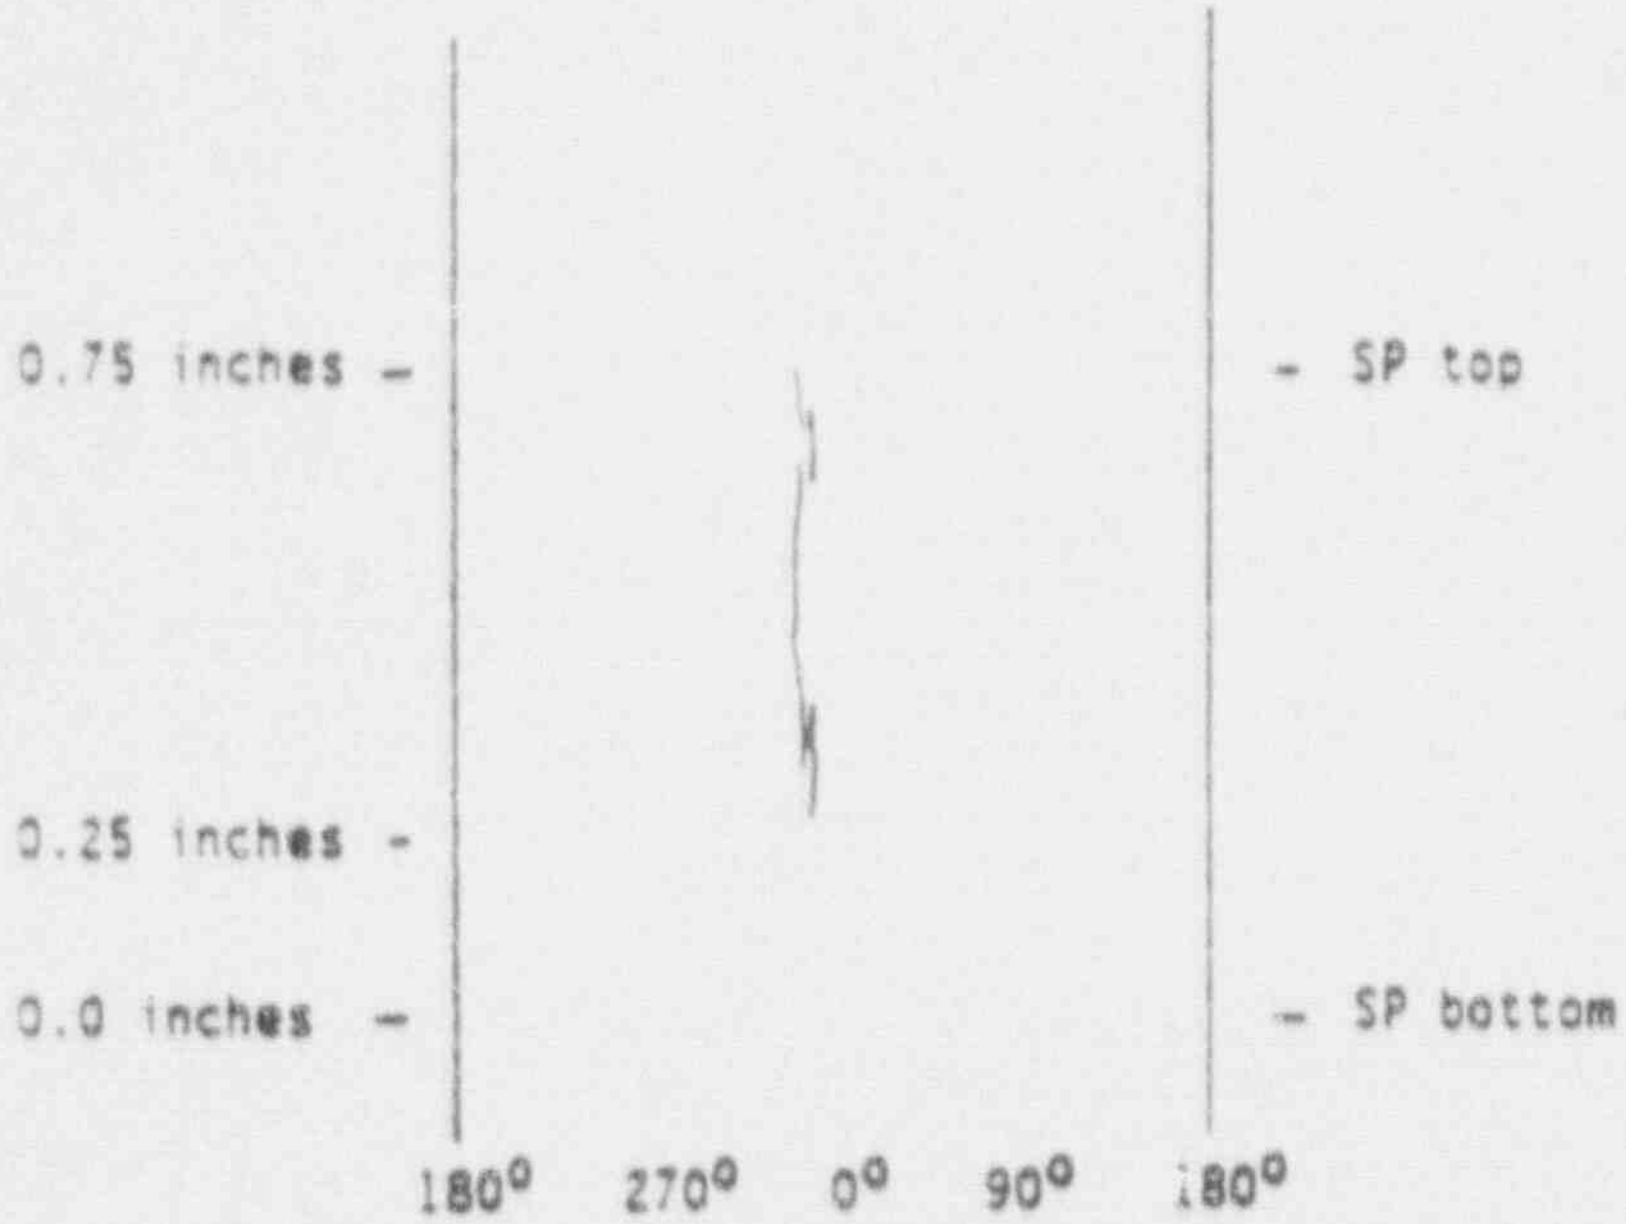
Macrocrack Length = 0.50 inches

Number of Microcracks = 4 (two ligaments with intergranular features, one with ductile overload features)

Morphology = Intergranular SCC with significant IGA characteristics (width of IGA 0.030 inches)

Description of OD origin corrosion at the first support plate crevice region of tube R21-C22.

Figure 4-9. Sketch of crack distribution and depth within the first support plate crevice region in tube R21-C22.

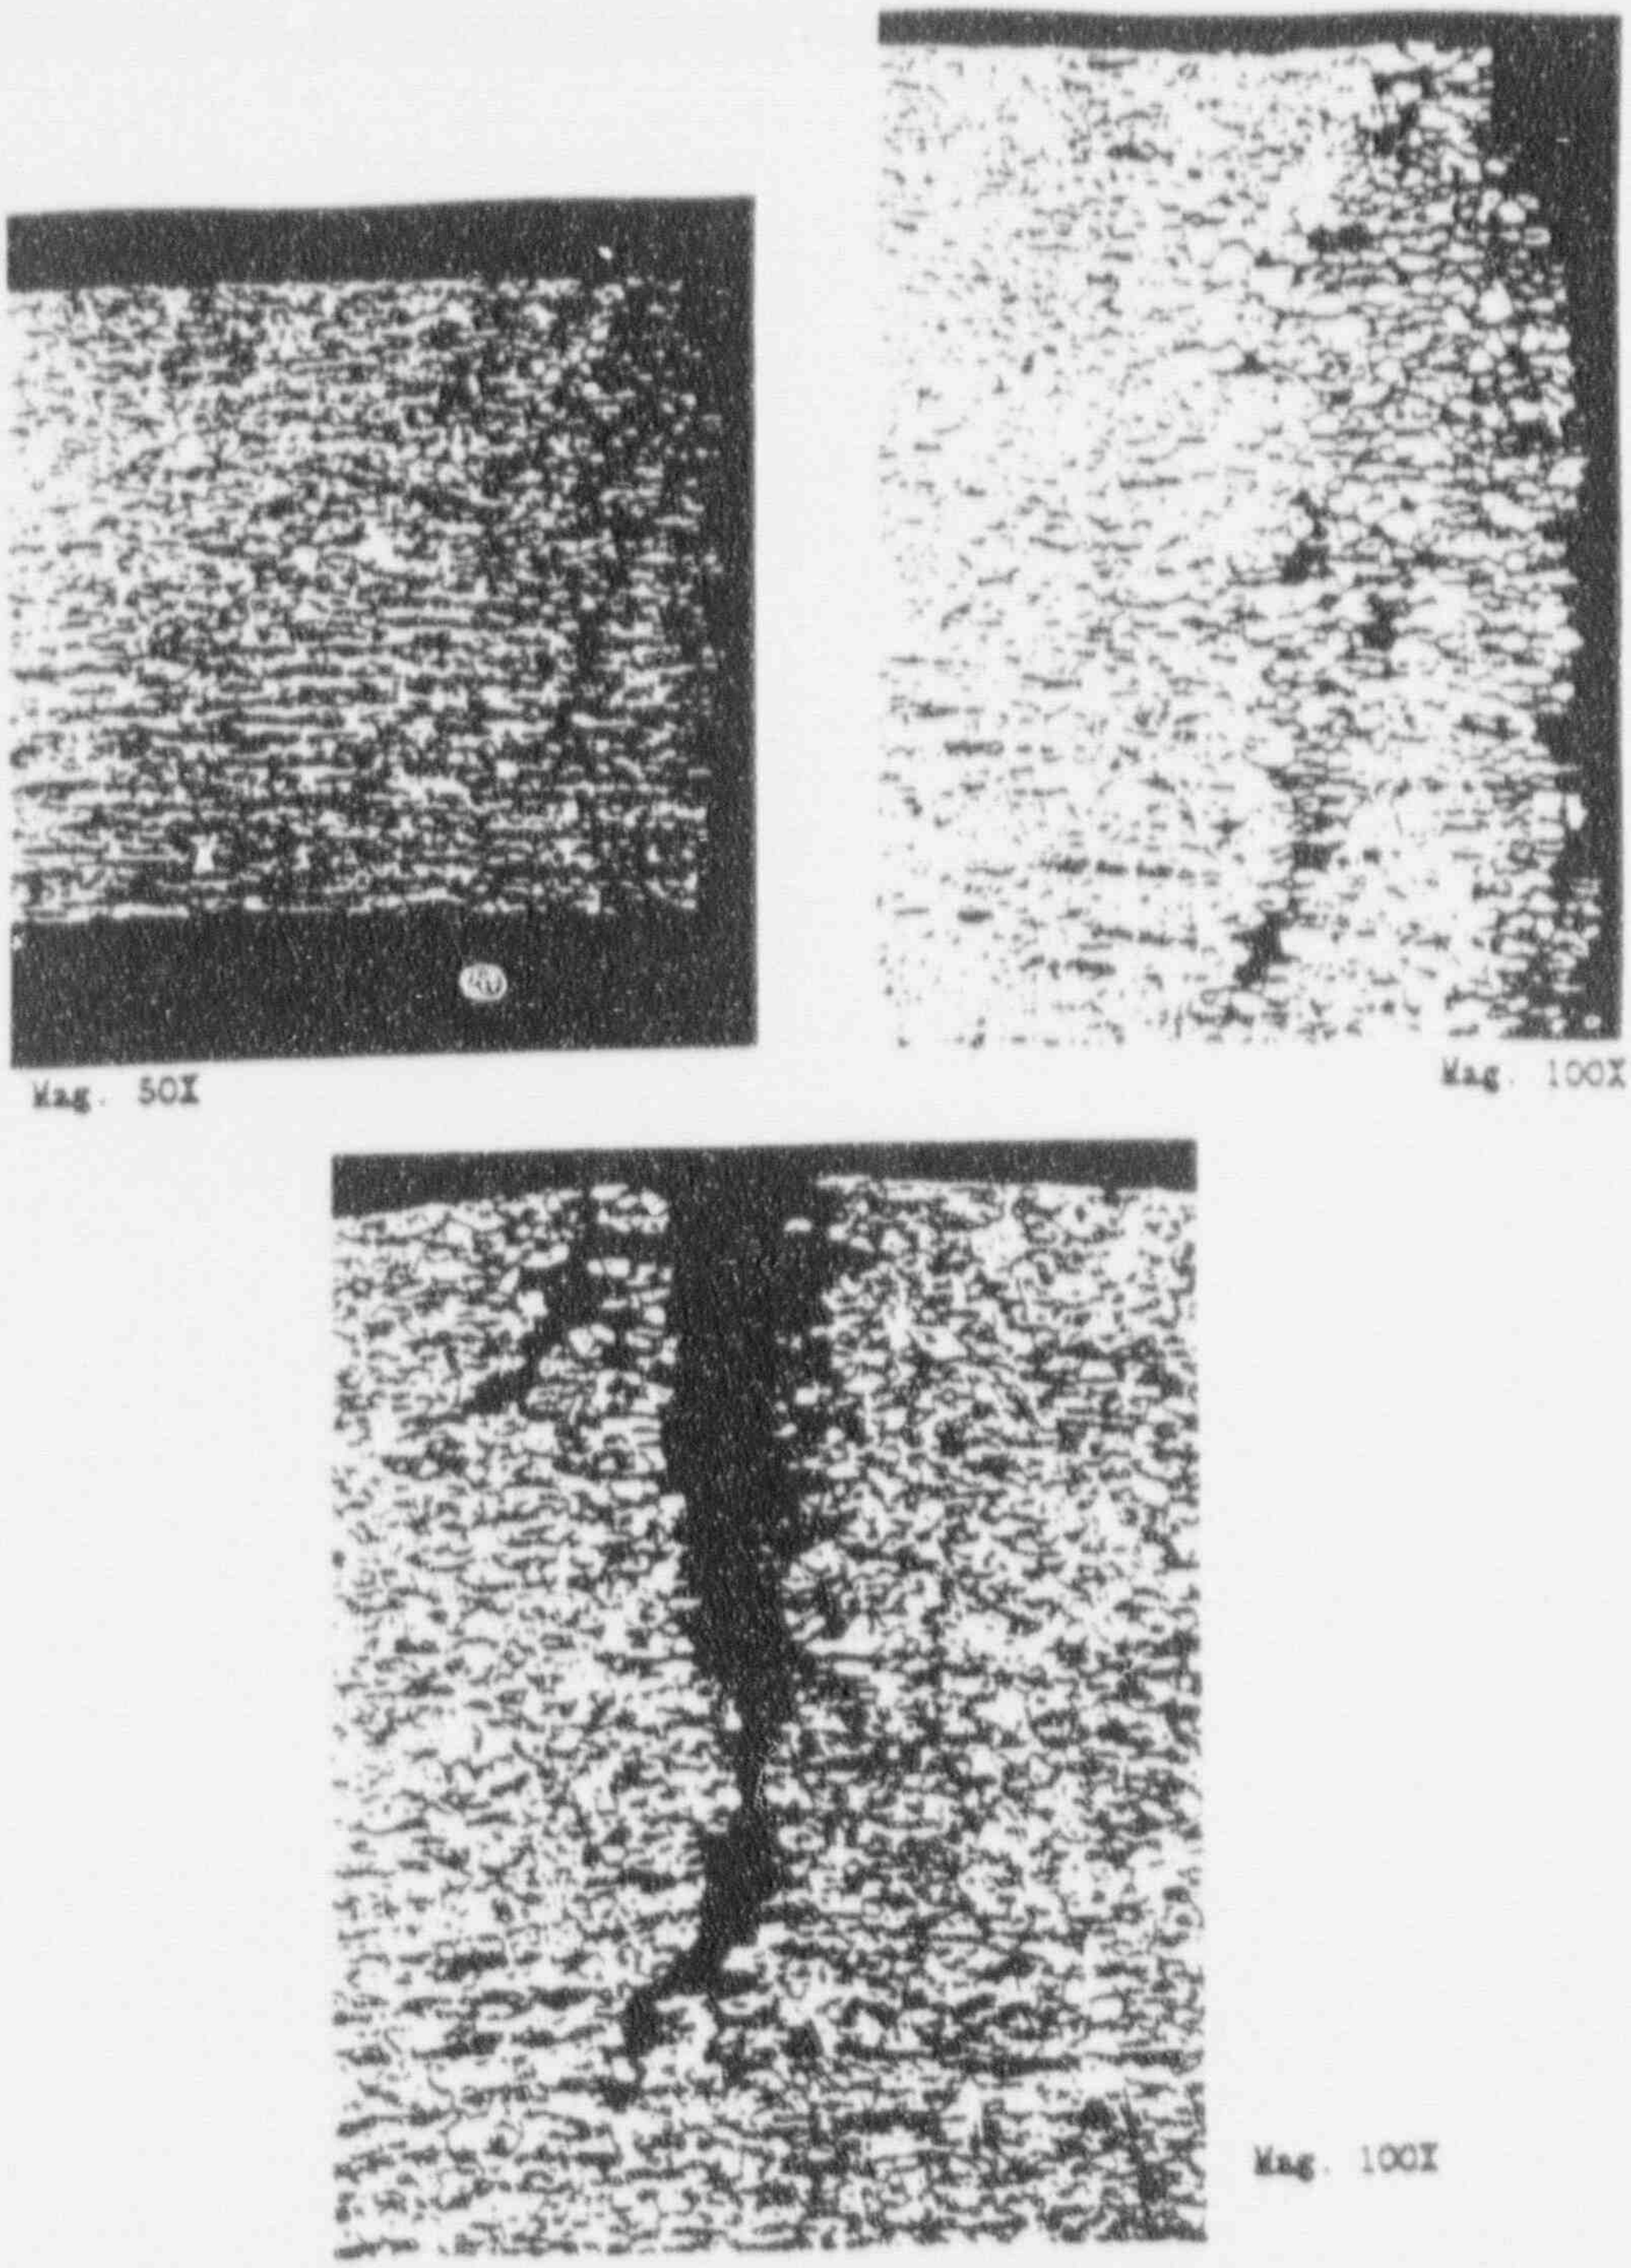
Top micrographs are from a transverse section through one half of the main burst crack. The morphology is that of IGSCC with significant IGA characteristics (width of IGA is 0.015 inch on one side of the crack). Bottom micrograph is from a transverse section through the only other crack found in the crevice region. Its morphology is more that of IGSCC. (Note: crack has been opened wide by tube deformation).

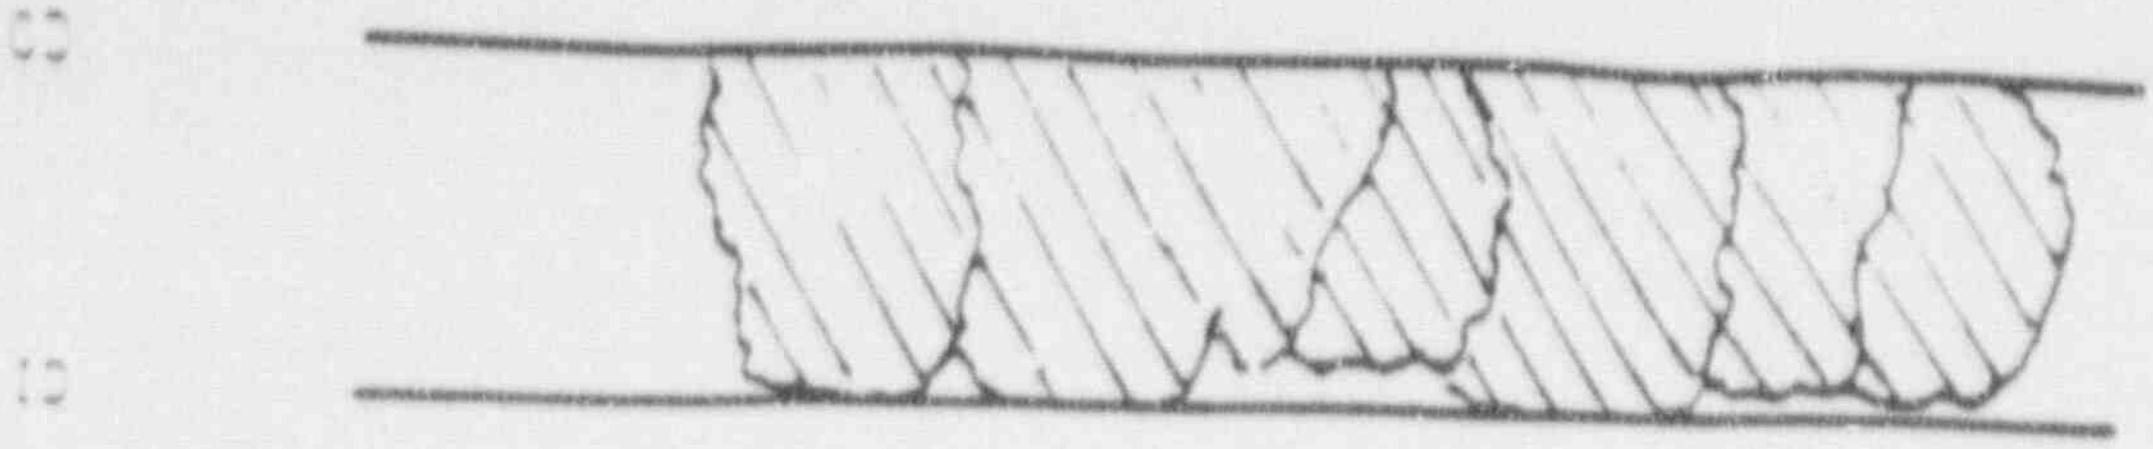
Macrocrack Length = 0.75 inch

Summary of the burst crack and overall crack distribution in the crevice region of tube 532-2.

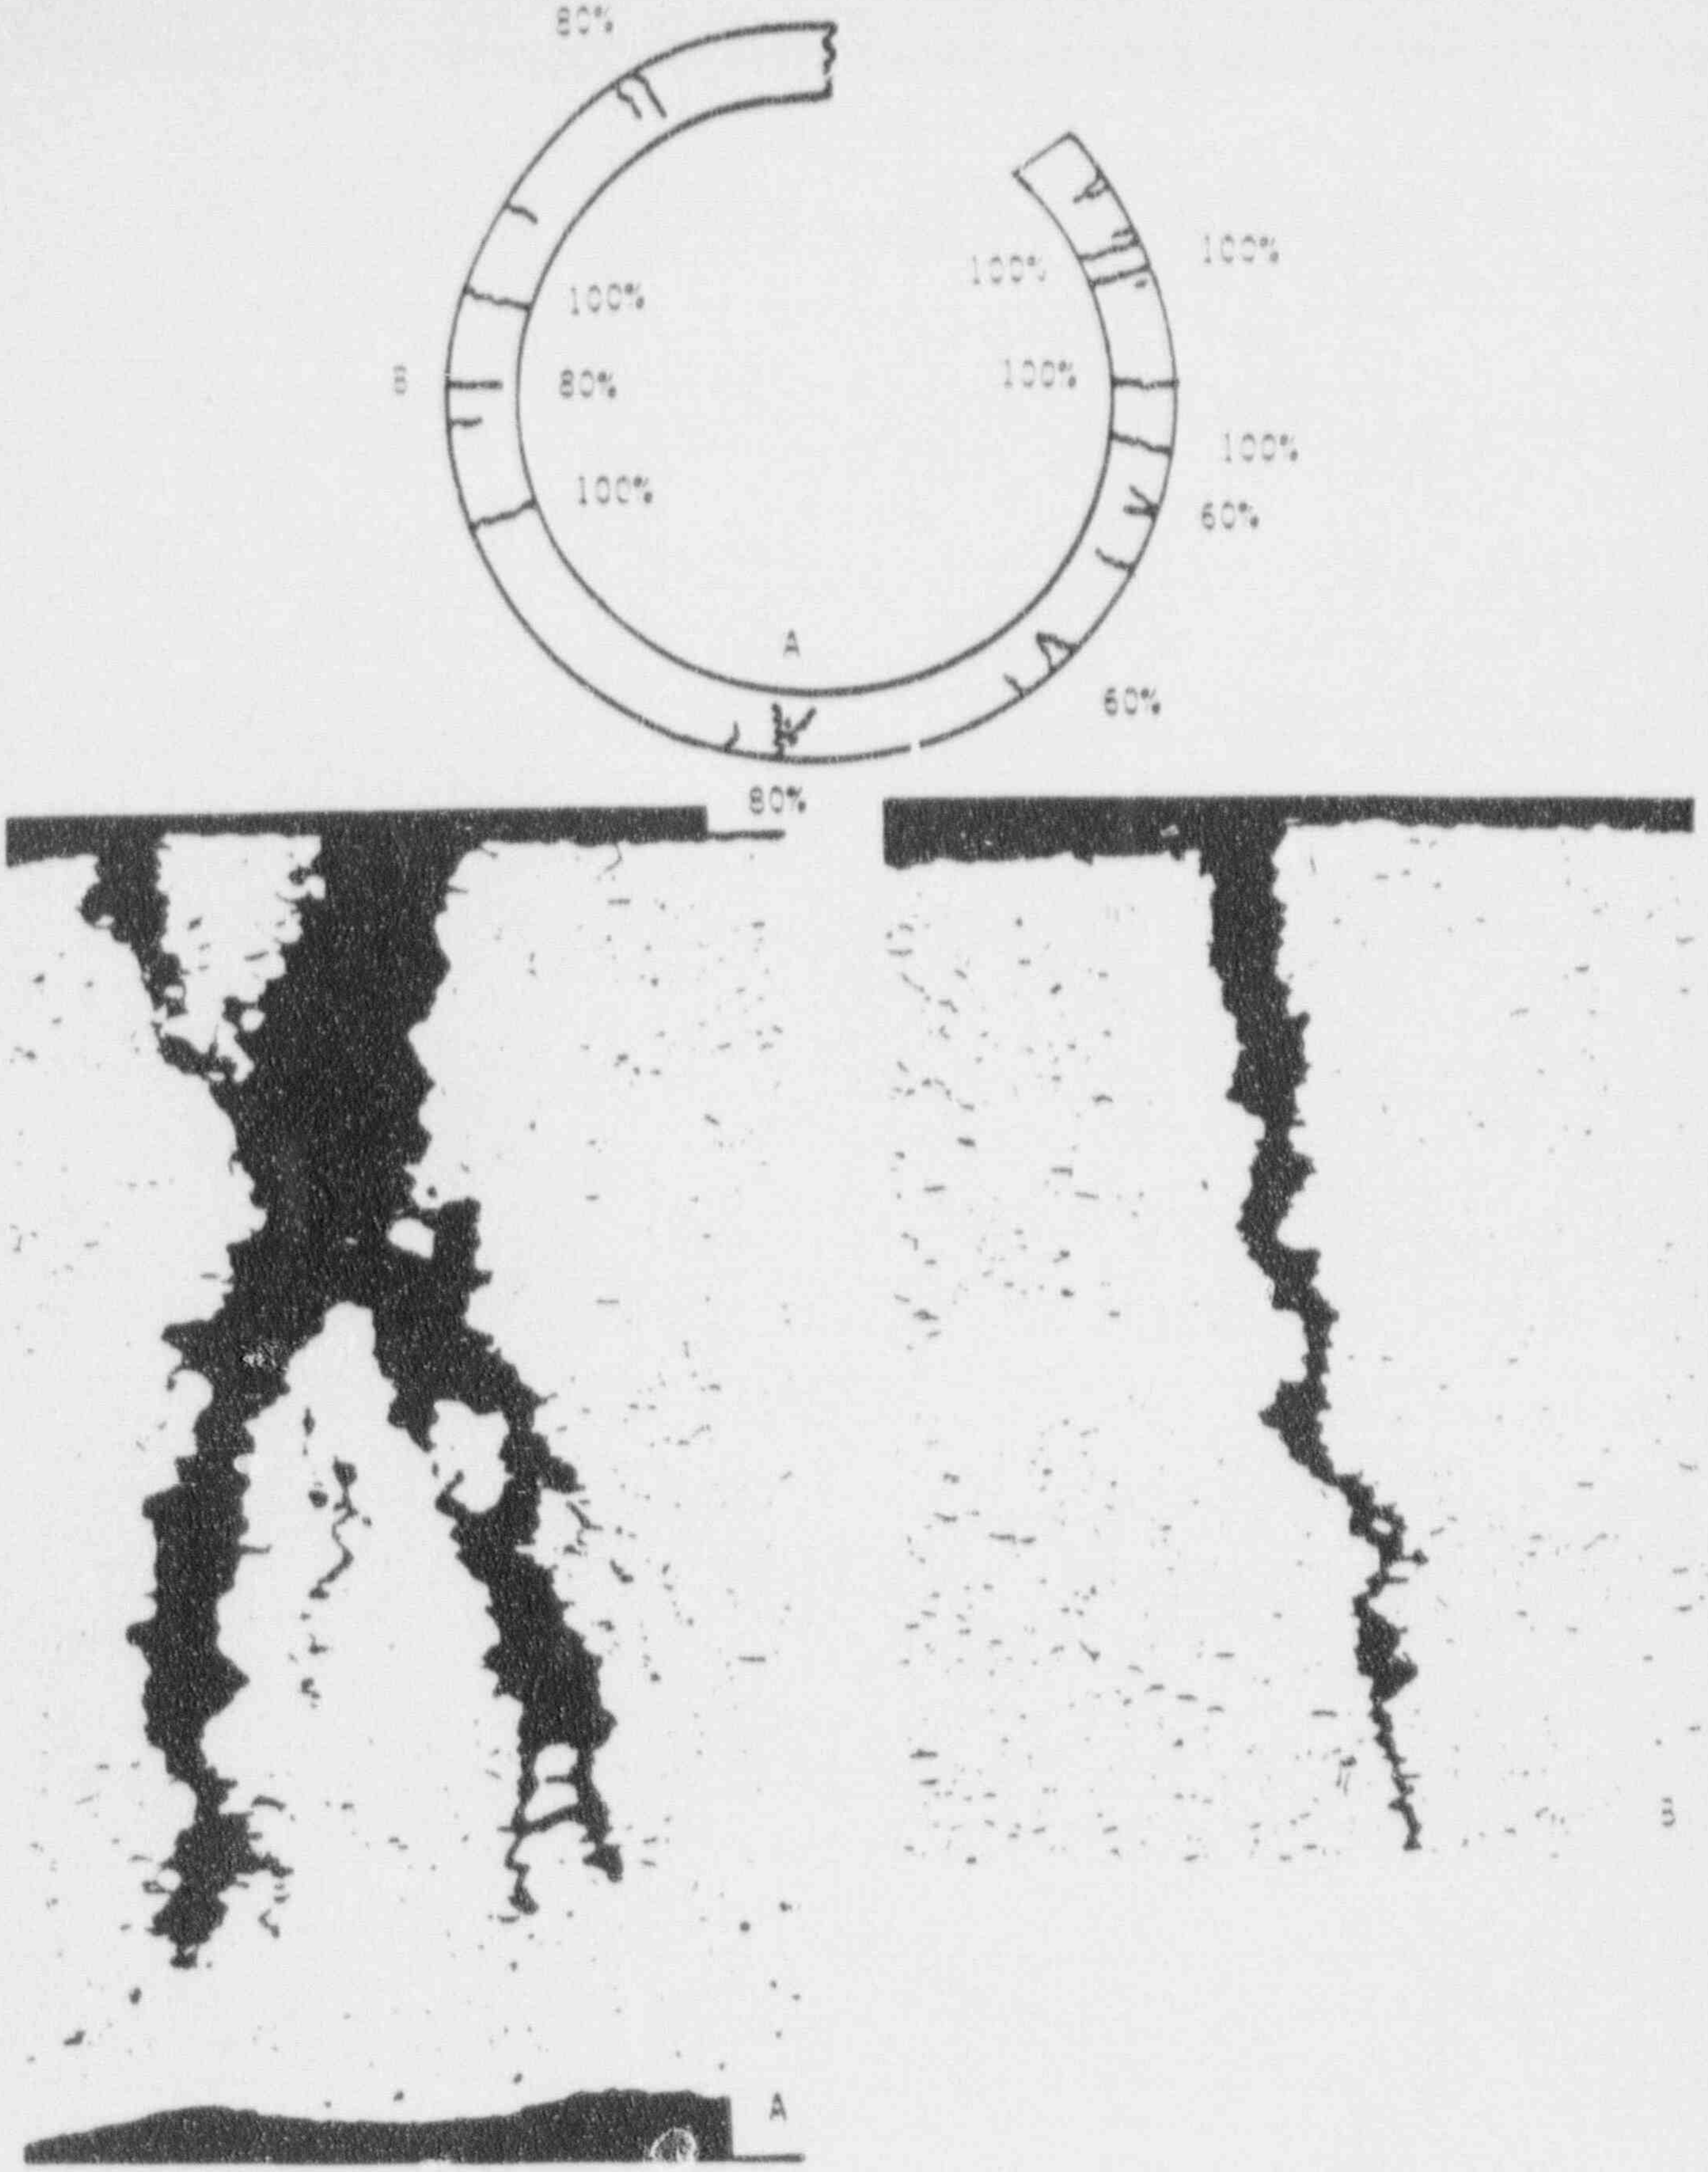
Crack distribution as revealed by a metallographic cross section through the center of the crevice of tube 532-2 and photomicrographs of secondary cracks A and B. Mag. 100X

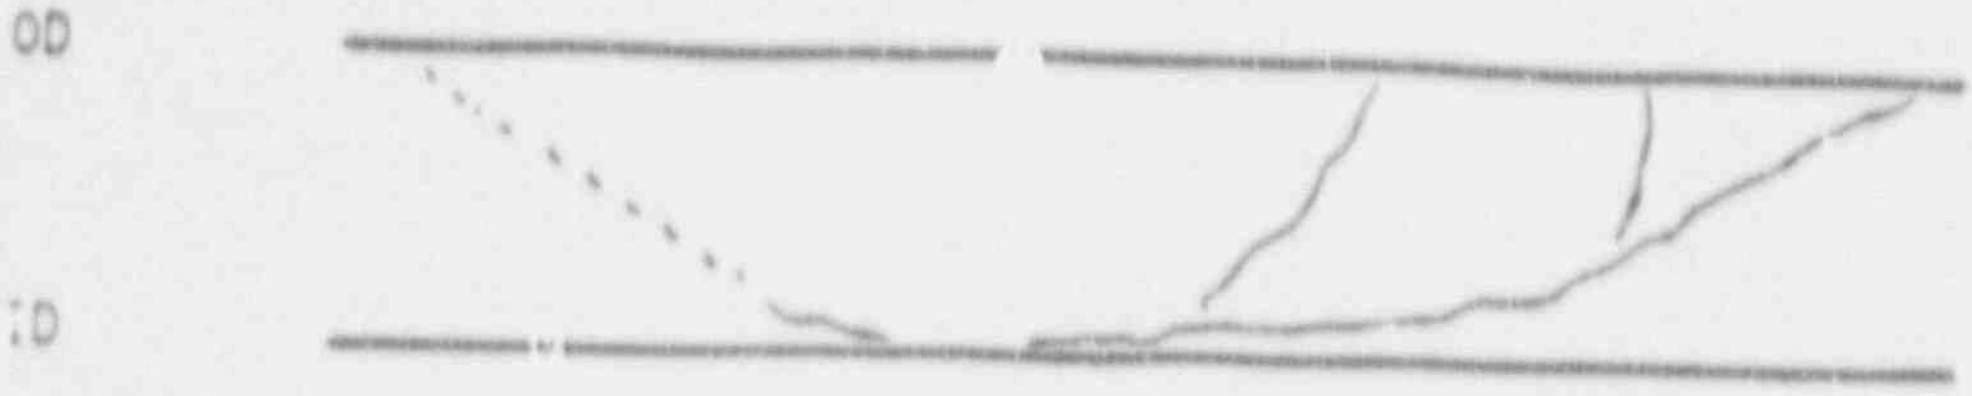
Macrocrack Length = 0.52 inch

Figure 4-1. Summary of crack distribution and morphology observed on the first support plate crevice region of tube R31-C46, Farley Unit 2.

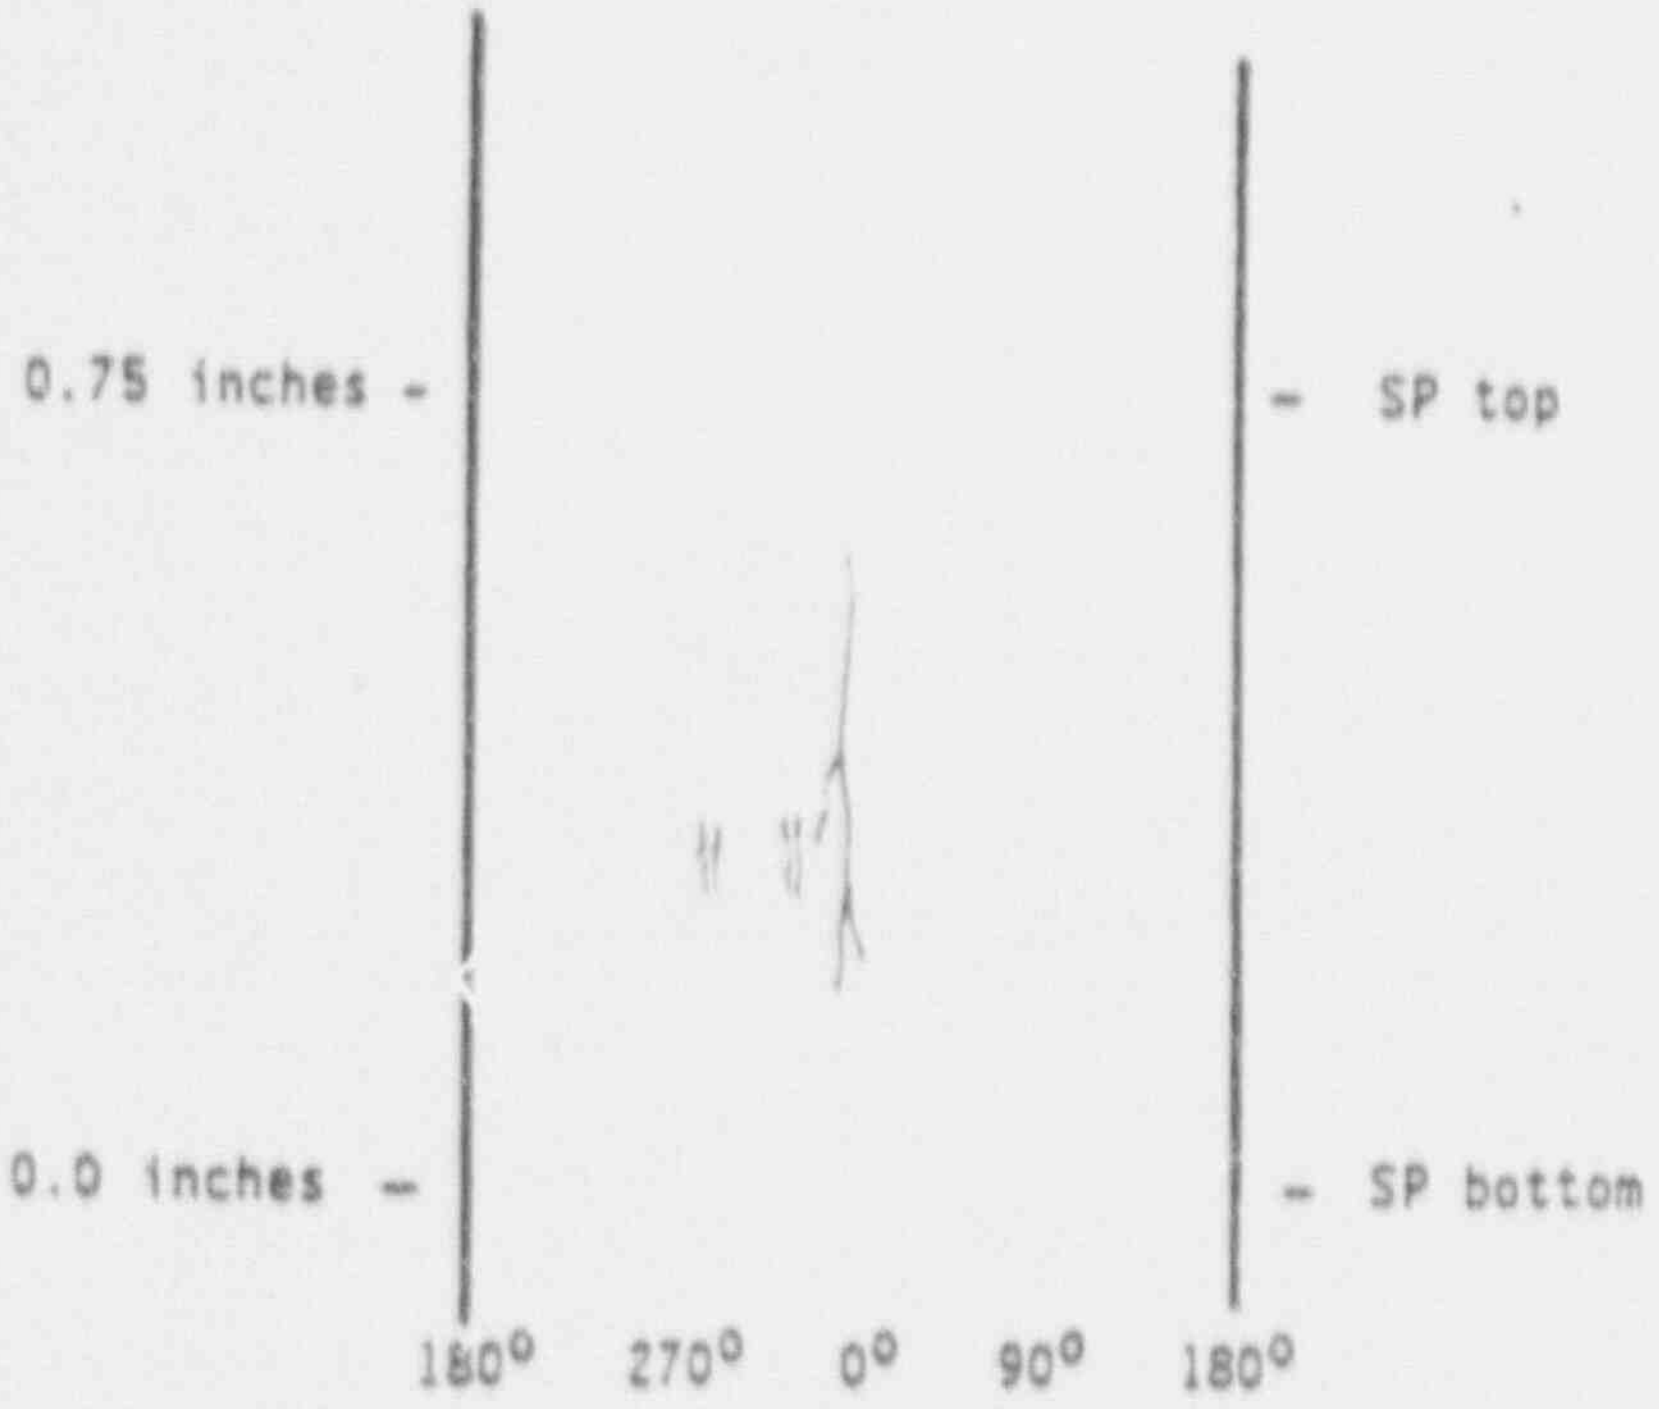
Morphology = IGSCC with moderate IGA components

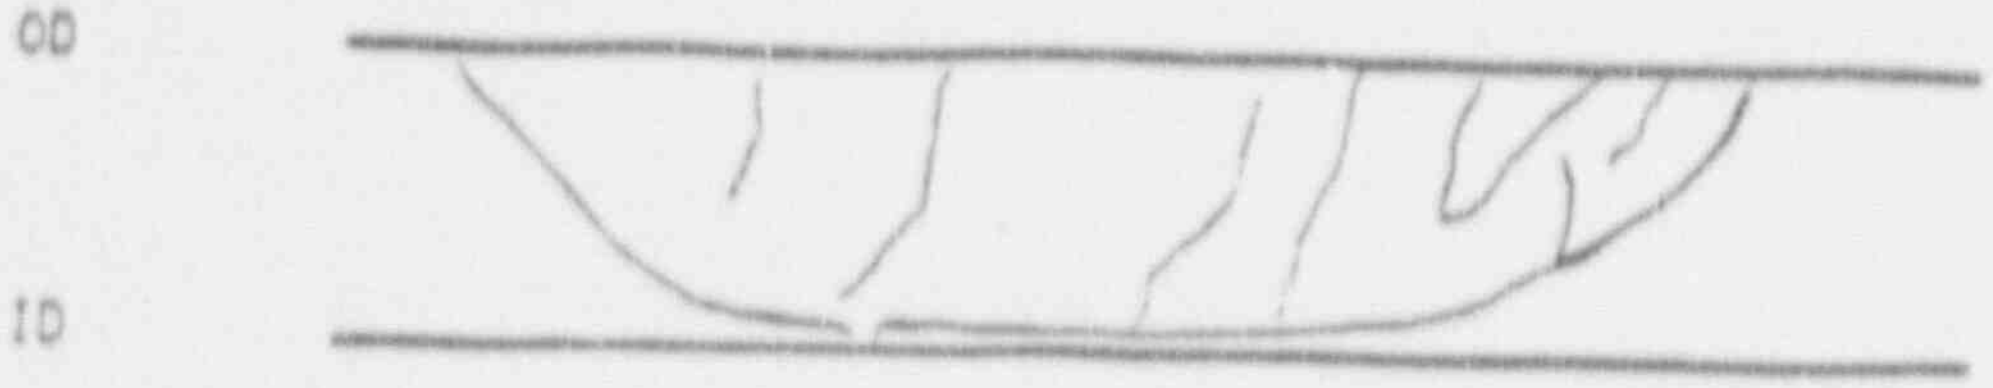
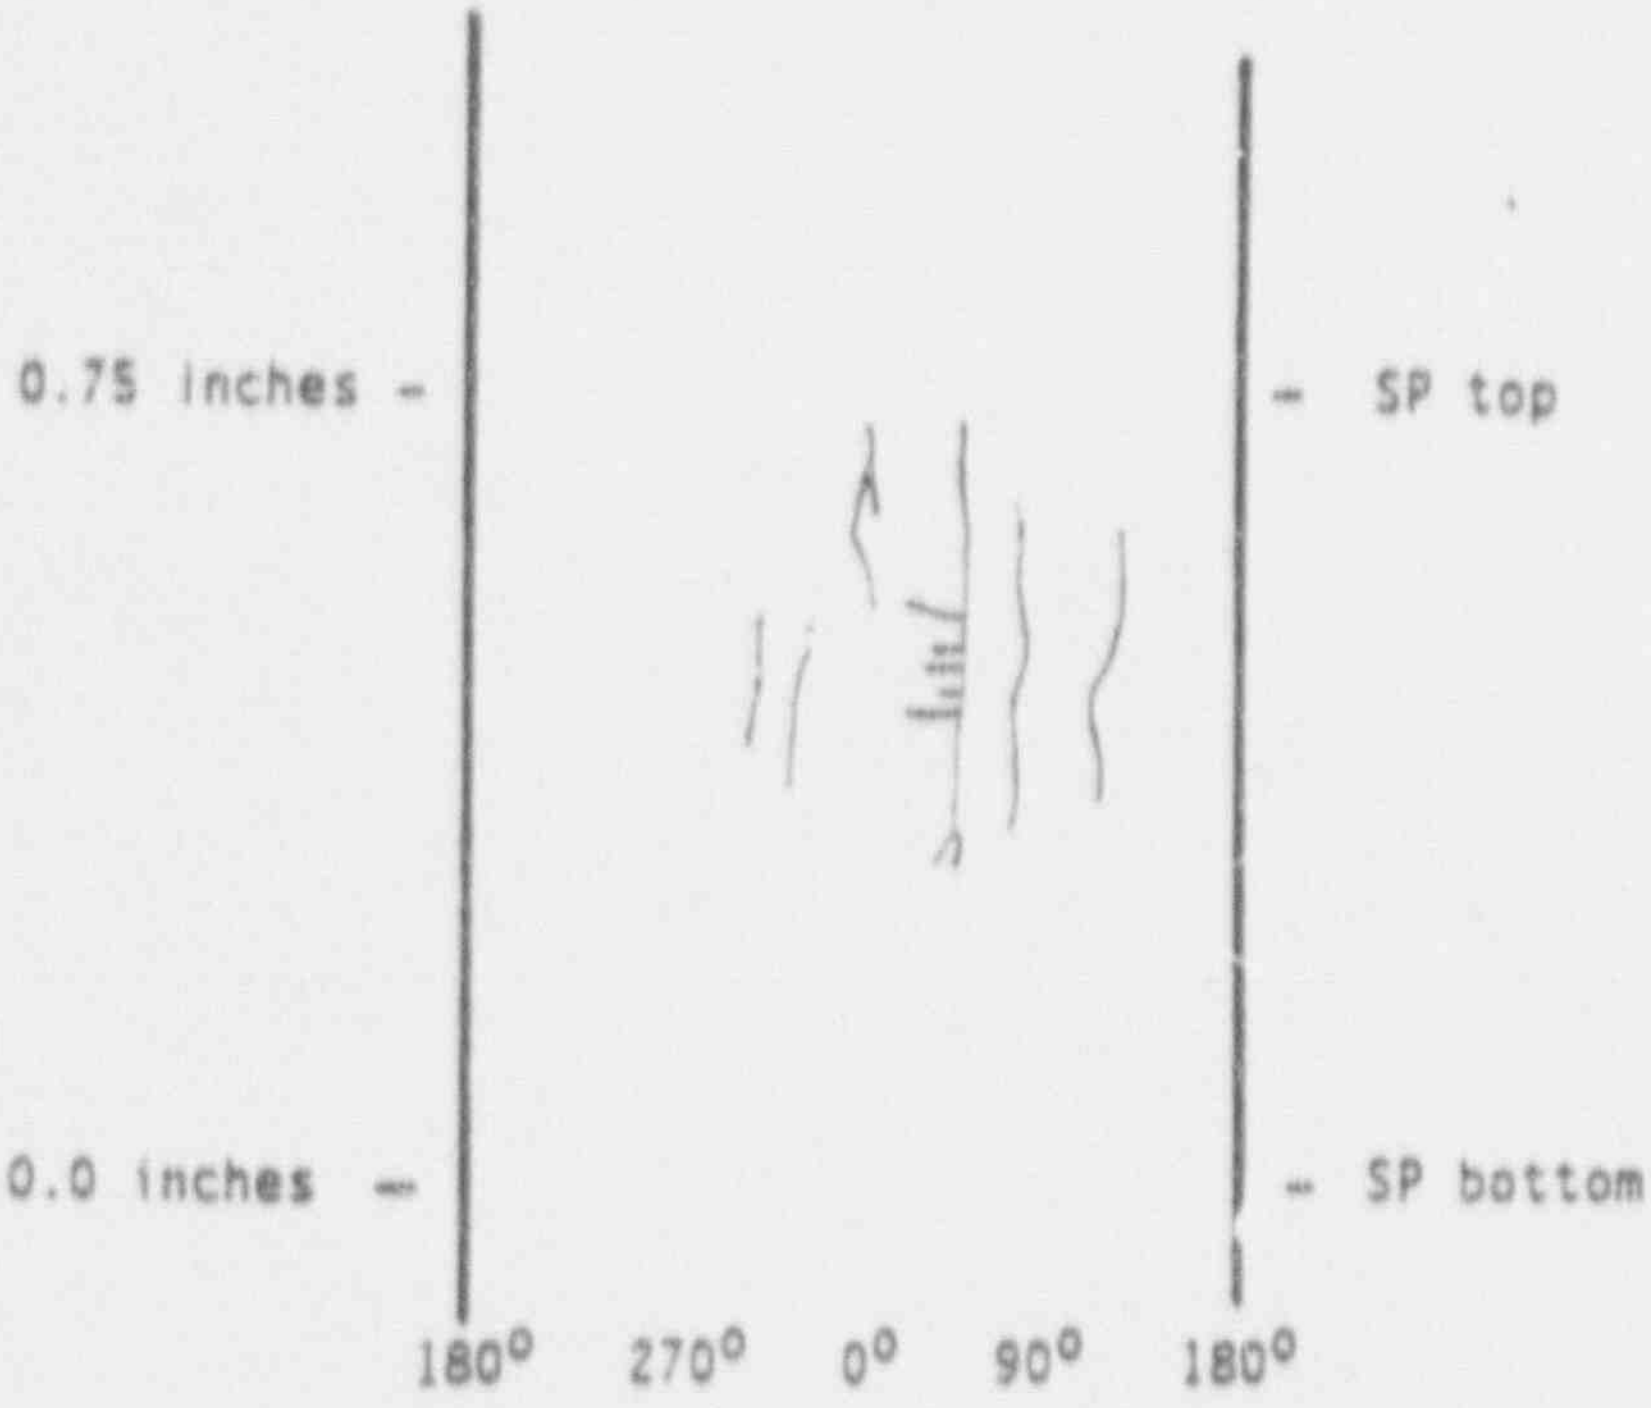
Macrocrack Length = 0.4 inch

Number of Microcracks = 7 (all ligaments have predominantly intergranular features)

Morphology = IGSCC with some IGA aspects (circumferential cracking has more IGA characteristics)

Figure 4-3. Description of OD origin corrosion at the fifth support plate crevice region of tube R4-C61, Plant B-1

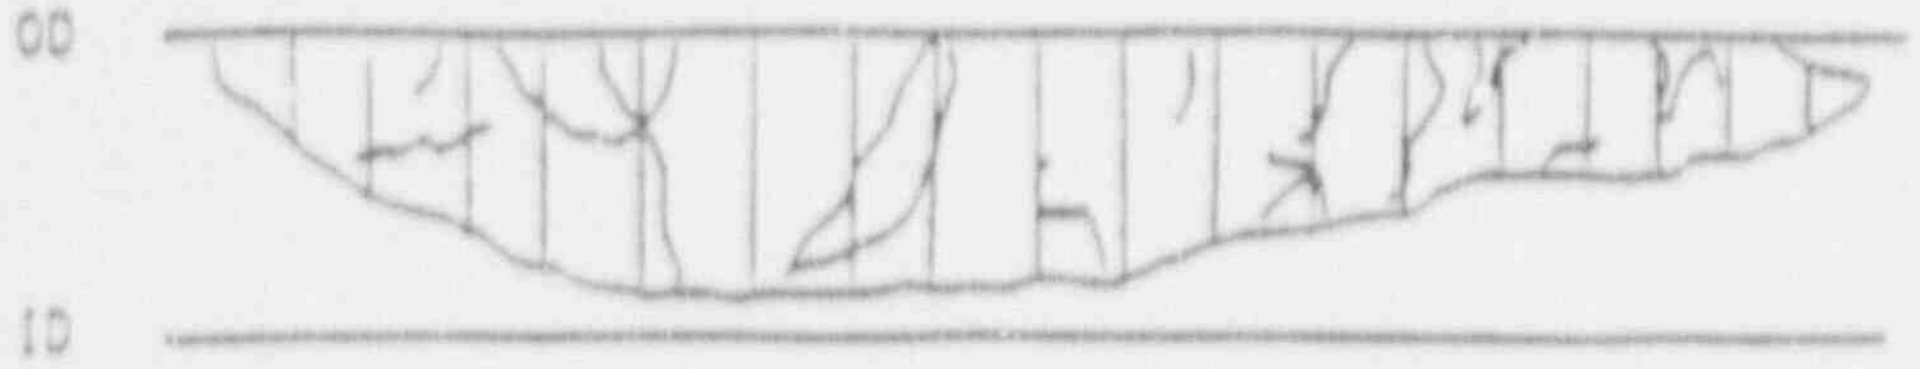
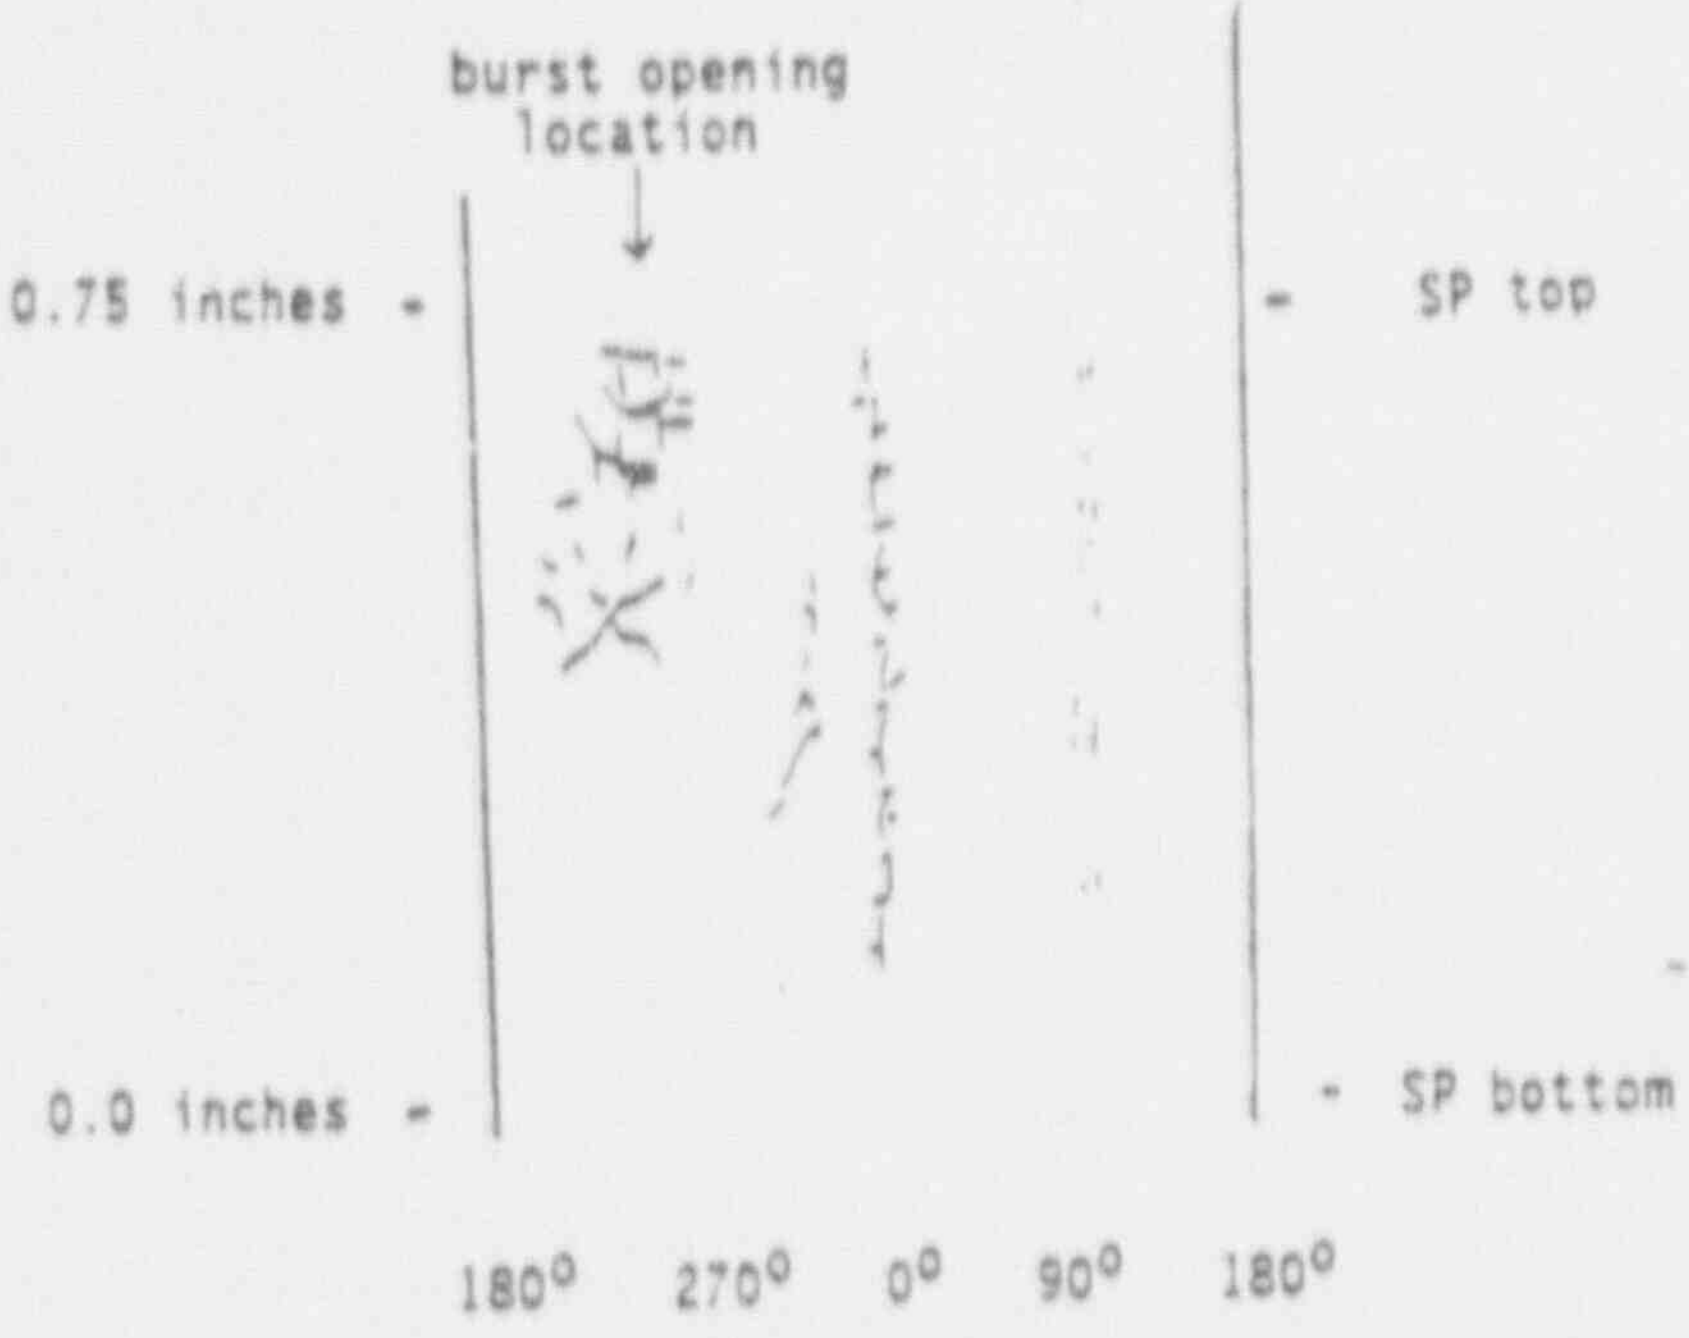
Macrucrack Length = 0.37 inches

Number of Microcracks = numerous (ligaments have intergranular features)

Morphology = Intergranular SCC with minor IGA features (Unusual spider-shaped crack distribution)

Figure 4-11. Description of OD origin corrosion at the first support plate crevice region of tube R38-C46.

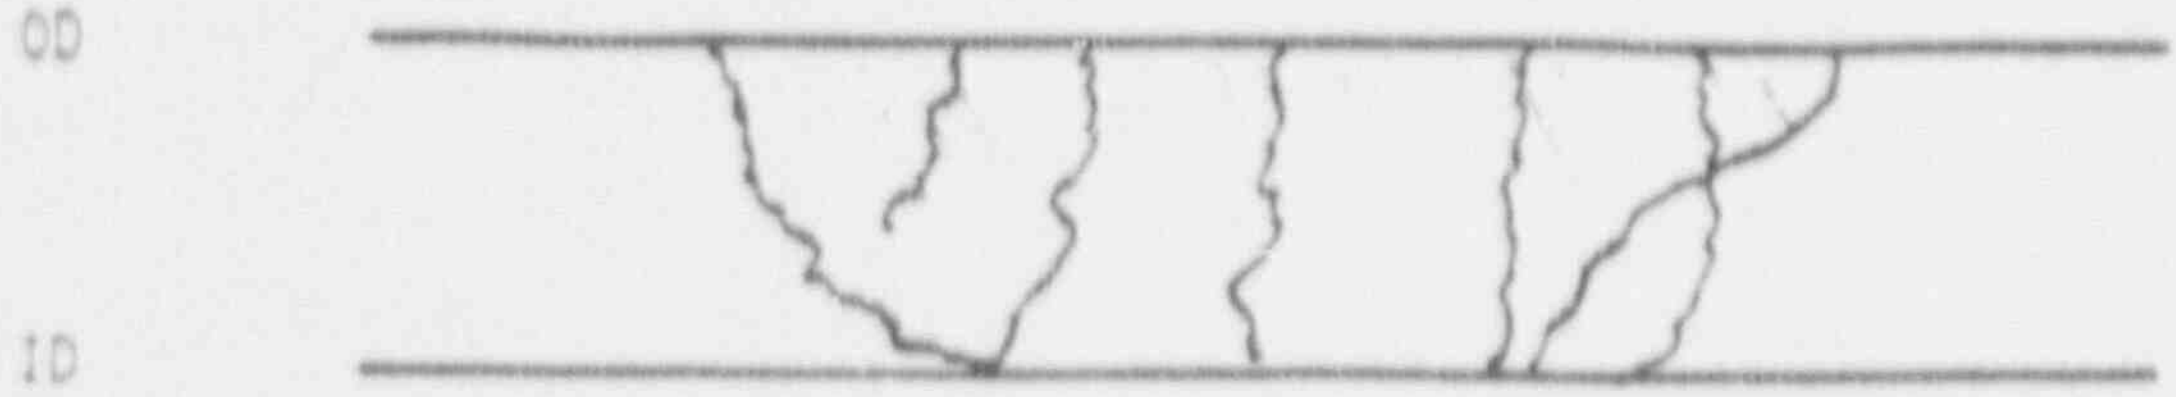
Macrocrack Length = 0.67 inch

Figure 10-21 Summary of overall crack distribution and morphology observed on tube 528-2.
