WCAP-13139

FARLEY UNITS 1 AND 2

STEAM GENERATOR TUBE/ TUBE SUPPORT PLATE ELEVATION ALTERNATE PLUGGING CRITERION SUMMARY

DECEMBER 1991

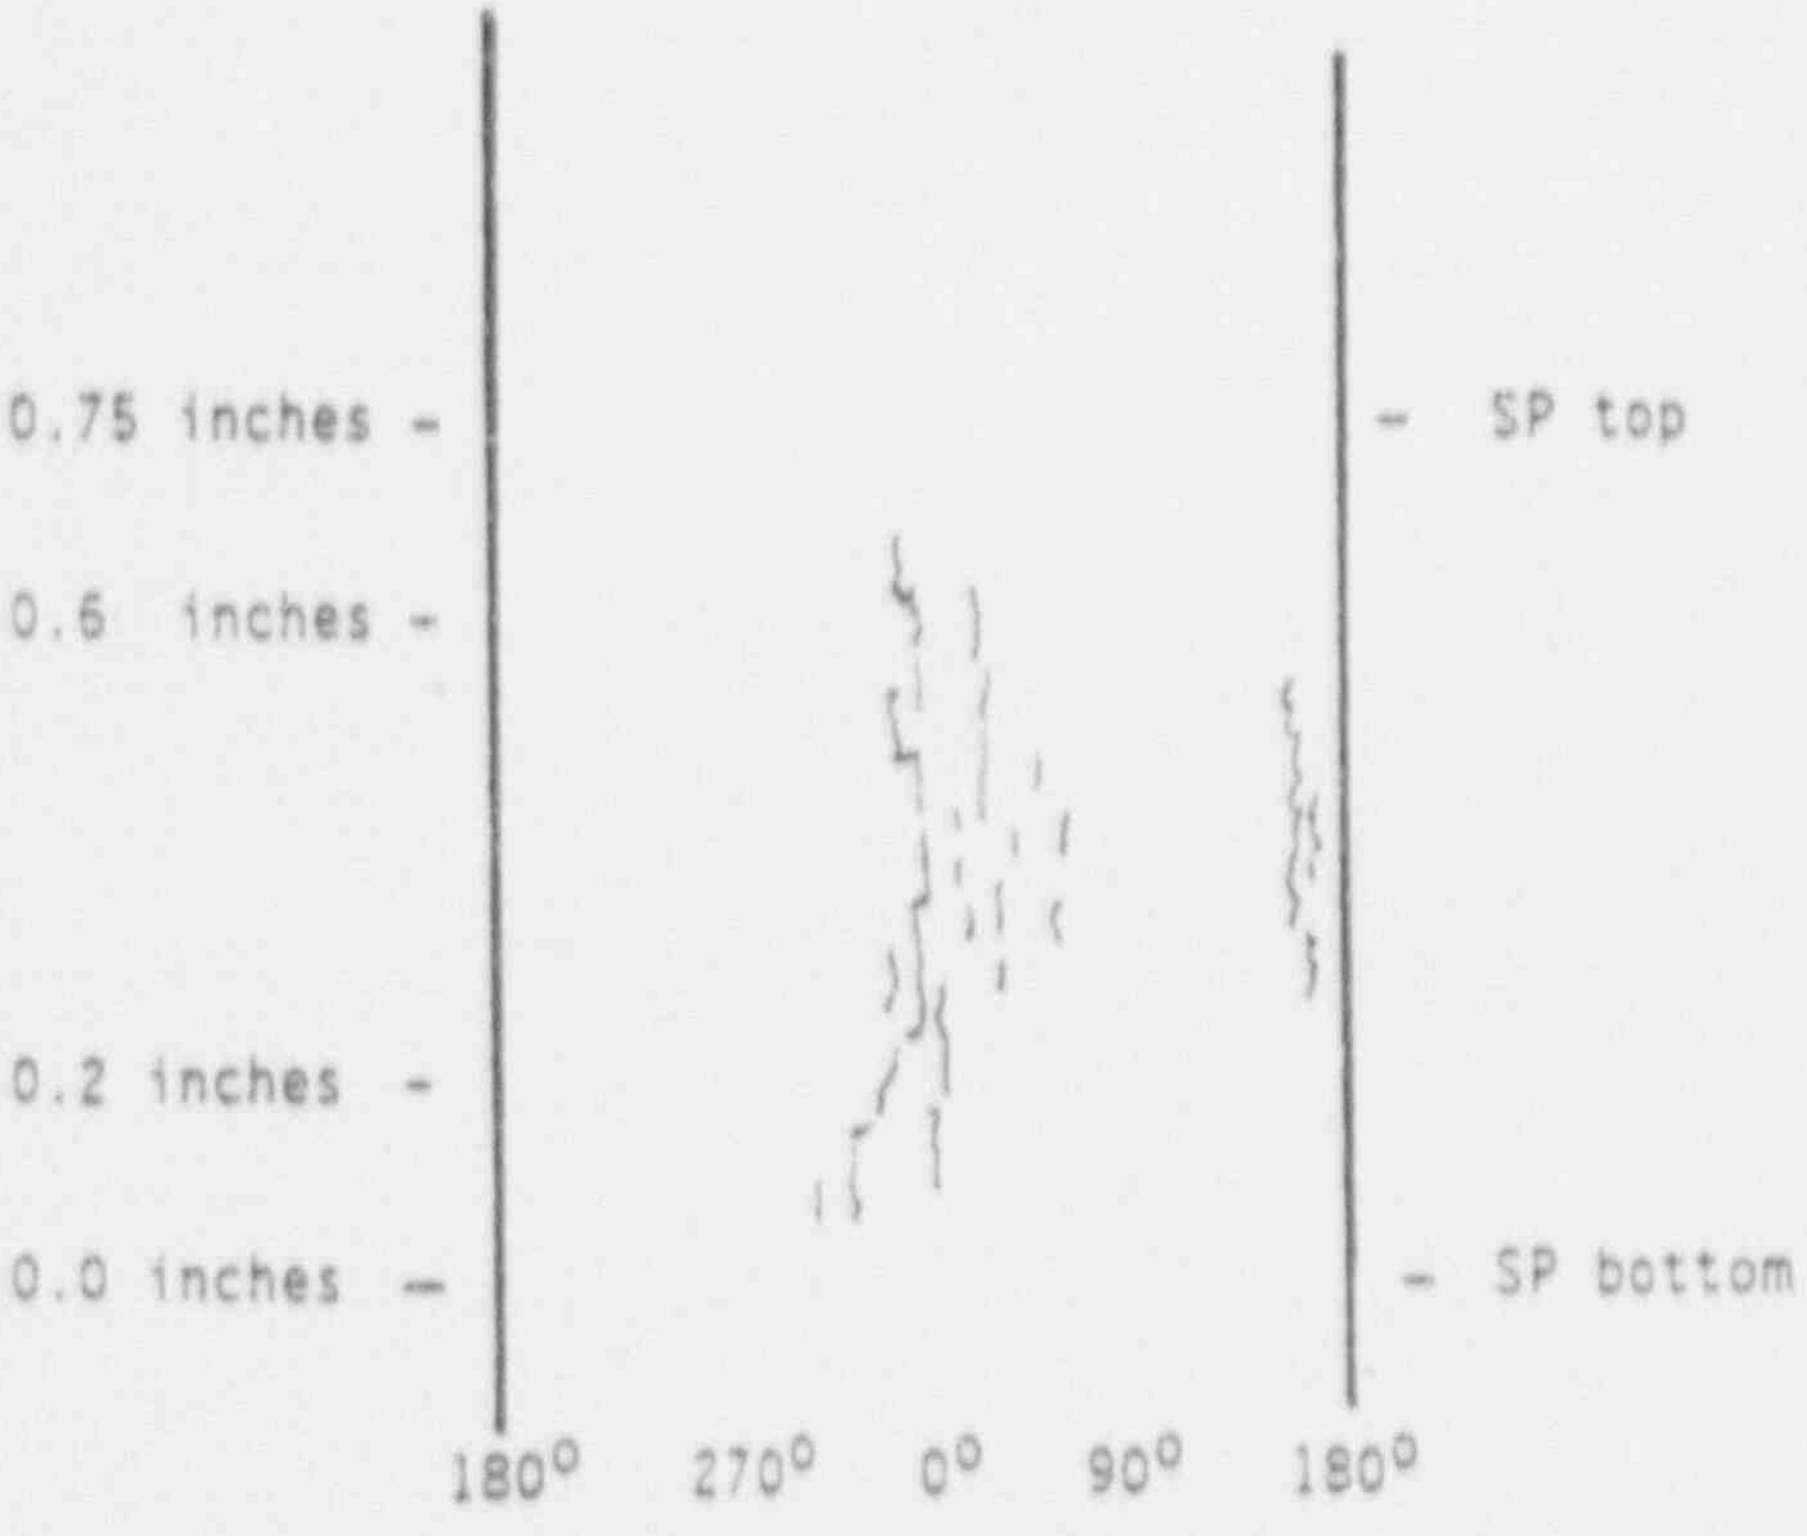
Figure 10-21 Summary of overall crack distribution and morphology observed on tube 528-2.

Morphology = IGSCC

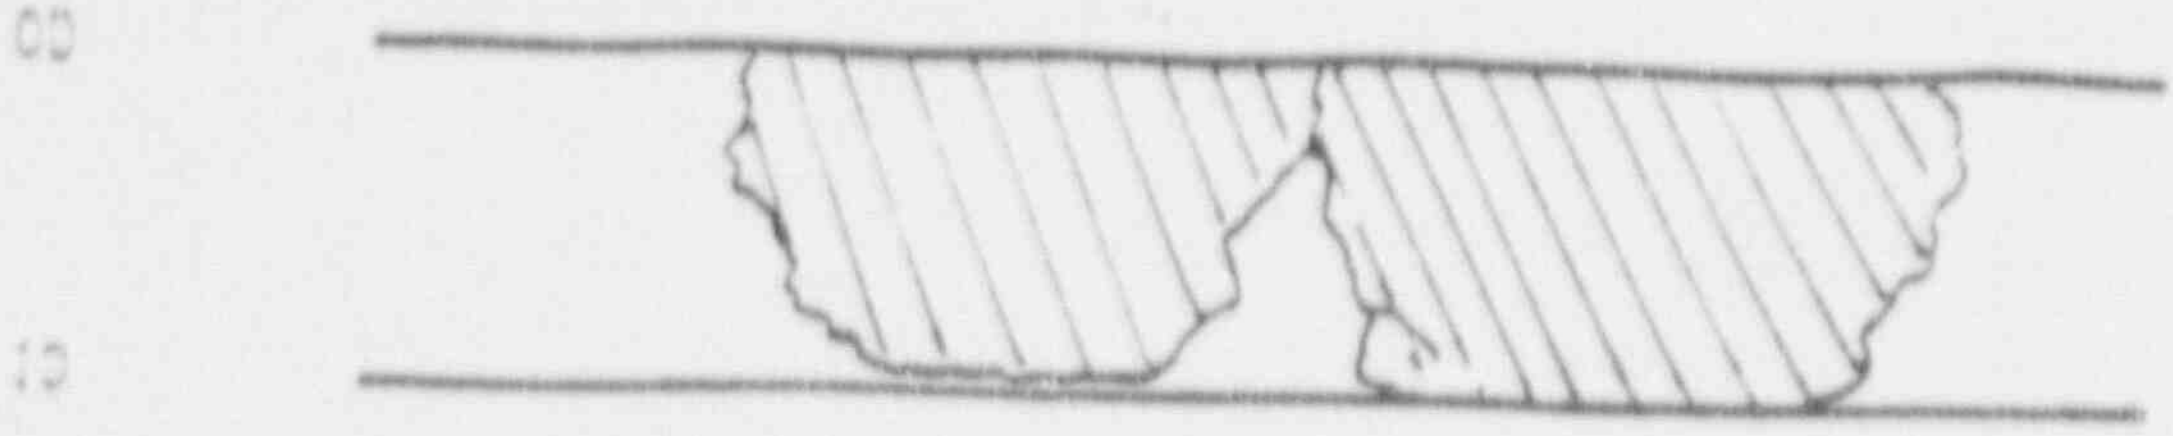
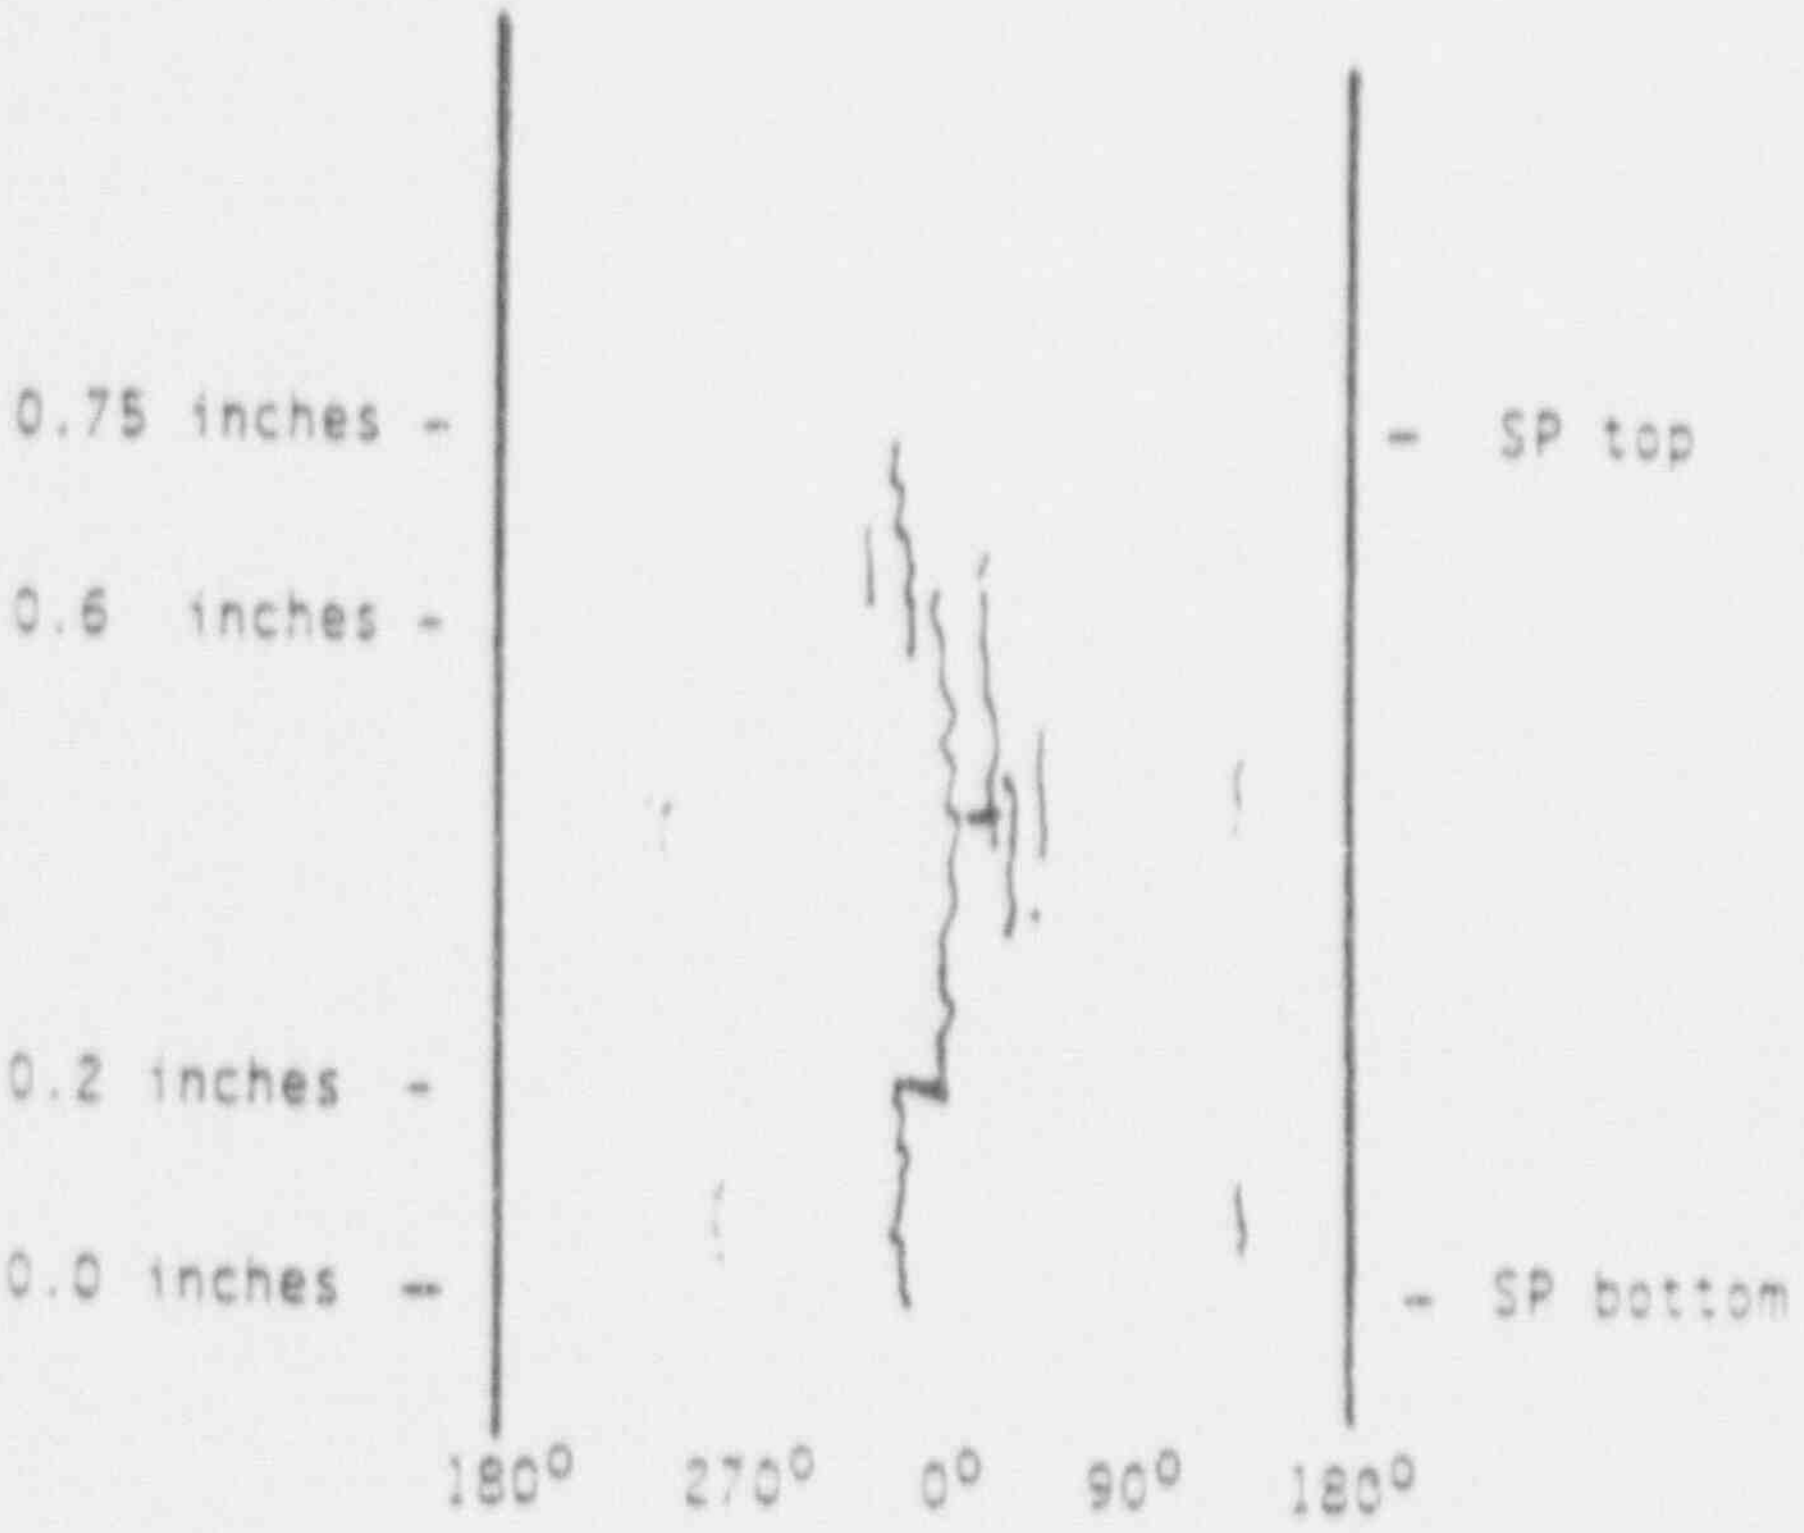
Macrocrack Length = 0.75 inch

Number of Microcracks = 2 (separated by ductile ligaments)

Morphology = IGSCC

Figure 10-34 Summary of burst crack observations and the overall crack distribution observed at the crevice region of tube 555-3.

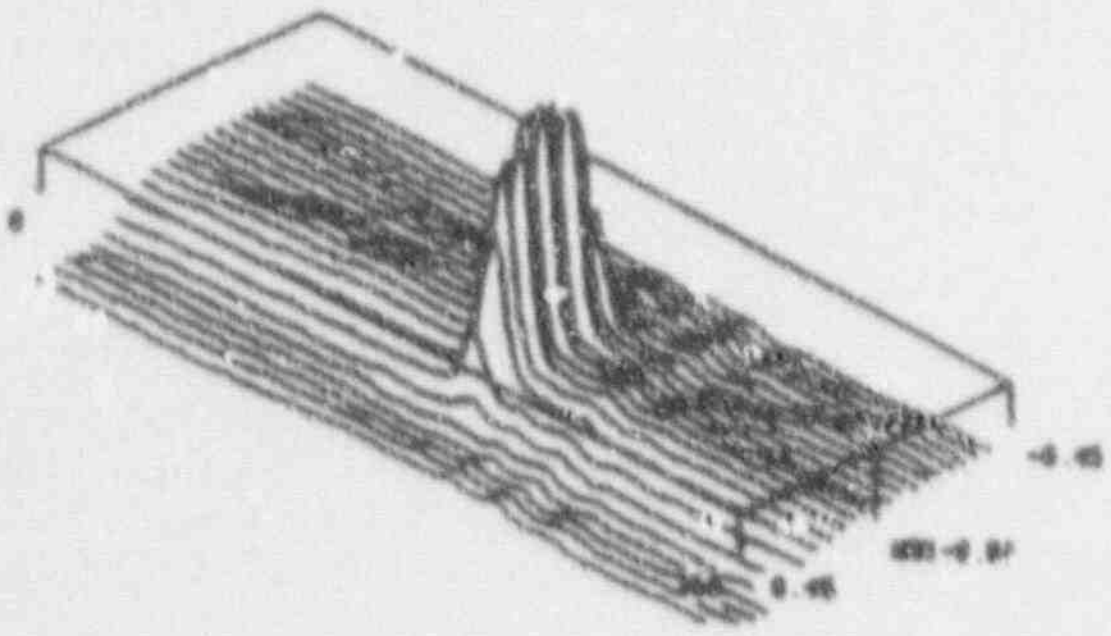
R21C22 S/G 21

- 8 TUBES, 14 TSP INTERSECTIONS OVER 1986-1990
- MINOR IGA INVOLVEMENT FOUND AT CRACK FACES
  - SLIGHTLY GREATER (~ 15 MILS WIDE) IN PREVIOUSLY PLUGGED TUBE (R21C22) THAN ACTIVE TUBE (6 MILS WIDE IN R4C73)

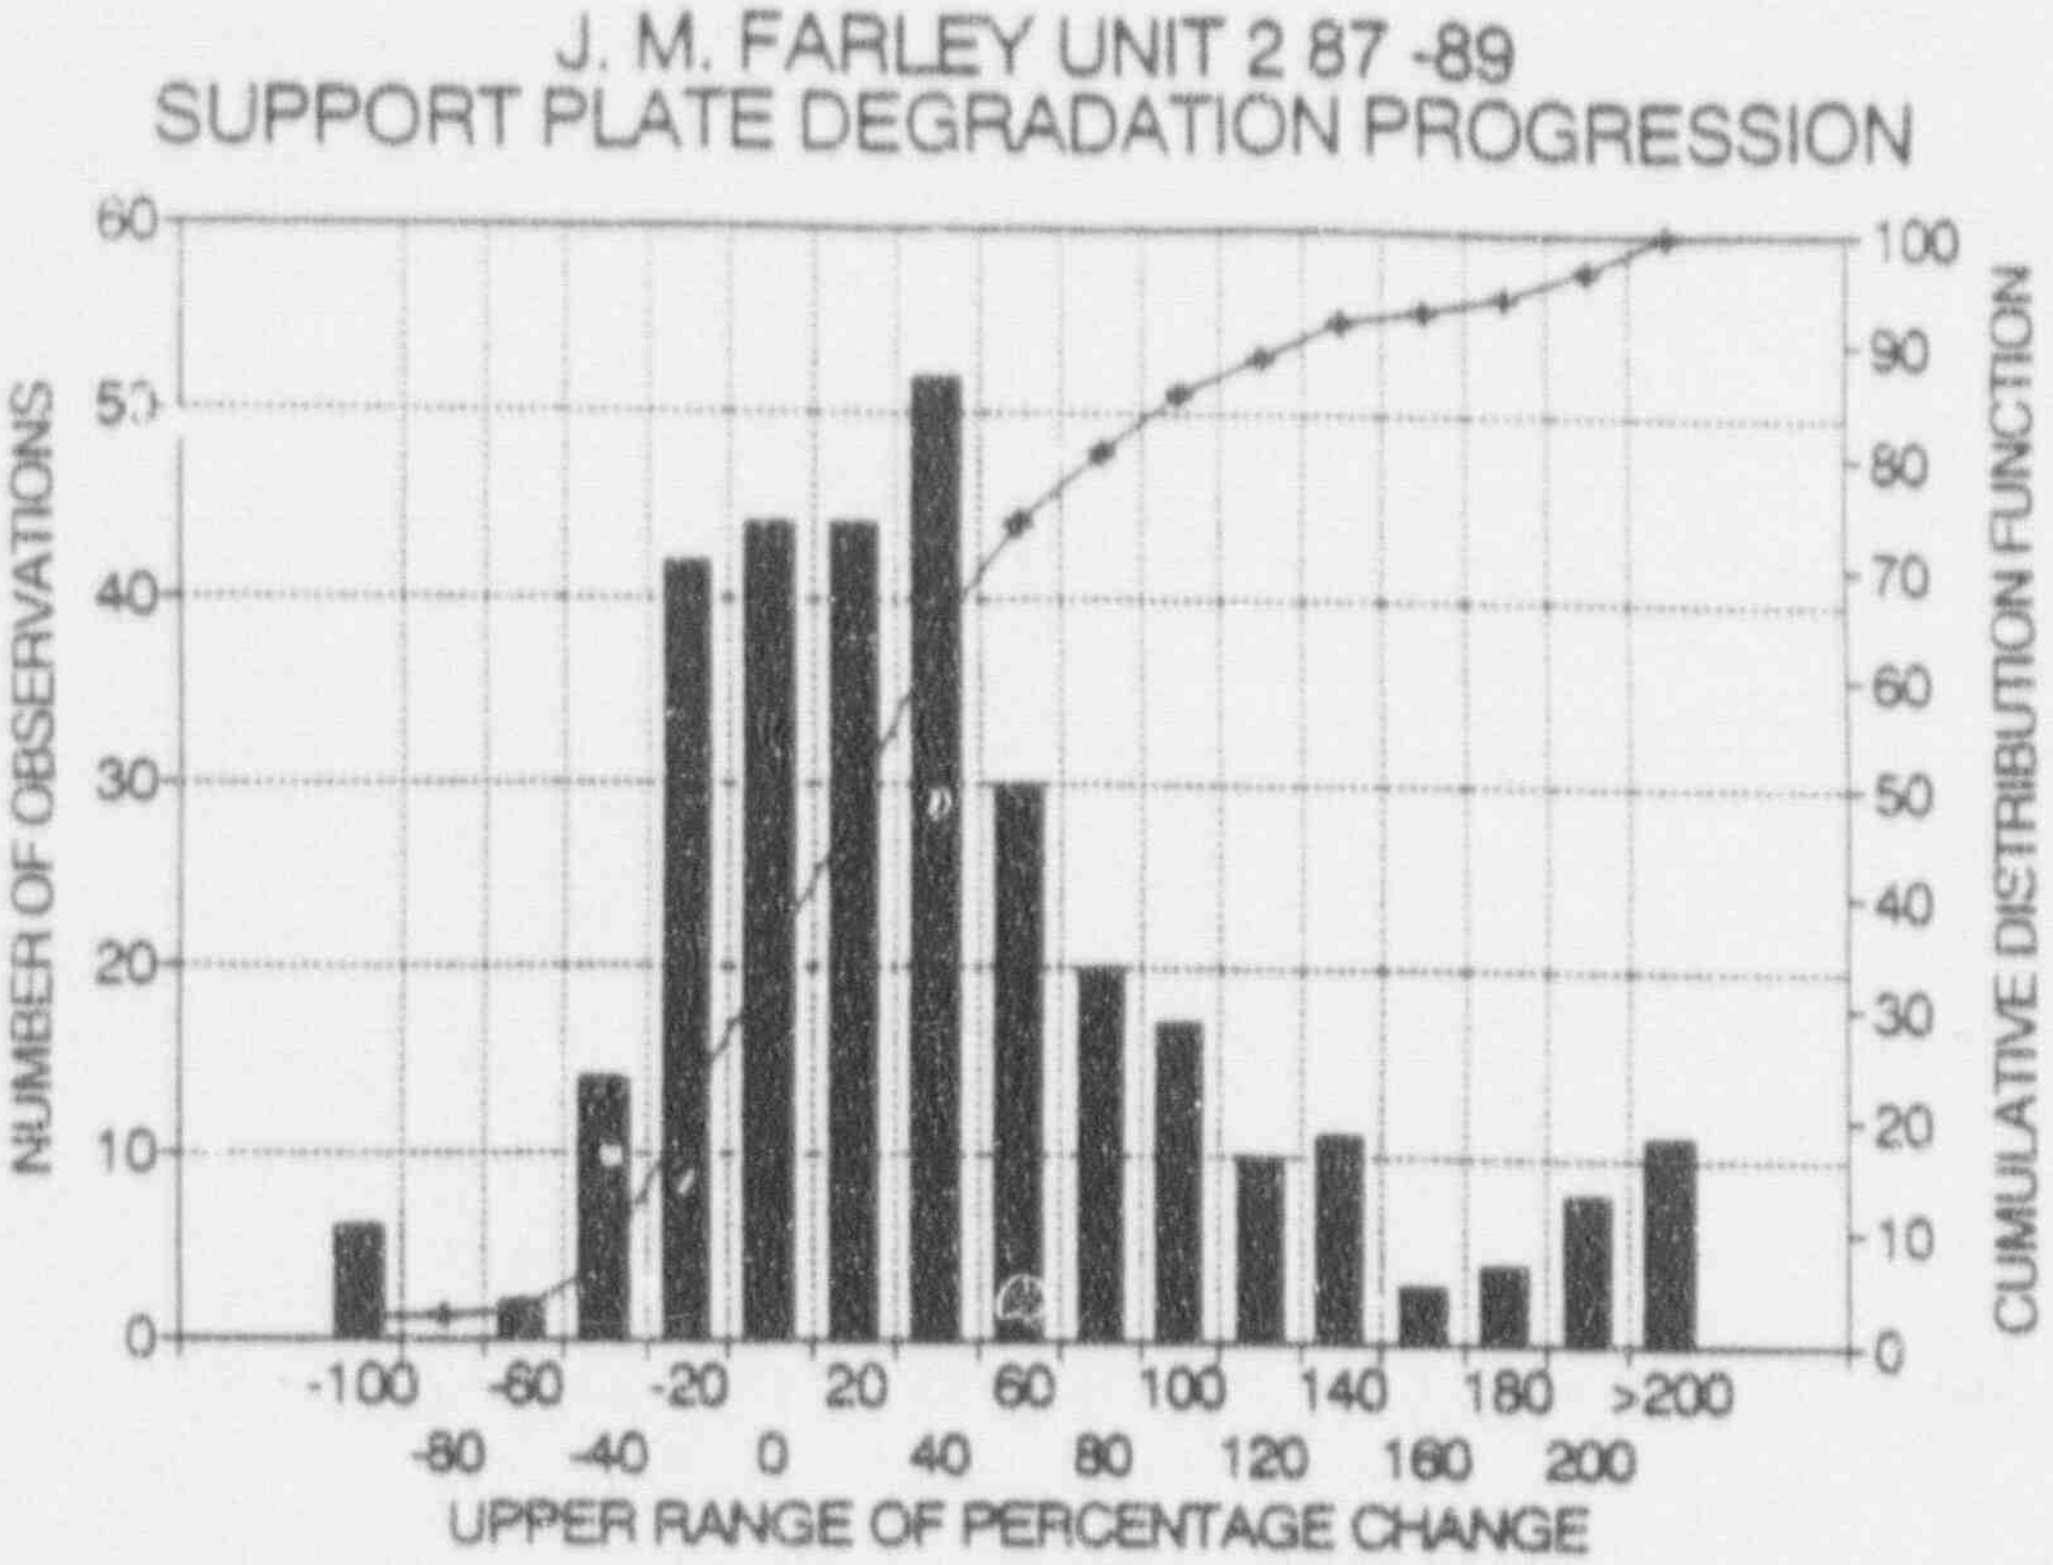
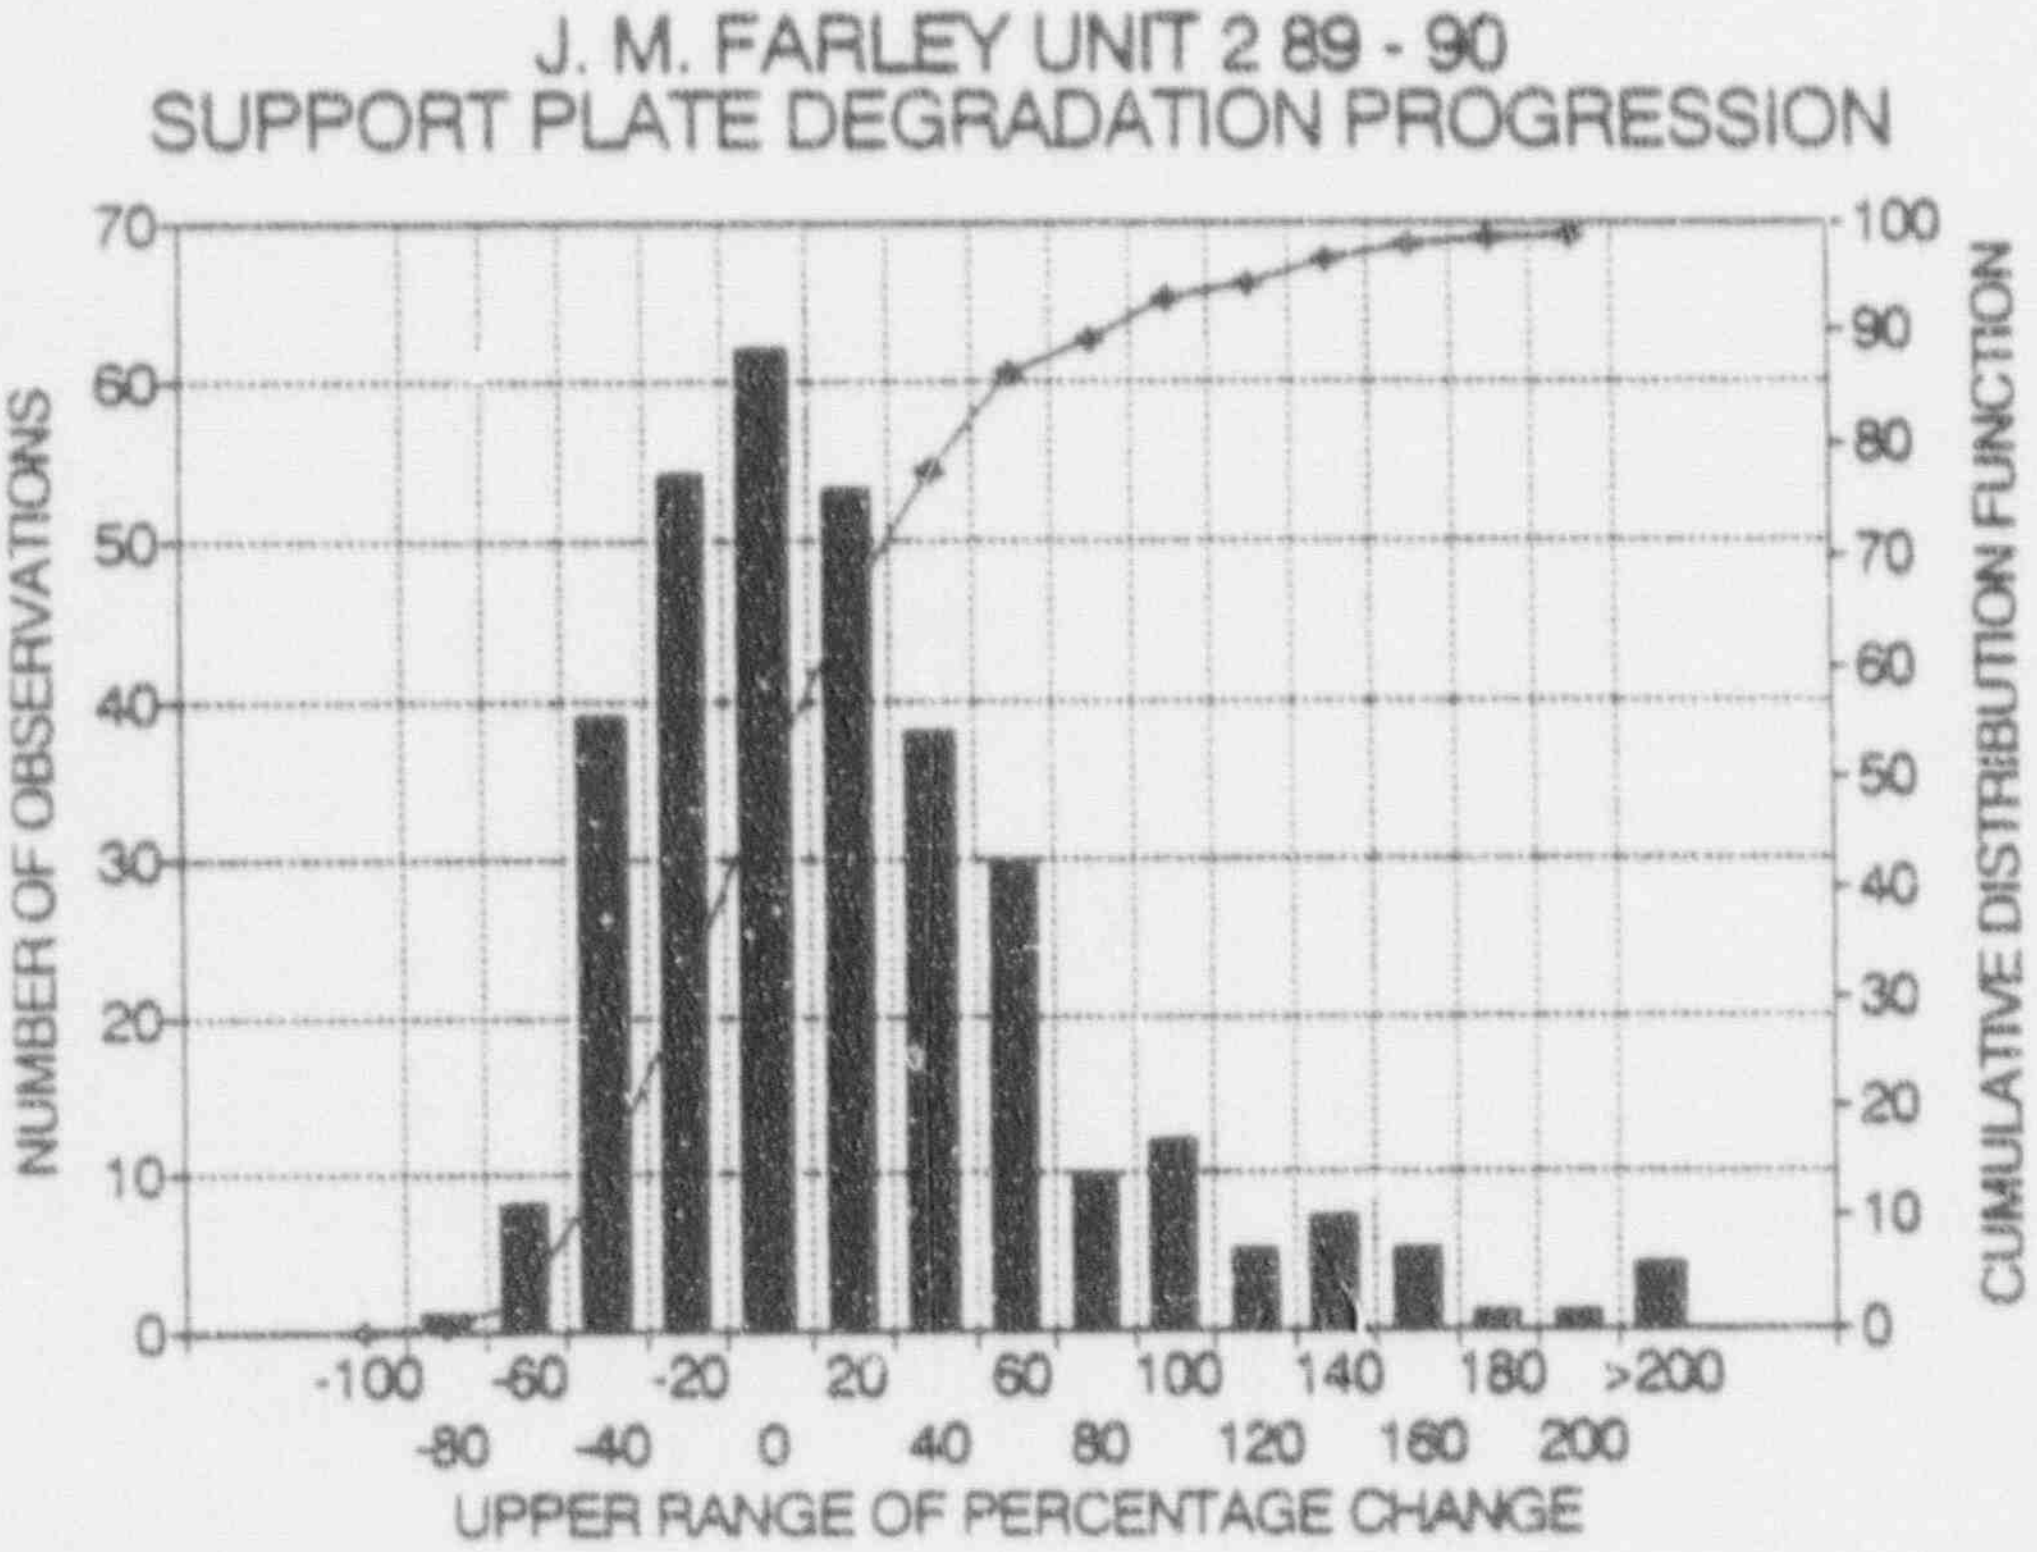
Figure 5-13

Histogram and Cumulative Probability of Voltage Growth in Farley-2 for Last Two Cycles

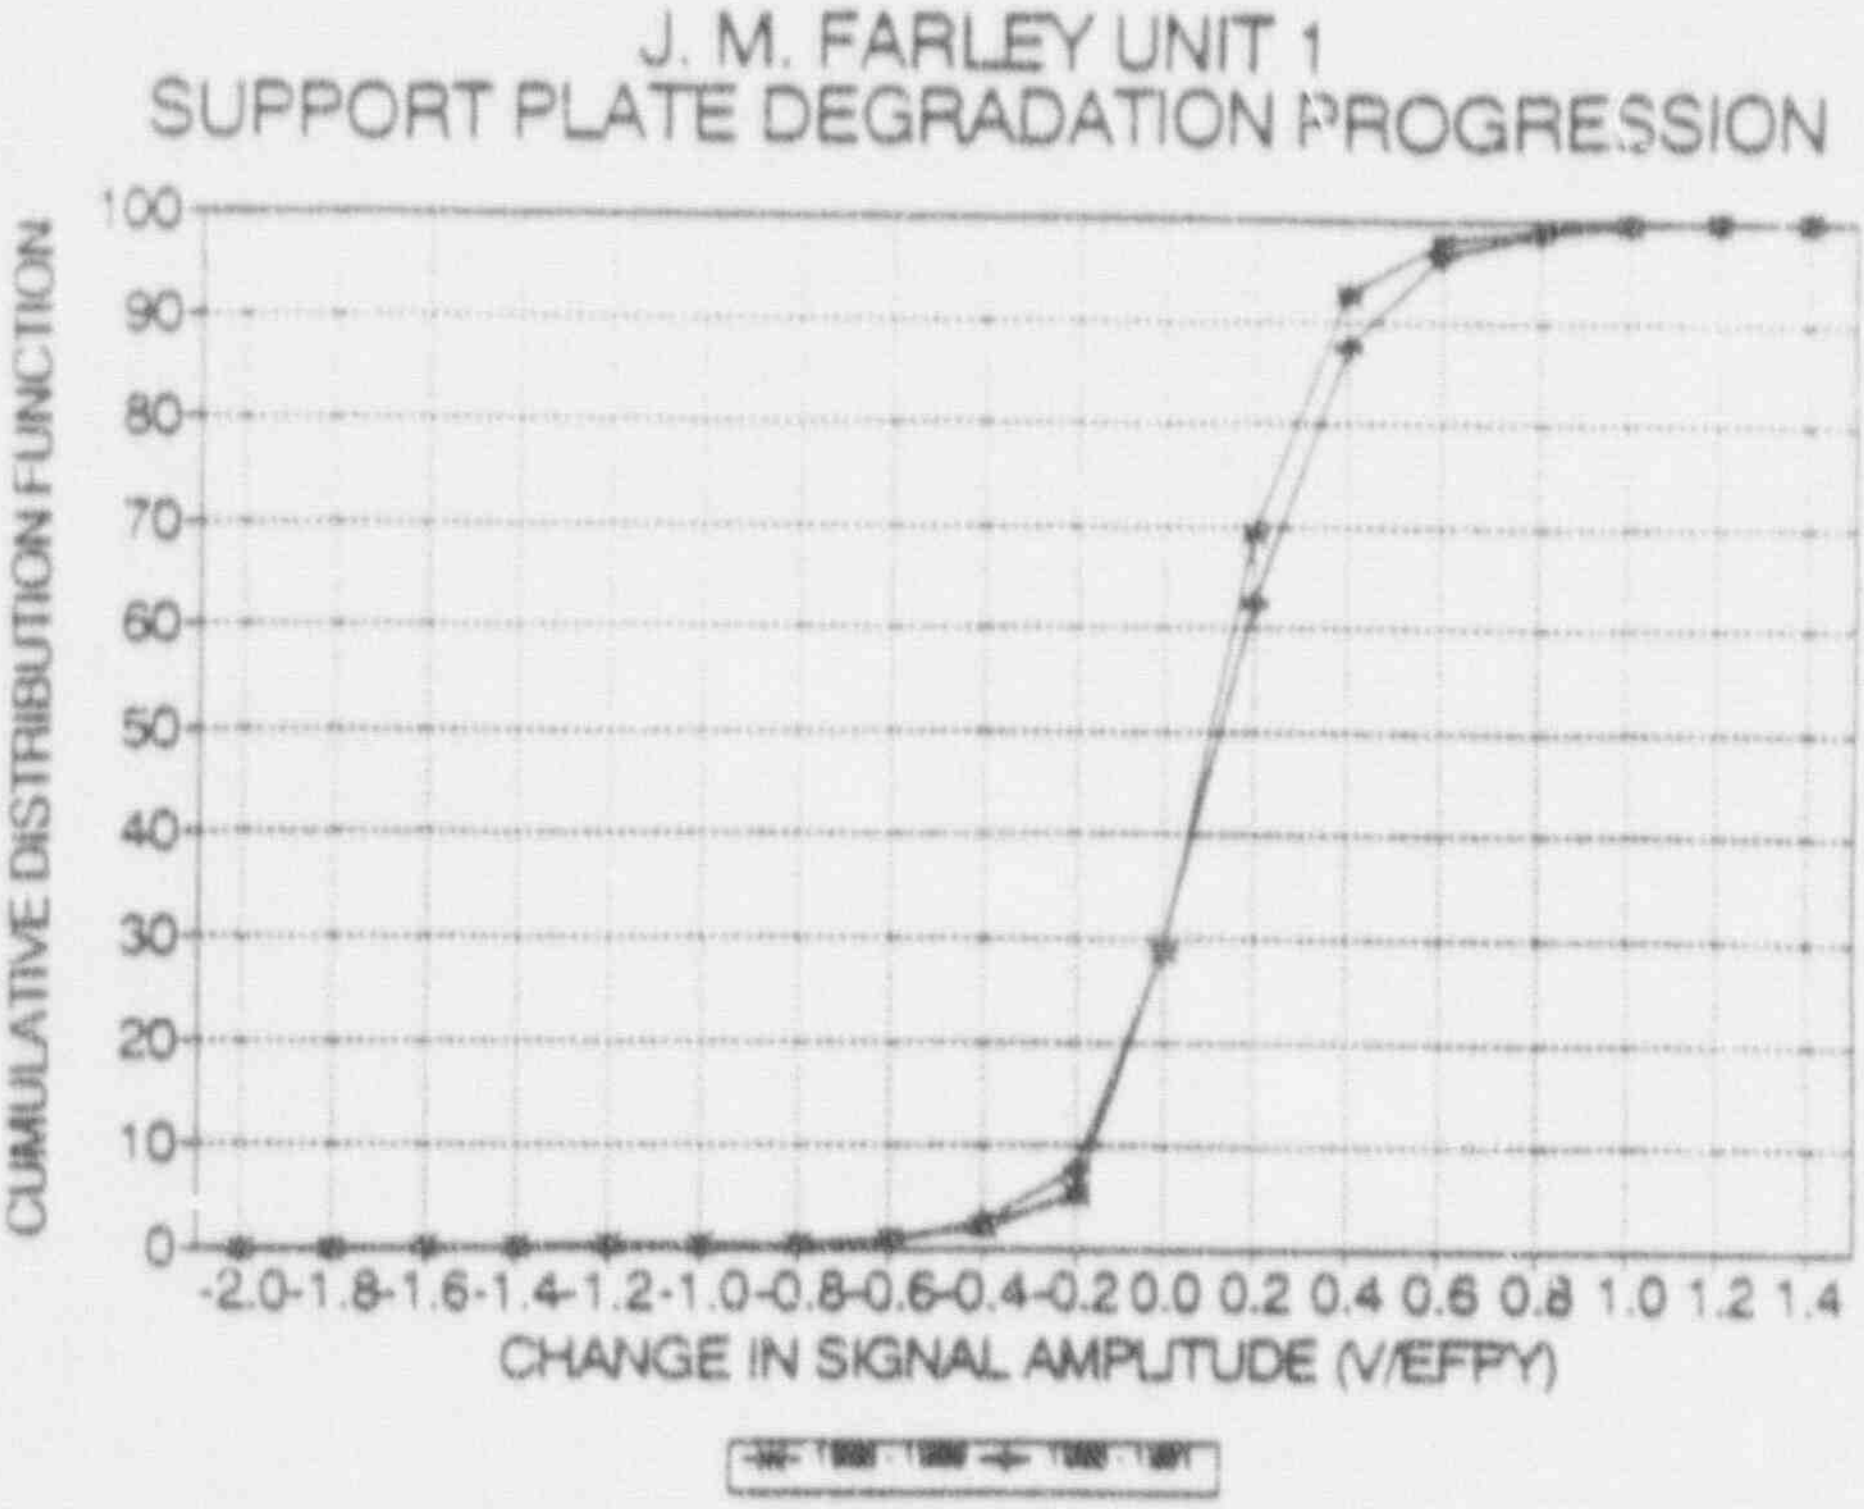
Figure 5-14

Cumulative Probability of Voltage Growth per EFPY for Farley Units 1 and 2

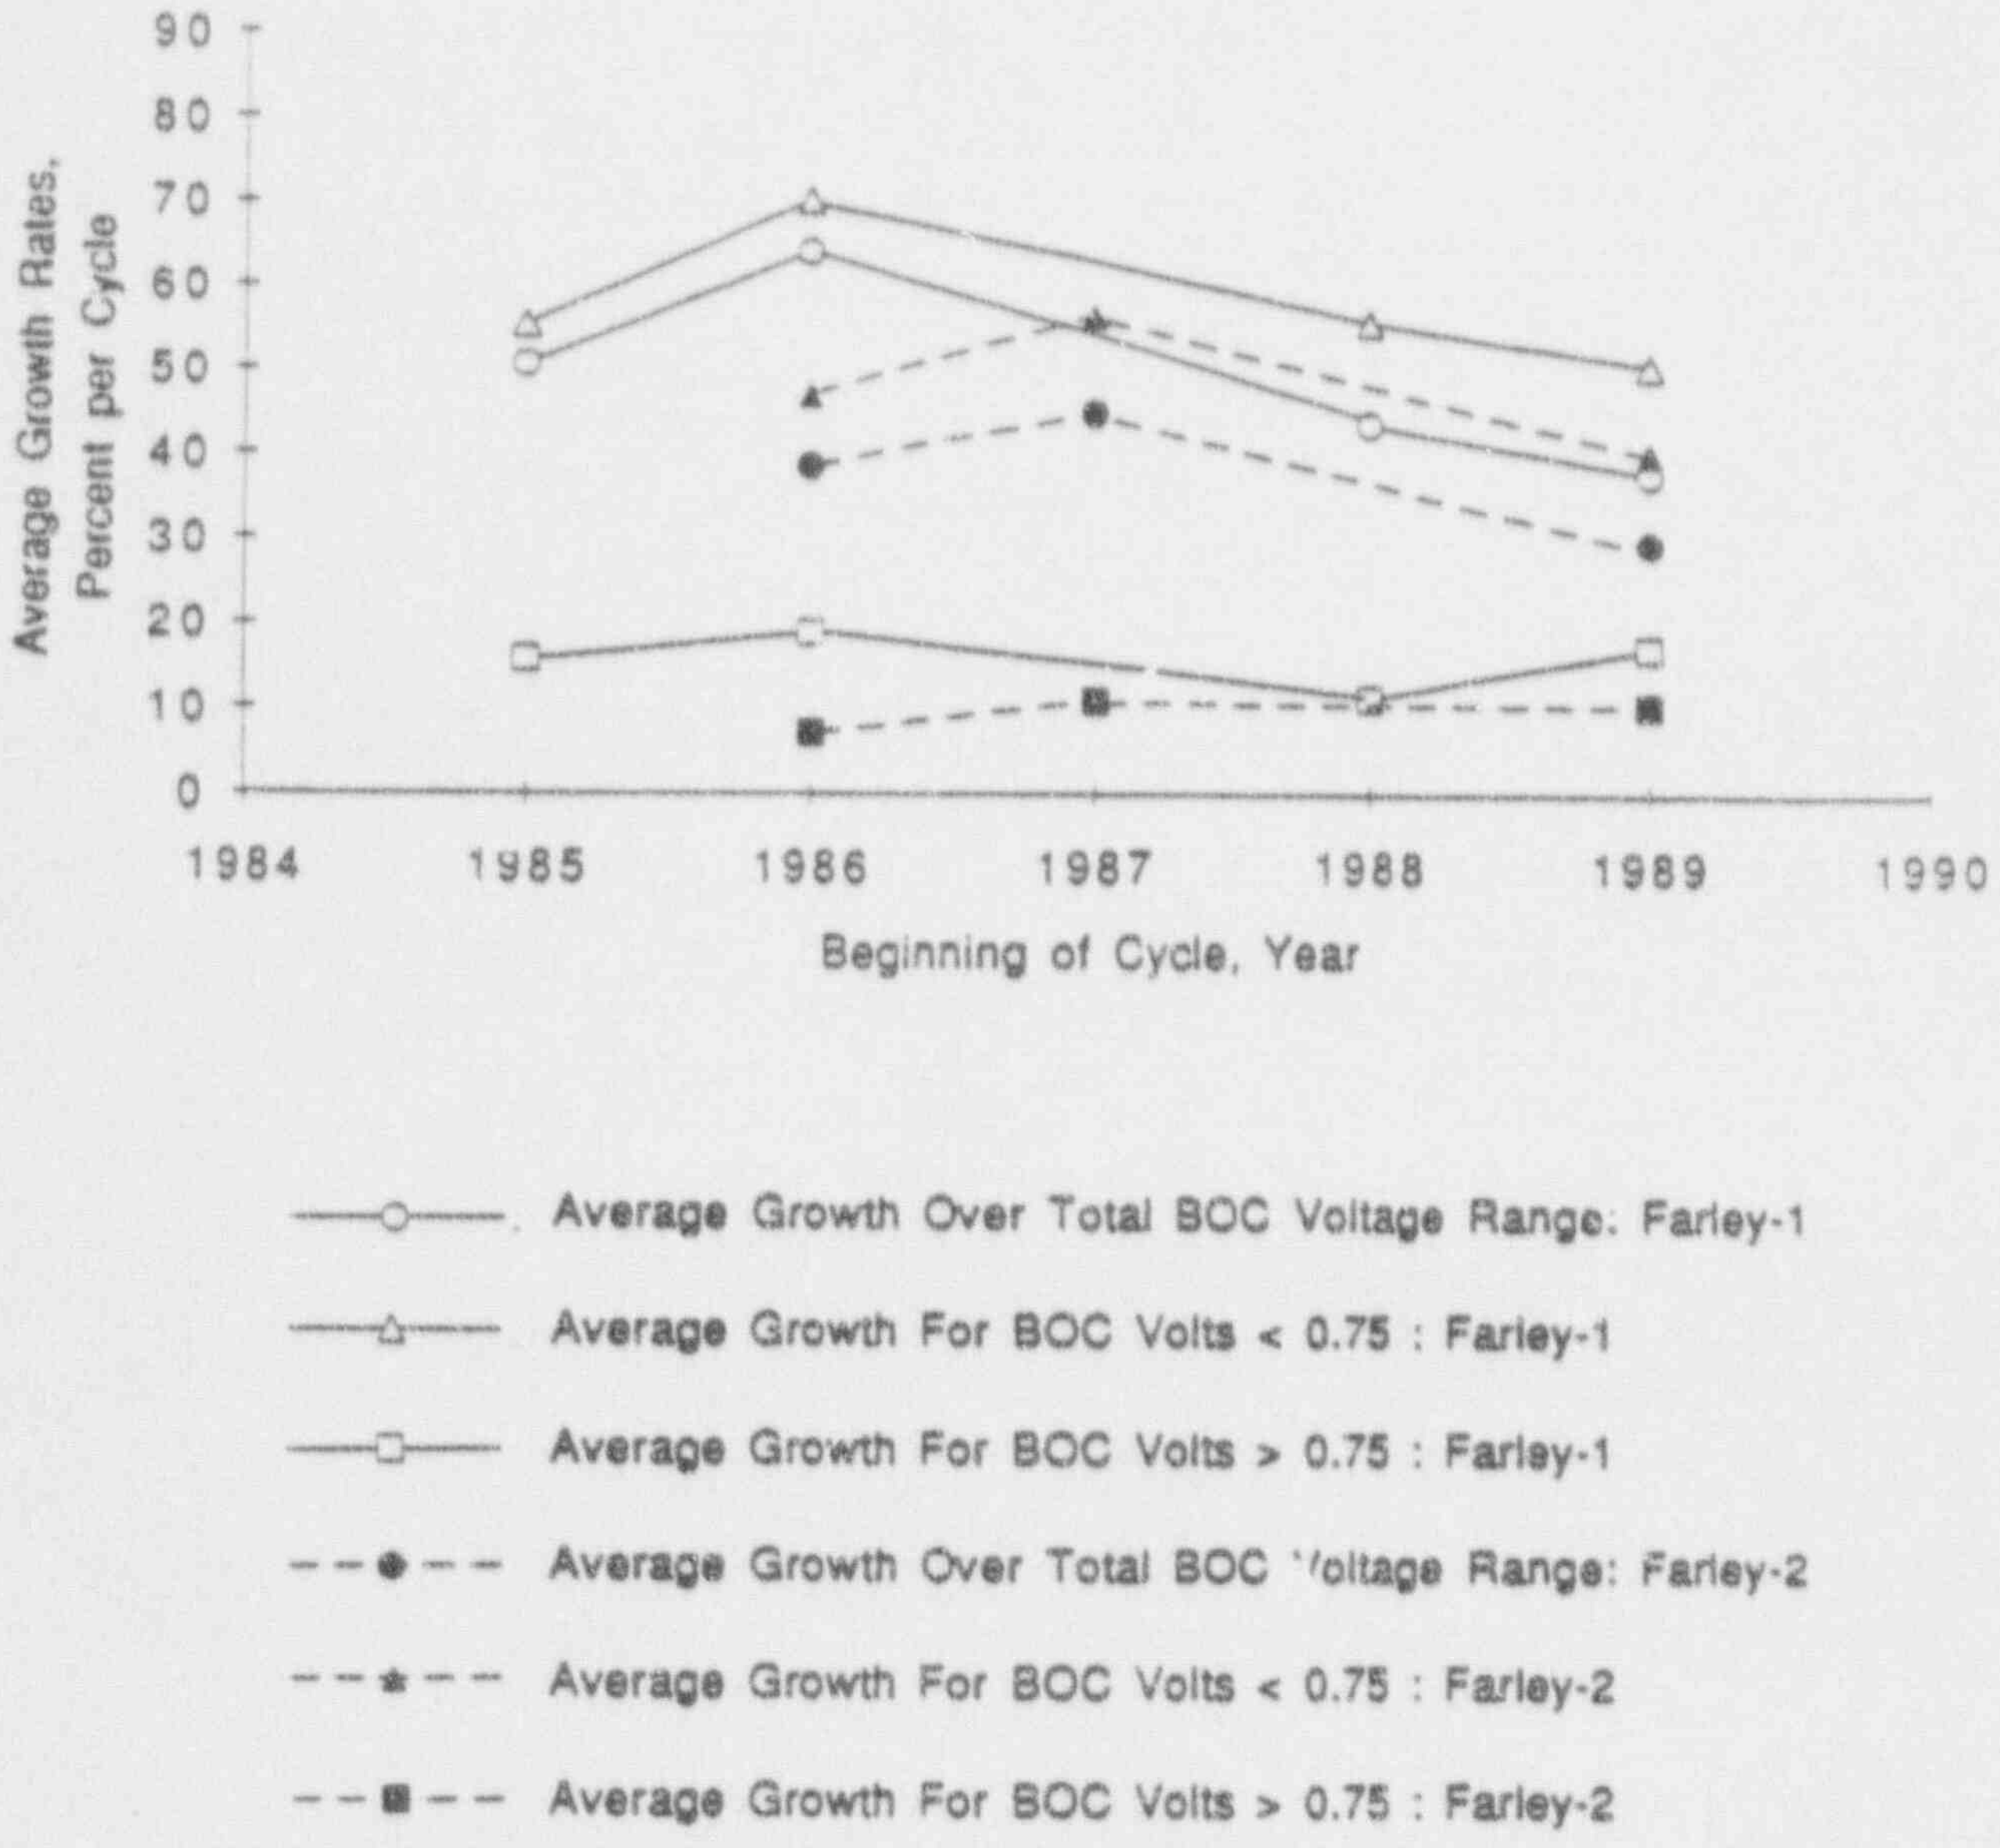
Figure 5-15

Historical Average Voltage Growth Trends in Farley SGs
