WCAP-13139

FARLEY UNITS 1 AND 2

STEAM GENERATOR TUBE/ TUBE SUPPORT PLATE ELEVATION ALTERNATE PLUGGING CRITERION SUMMARY

DECEMBER 1991

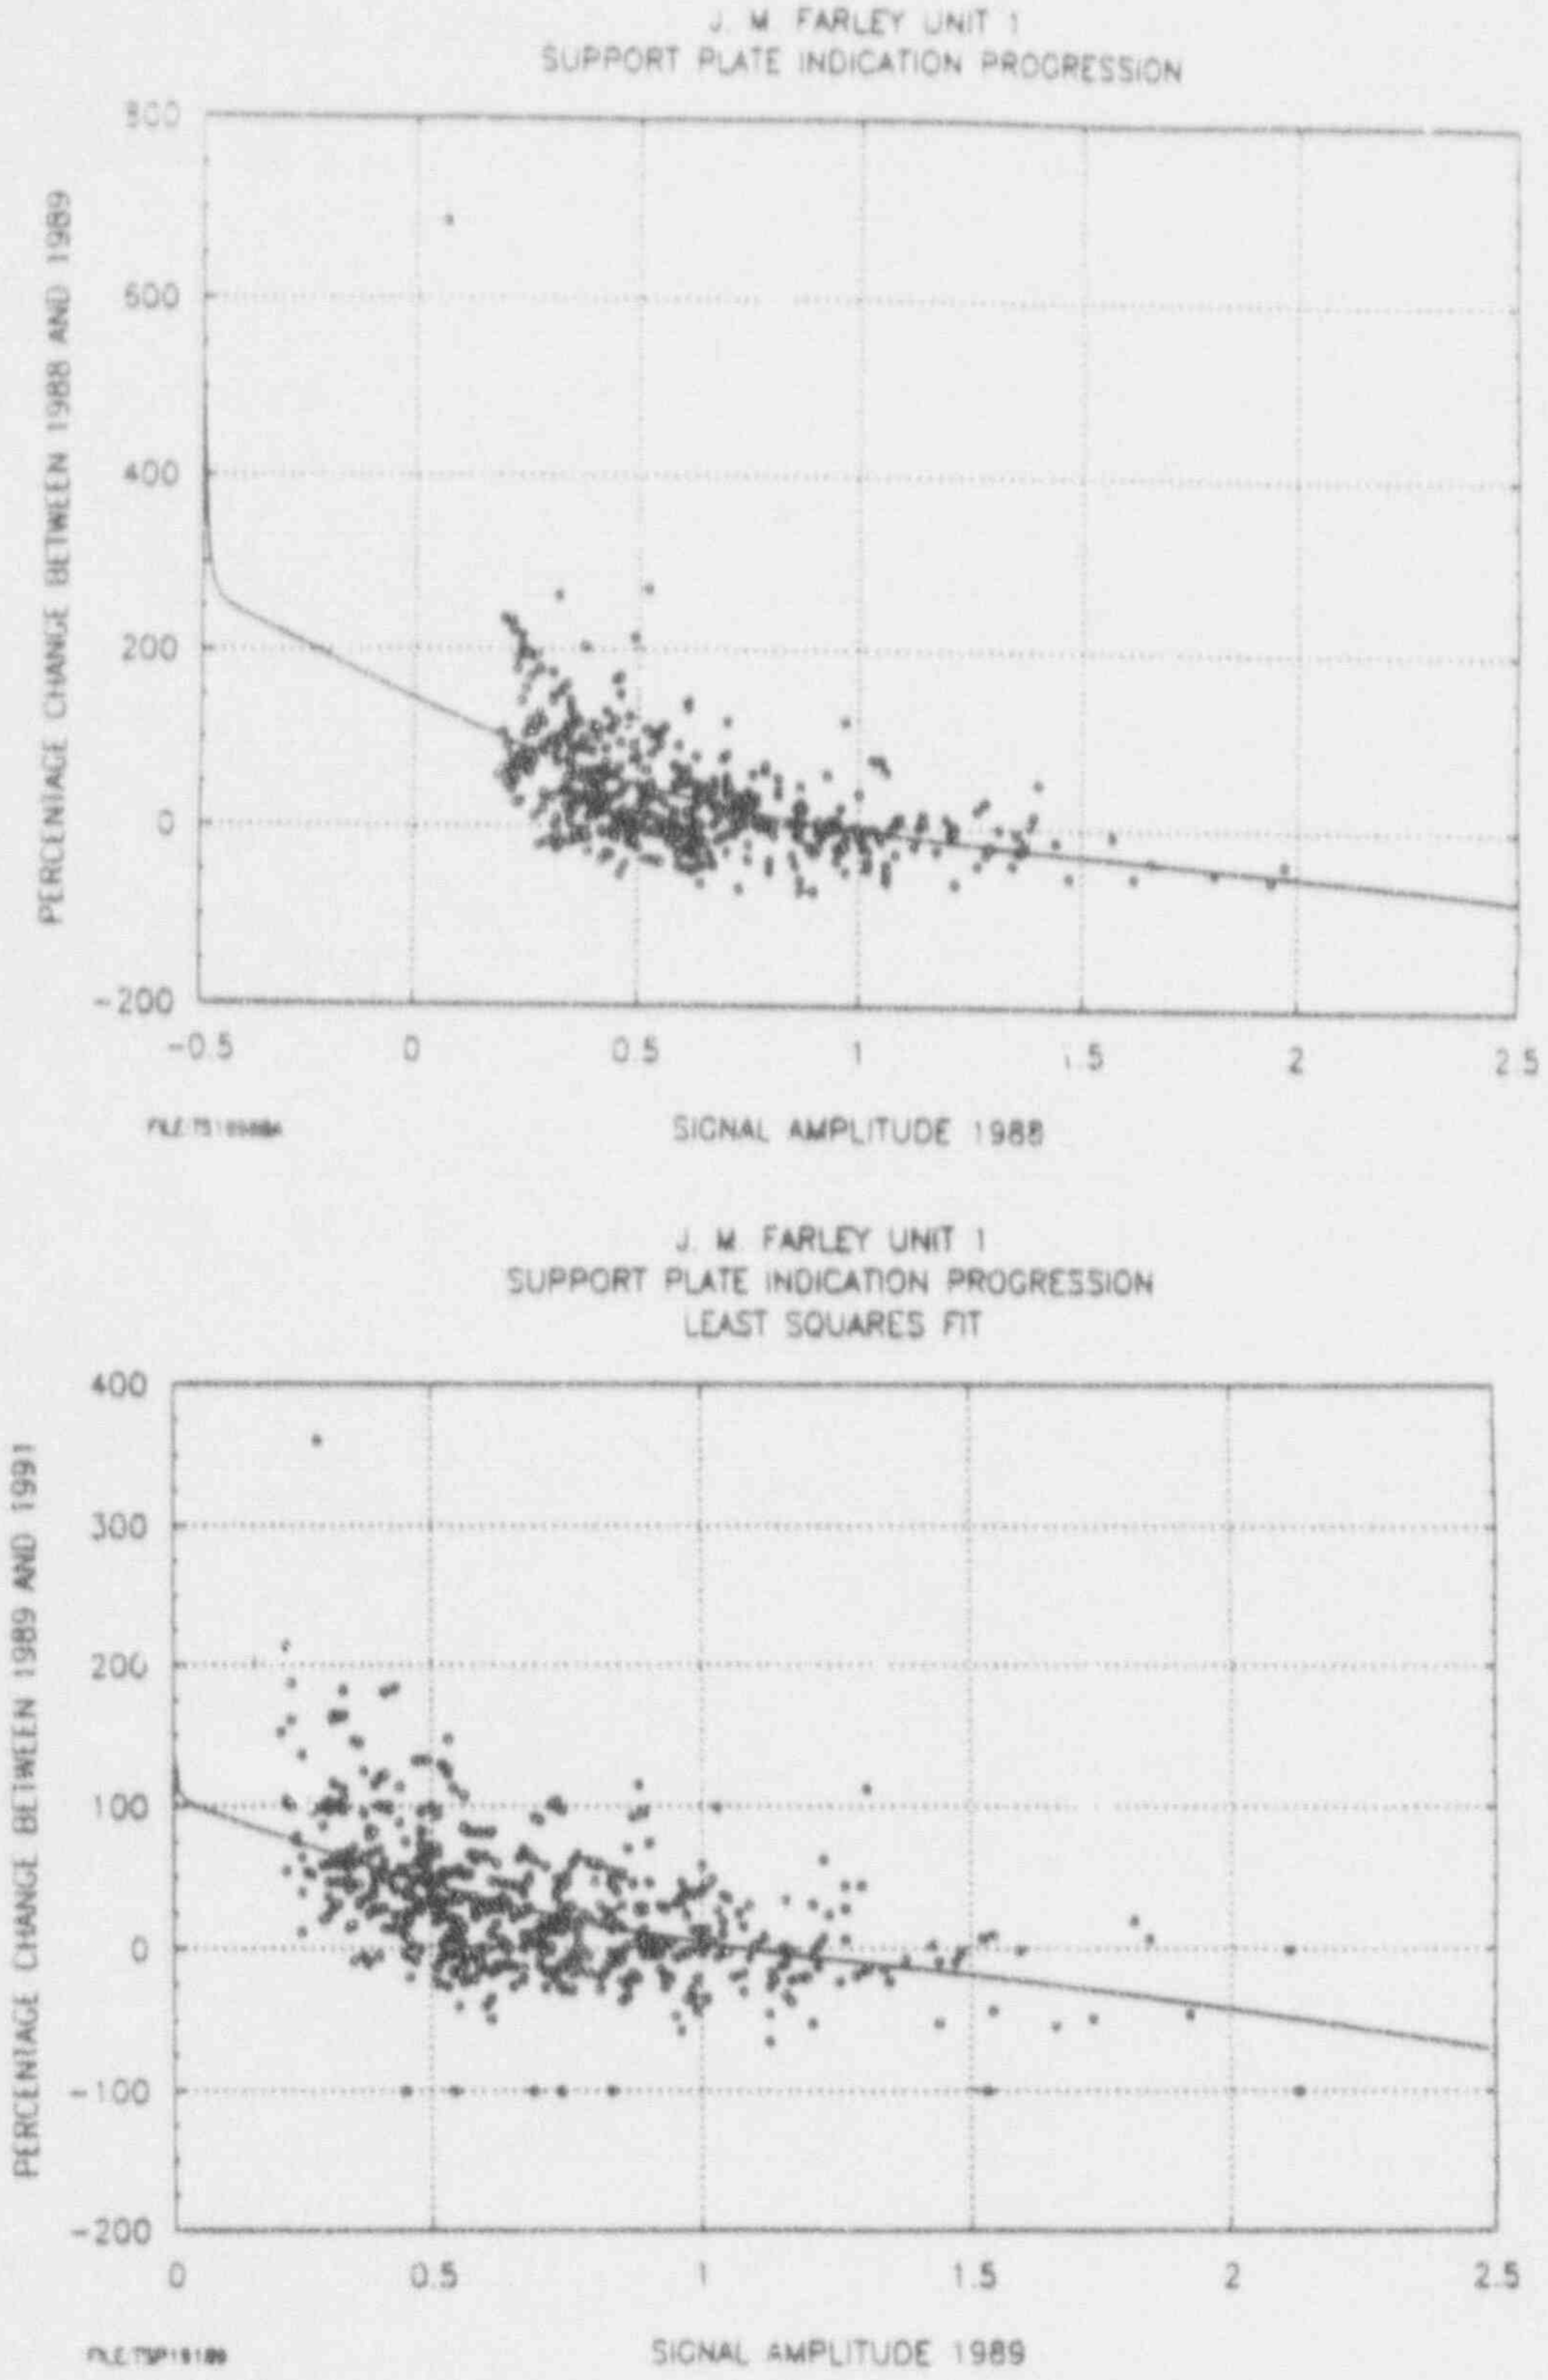
Figure 5-10

Scatter Plot of Voltage Growth in Farley-1 for Last Two Cycles

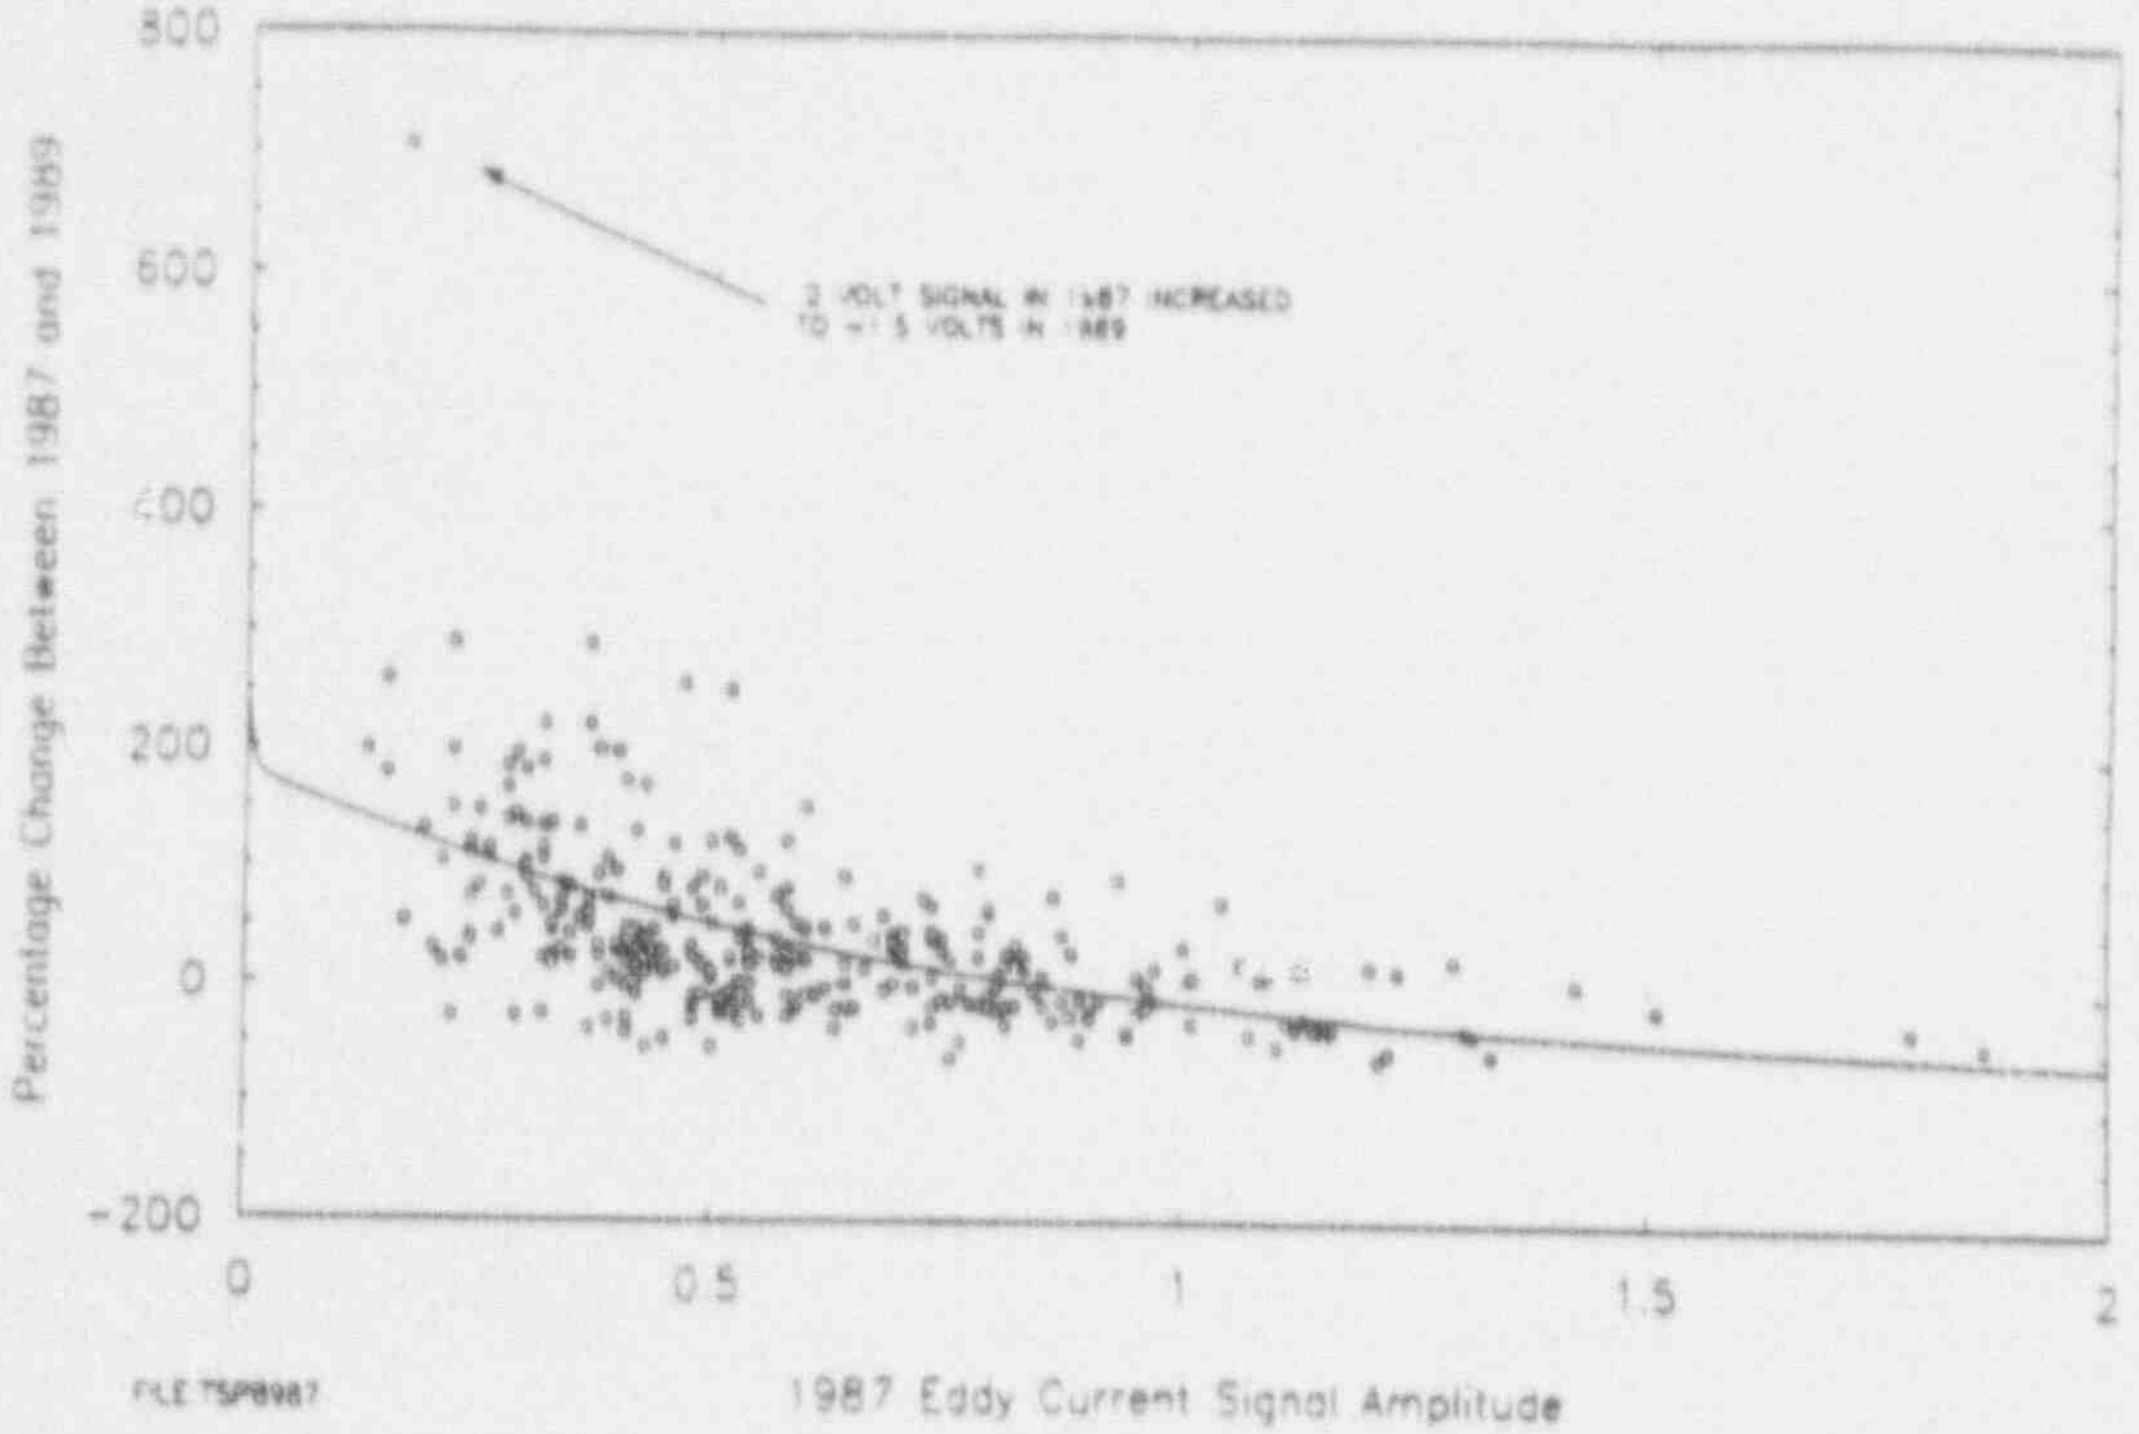
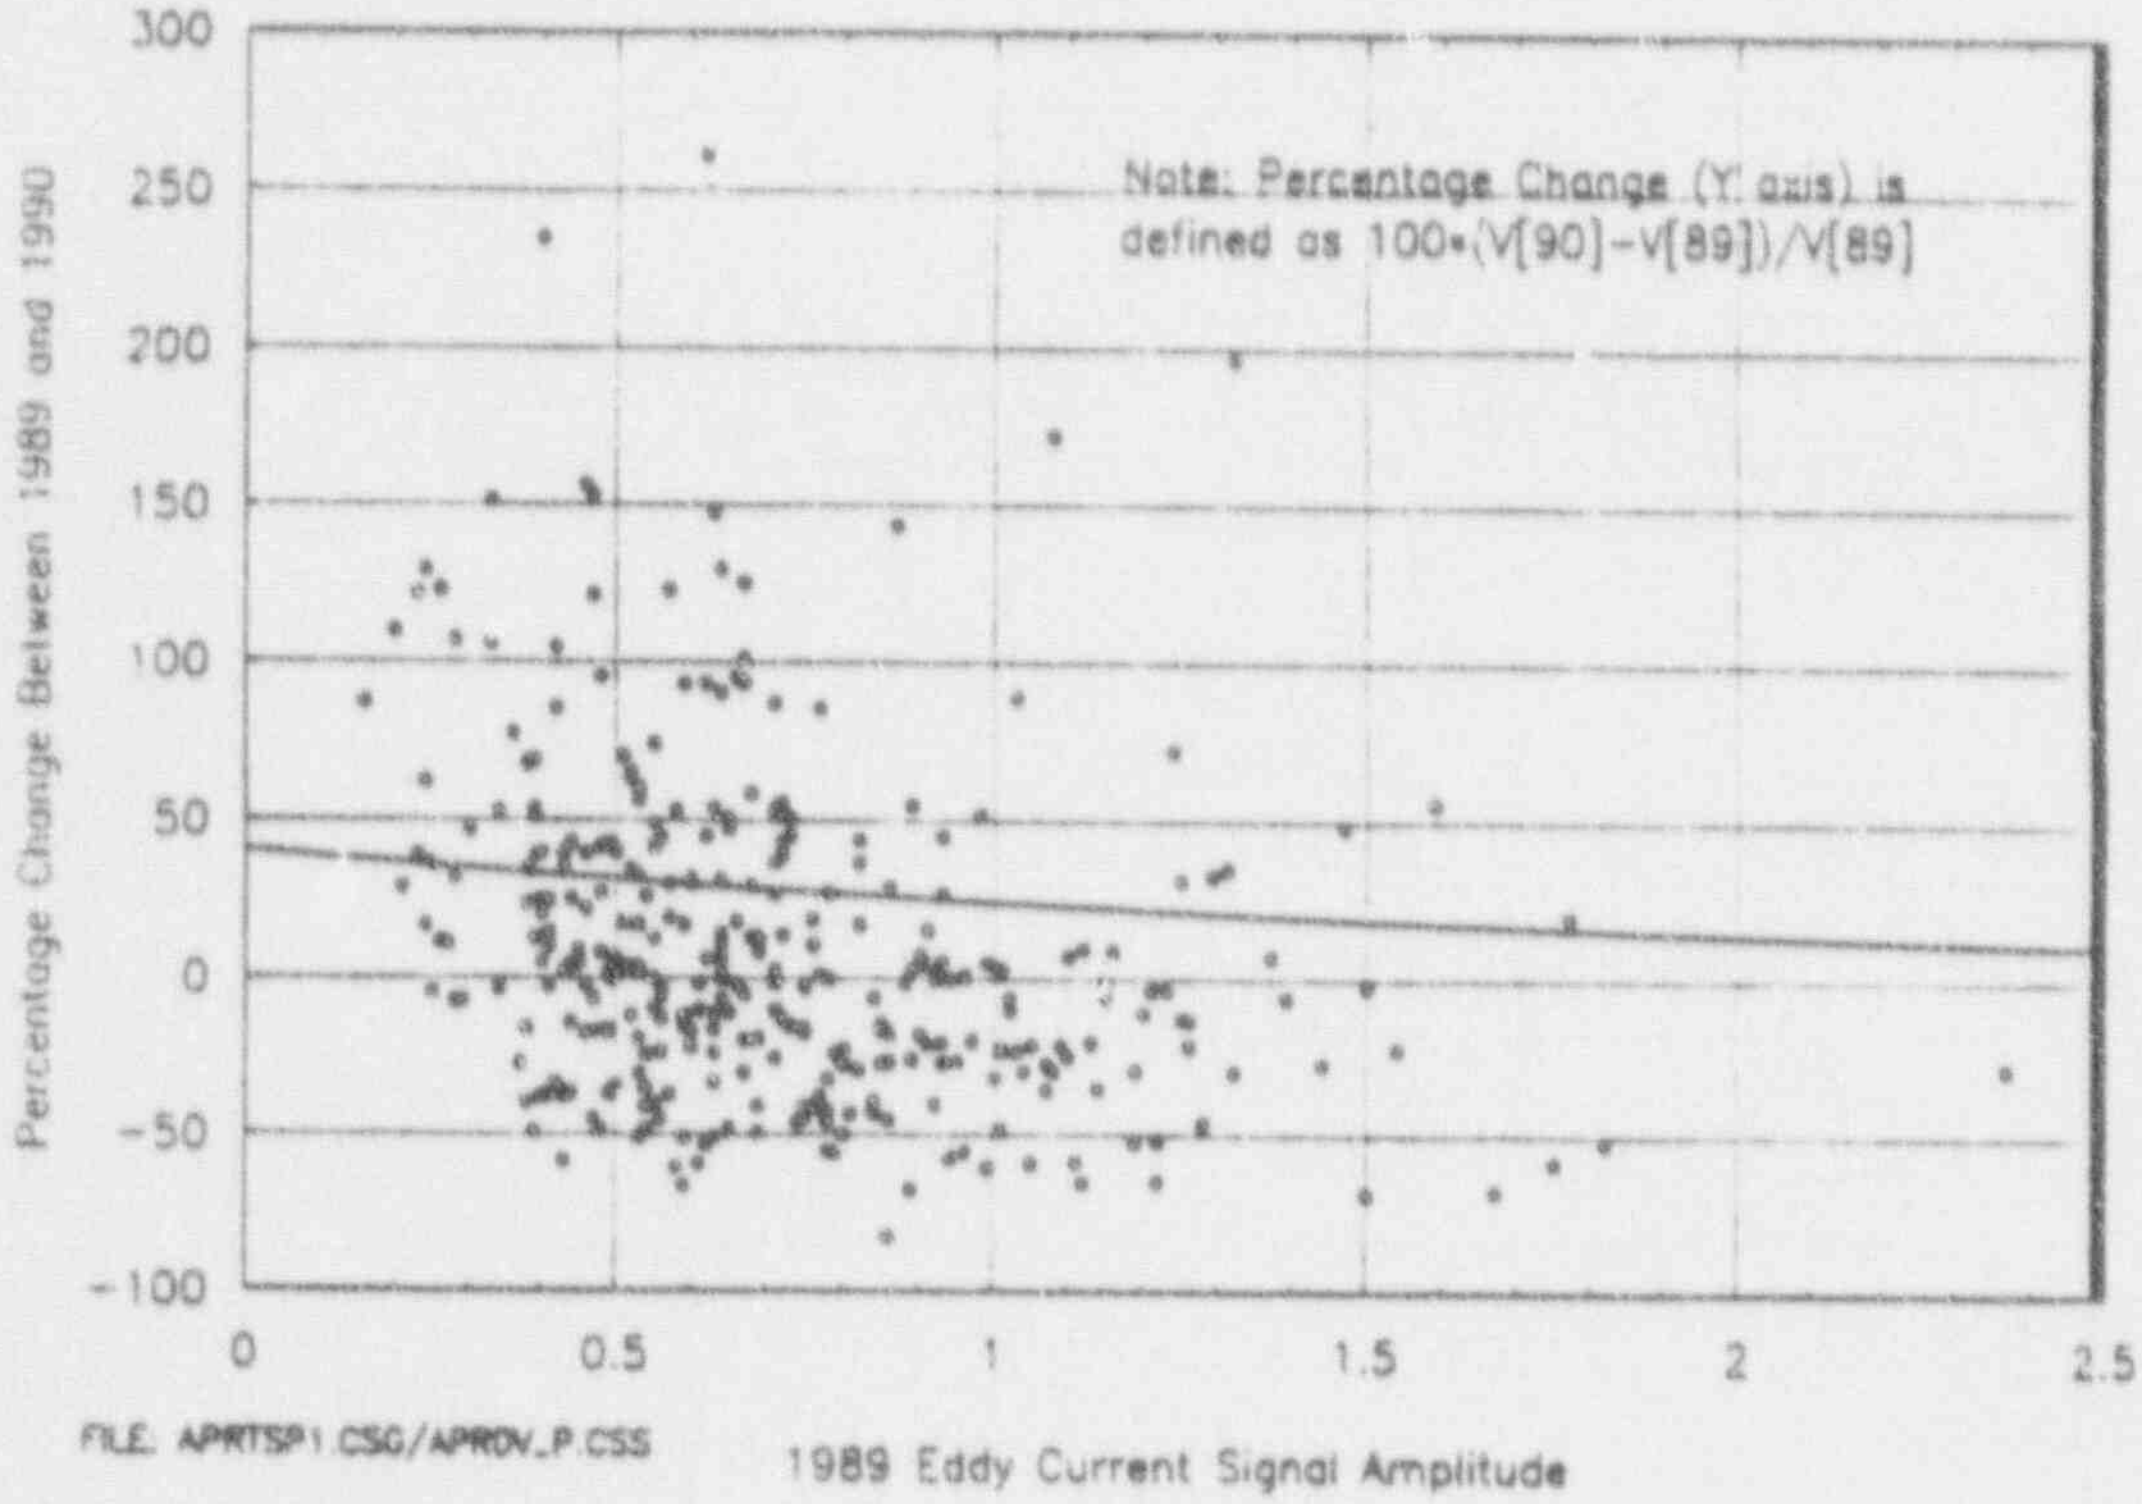
Figure 5-11

Scatter Plot of Voltage Growth in Farley-2 for Last Two Cycles

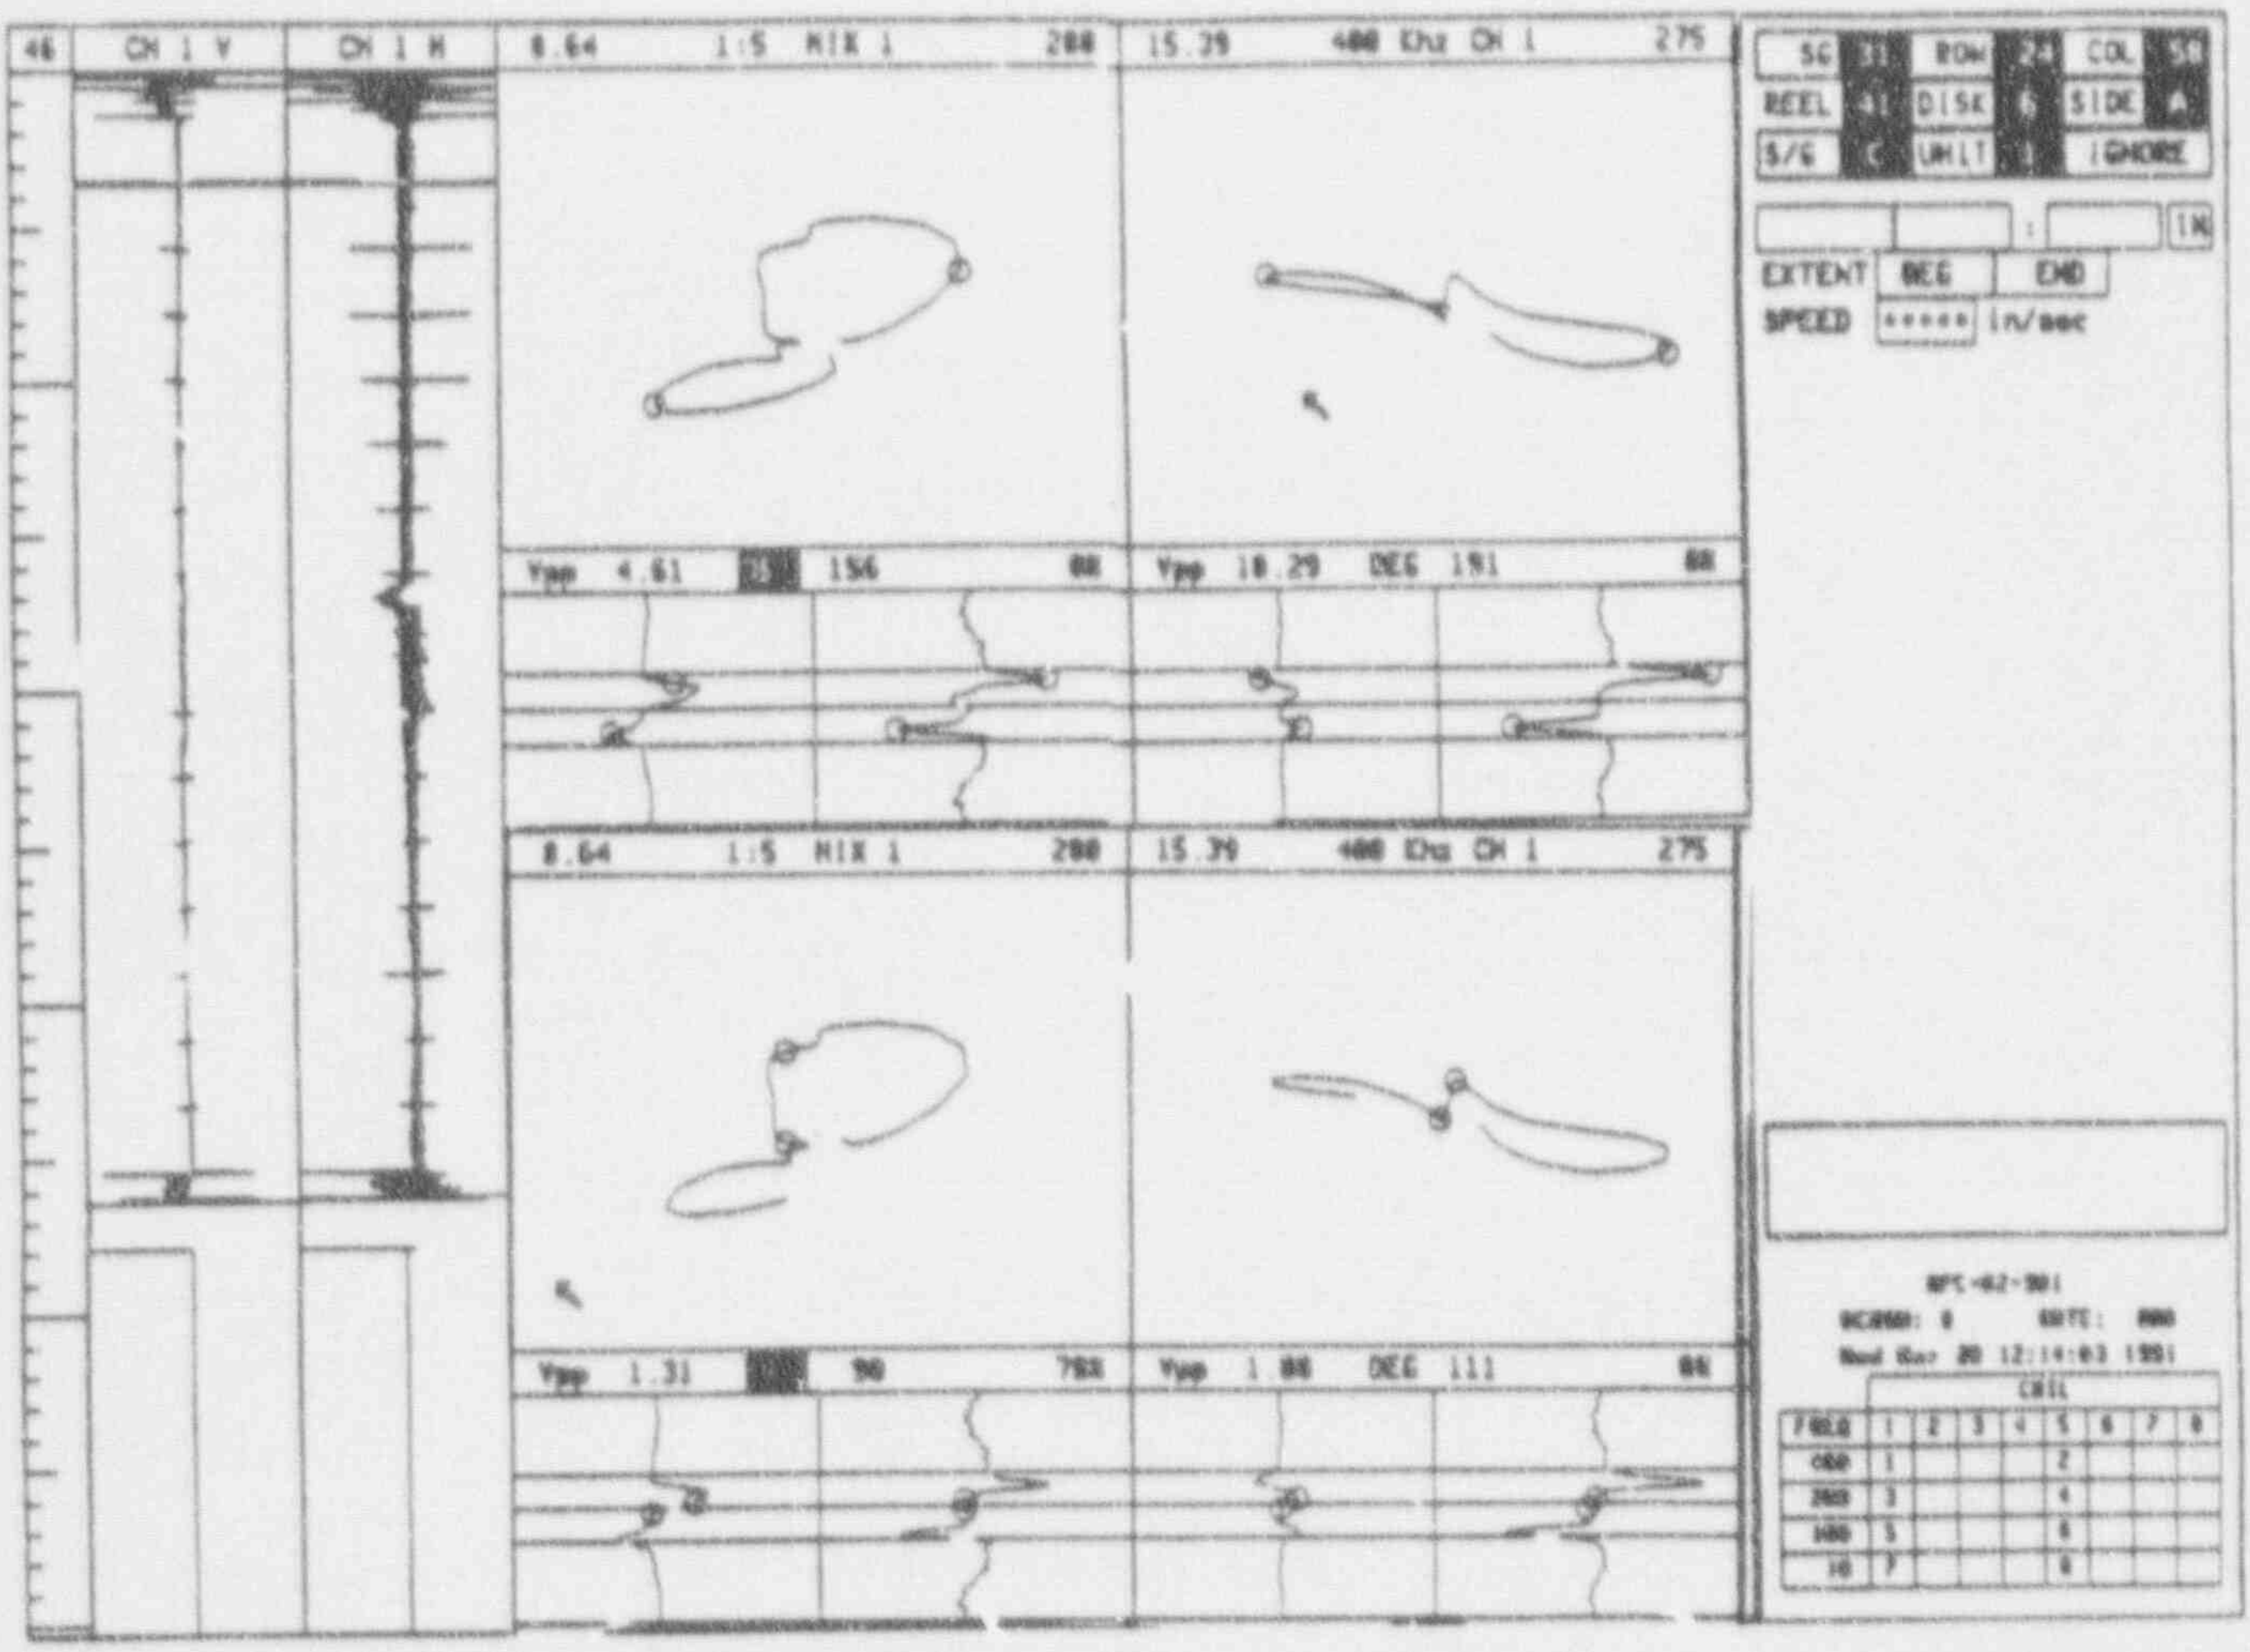
Figure A-1. ODSCC at TSP - Bobbin Coil Amplitude Analysis

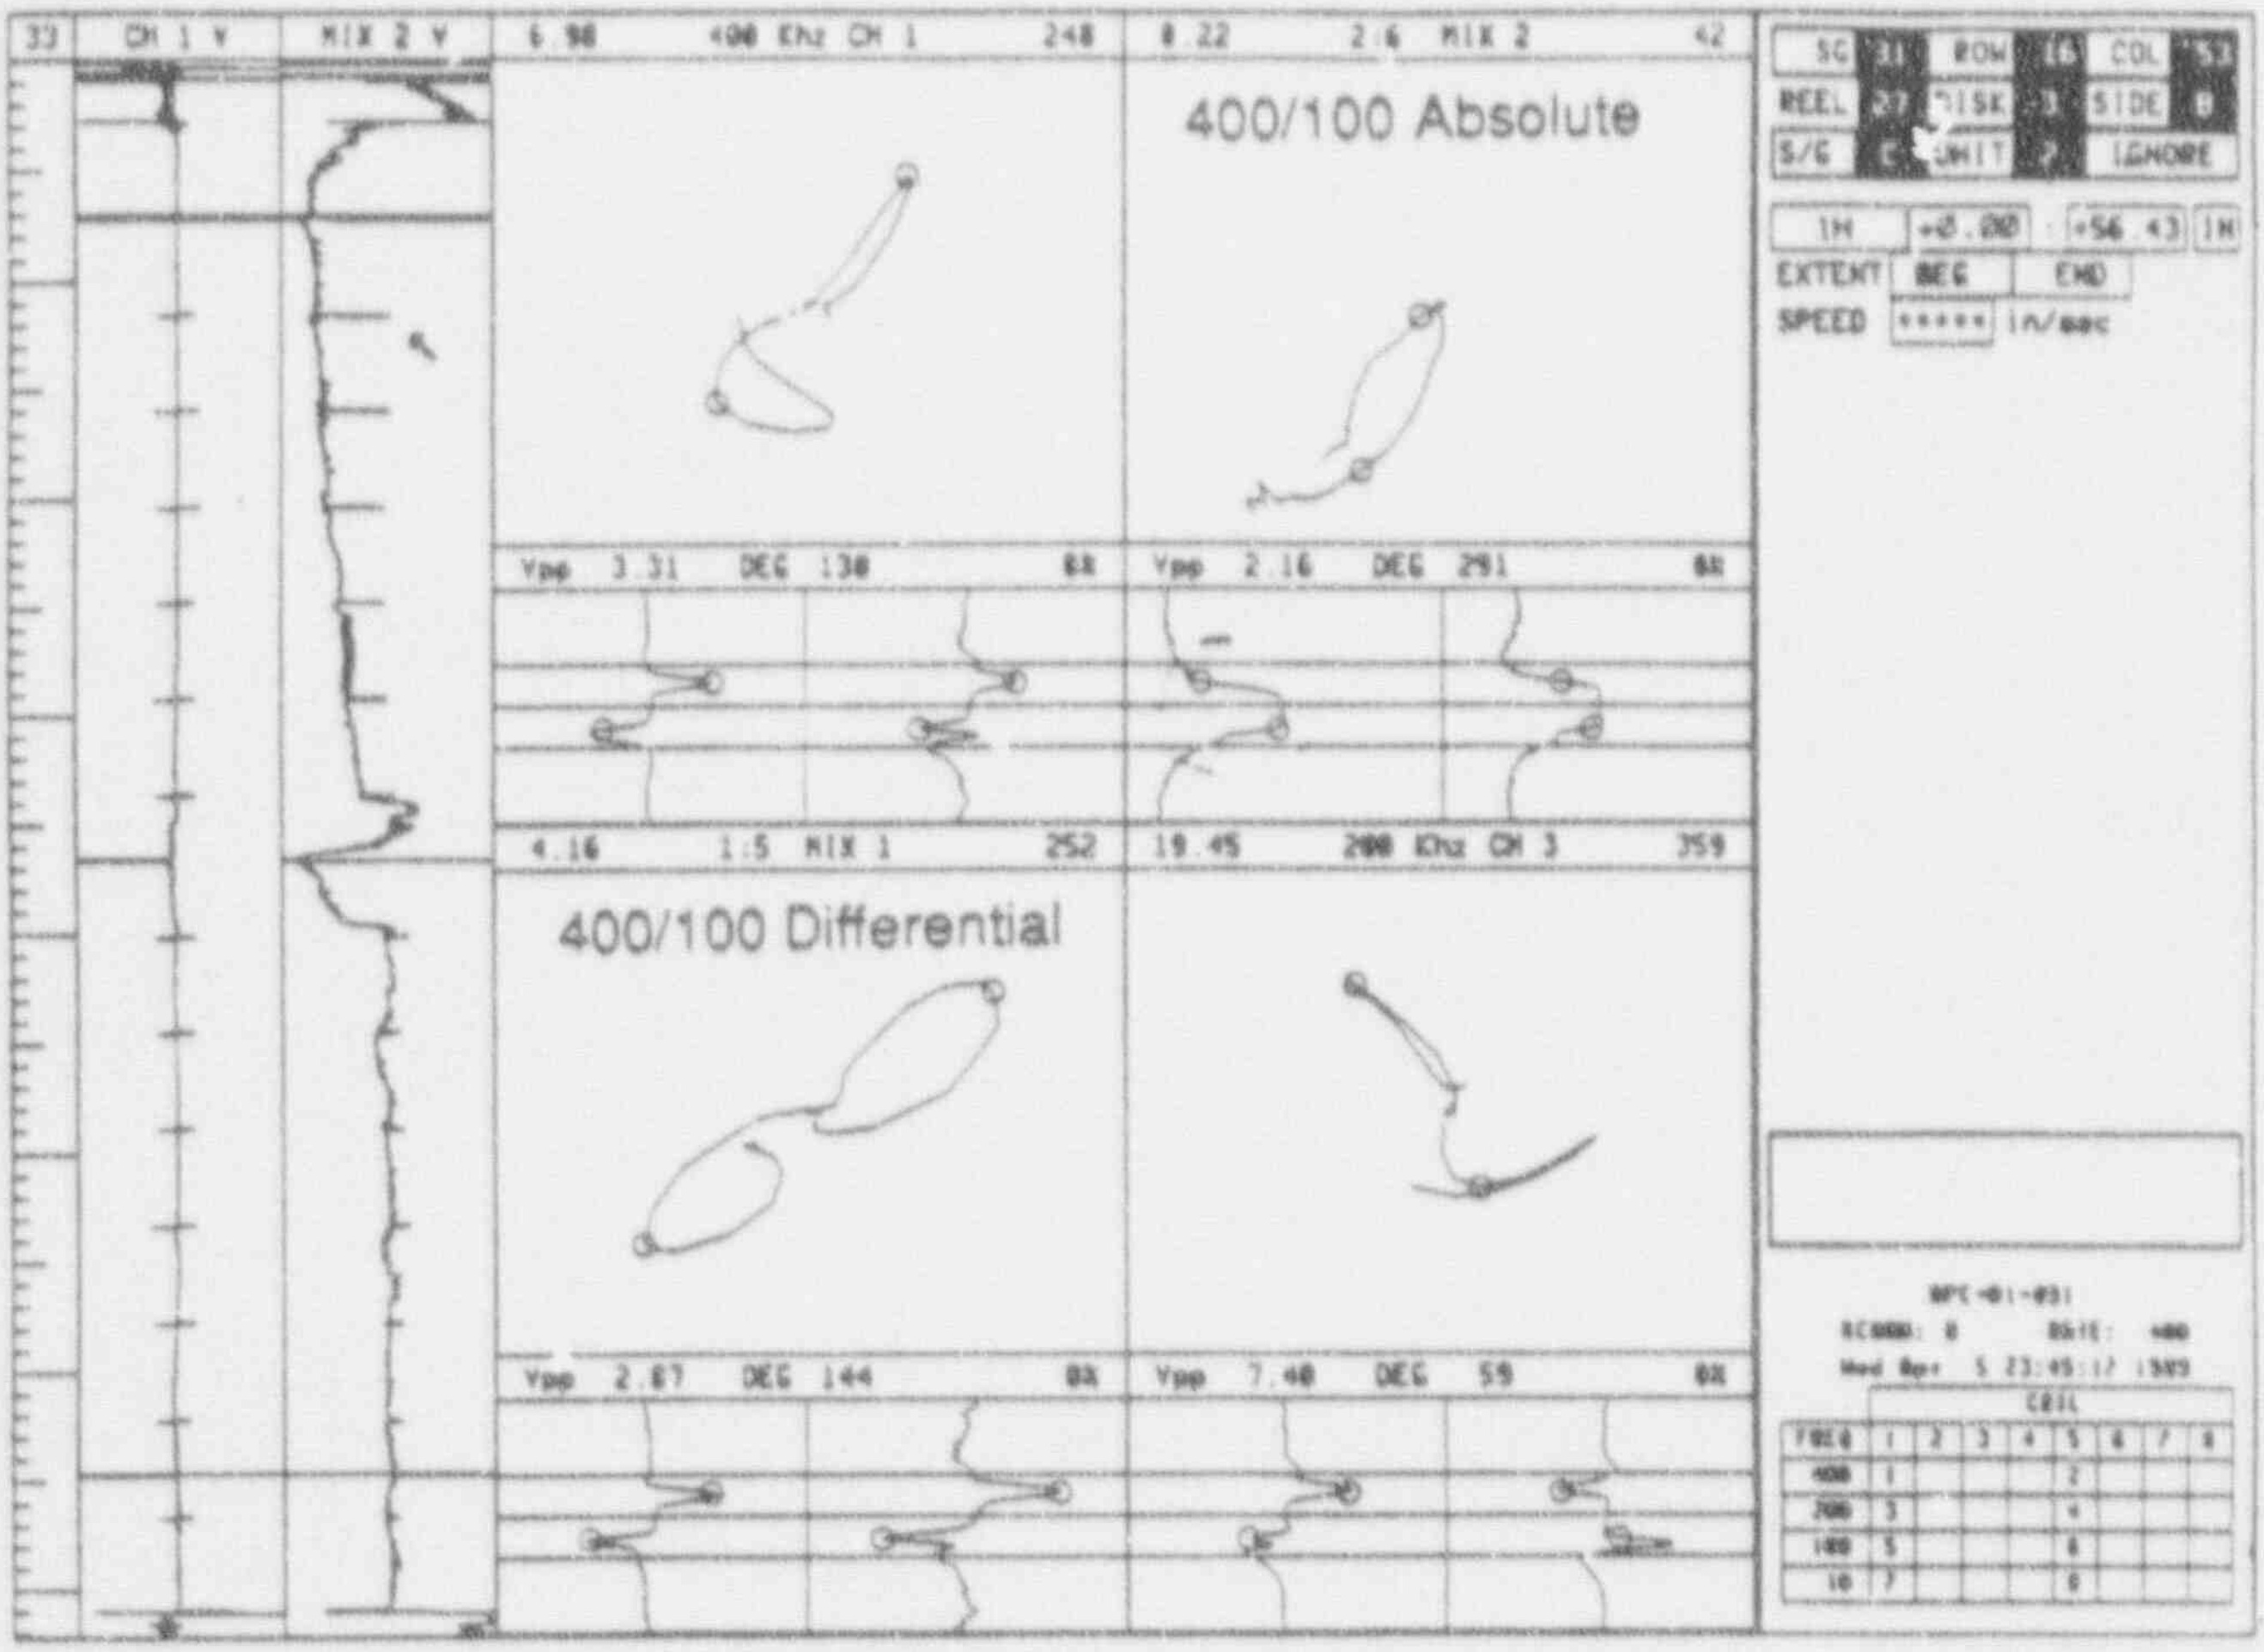
Figure A-6. Example of Bobbin Coil Field Data - Flaw Signals for ODSCC at Dented TSP Intersection

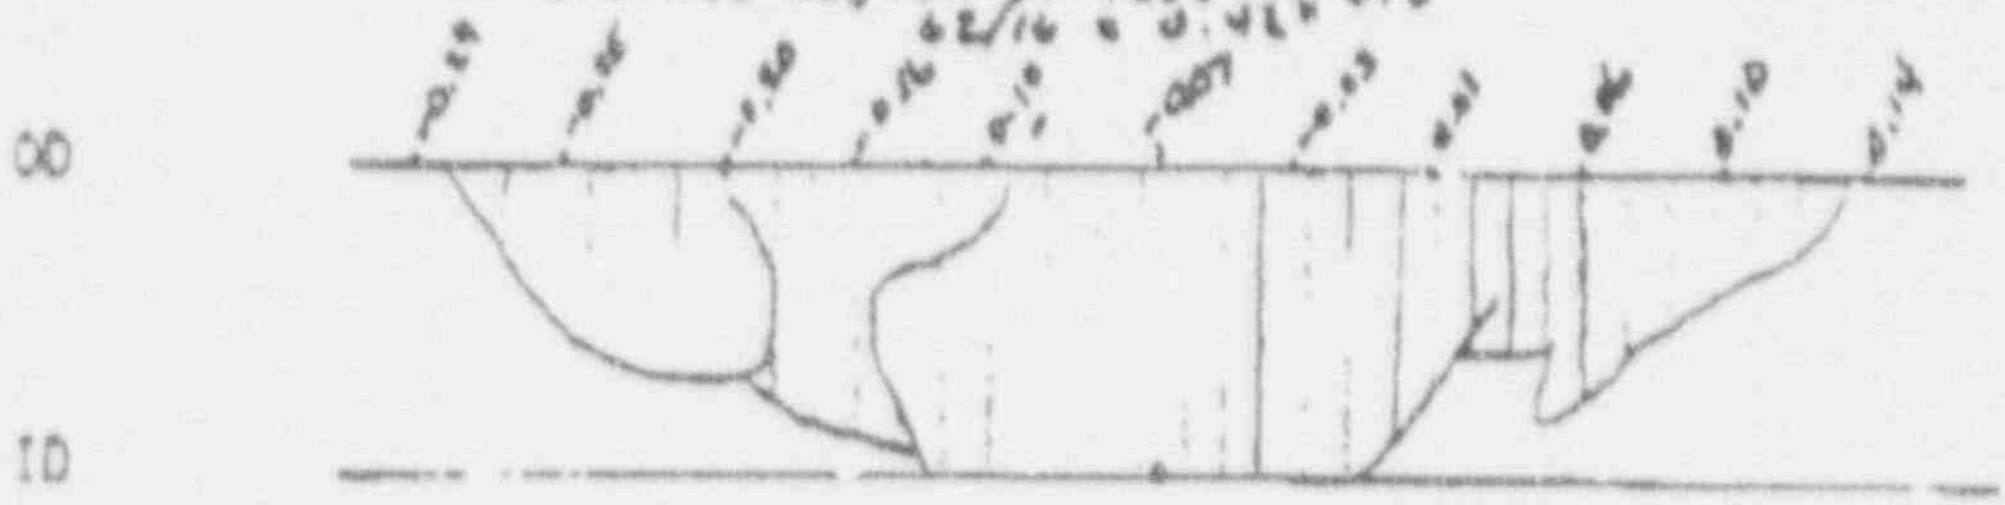
Figure 4-1

Description of OD Origin Corrosion at the First Support Plate Crevice Region of Tube R1-C73

Macrocrack Length = 0.42 inches

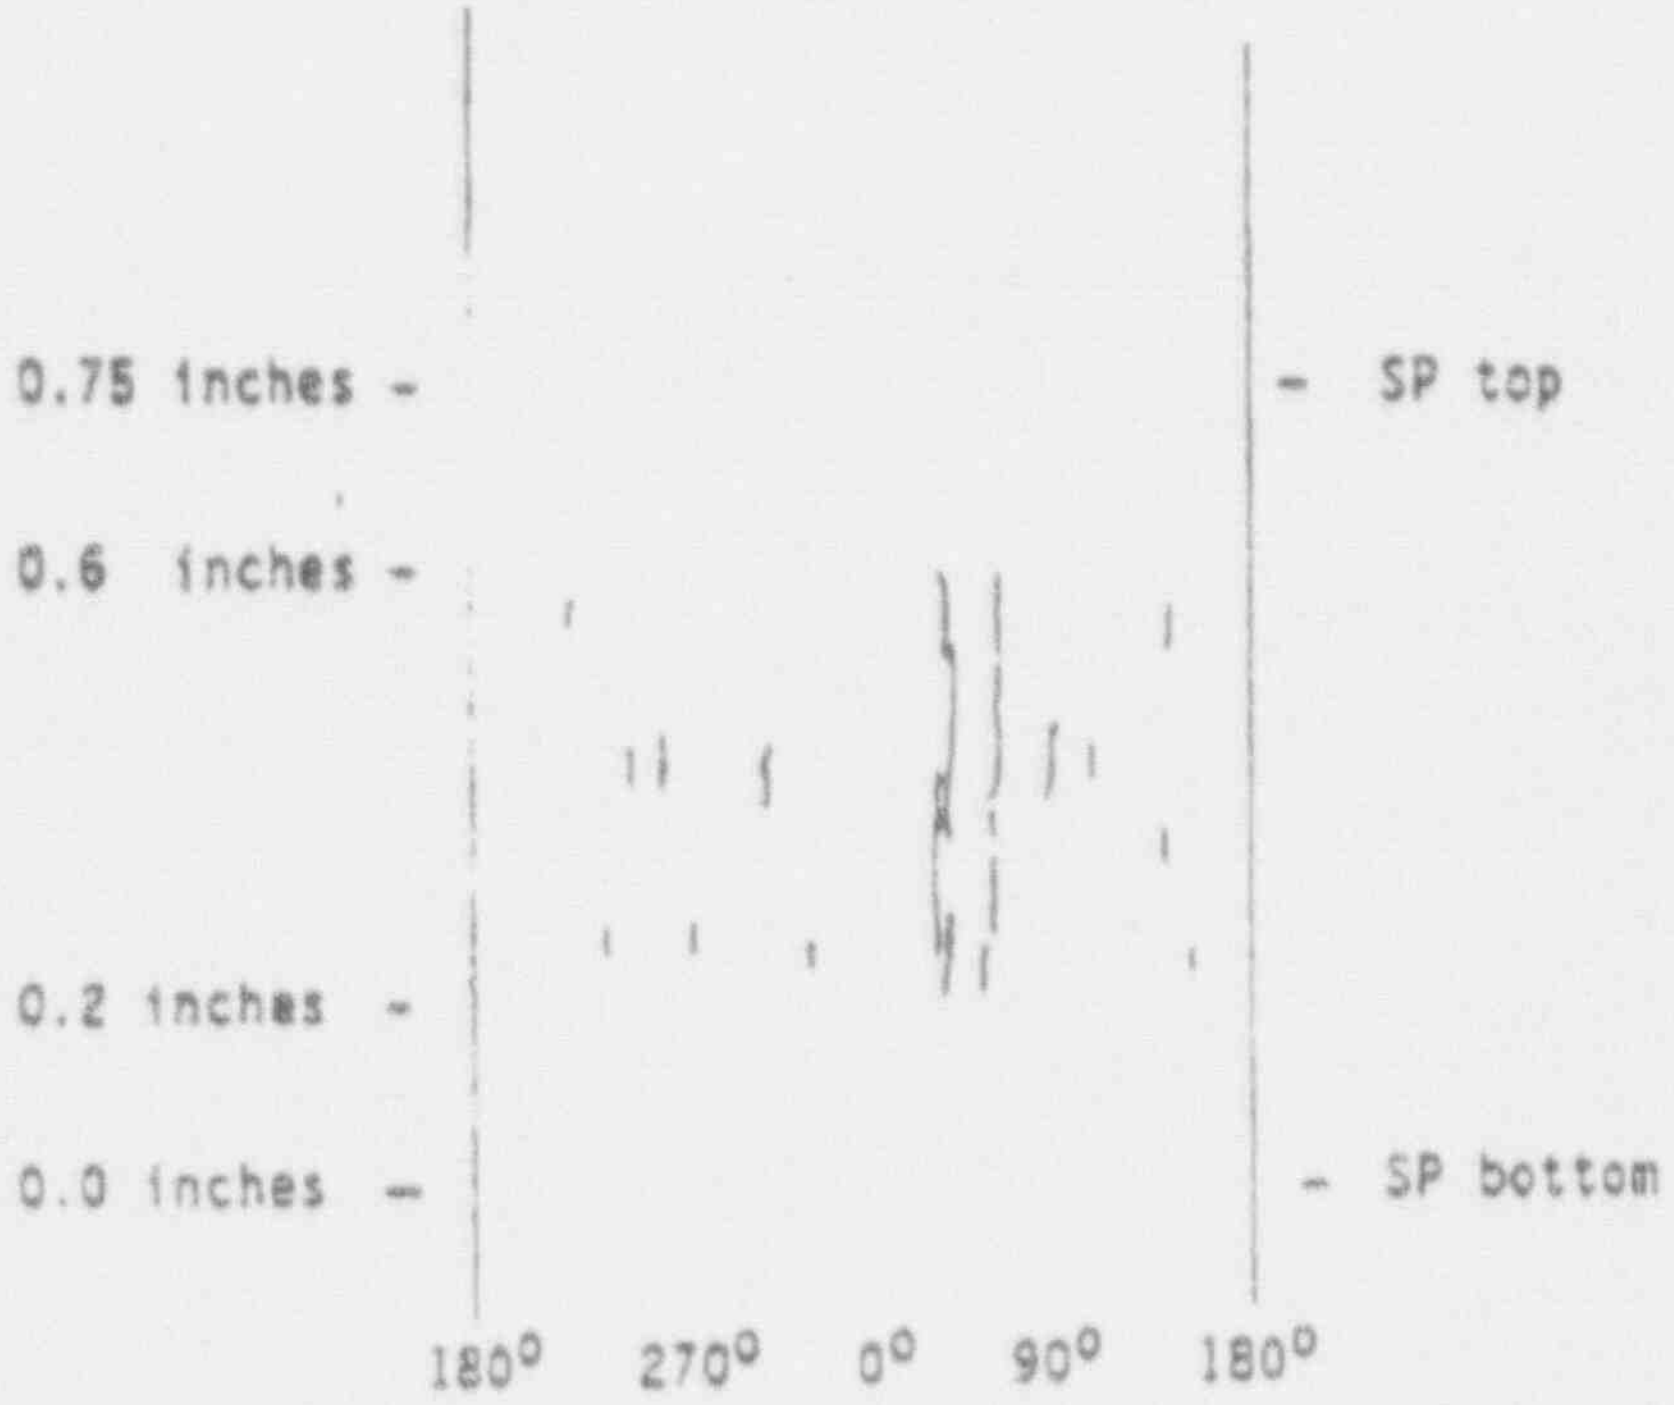
Morphology = Intergranular SCC with some IGA characteristics (width of IGA 0.012 inches)
