WCAP-13139

FARLEY UNITS 1 AND 2

STEAM GENERATOR TUBE/ TUBE SUPPORT PLATE ELEVATION ALTERNATE PLUGGING CRITERION SUMMARY

DECEMBER 1991

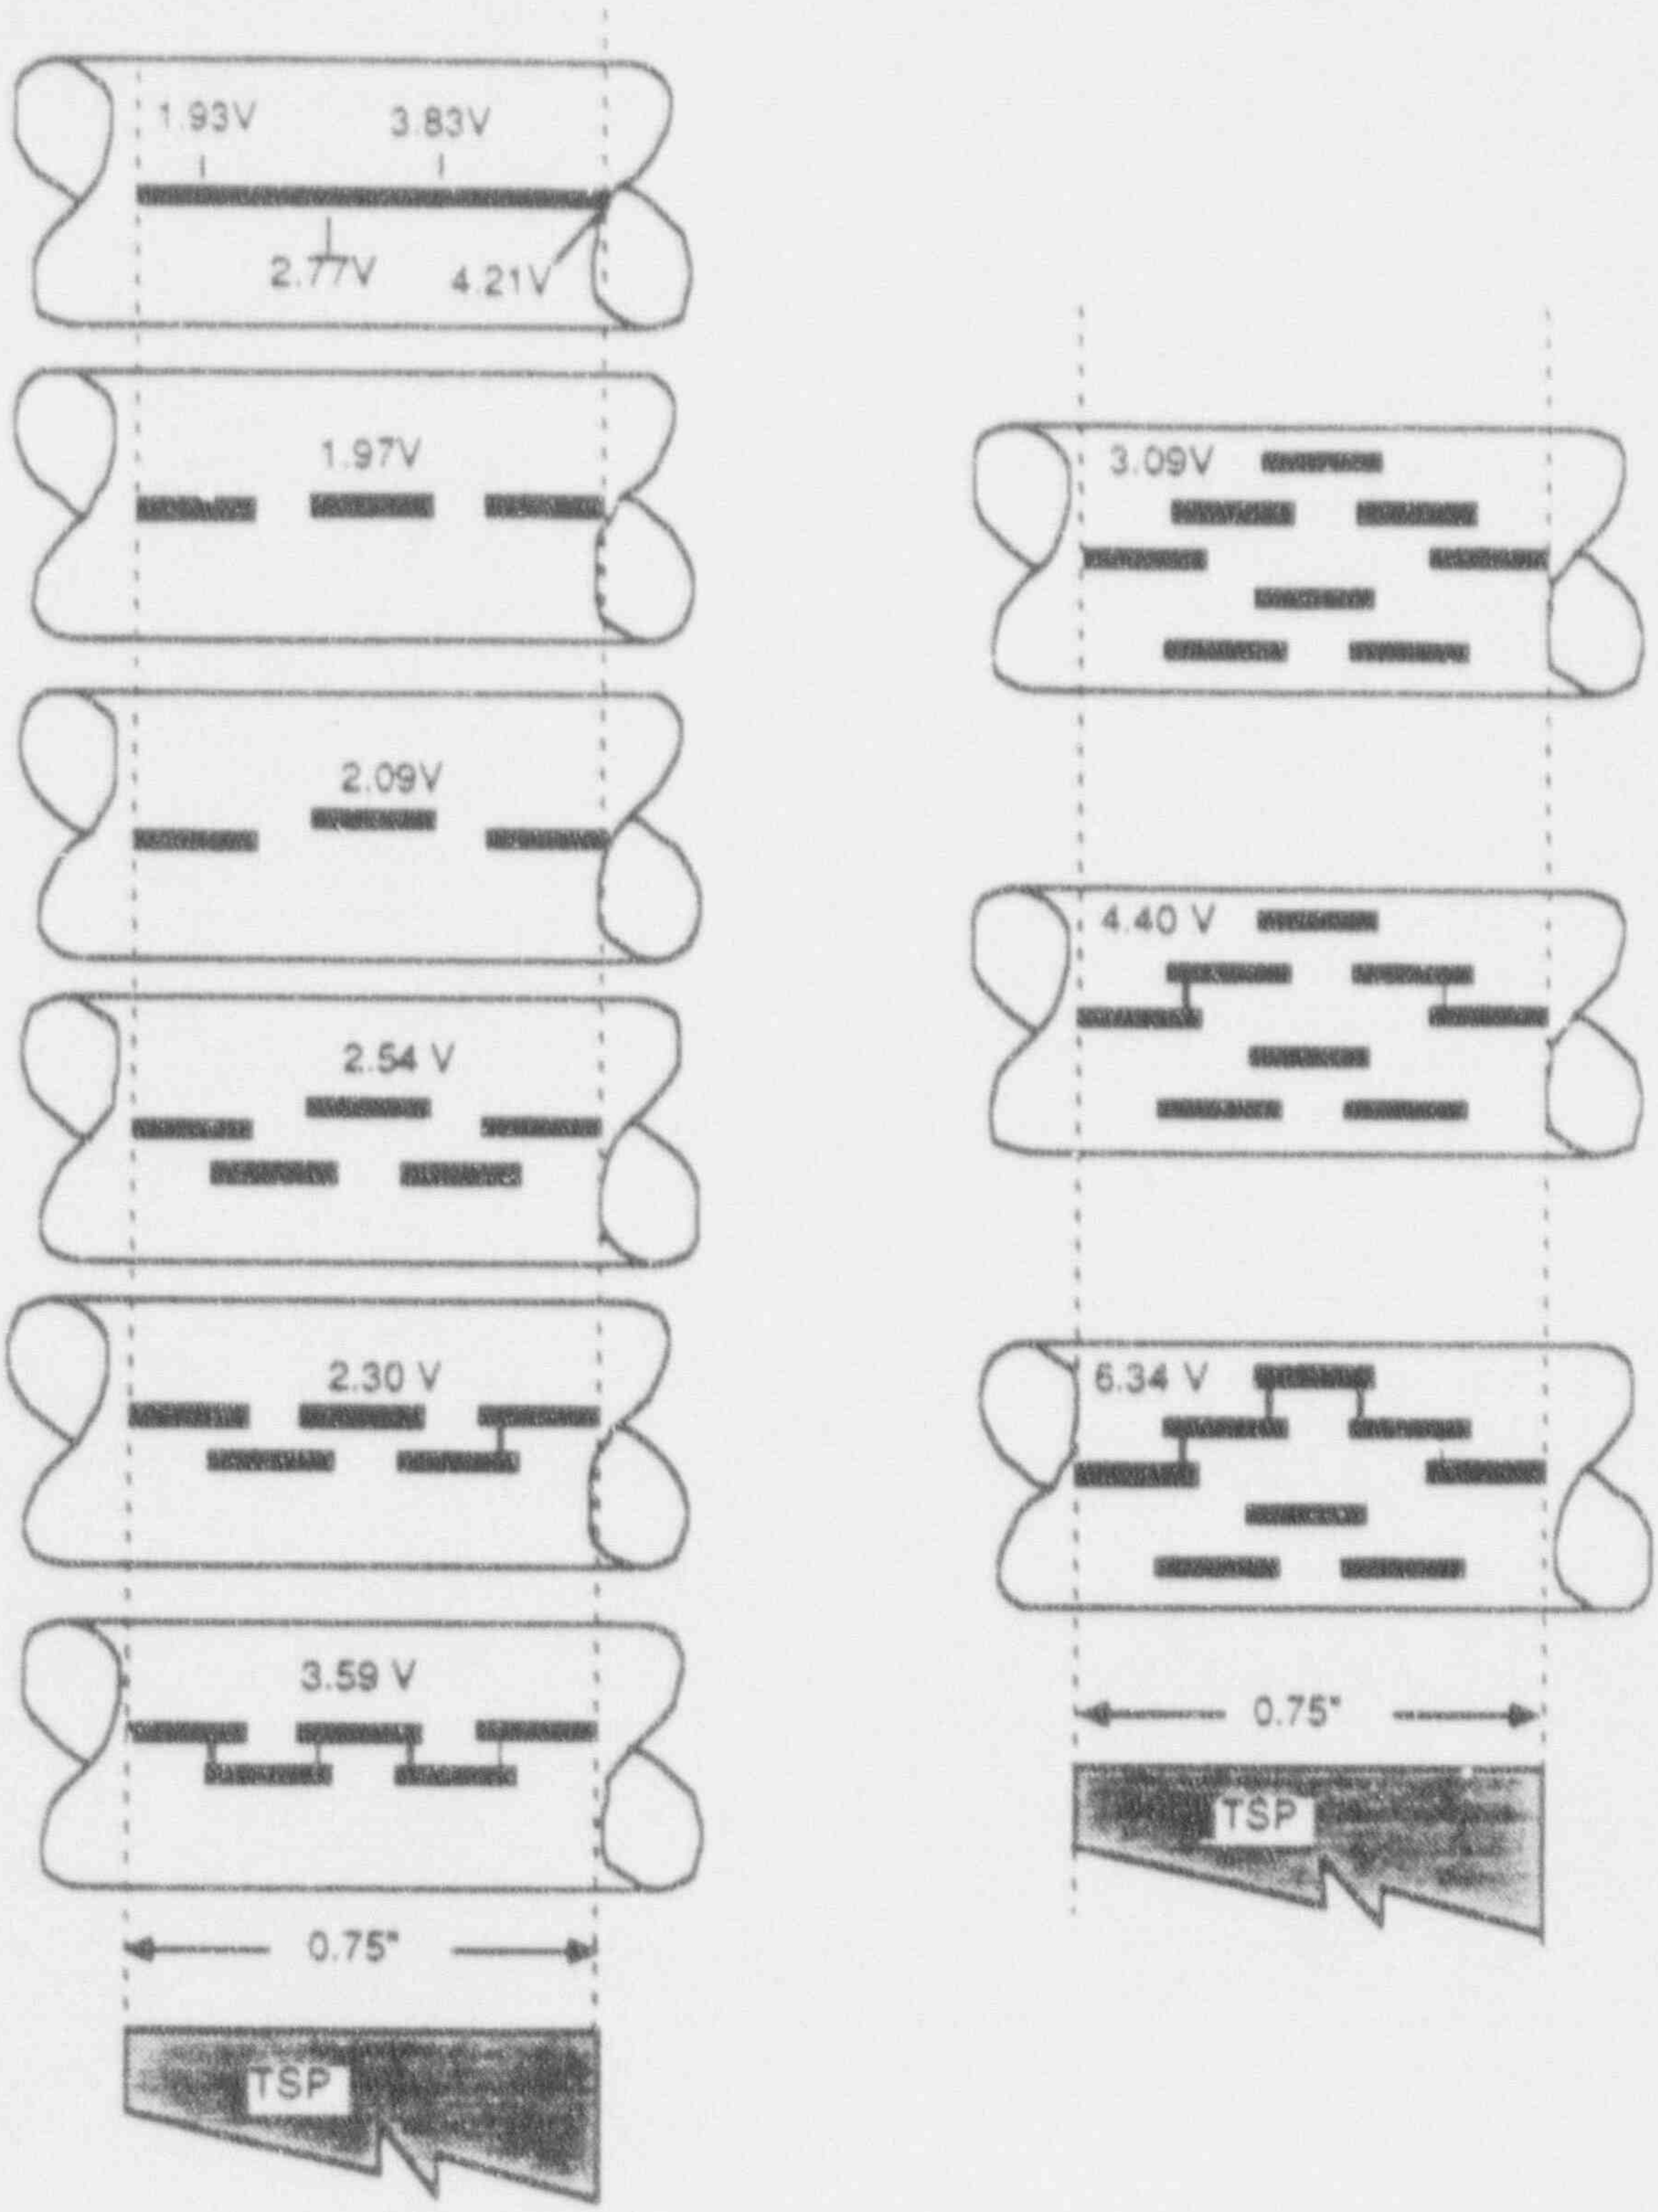
Figure 8-1

Voltage Sensitivity to Crack Network Morphology

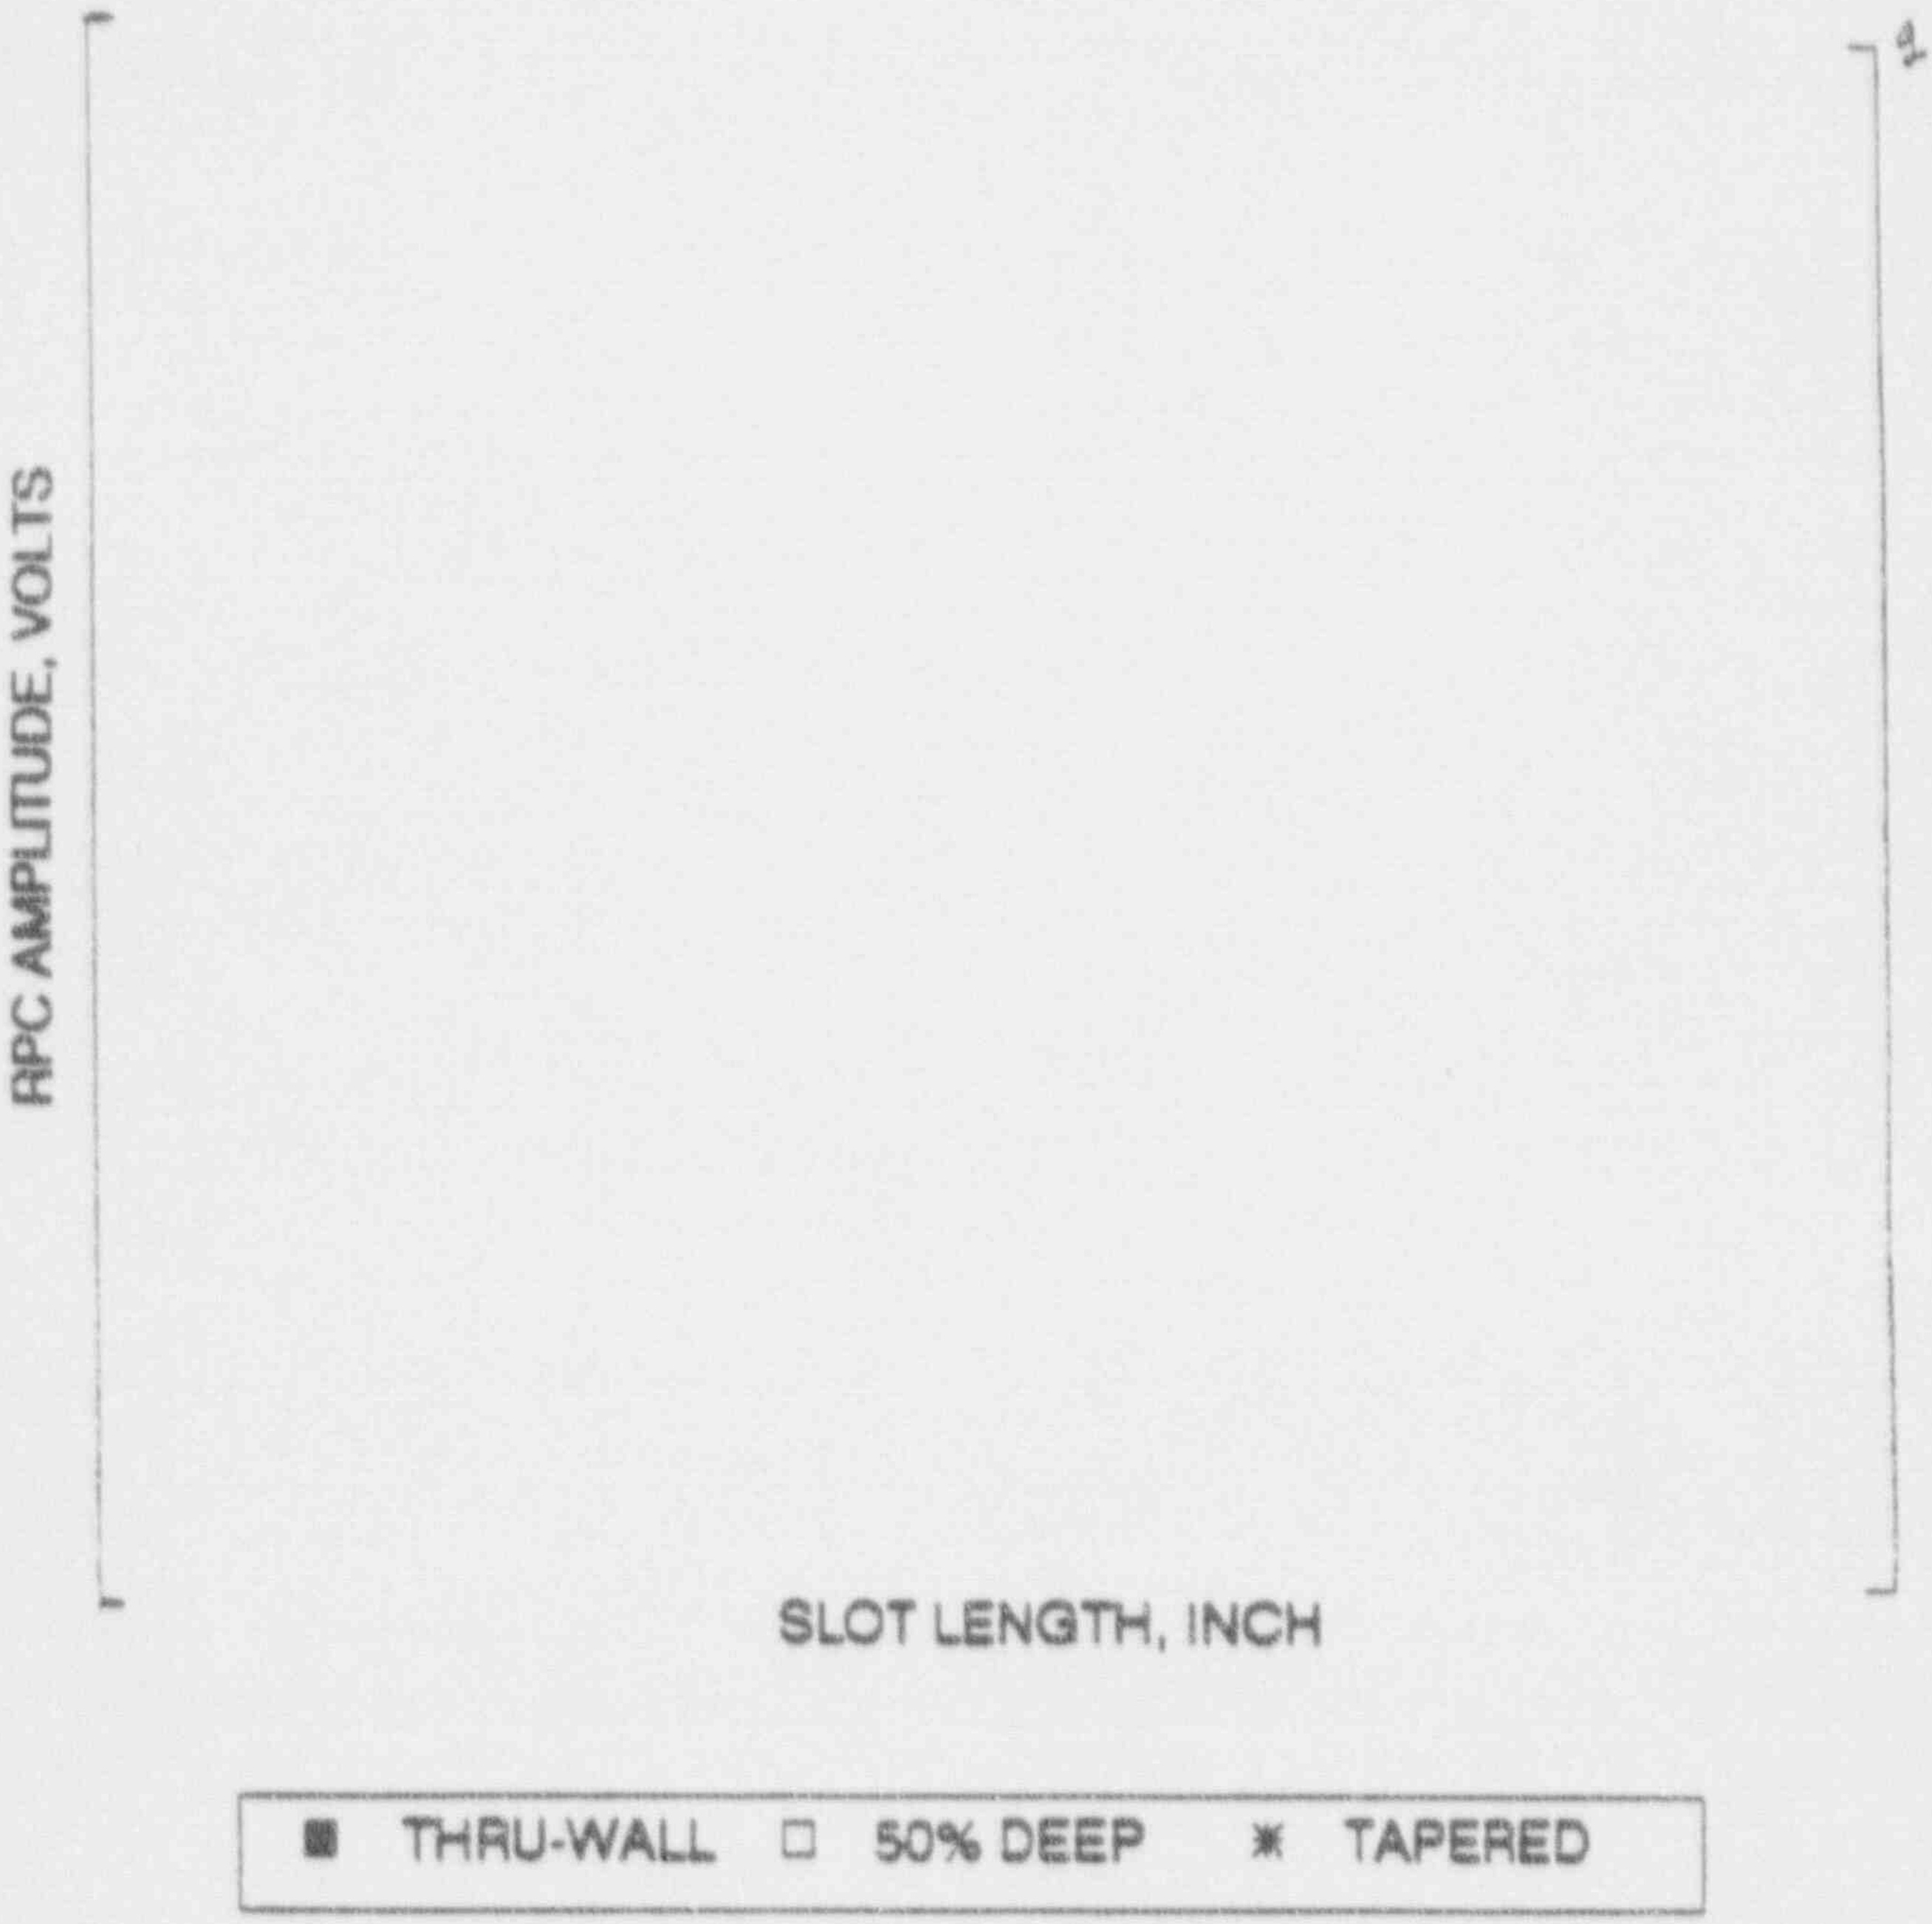
Figure 8-4

RPC Voltage Dependence on Slot Length and Depth

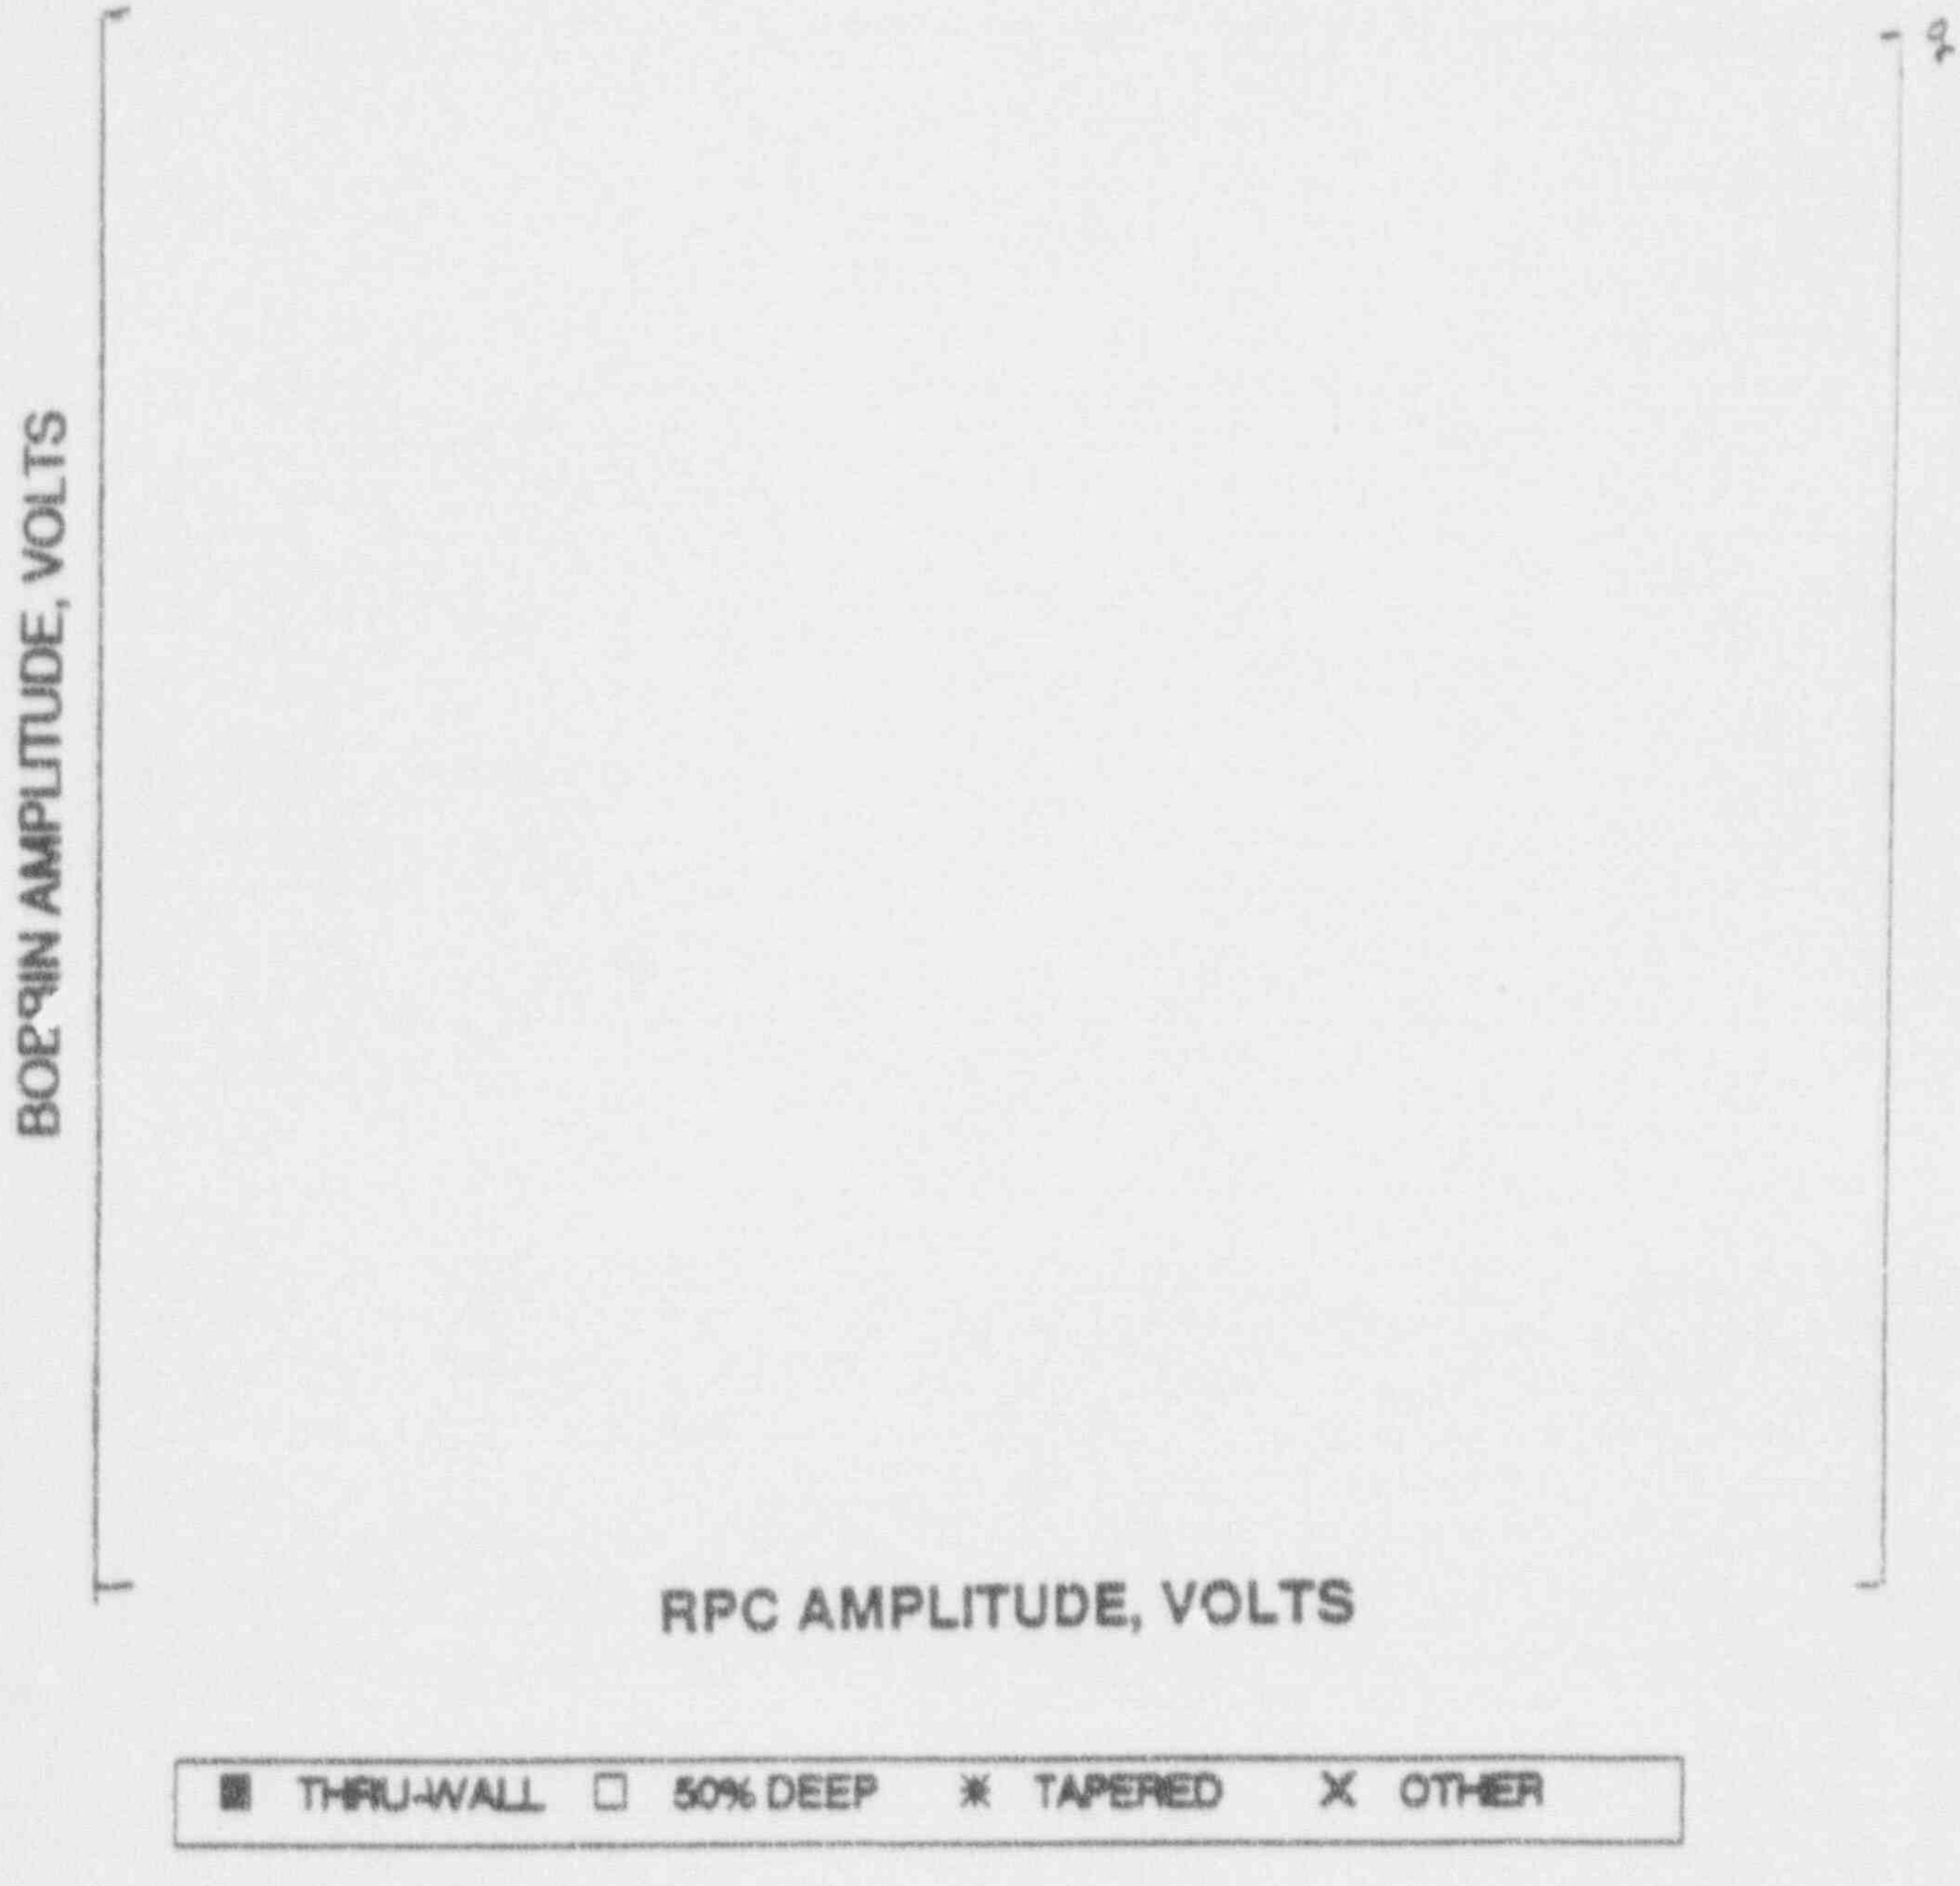
Figure 8-5

Correlation of Bobbin Coil to RPC Voltage

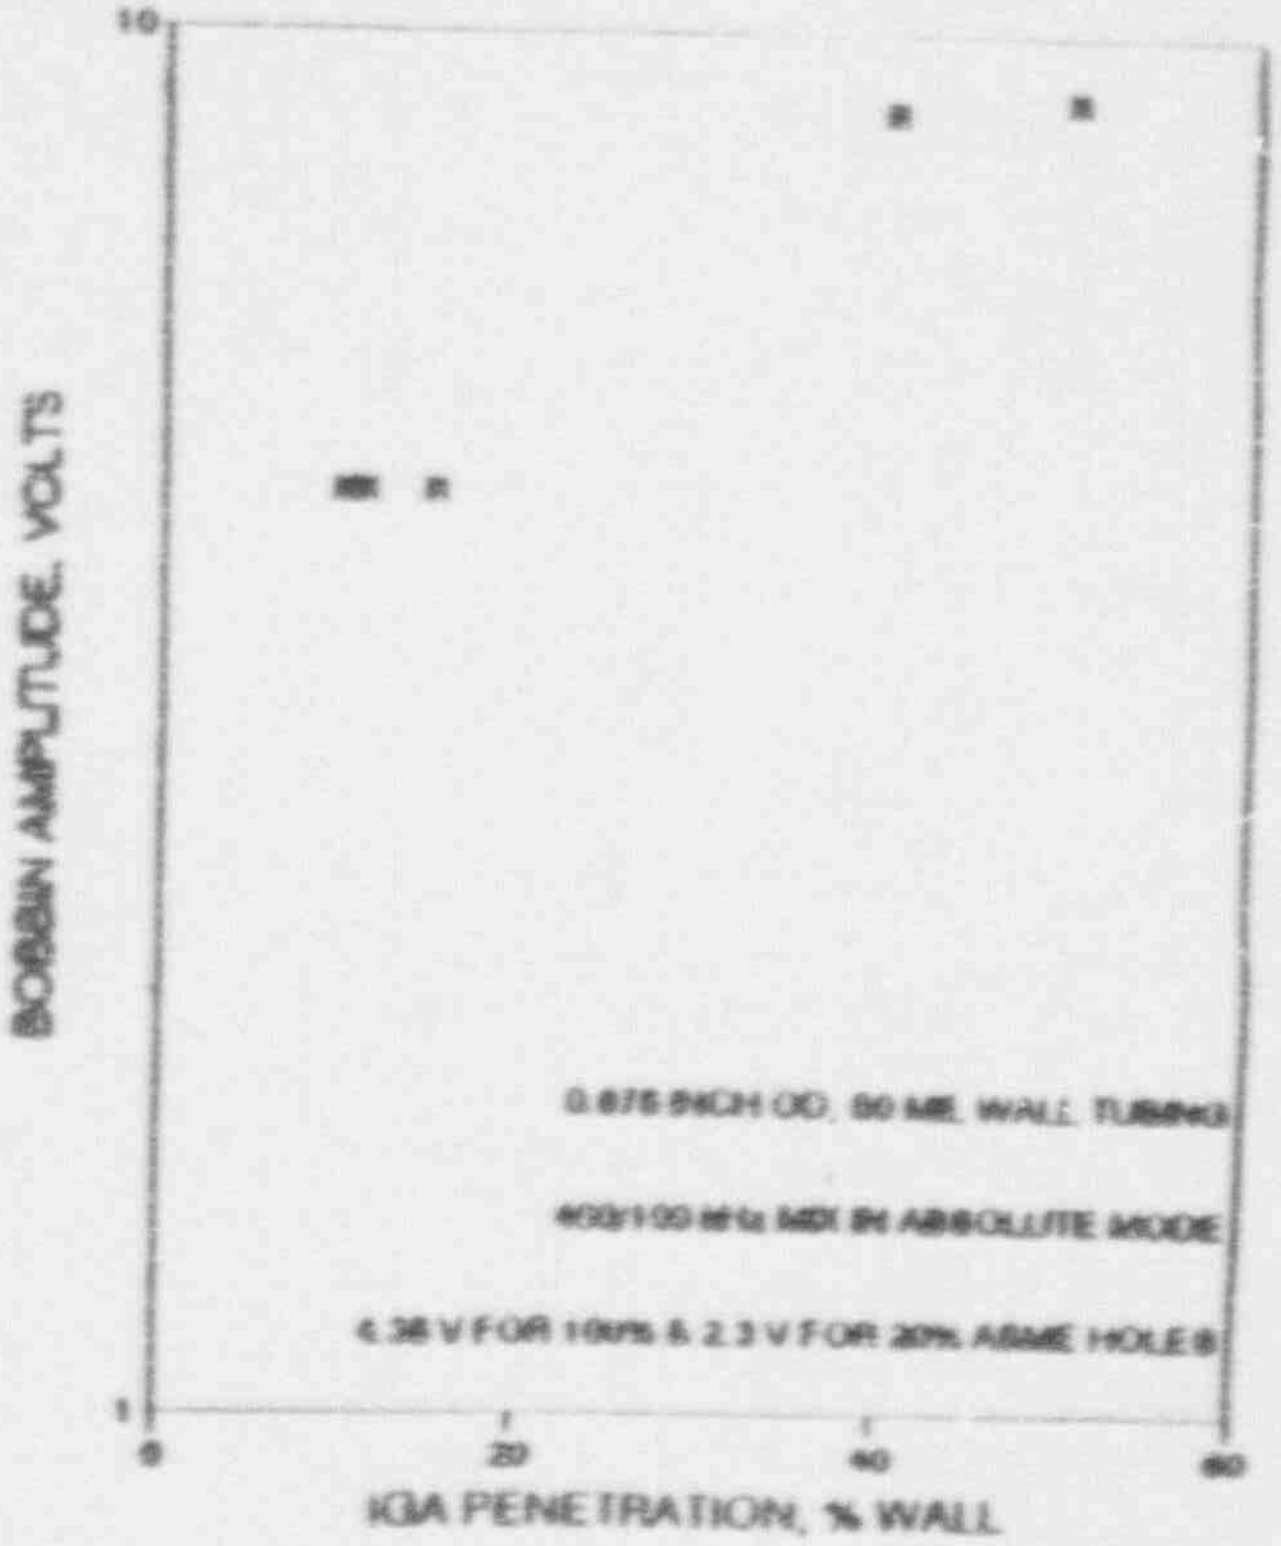
Figure 8-12b

Bobbin Data from Simulated IGA Specimens Using Non-Sensitized Alloy 600MA Tubing

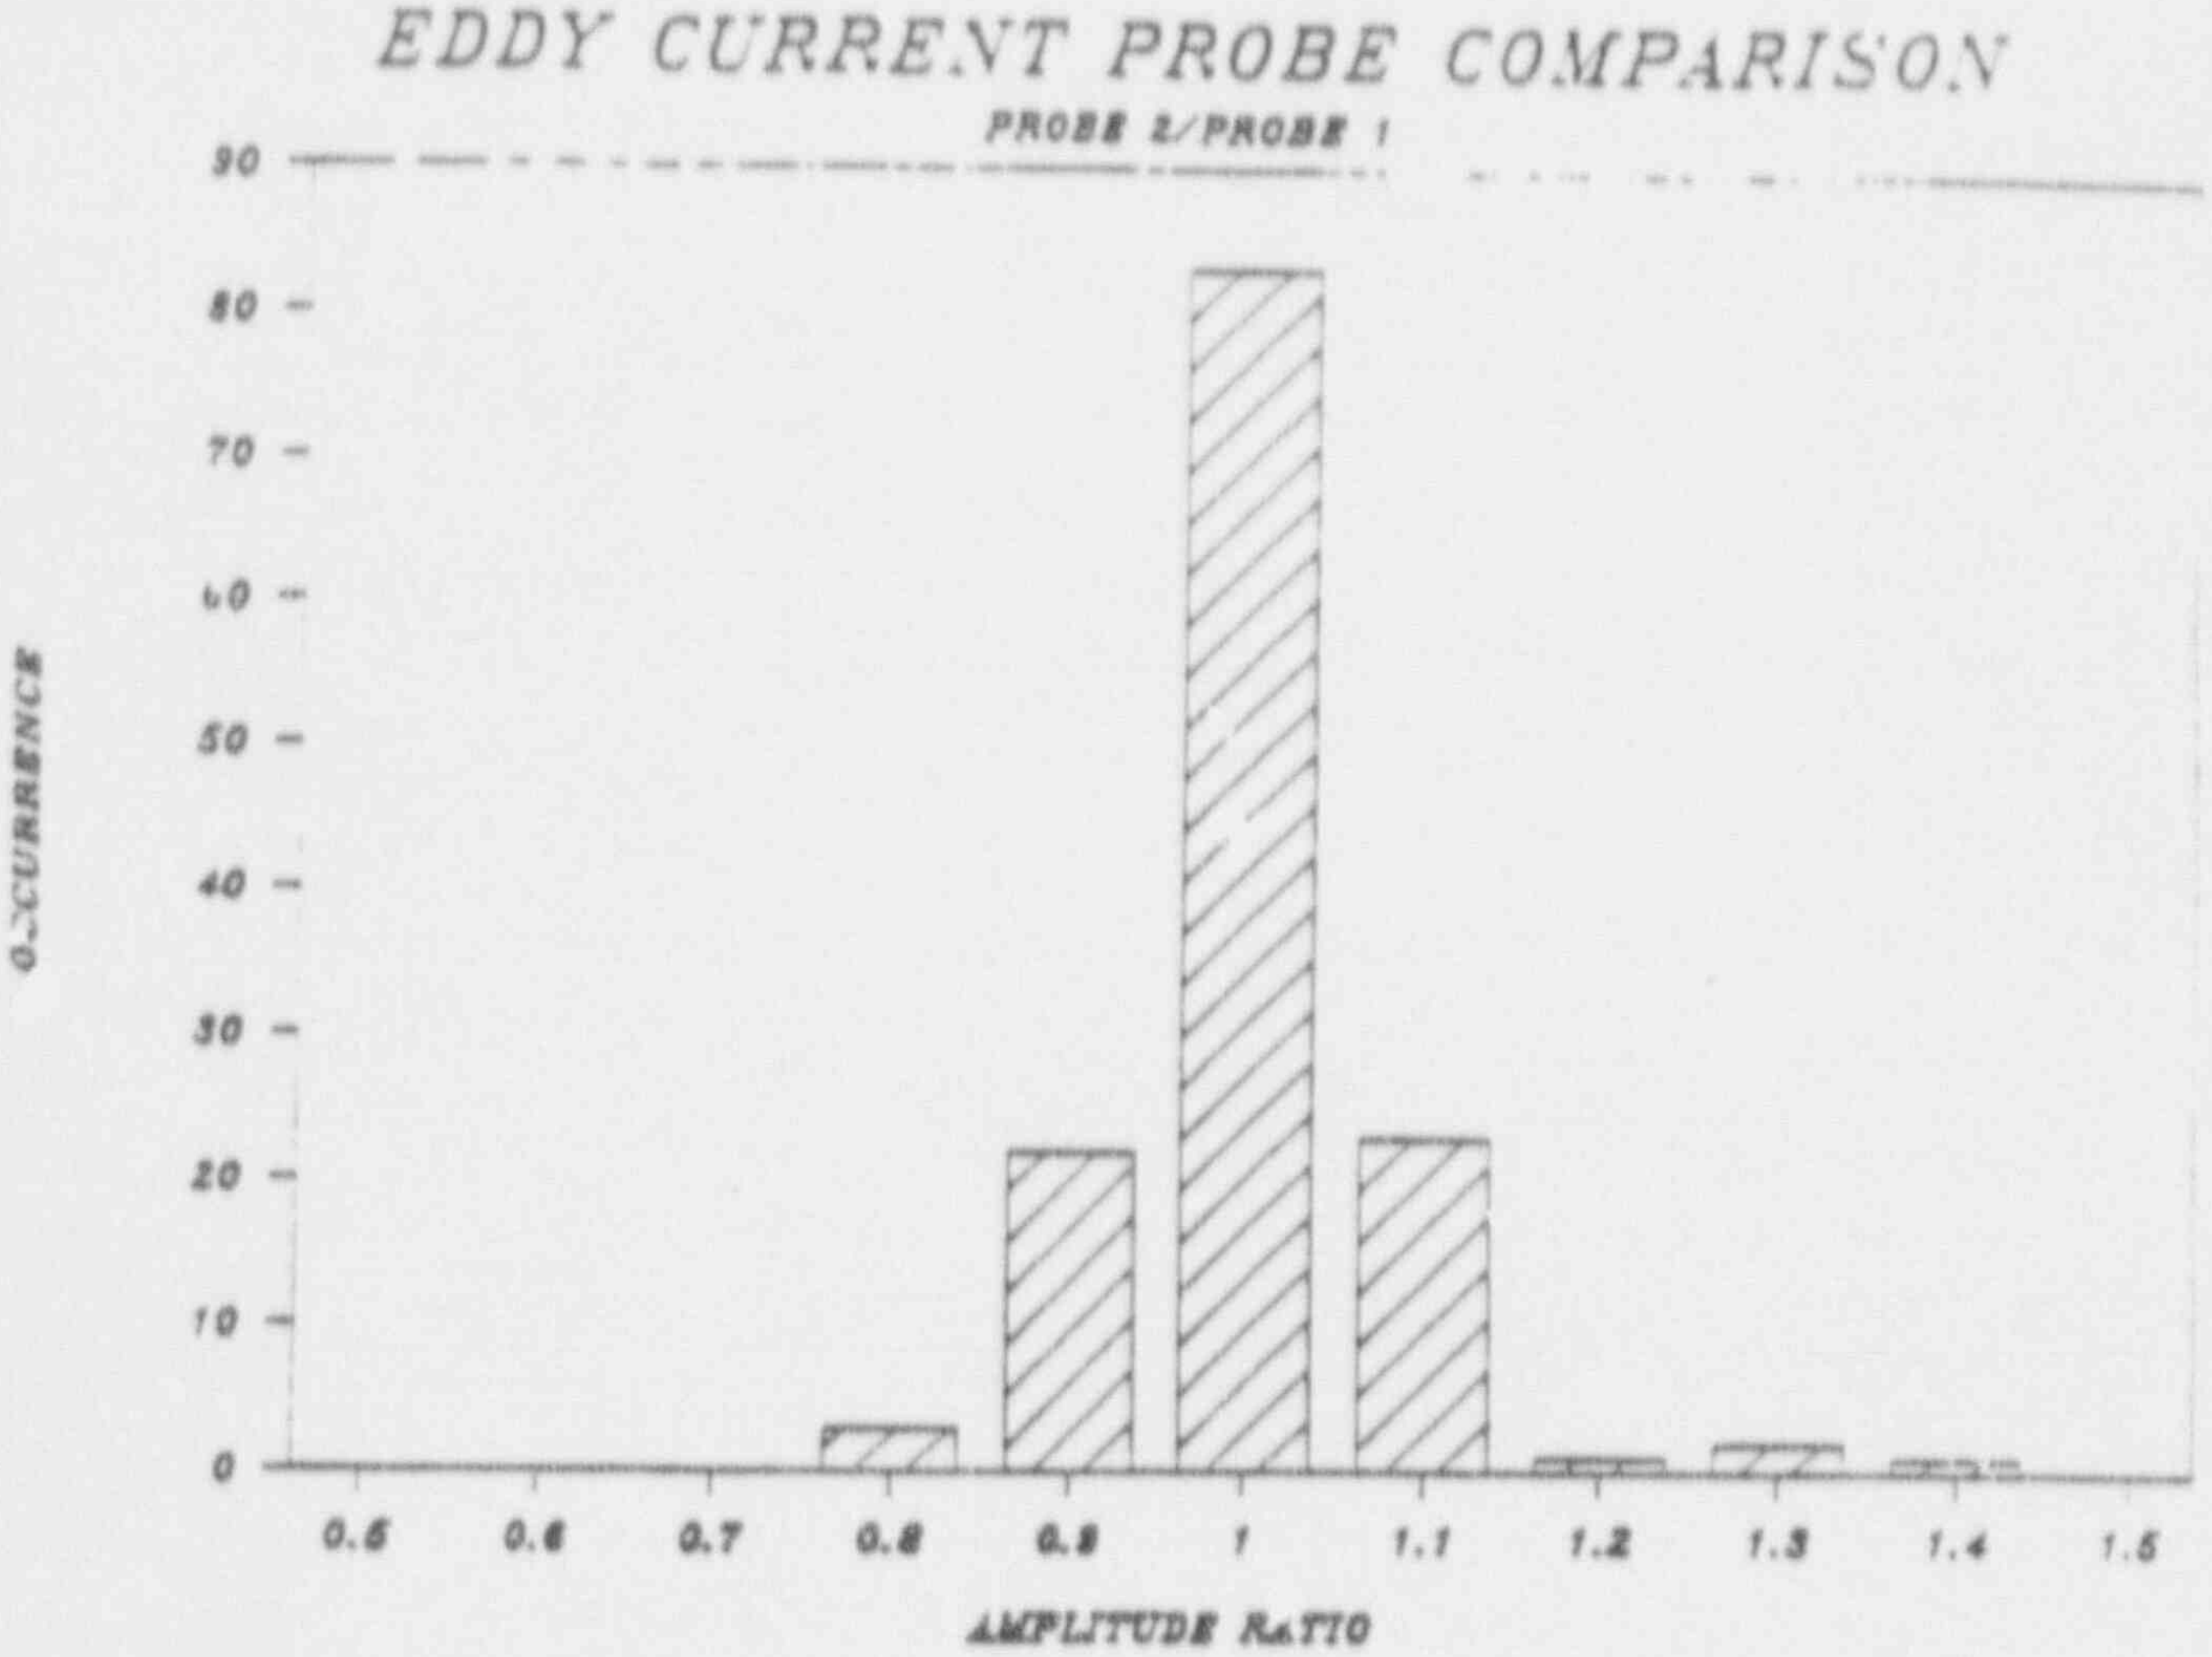
Figure 8-15

Comparison of 400/100 kHz Mix Amplitude Response from Two Probes (Model Boiler Sample)

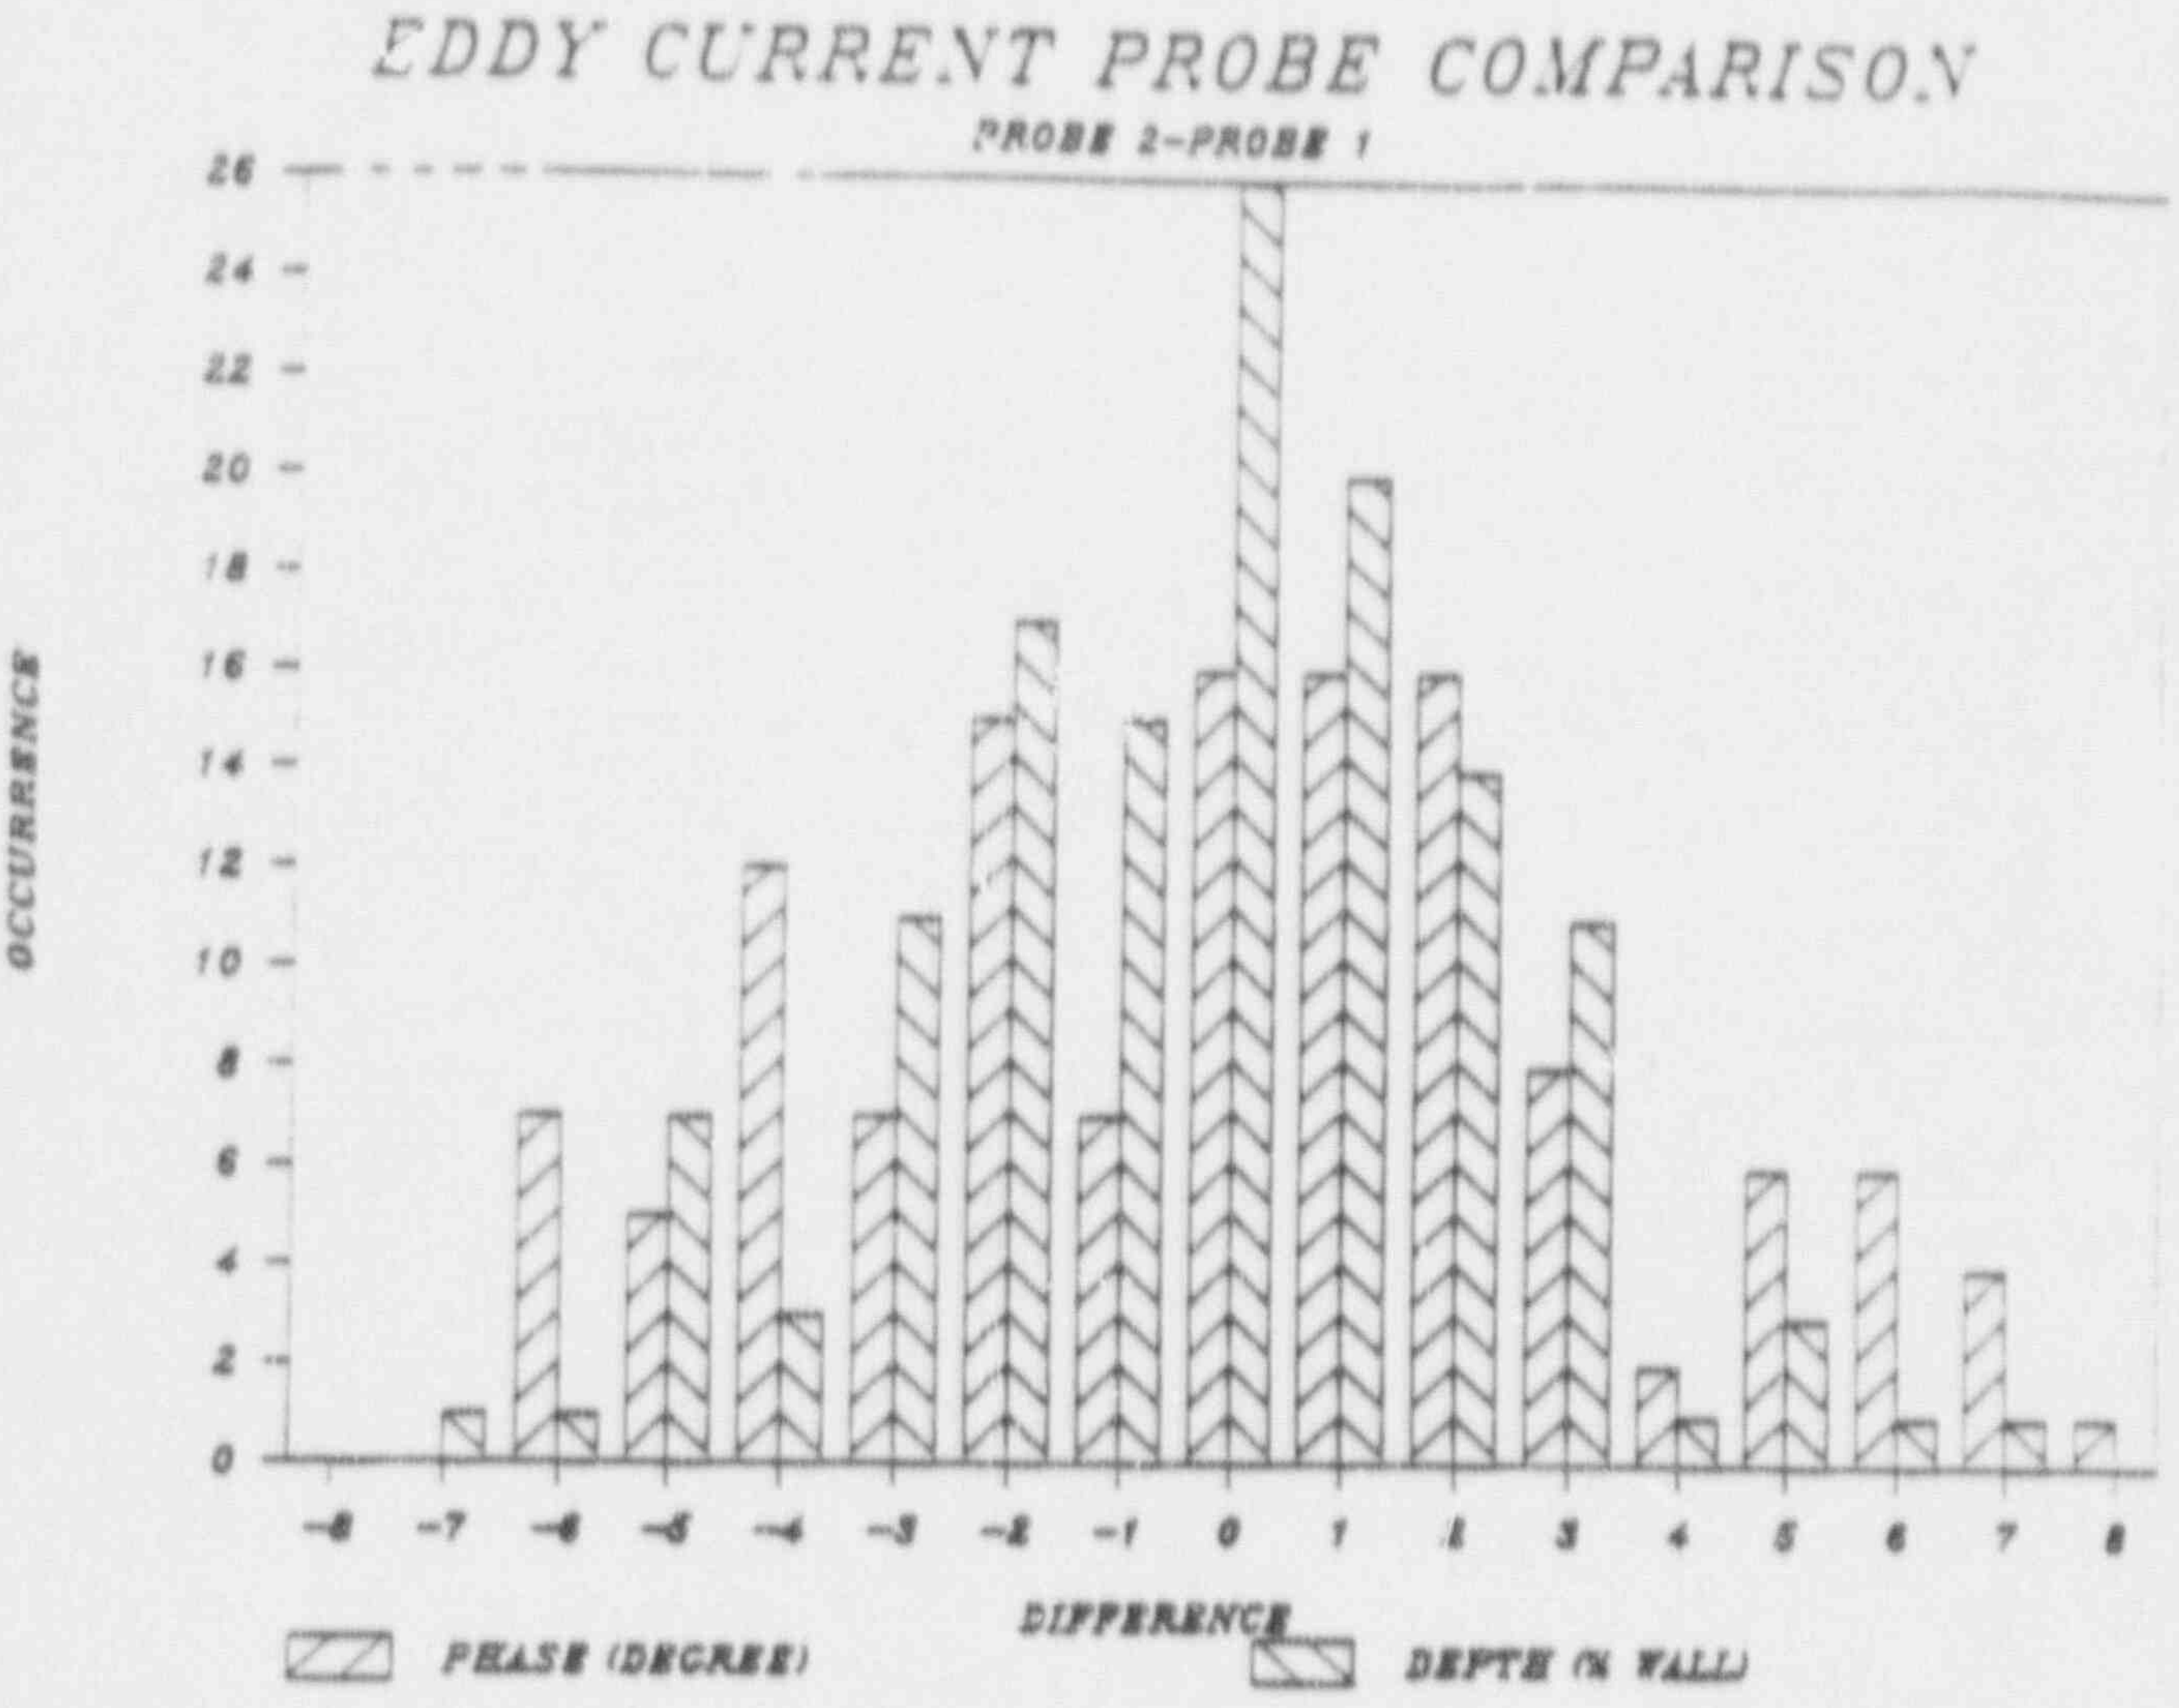
Figure 6-16

Comparison of 400/100 kHz Mix Phase Response form Two Probes (Model Boiler Sample)
