WCAP-13139

FARLEY UNITS 1 AND 2

STEAM GENERATOR TUBE/ TUBE SUPPORT PLATE ELEVATION ALTERNATE PLUGGING CRITERION SUMMARY

DECEMBER 1991

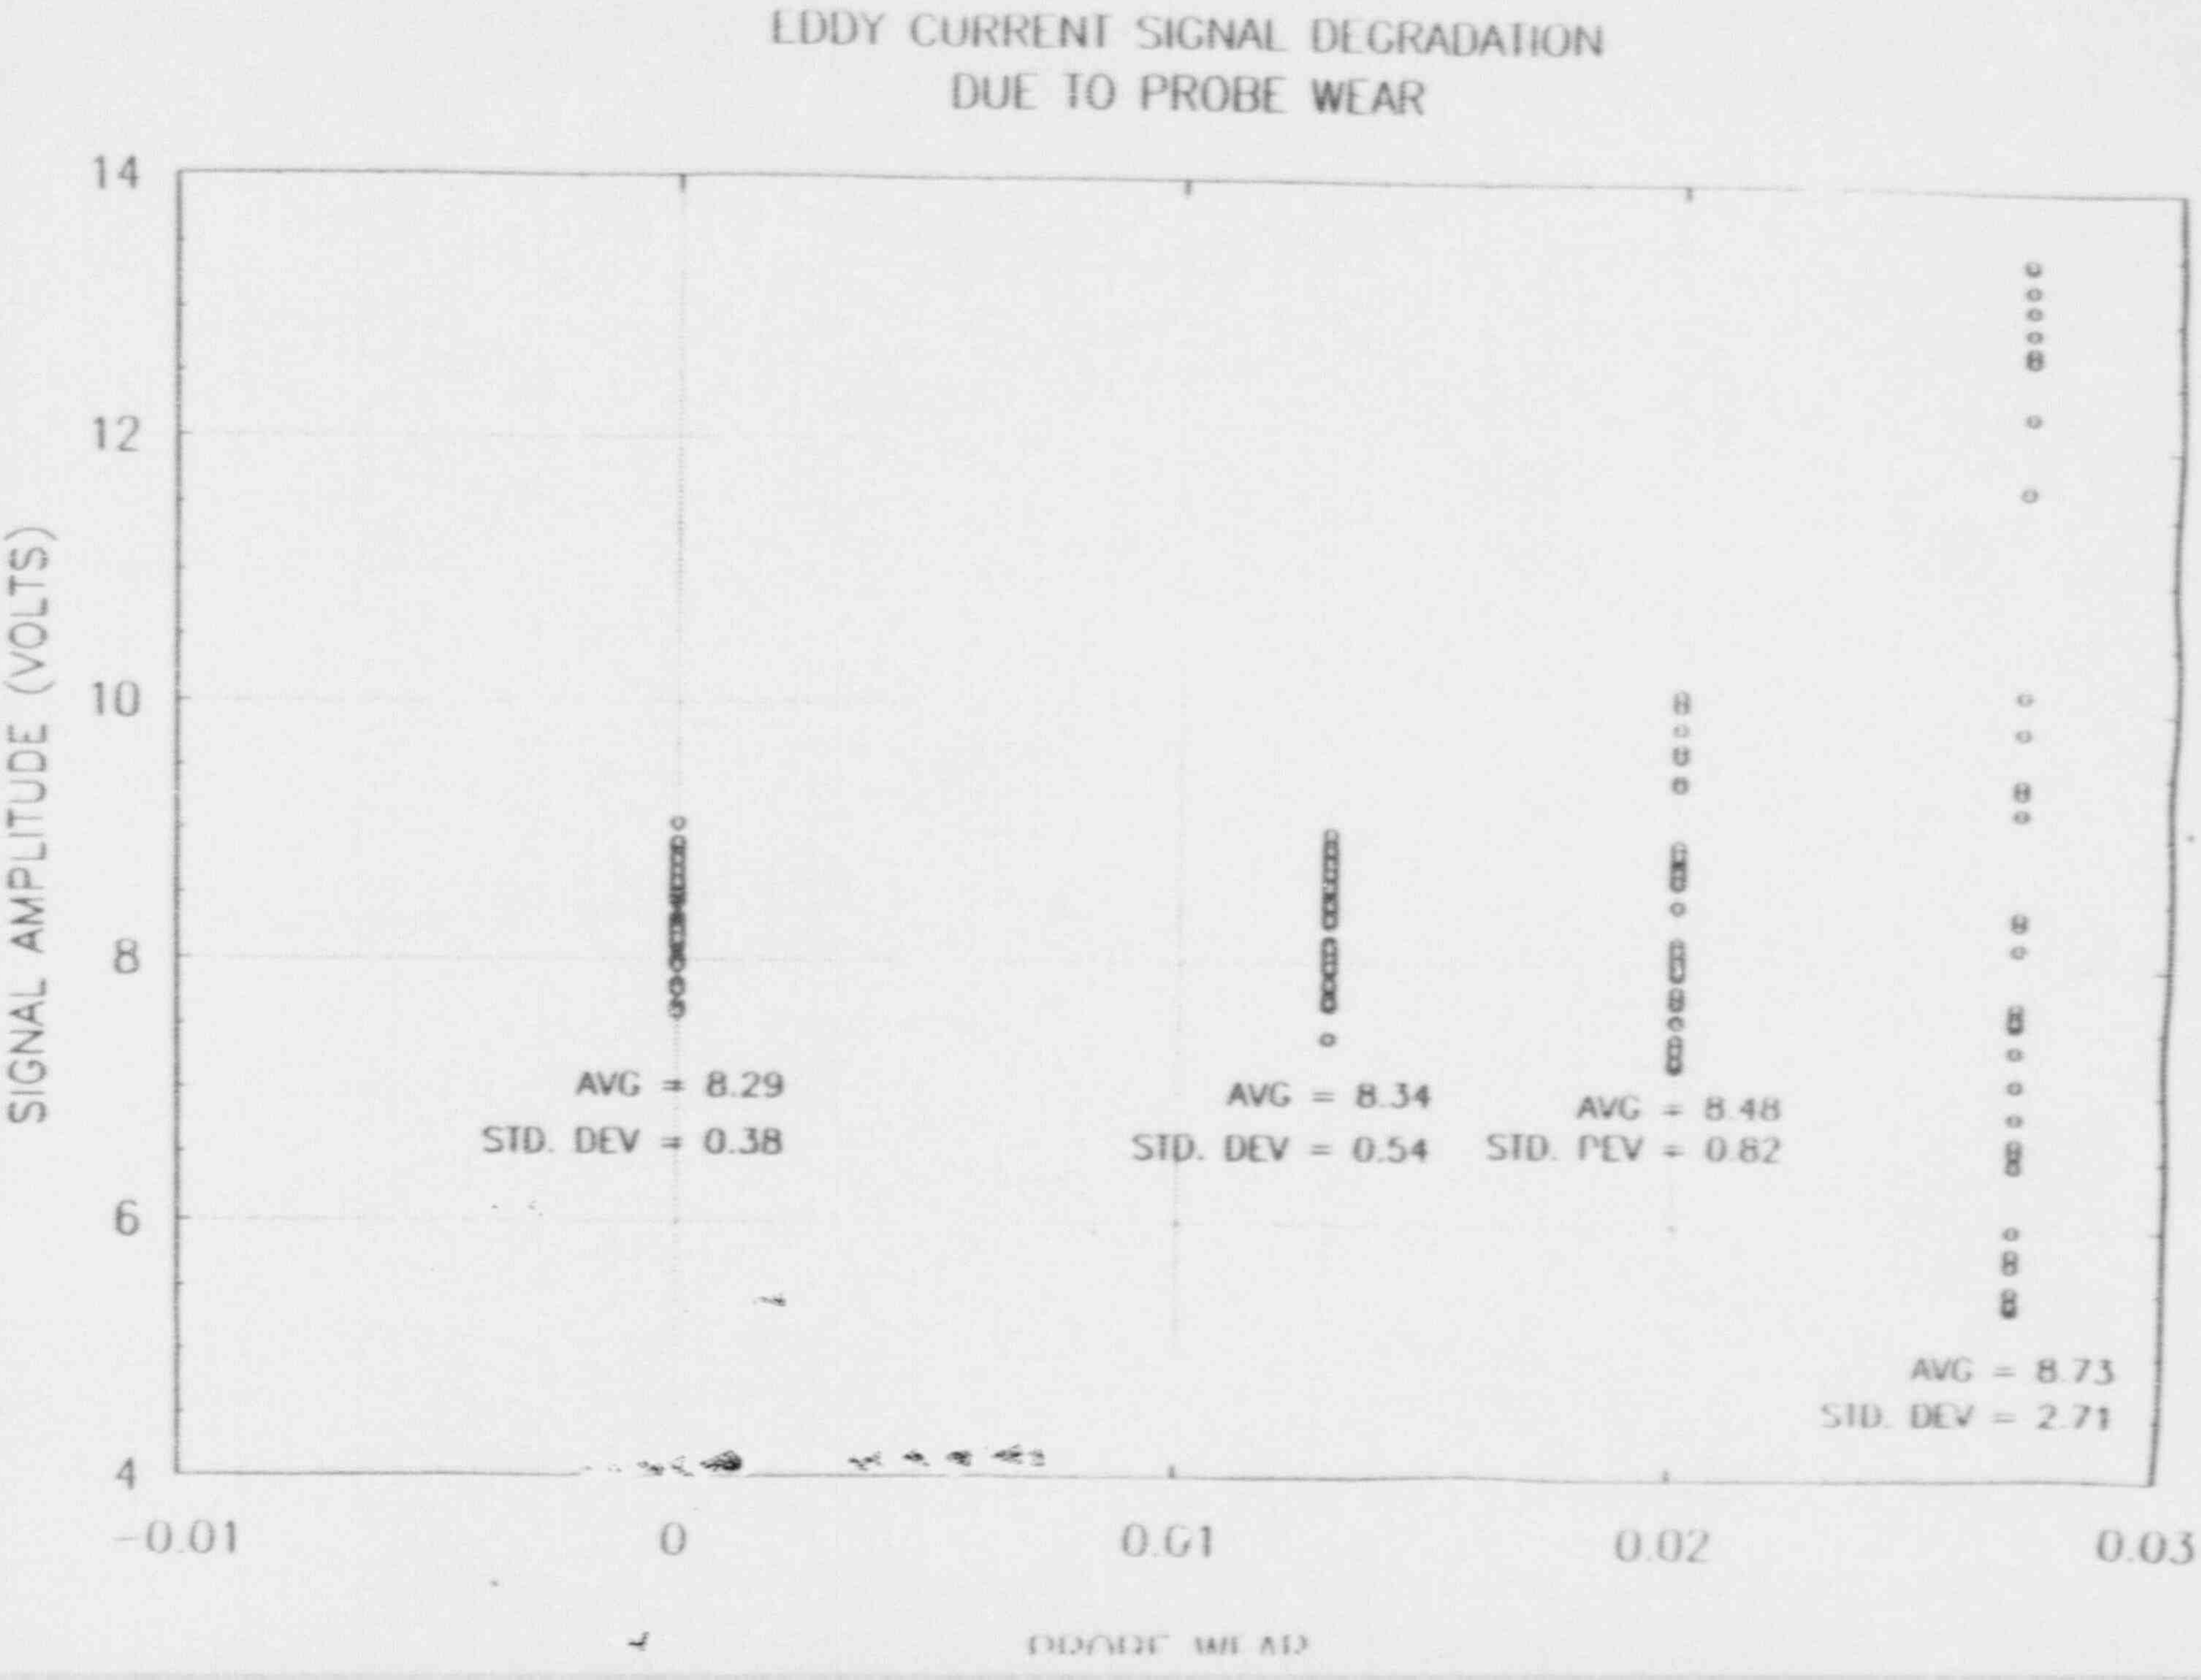
EDDY CURRENT SIGNAL DEGRADATION
DUE TO PROBE WEAR
SIGNAL AMPLITUDE (VOLTS)
14
12
10
8
6
4
AVG = 8.29
STD. DEV = 0.38
AVG = 8.34
STD. DEV = 0.54
AVG = 8.48
STD. PEV = 0.82
AVG = 8.73
STD. DEV = 2.71
-0.01
0
0.01
0.02
0.03
PROBE WEAR

6 Probe centering characteristics, related to probe wear, can contribute to uncertainty of eddy current signal.

2 Additional standard should be used in line with ASME standard to limit effect of probe wear (i.e. probe centering) on field data. This standard will highlight data uncertainties from probe wear, identifying when variation exceeds acceptable limits for tube plugging criteria, requiring use of new probe

1. Minimized in the field during APC implementation by use of a 4-hole probe wear standard.

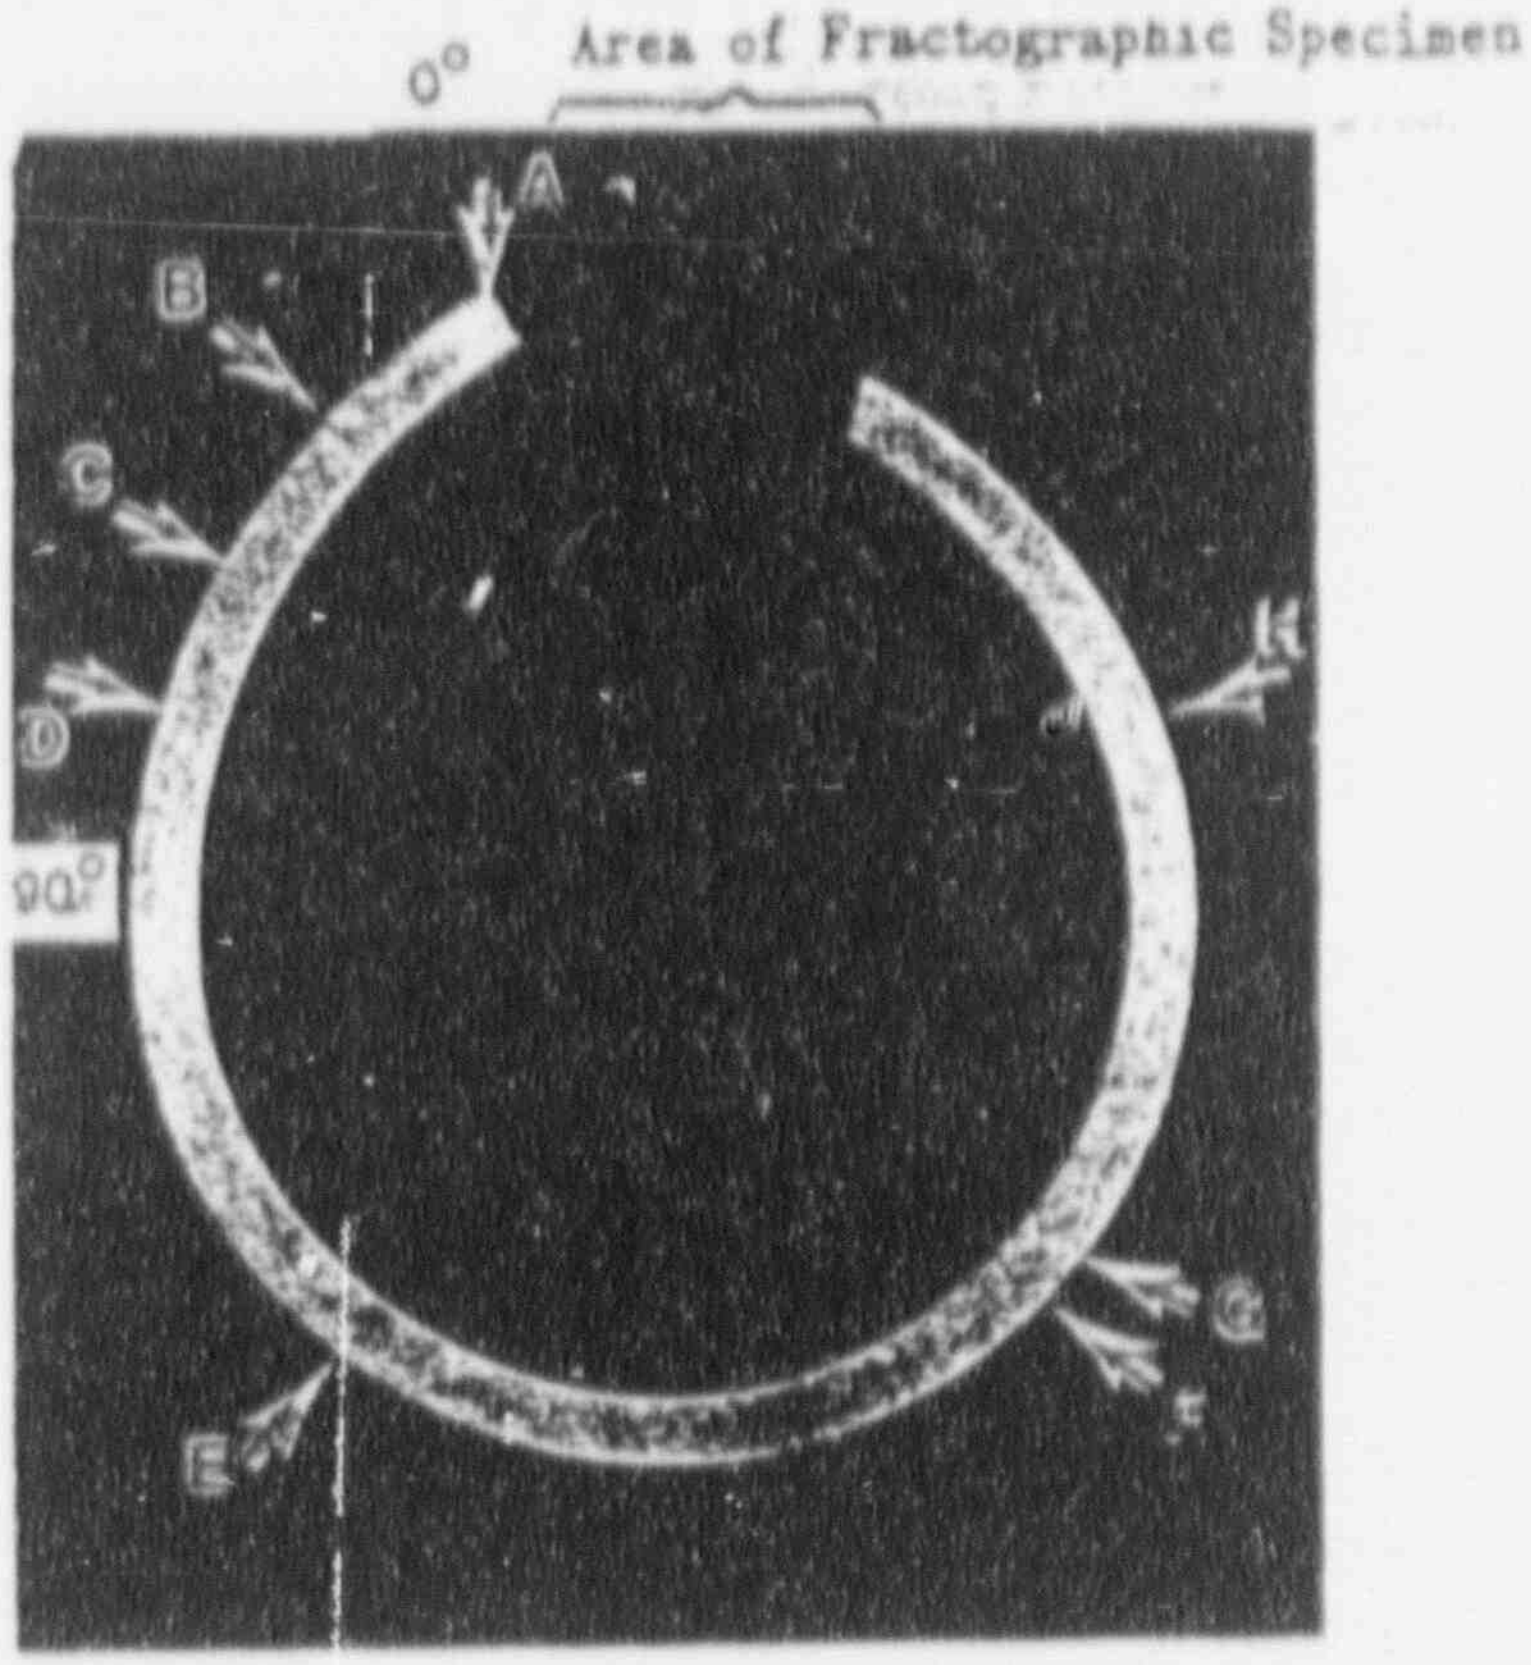
Figure 4-5. Metallographic cross section through center of the first support plate intersection of Tube R4-C73. Locations examined are indicated by Area A through H. Area A is shown in the lower photomicrograph.

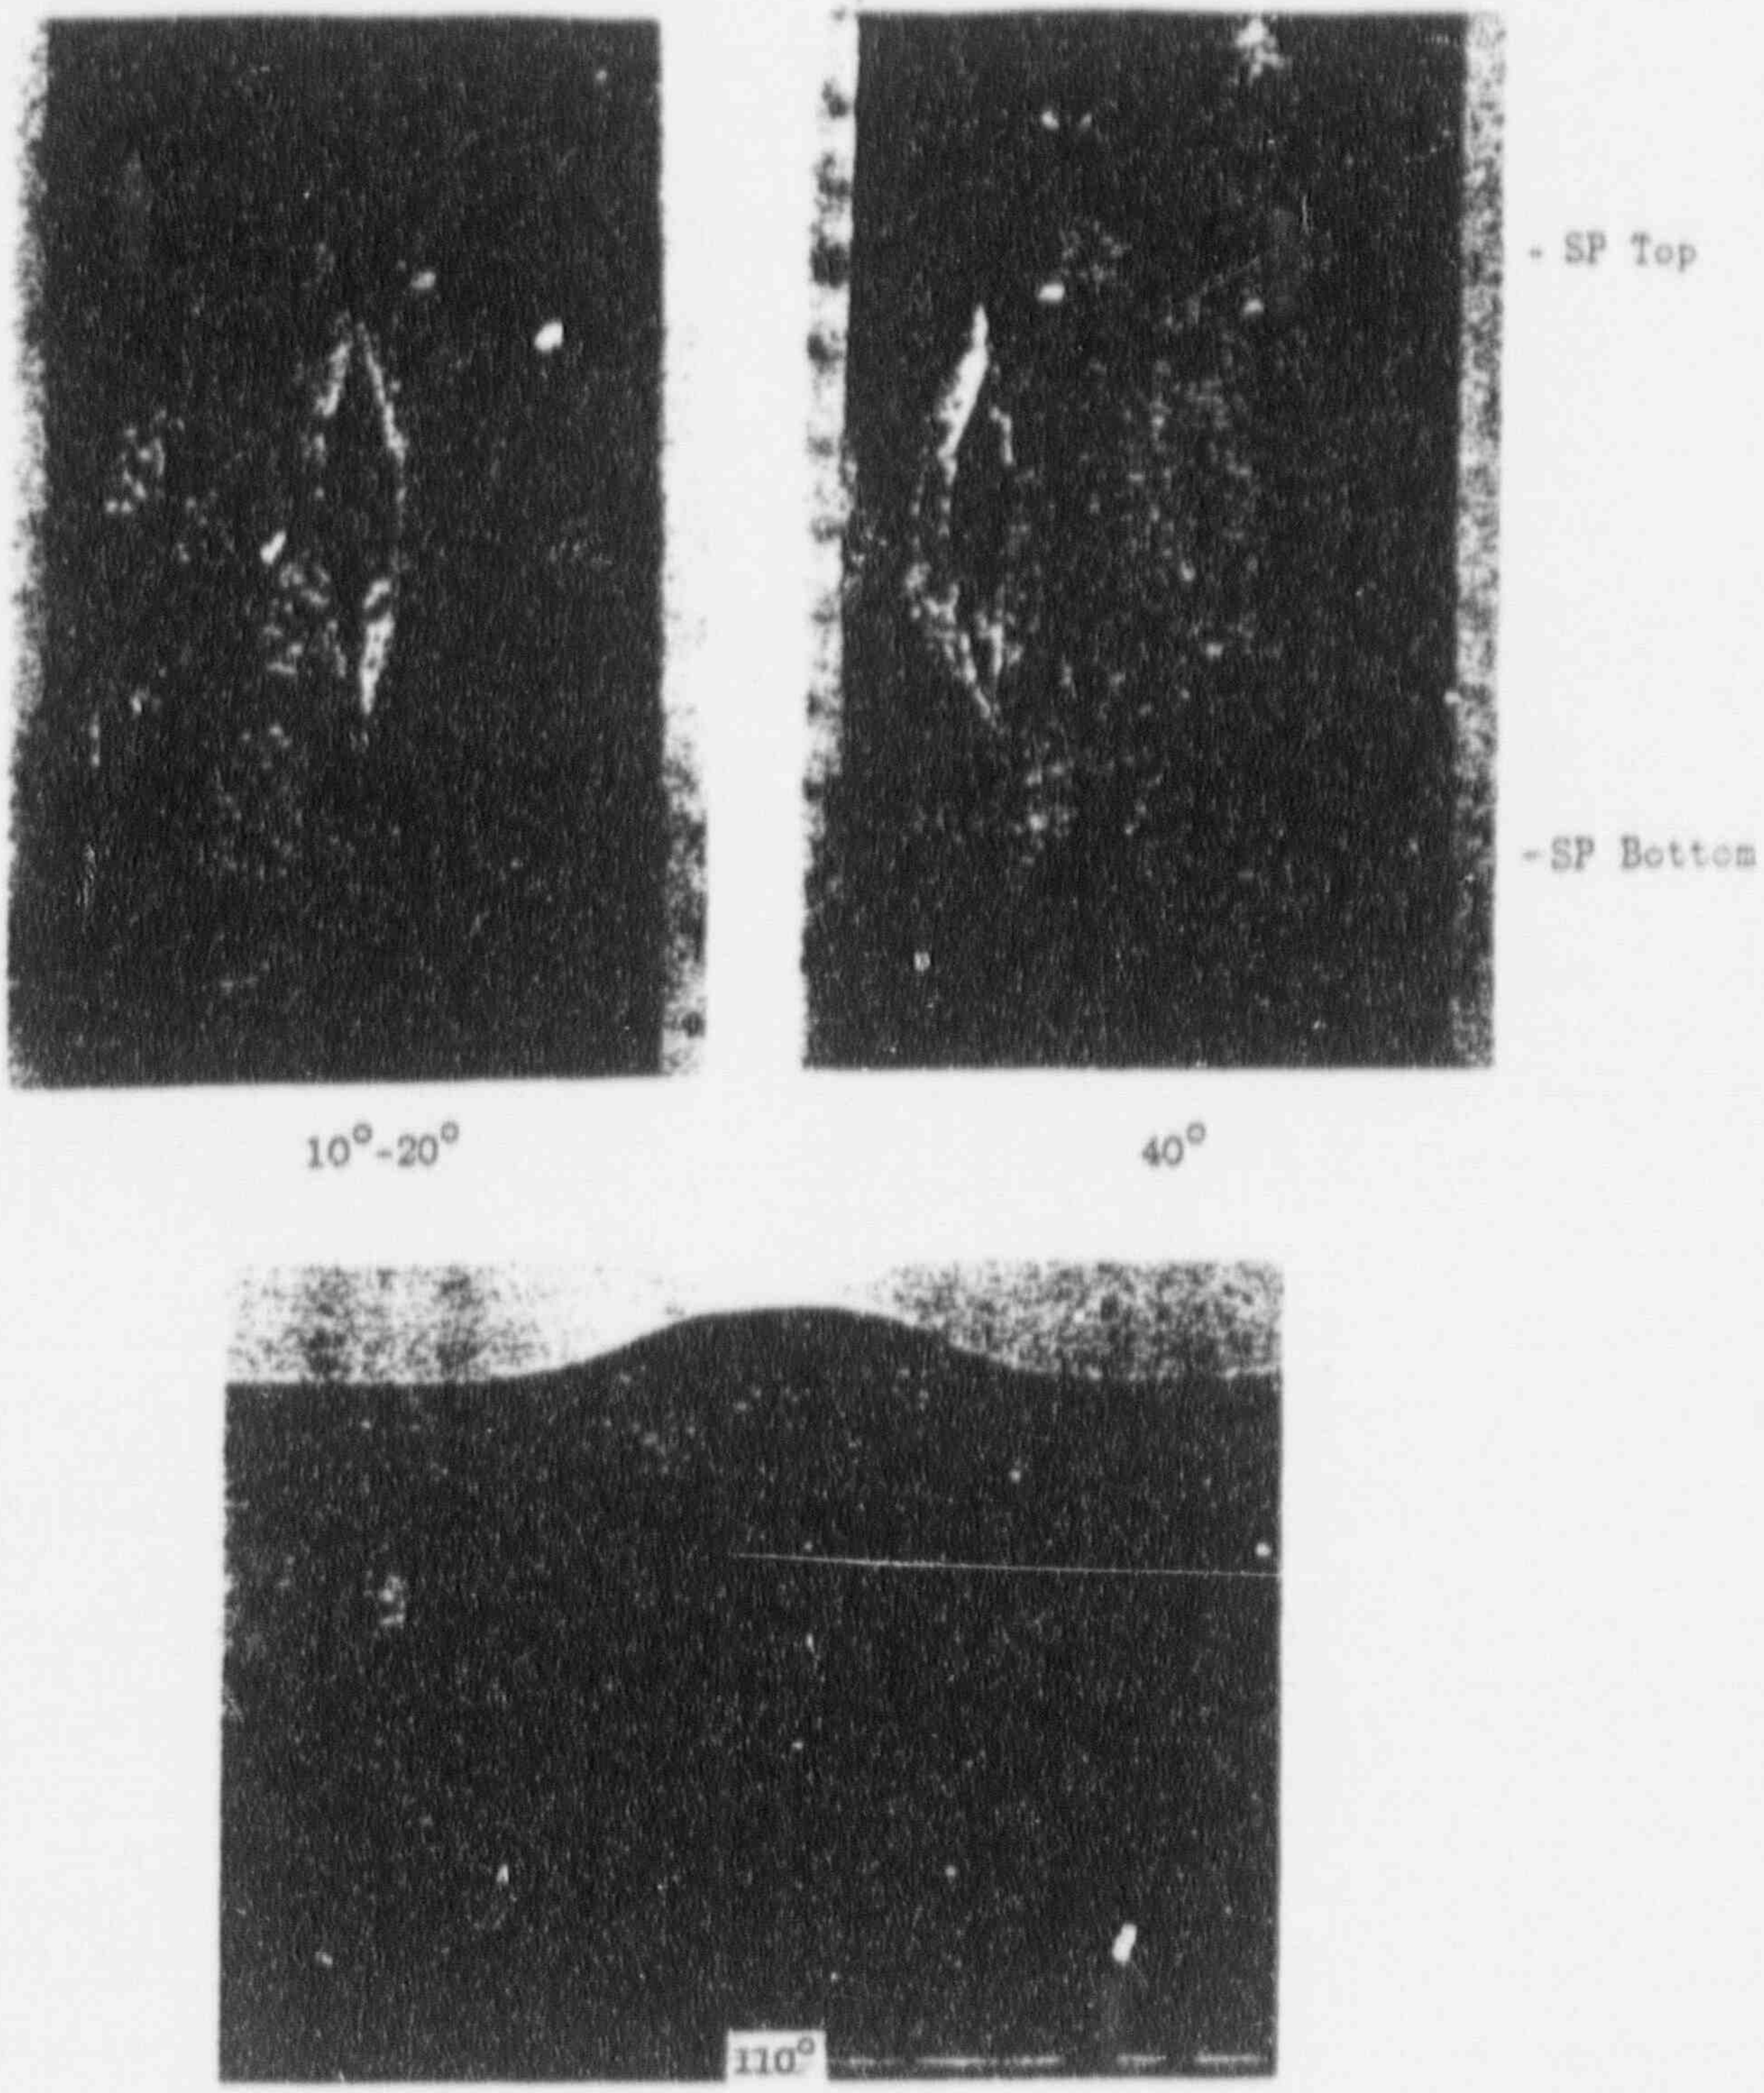
Figure 4-16. Sketch of crack distribution and depth within the center of the first support plate intersection in Tube R4-73.

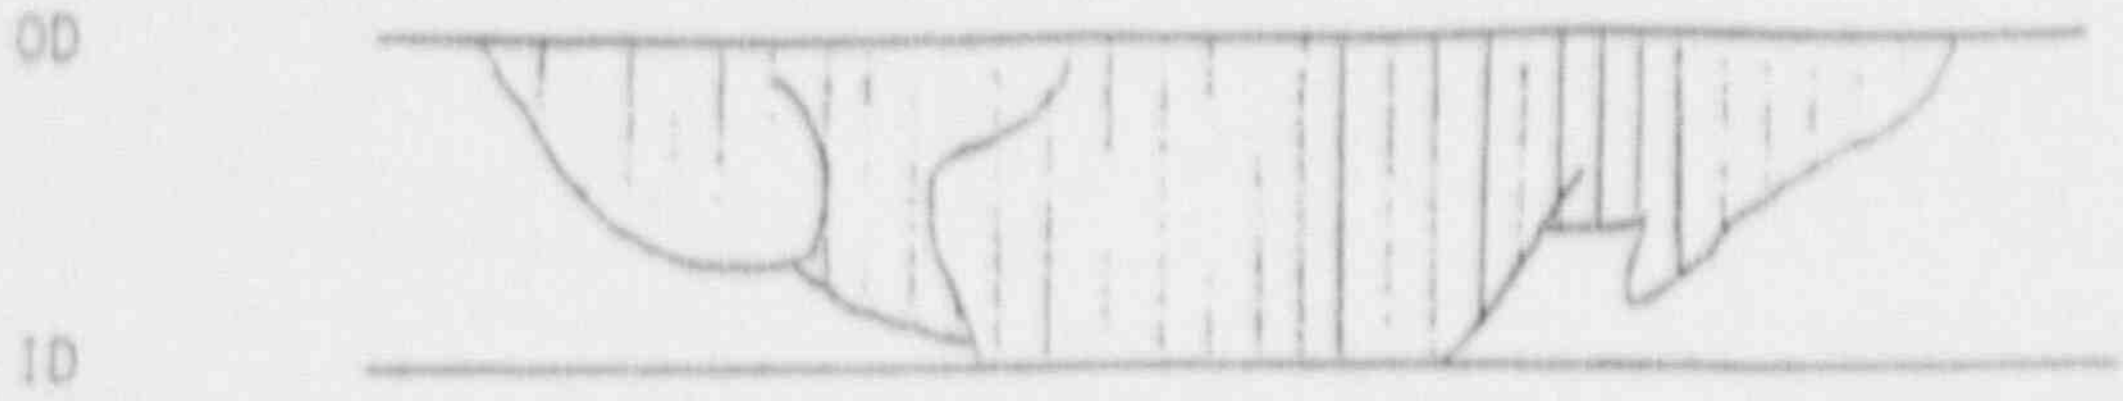
Macrocrack Length = 0.42 inches

Figure 4-4. Description of OD origin corrosion at the first support plate crevice region of Tube R4-C73.

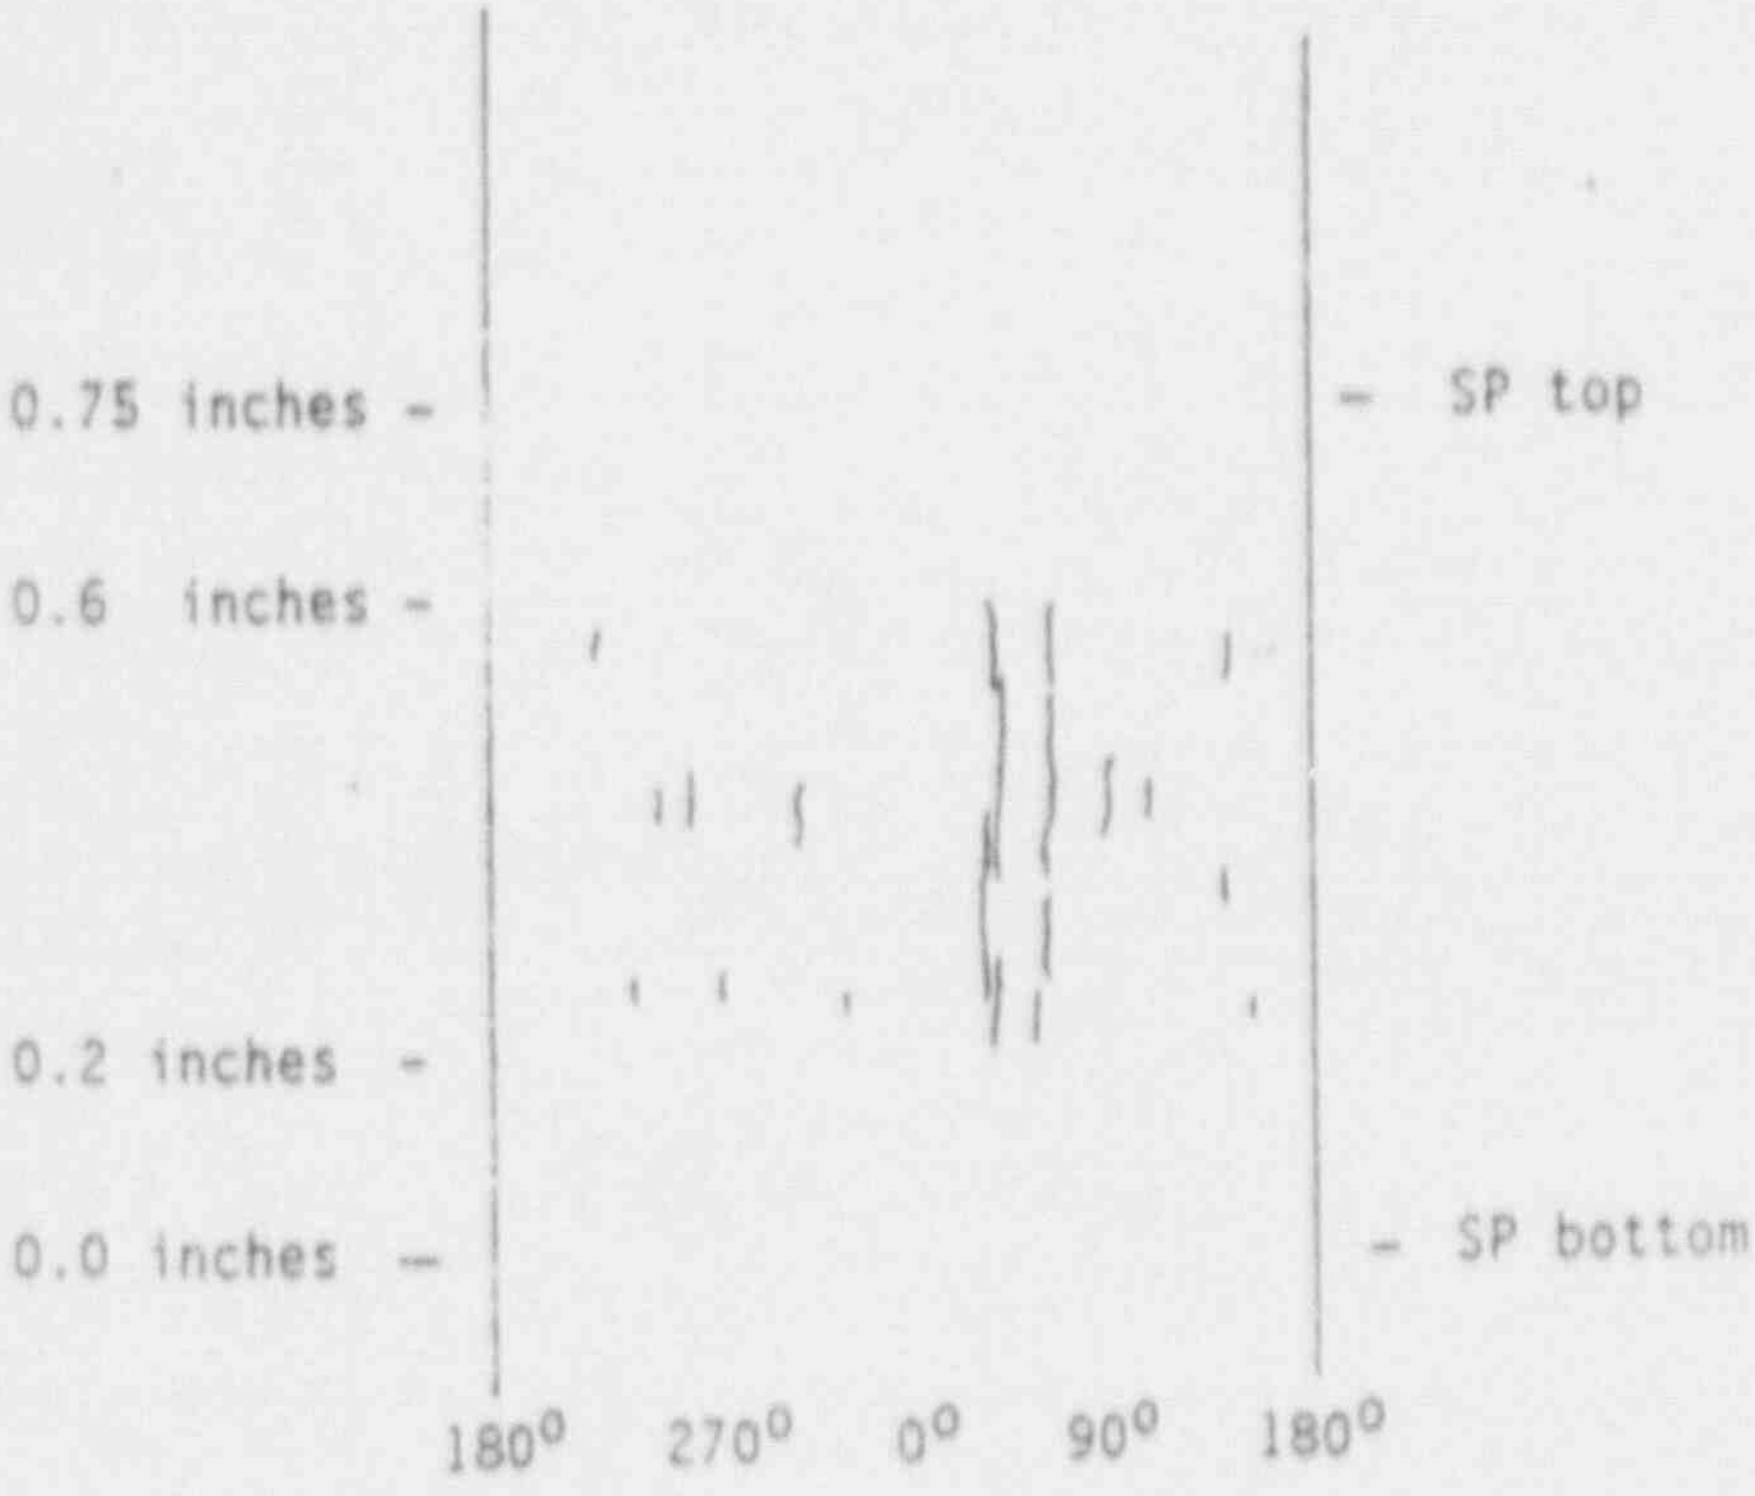
Morphology = Intergranular SCC with some IGA characteristics (width of IGA 0.012 inches)

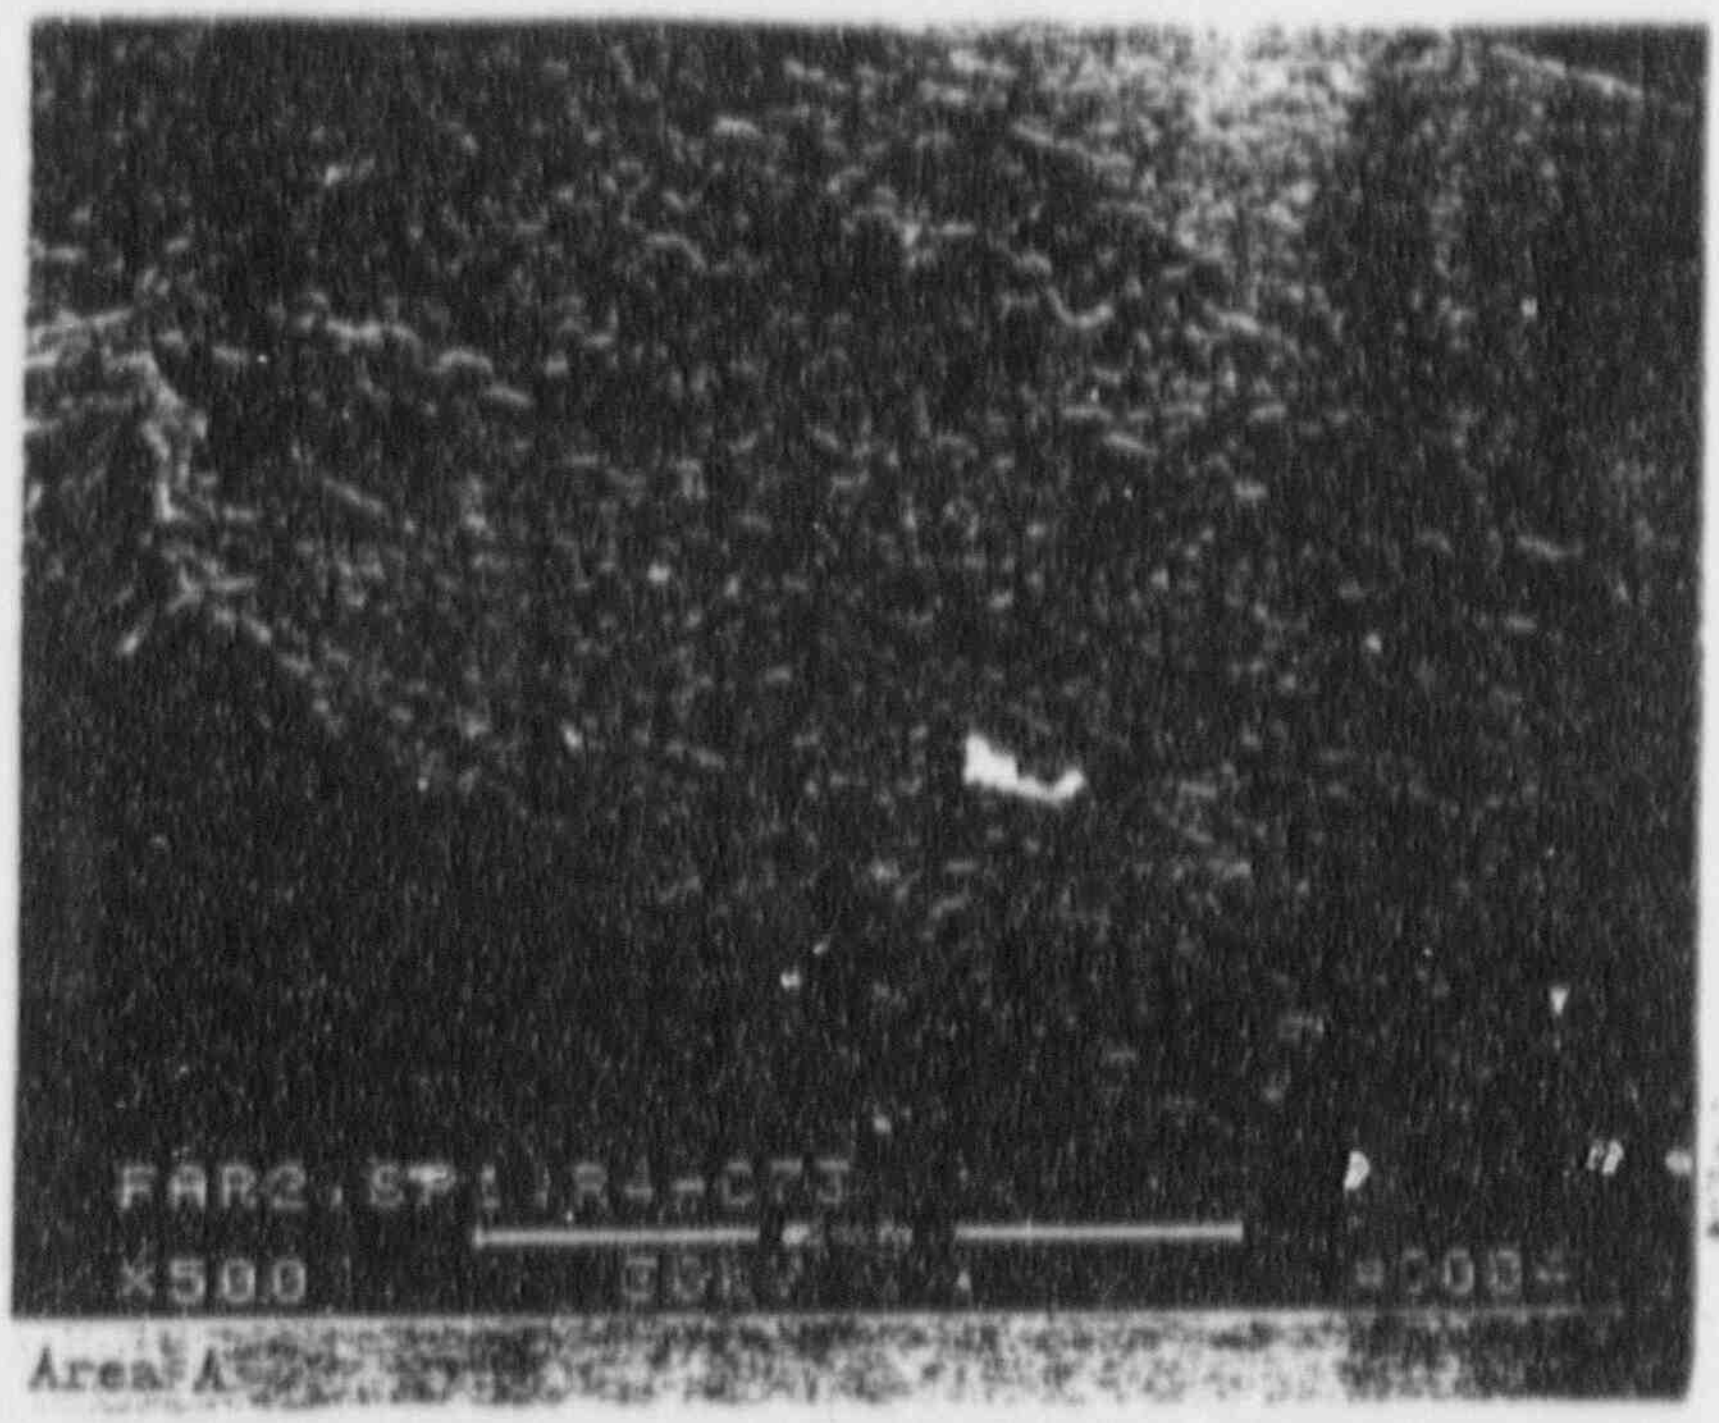
Figure 4-2. Fractographic details seen in Areas A and B. Areas are those marked in previous figure.

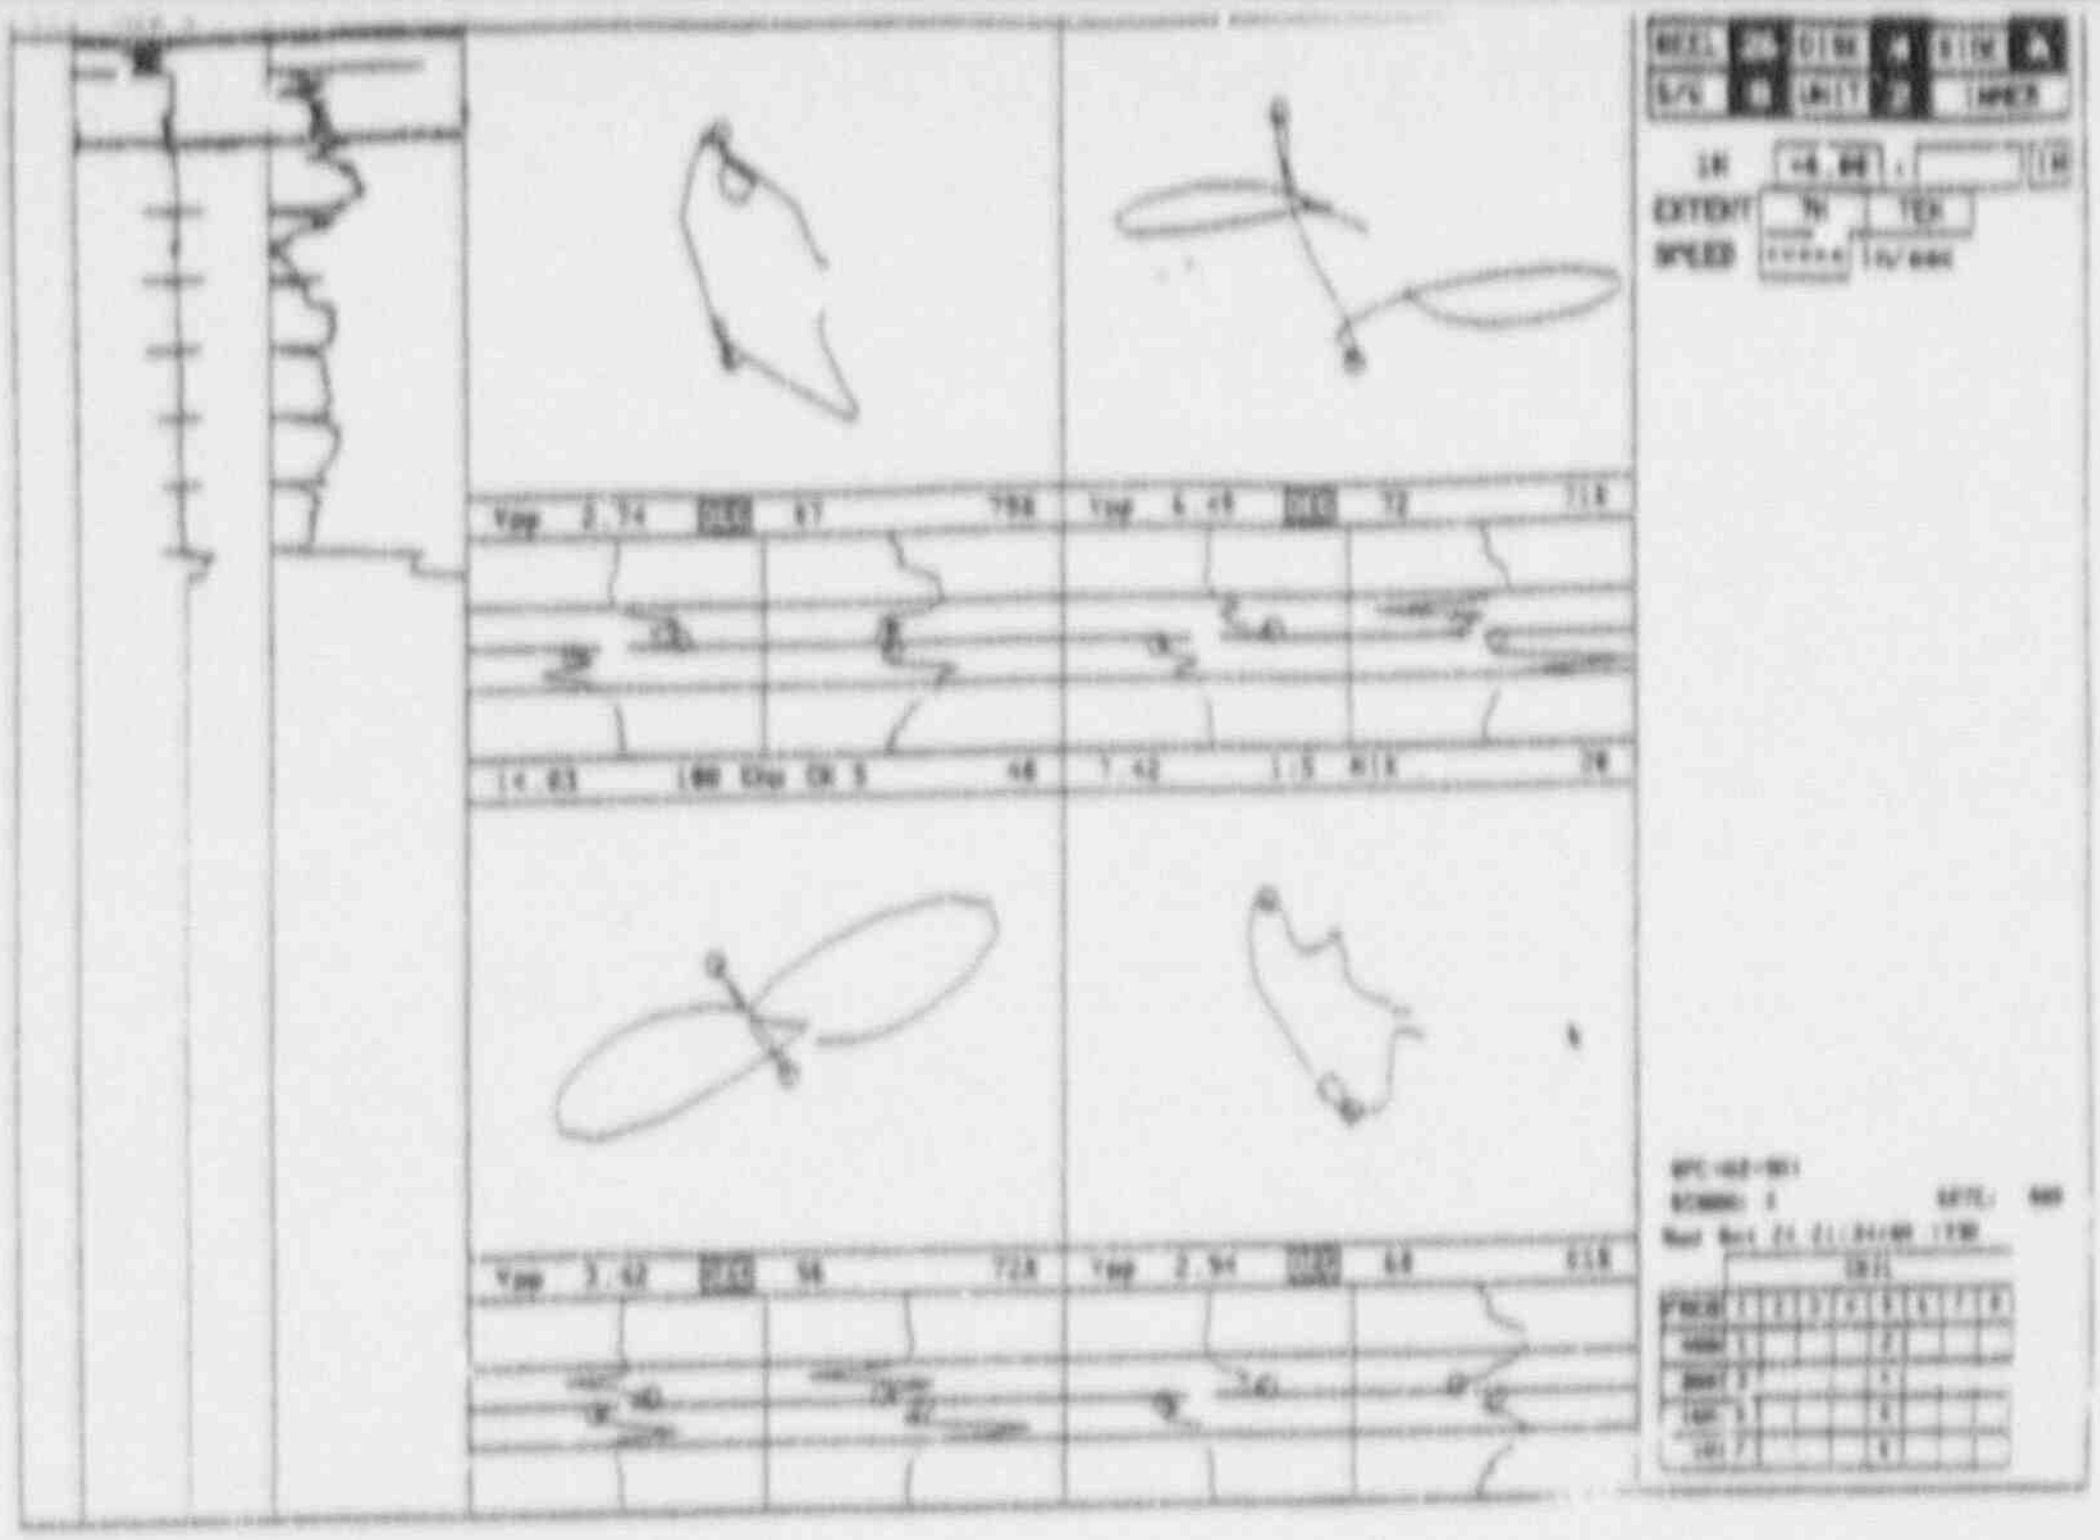
a) Bobbin Probe

Figure 2-30. Bobbin probe and RPC eddy current data from the October-November 1990 field inspection of the first support plate intersection of Tube R4-C73. The bobbin probe data shows a 2.94 volts amplitude signal and an indicated crack depth of 81% throughwall. The RPC data shows one large axial indication (0.43 in).

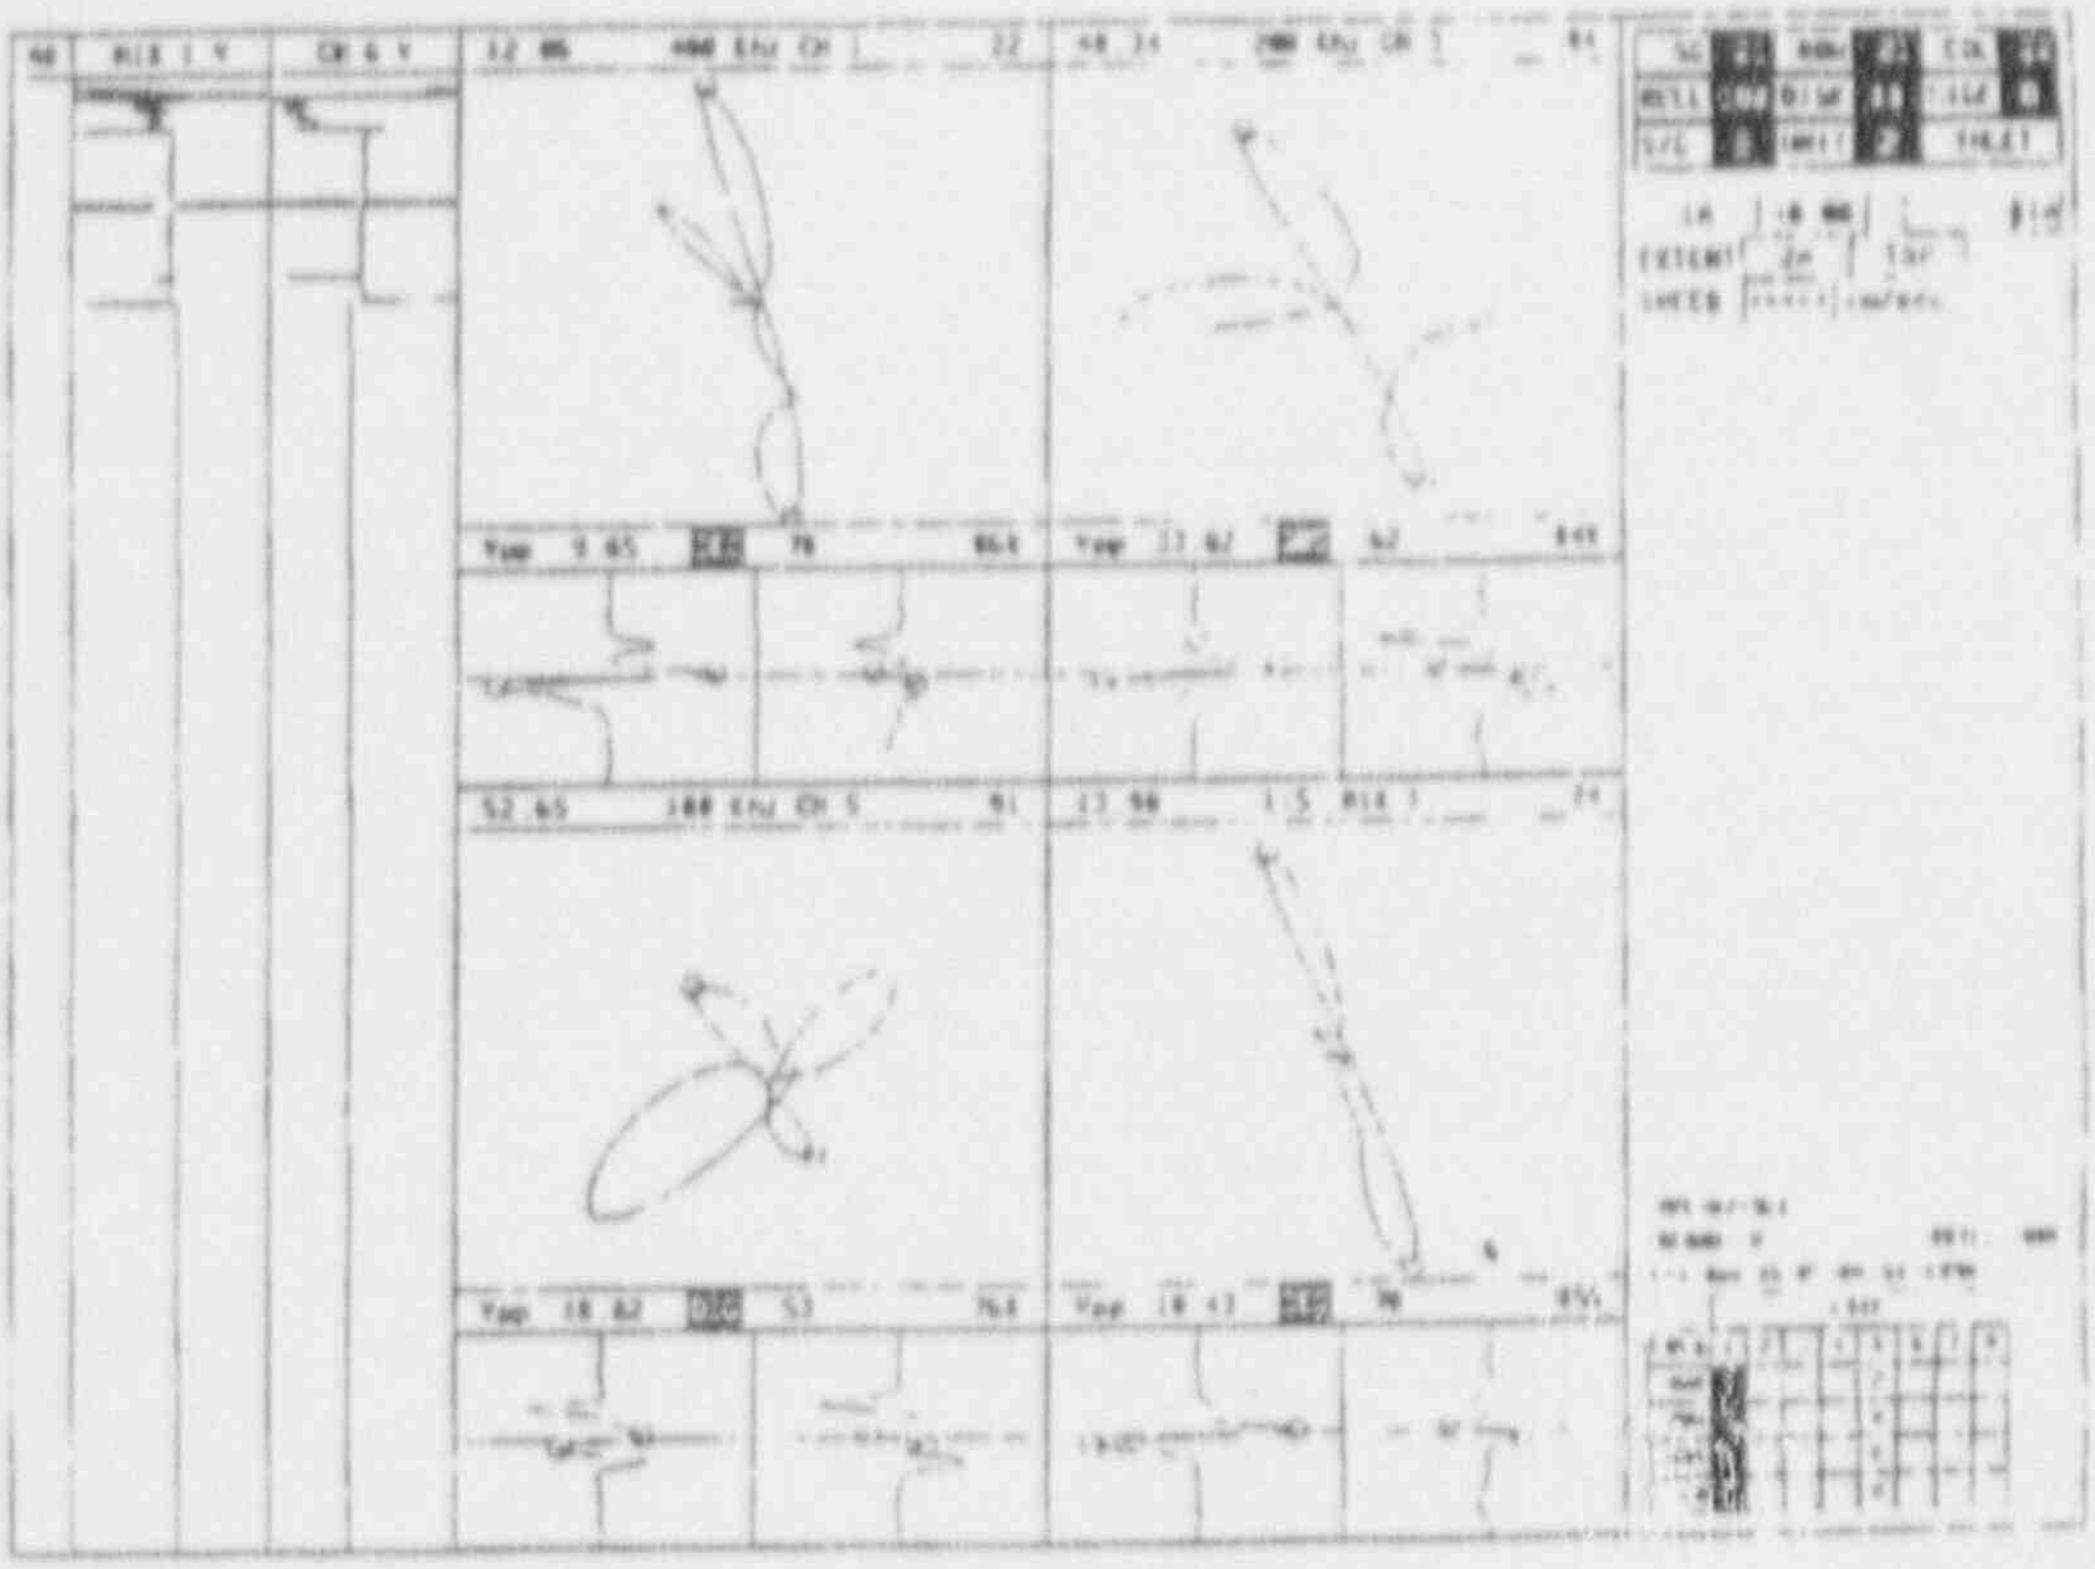
Figure 2-32. Bobbin probe and RPC eddy current data from the October-November 1990 field inspection of the first support plate intersection of Tube R21-C22. The bobbin probe data shows a 10.4 volts amplitude signal with an indicated crack depth of 85%. RPC data shows one axial crack indication whose length was estimated as 0.51 inches.
