WCAP-13139

FARLEY UNITS 1 AND 2

STEAM GENERATOR TUBE/ TUBE SUPPORT PLATE ELEVATION ALTERNATE PLUGGING CRITERION SUMMARY

DECEMBER 1991

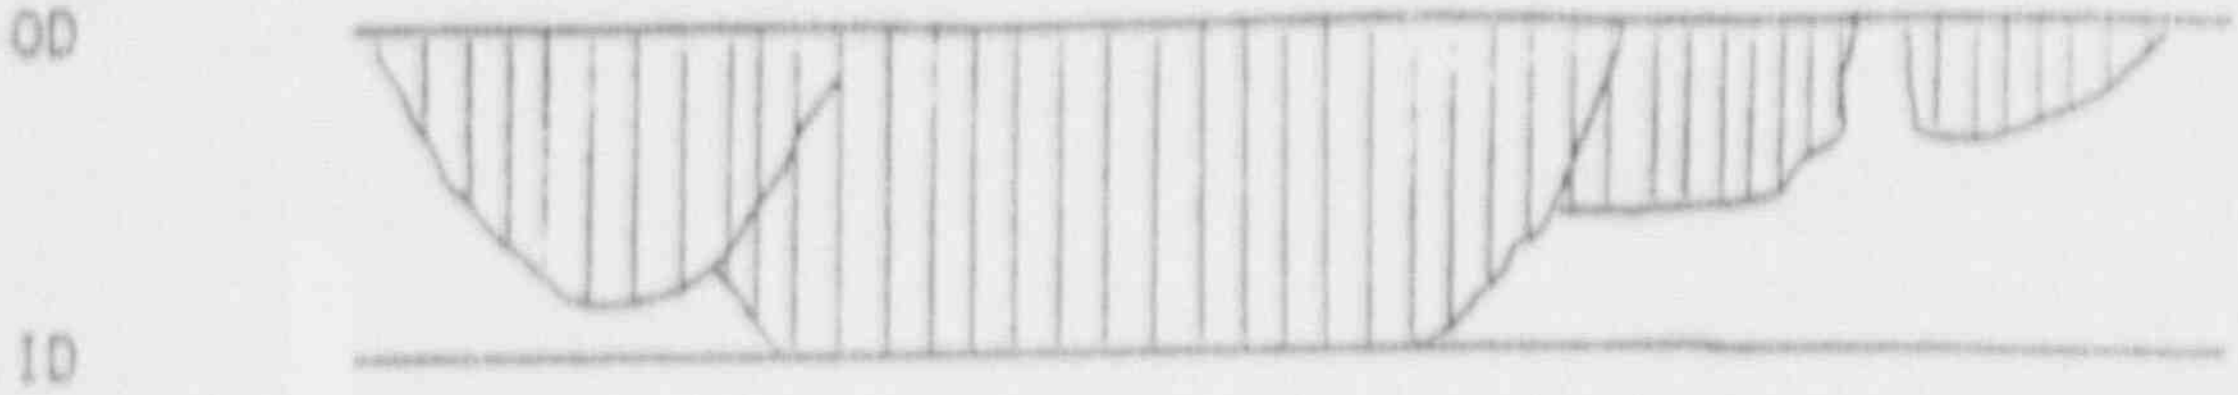
Macrocrack Length = 0.50 inches

Figure 4-21. Description of OD origin corrosion at the first support plate crevice region of Tube R21-C22.

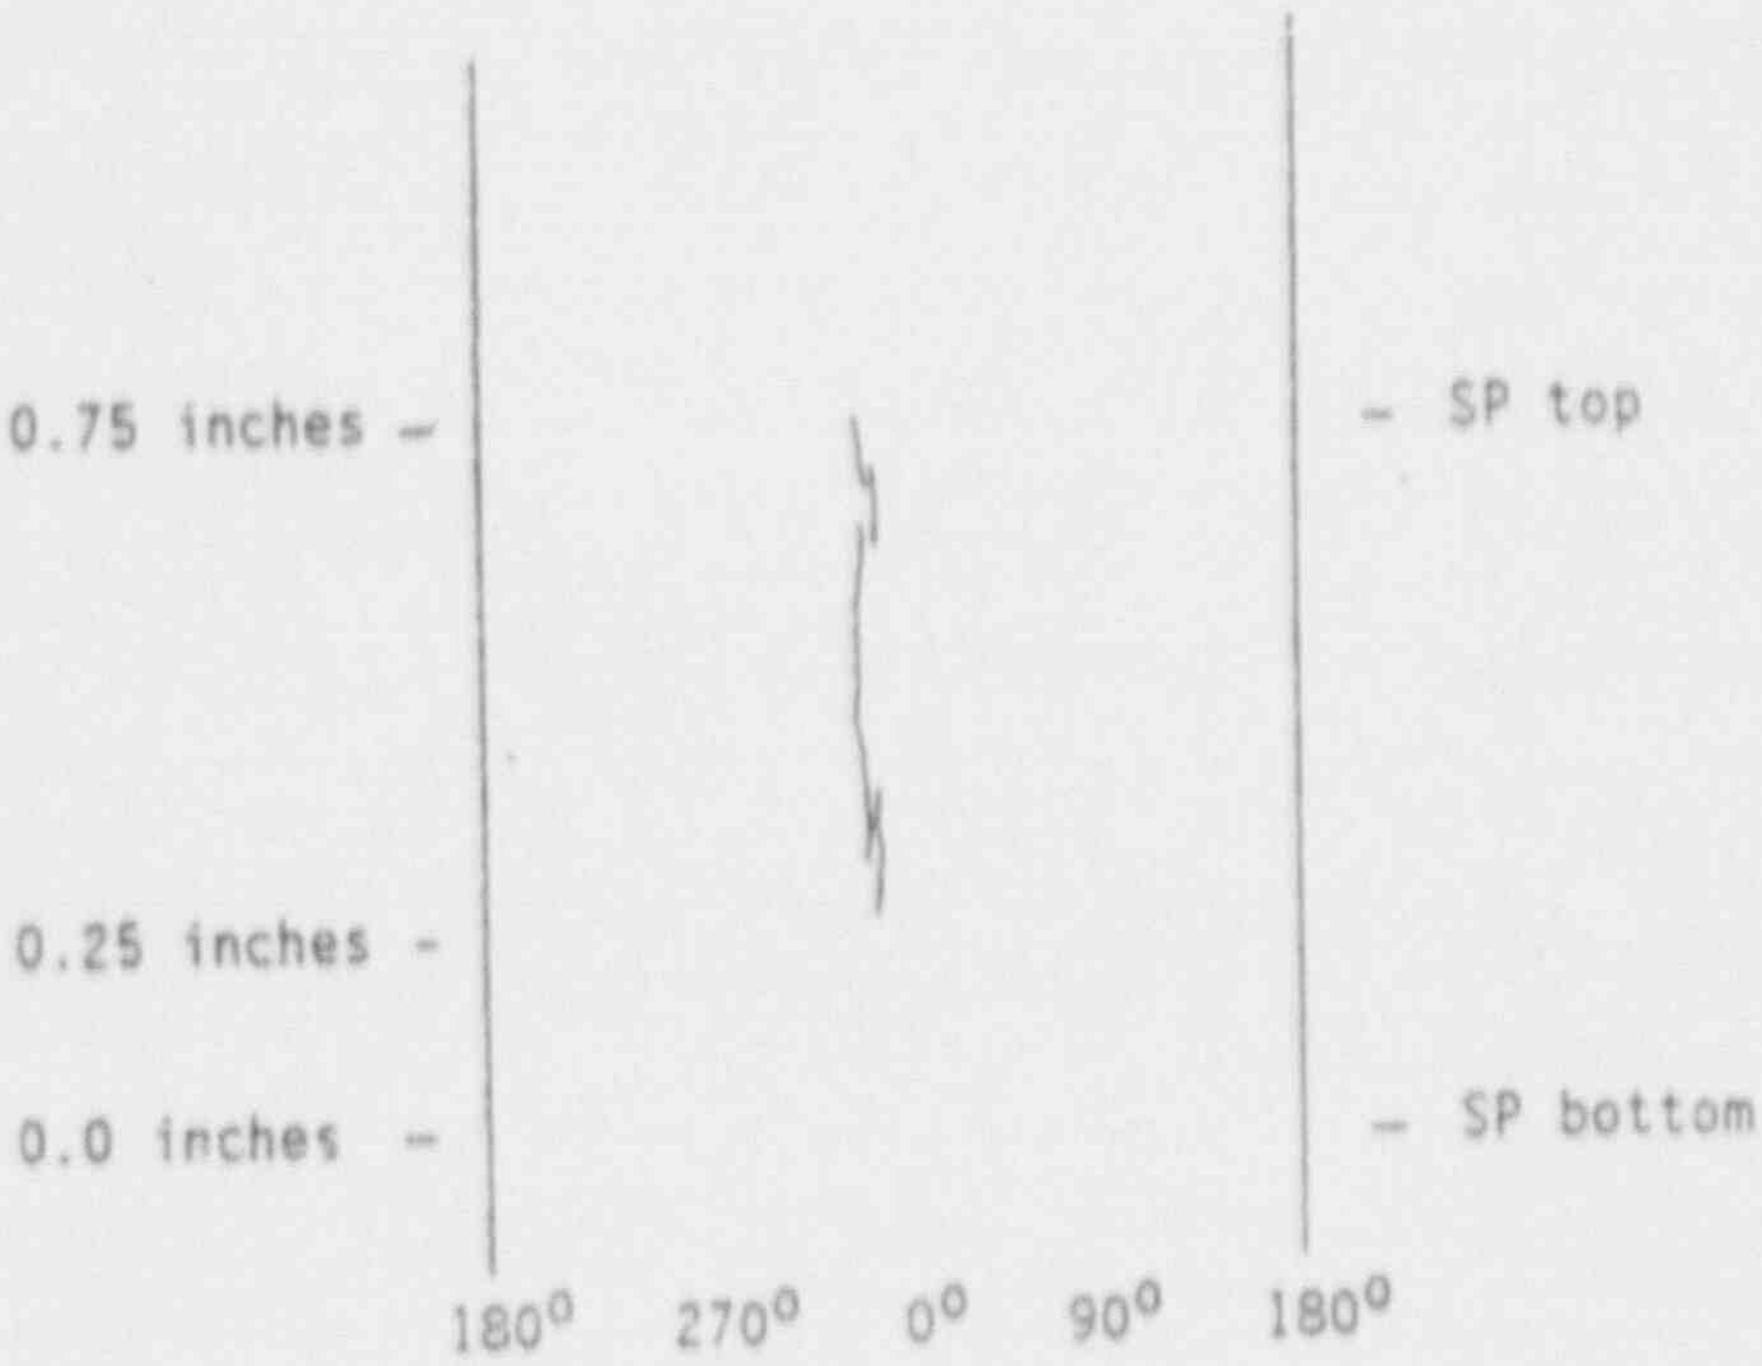
Morphology = Intergranular SCC with significant IGA characteristics (width of IGA 0.030 inches)

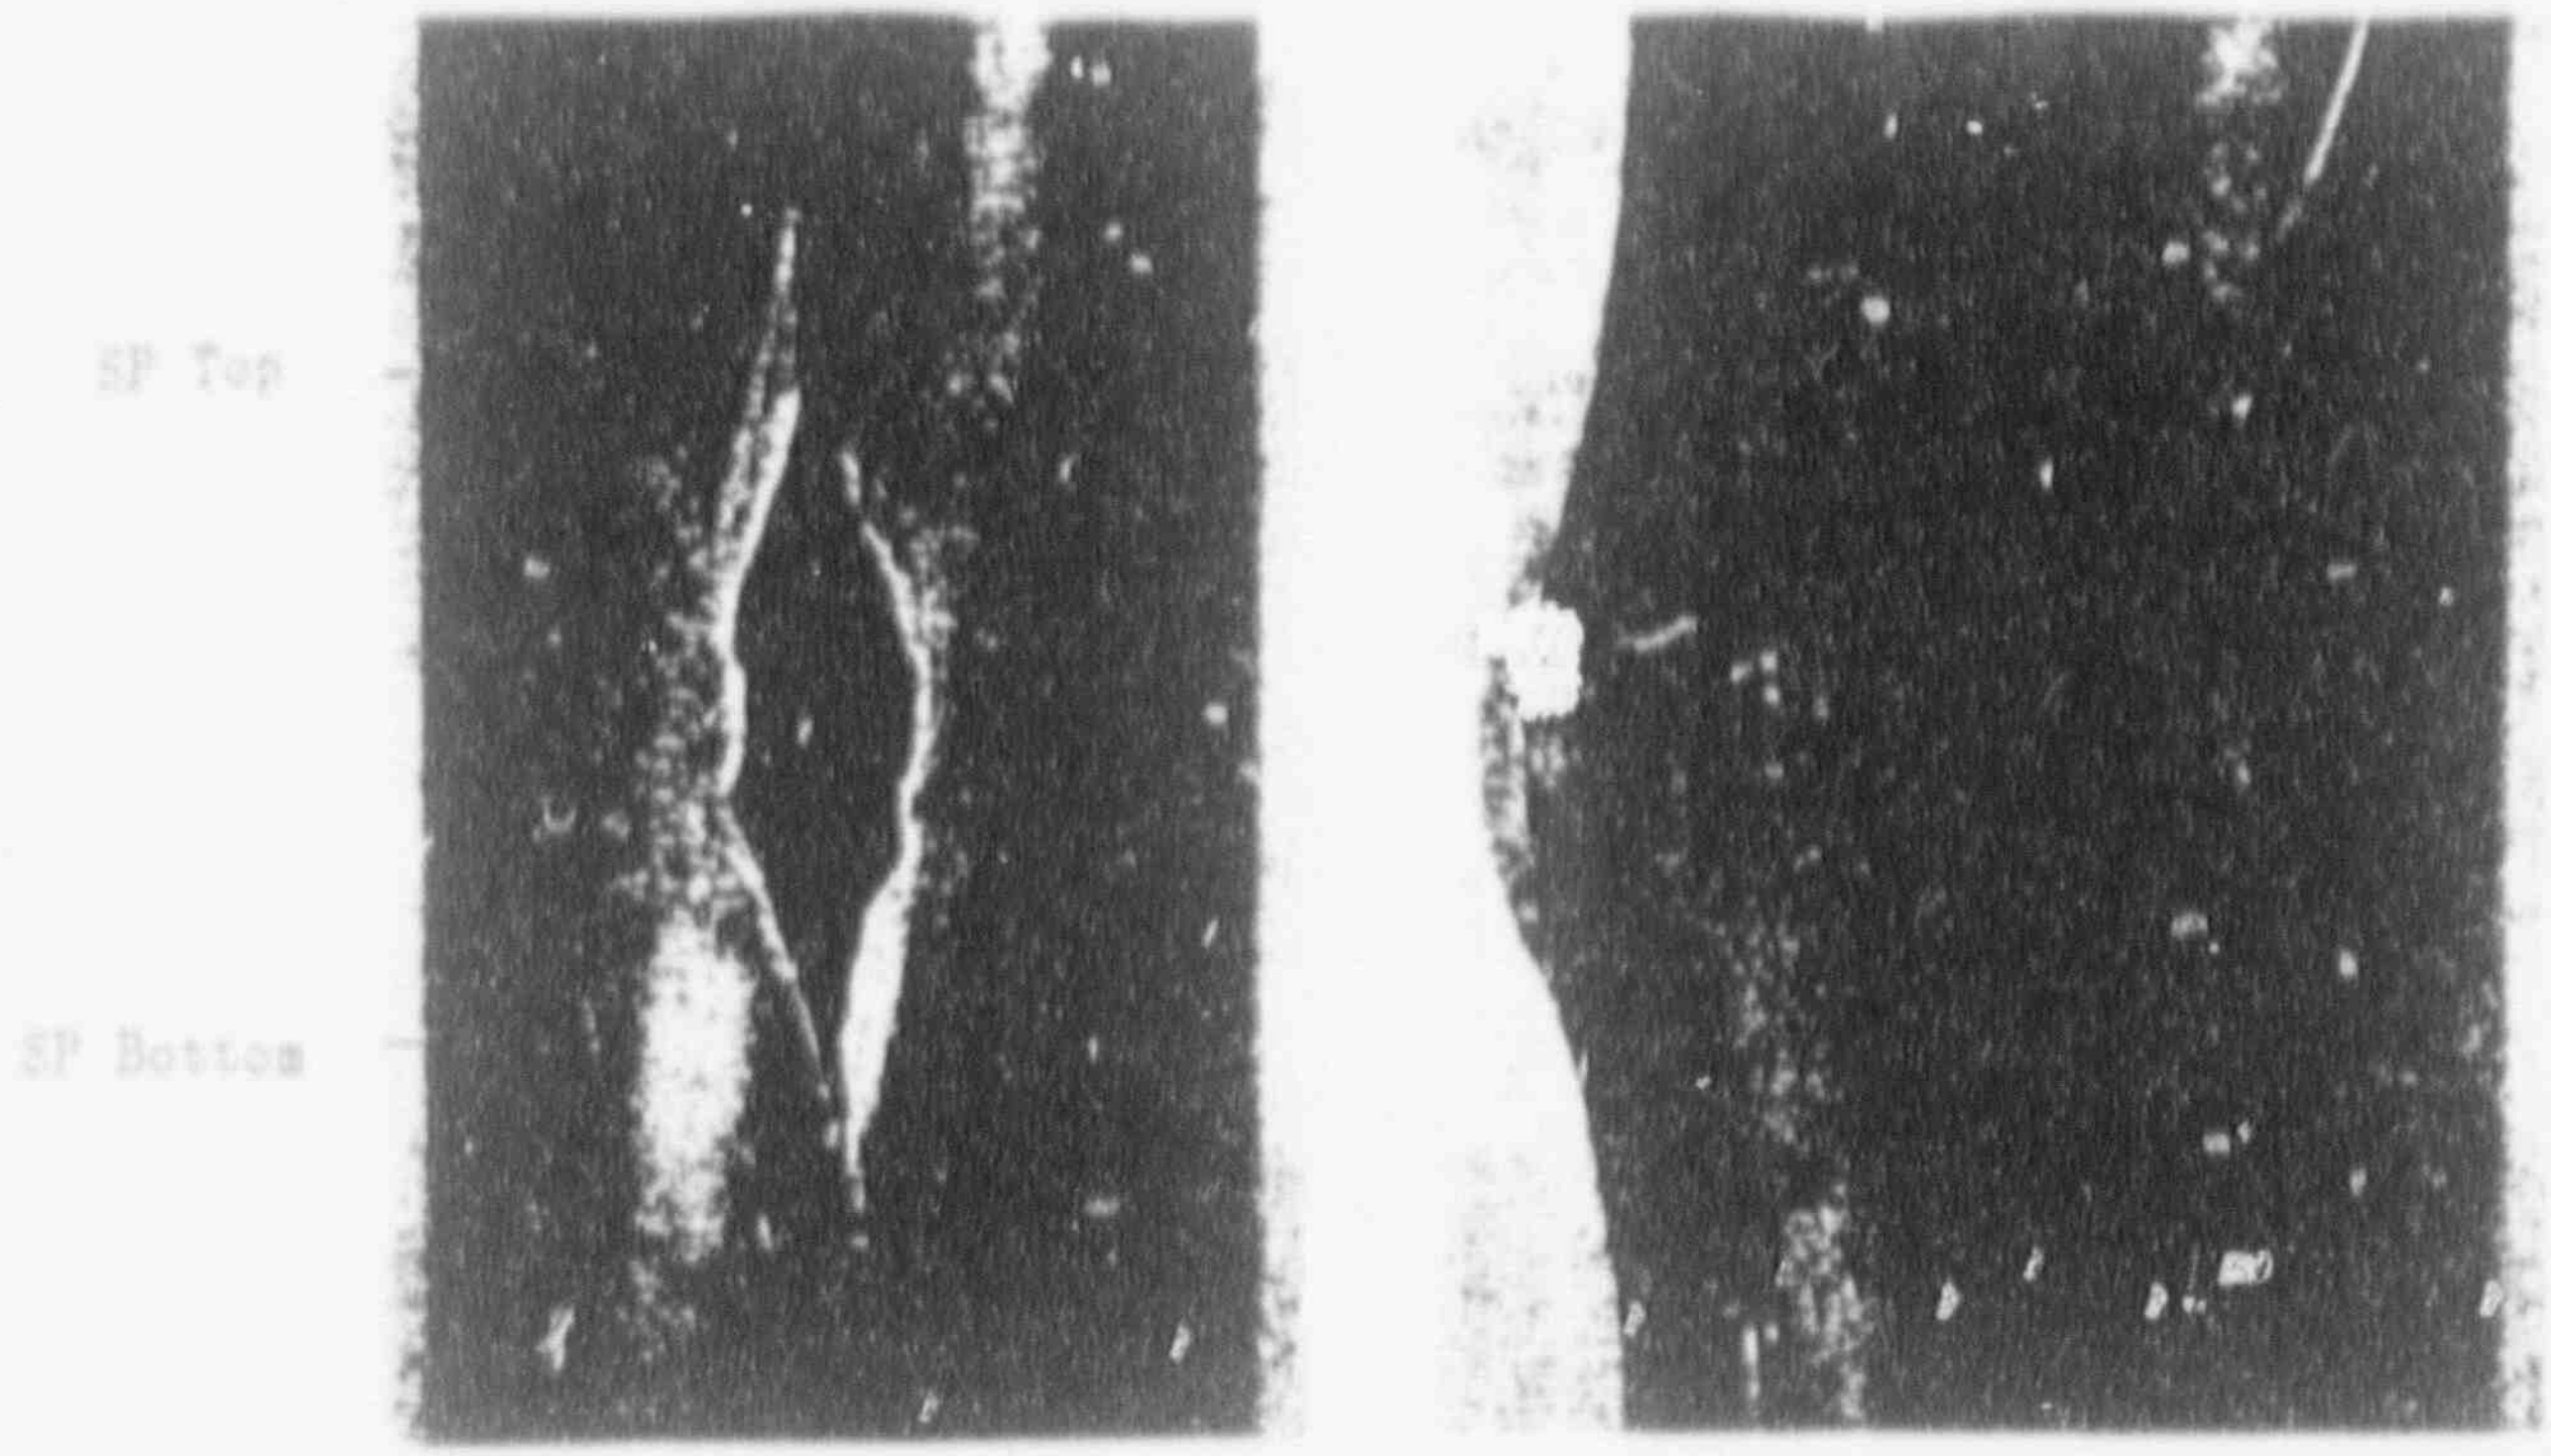
Figure 3-3. Appearance of the burst opening and opened cracks around the circumference at the first support plate region in Tube R38-C46

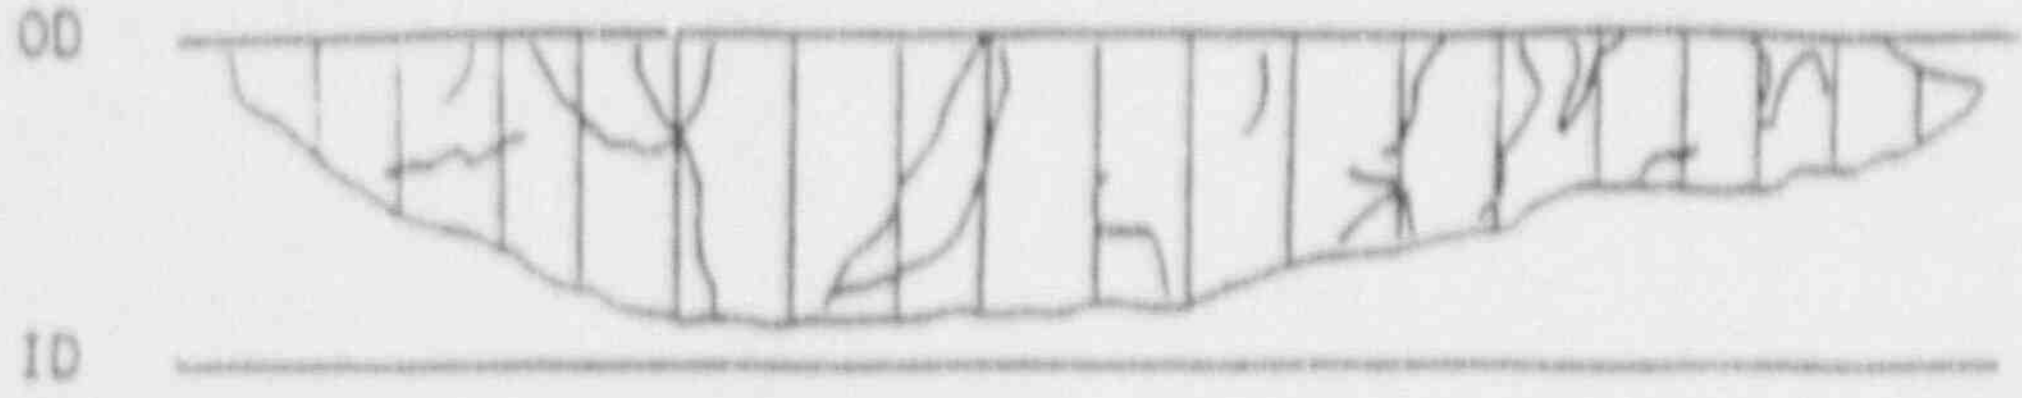
Macrocrack Length = 0.37 inches

Morphology = Intergranular SCC with minor IGA features (Unusual spider-shaped crack distribution)

Figure 4-28. Description of OD origin corrosion at the first support plate crevice region of Tube R38-C46.

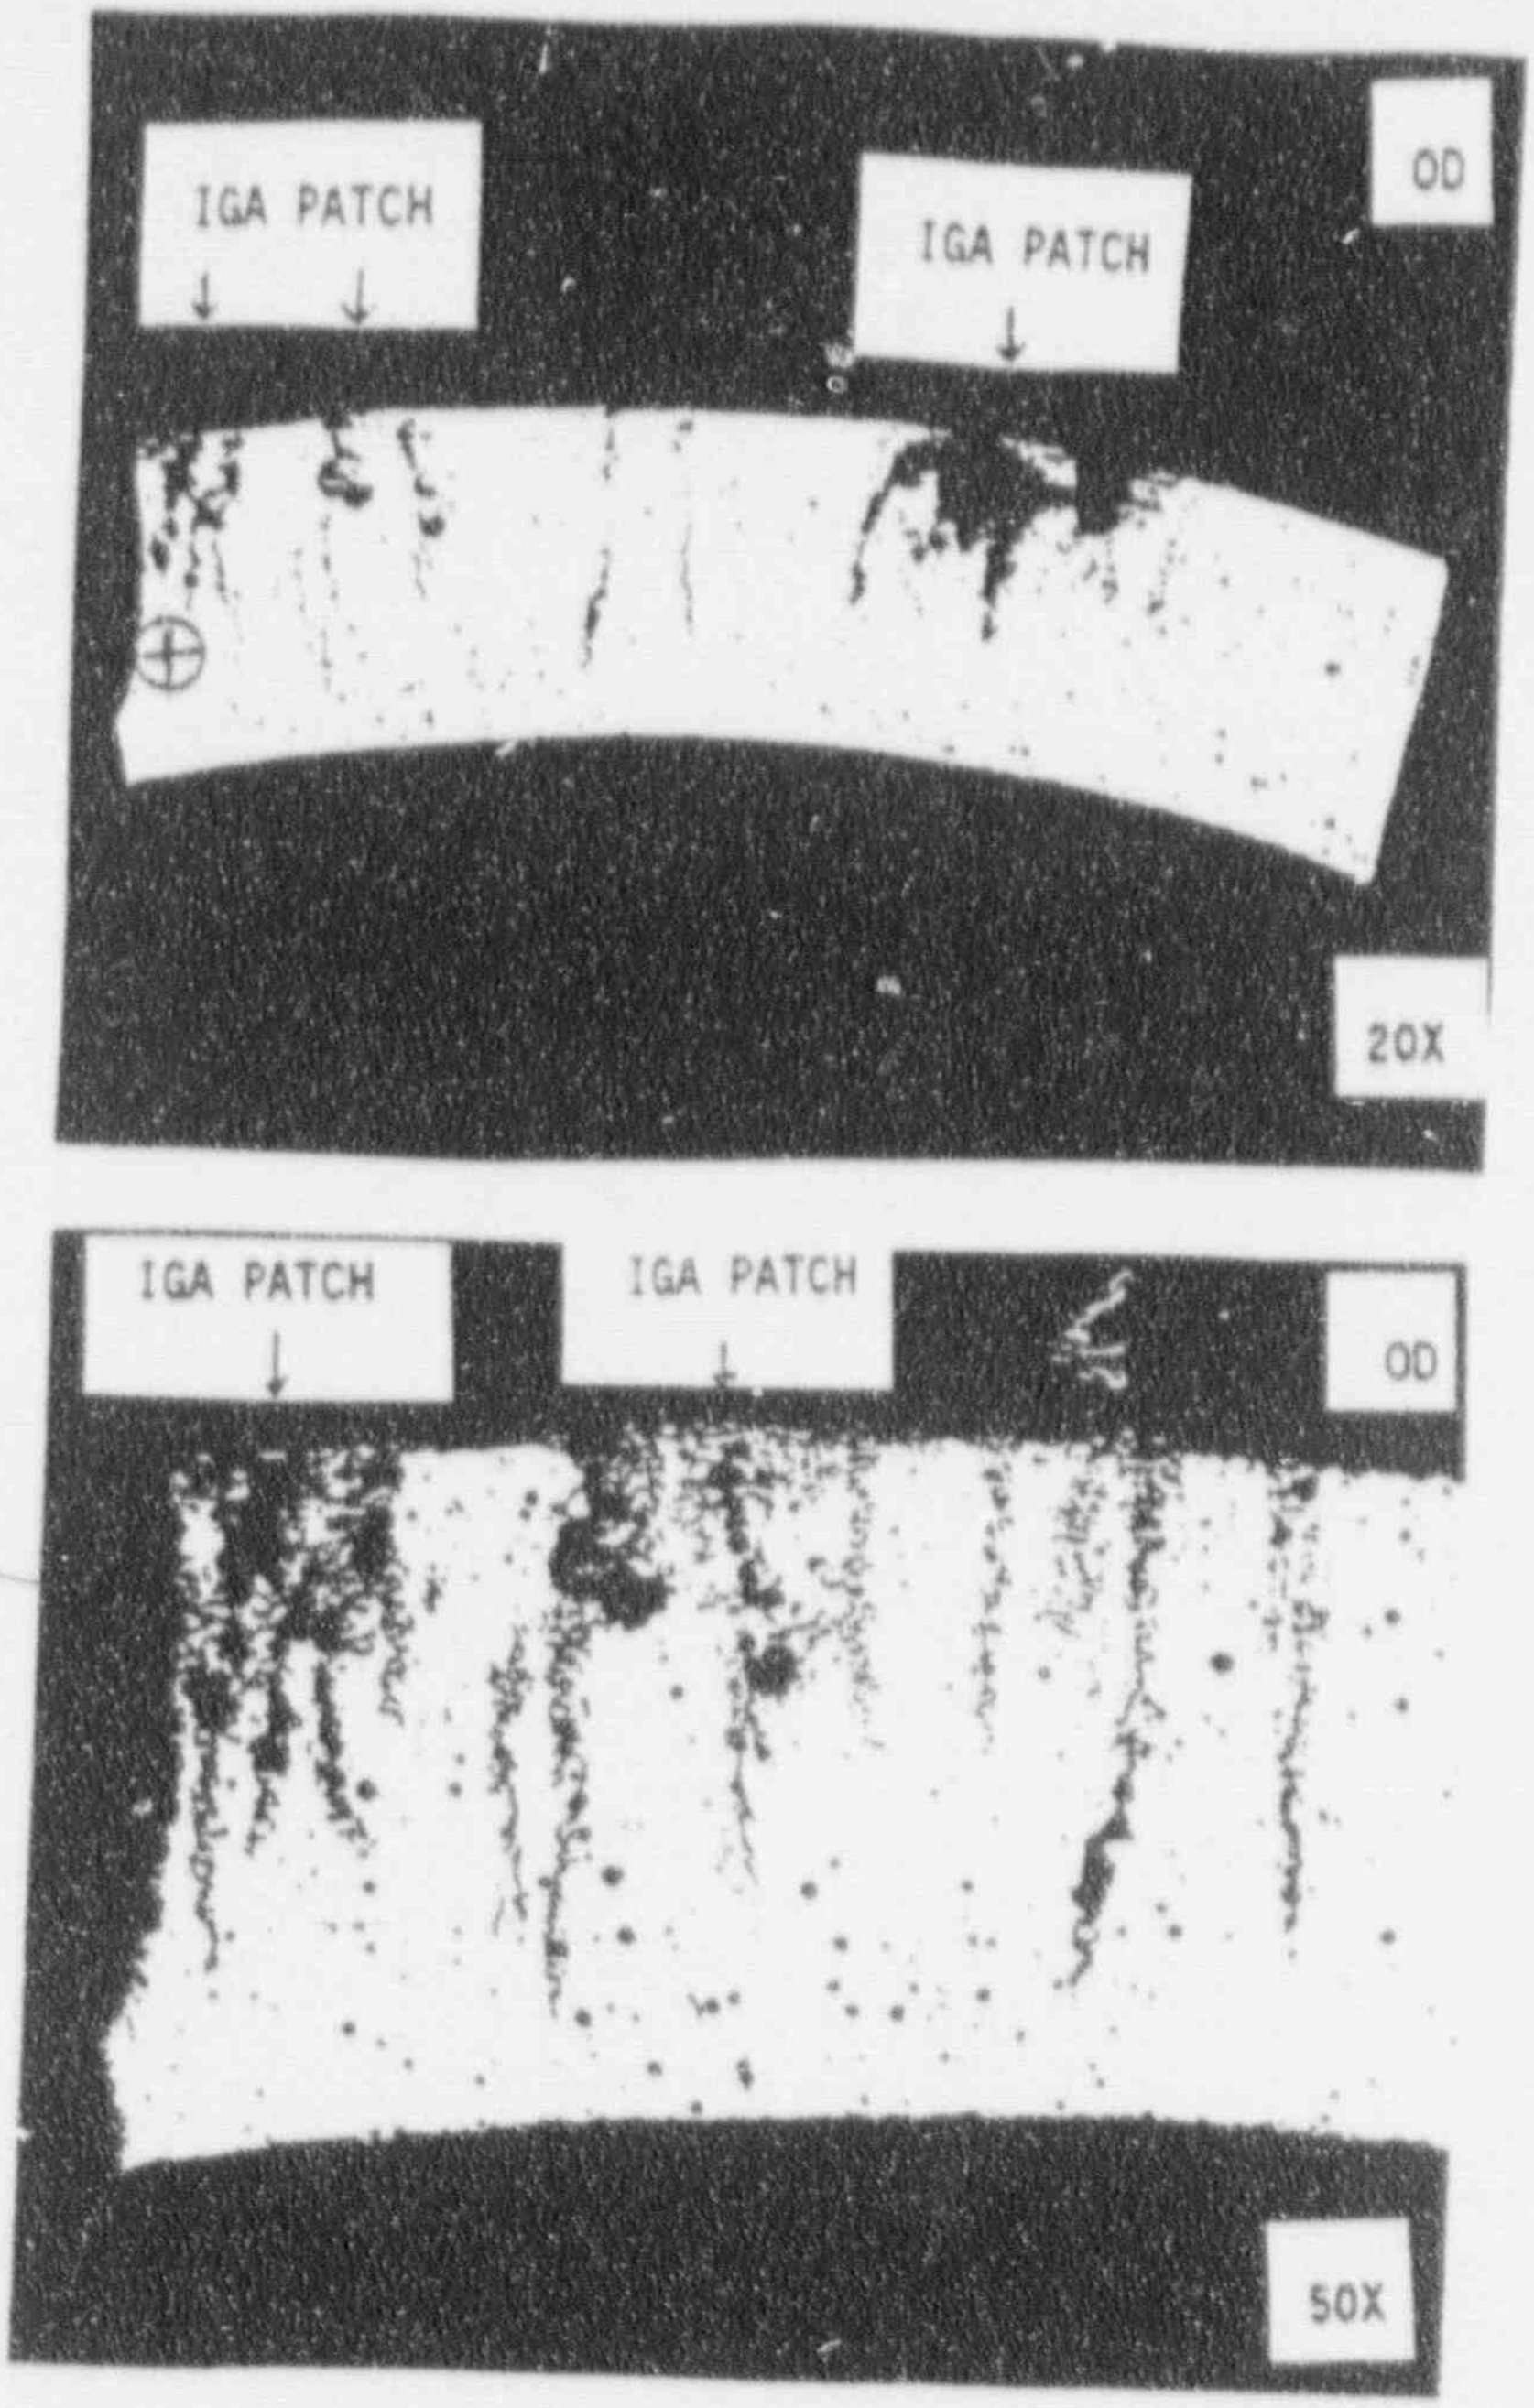
Figure 4-21. Transverse optical micrographs obtained just below the circumferential fracture at the center of the support plate. The circumferential location is that where the deepest corrosion was found. The deepest axial IGSCC is 85% through wall and three IGA patches are observed: one 43% through wall and 0.015 inch long, one 33% through wall and 0.05 inch long, and one 28% through wall and 0.015 inch long. The axial IGSCC had IGA aspects to individual cracks. These aspects can be characterized by ratios comparing the crack length (depth from OD surface) to IGA width at the mid-crack location. L/W ratios vary from 6 to 18. Plant L, R12C8

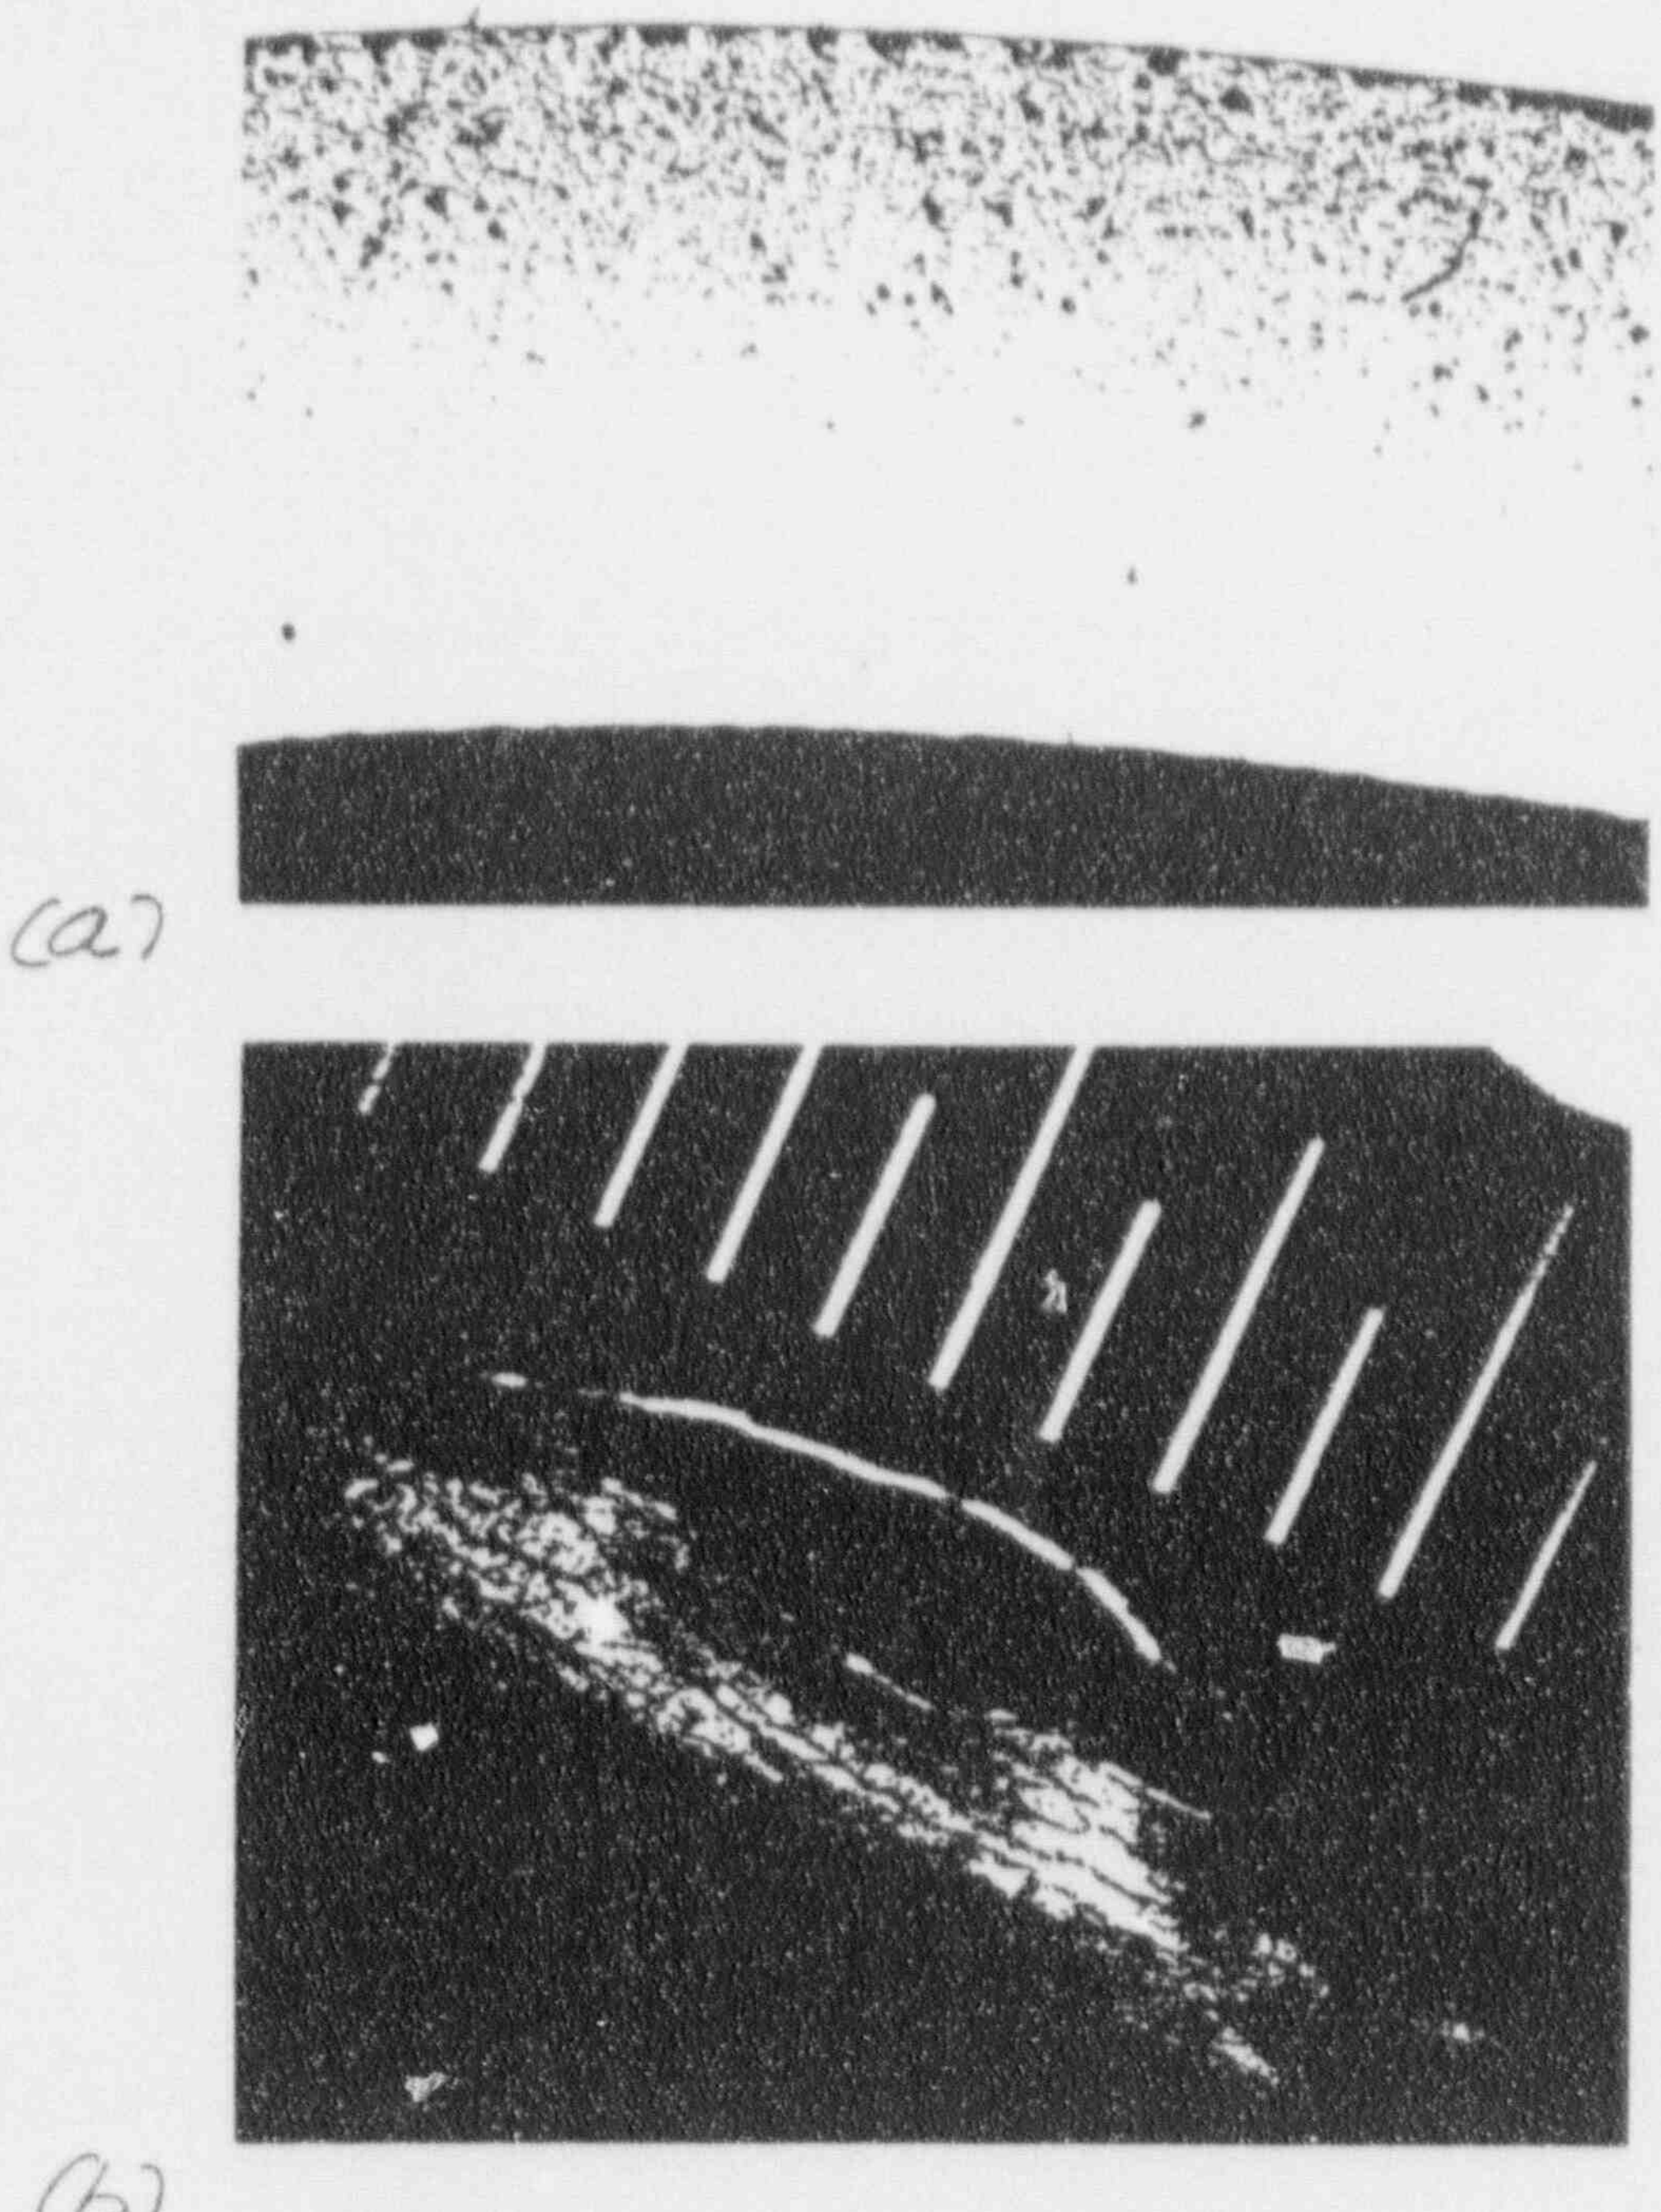
FIGURE 2 Metallograph of IGA in a Sensitized 0.75 inch Diameter Tube and Burst Test Fracture Appearance

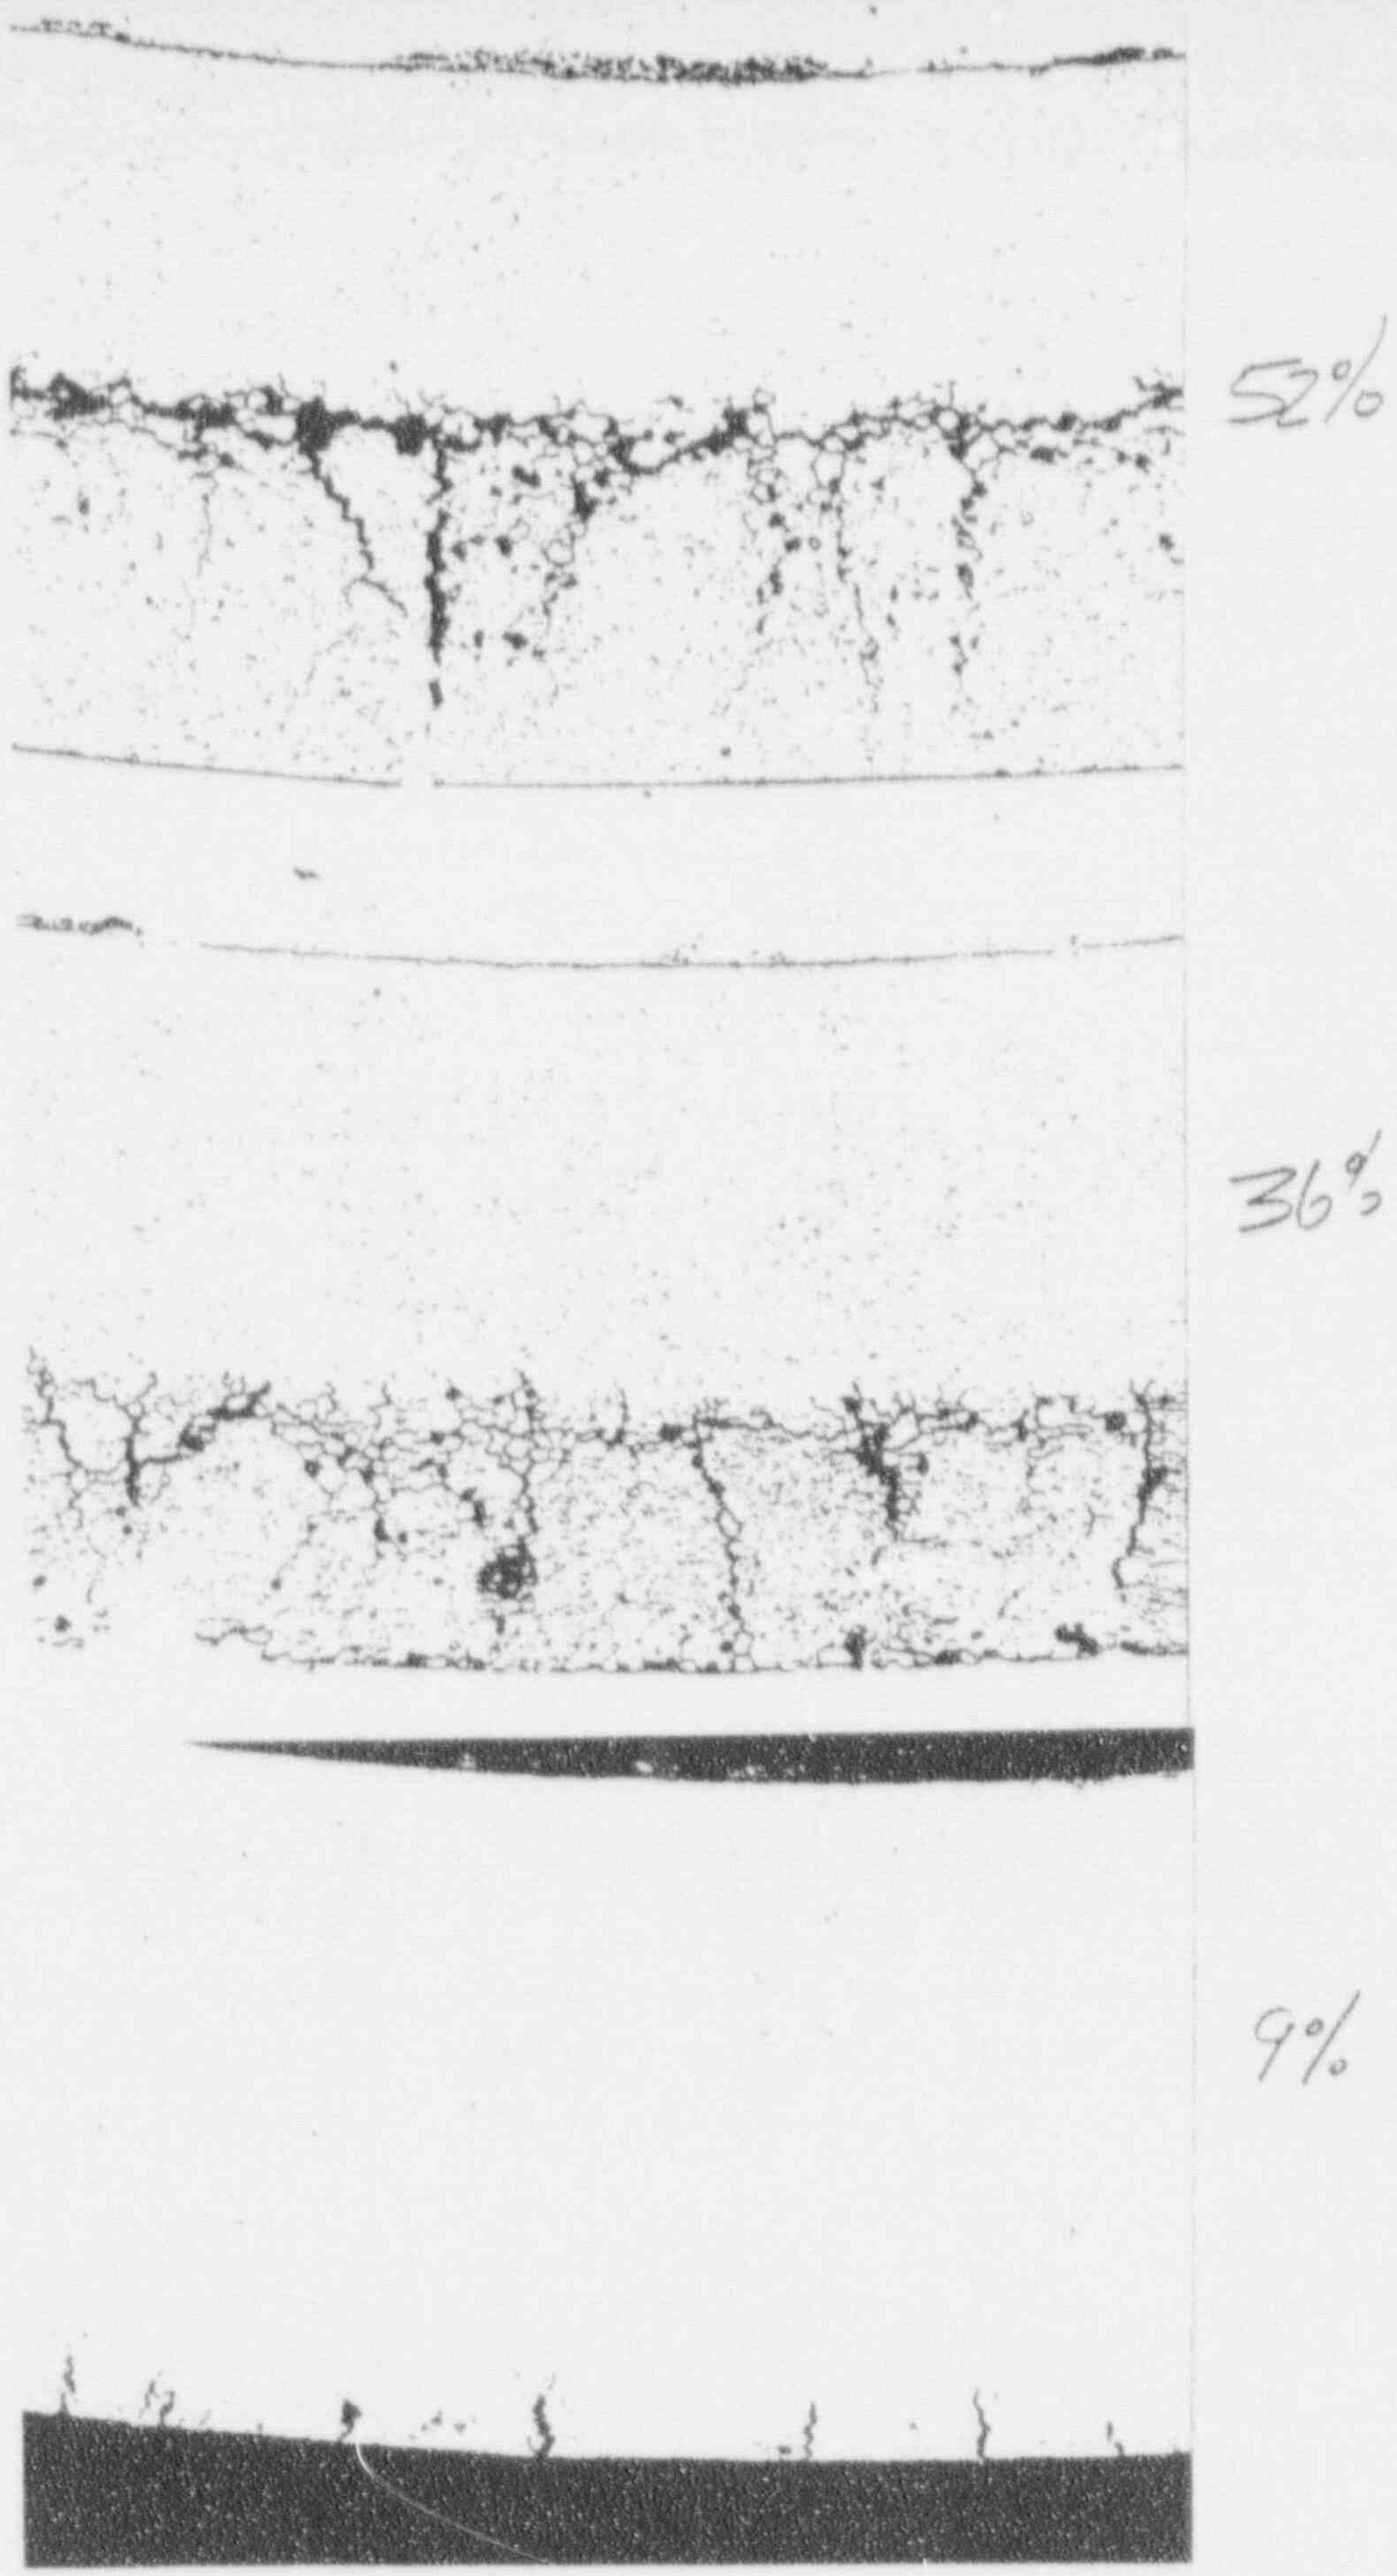
Figure 3 CRACKS IN IGA LAYERS CREATED DURING BURST TESTS.

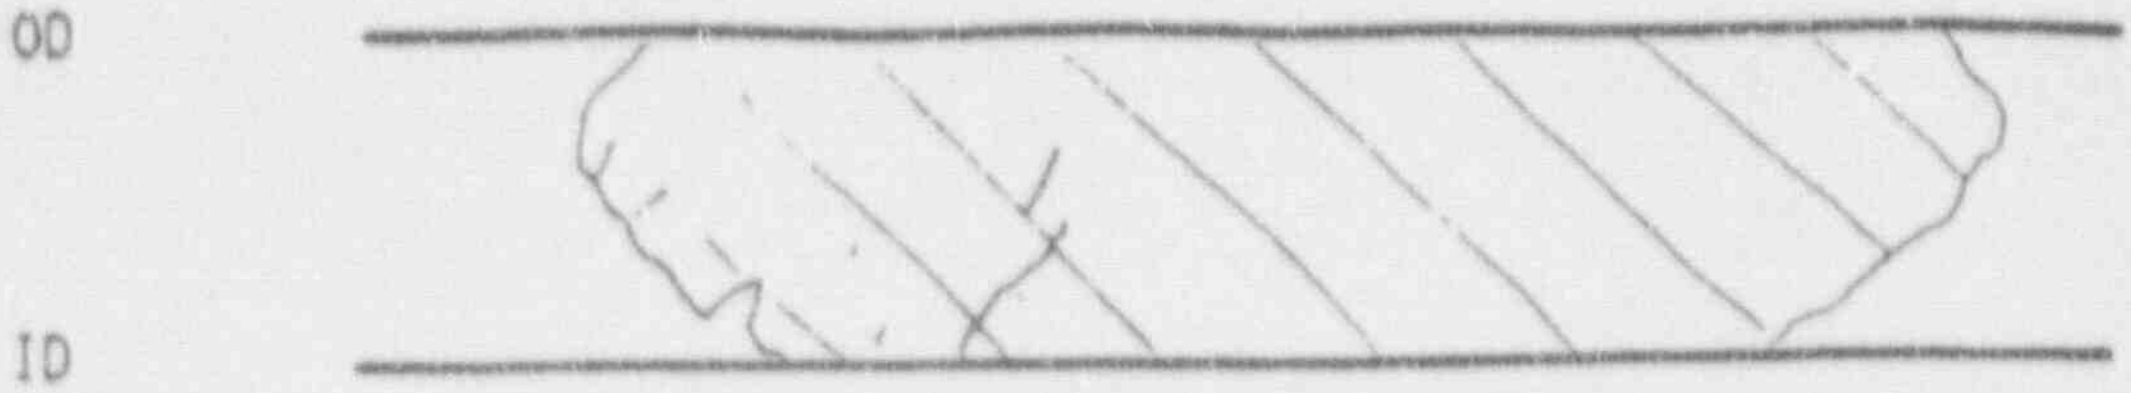
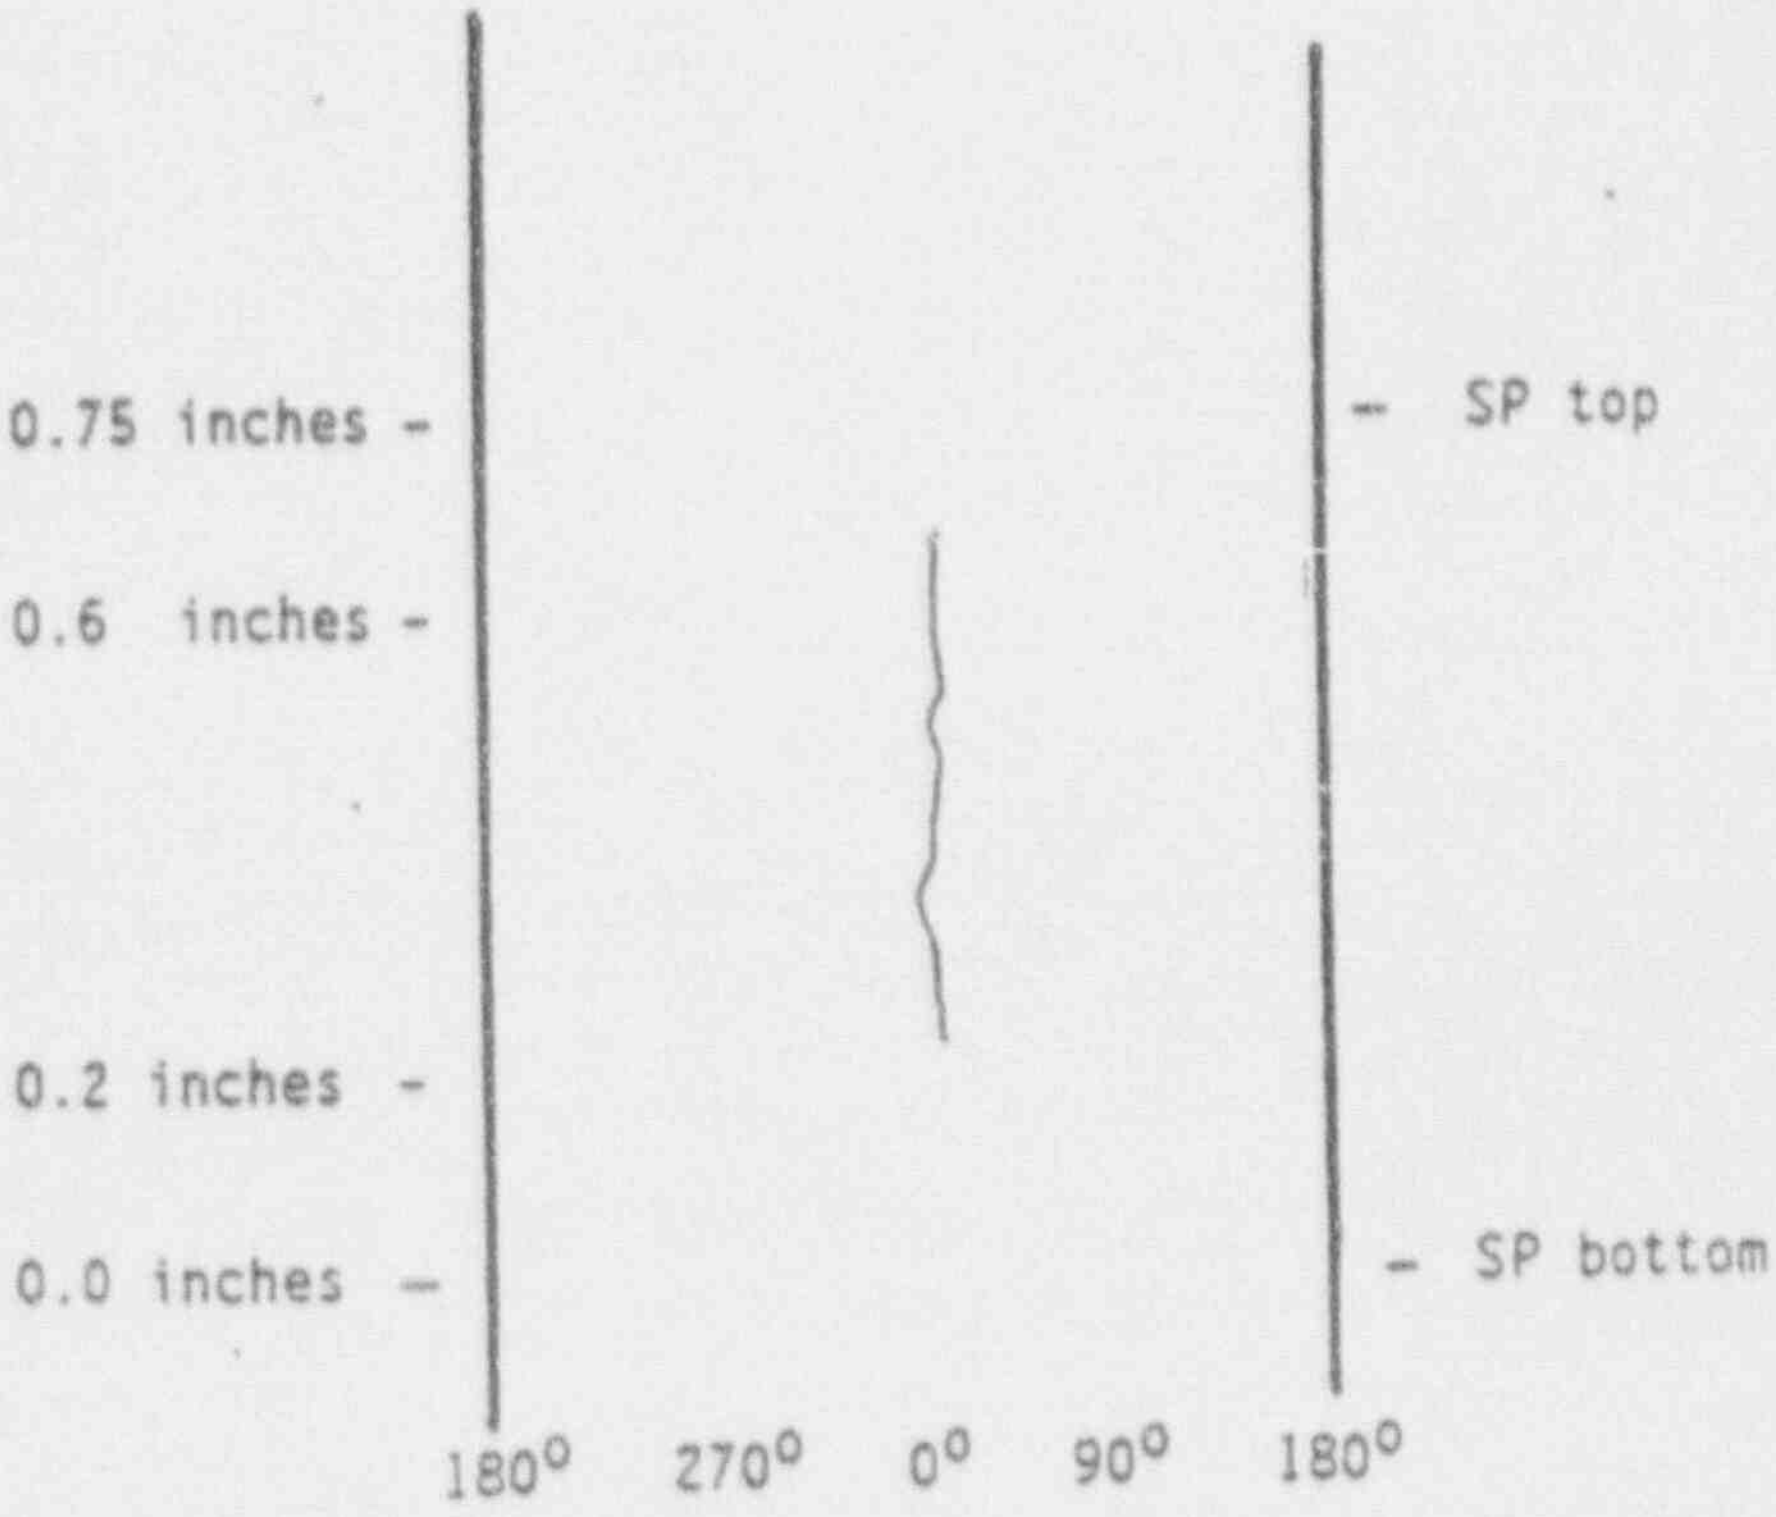
Macrocrack Length = 0.44 inches

Number of Microcracks = 1 to 4

Morphology = IGSCC

Figure 10-10 Summary of crack distribution and morphology observed on Tube 571-1.
