WCAP-13139

FARLEY UNITS 1 AND 2

STEAM GENERATOR TUBE/ TUBE SUPPORT PLATE ELEVATION ALTERNATE PLUGGING CRITERION SUMMARY

DECEMBER 1991

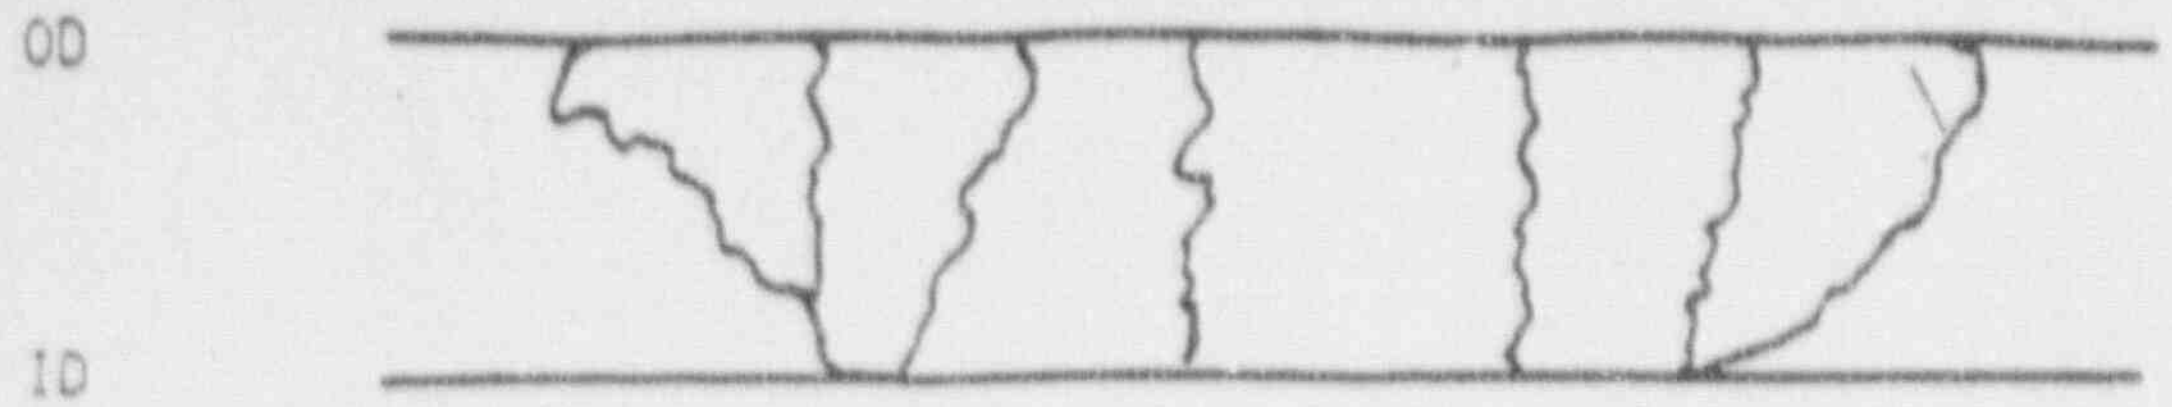
Macrocrack Length = 0.70 inch

Figure 10-25 Summary of overall crack distribution and morphology observed on tube 532-1.

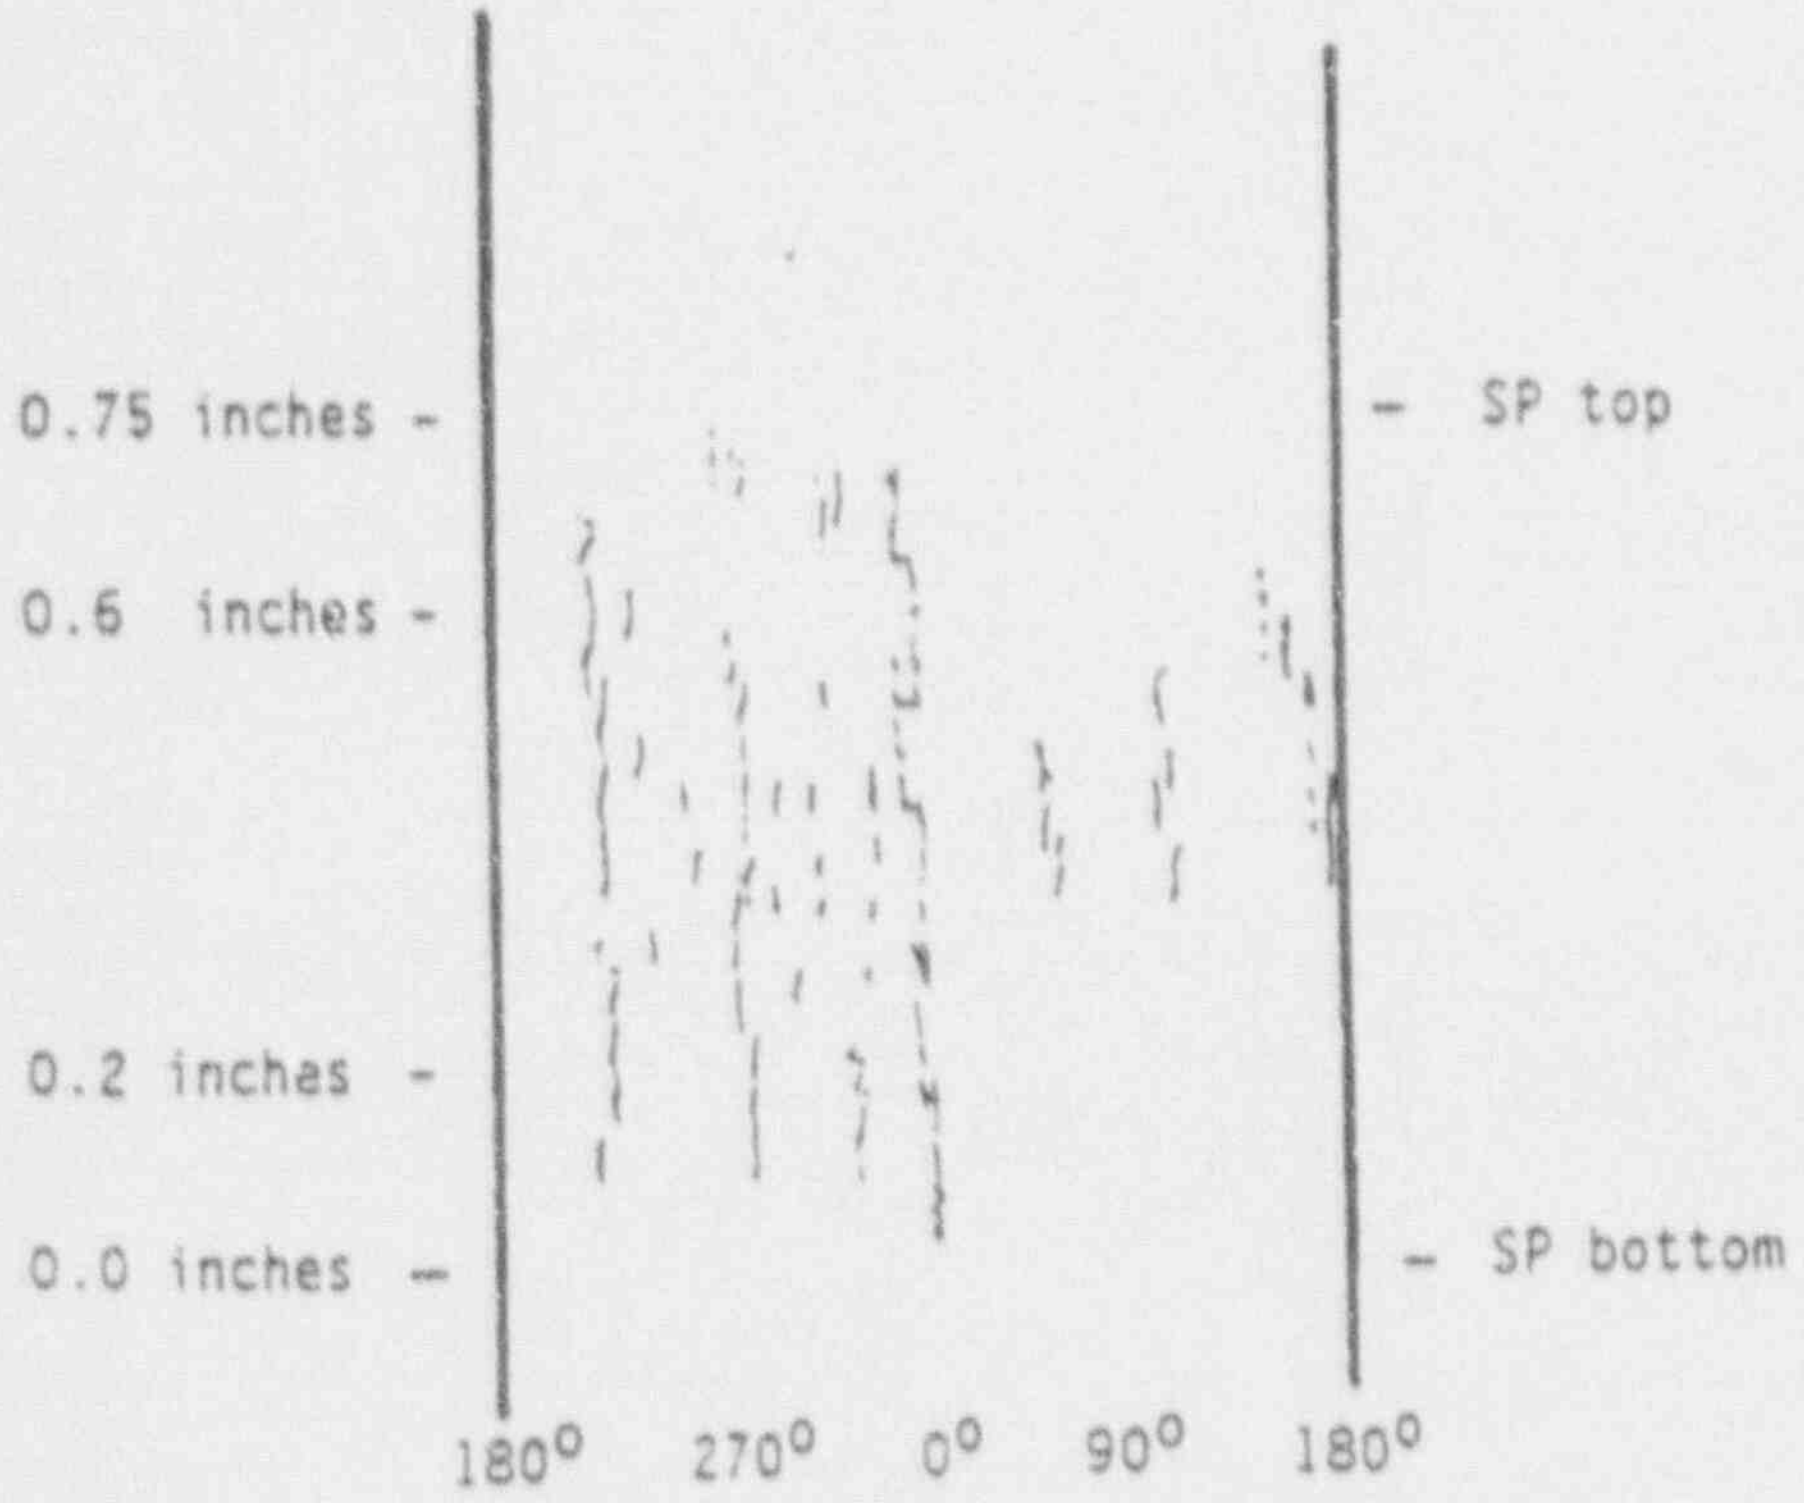
Morphology = IGSCC

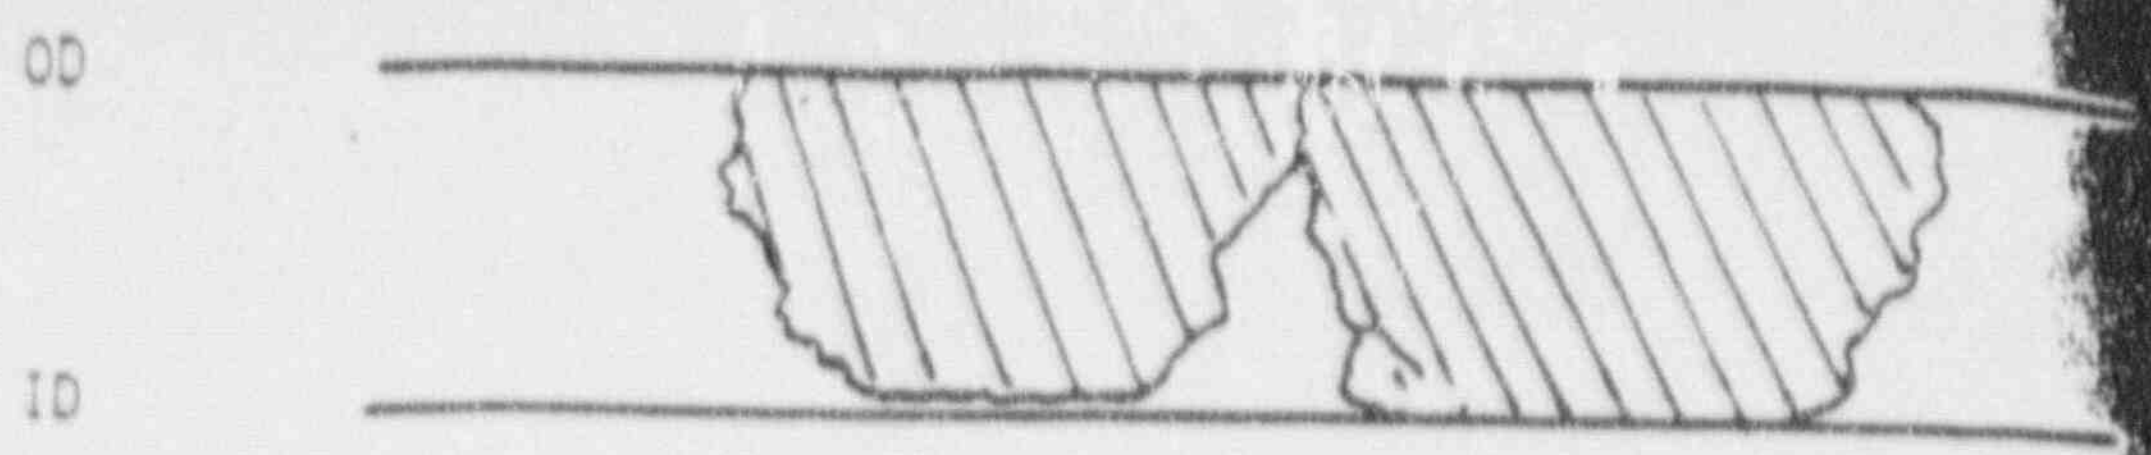
Macrocrack Length = 0.75 inch

Figure 10-34 Summary of burst crack observations and the overall cra distribution observed at the crevice region of tube 555

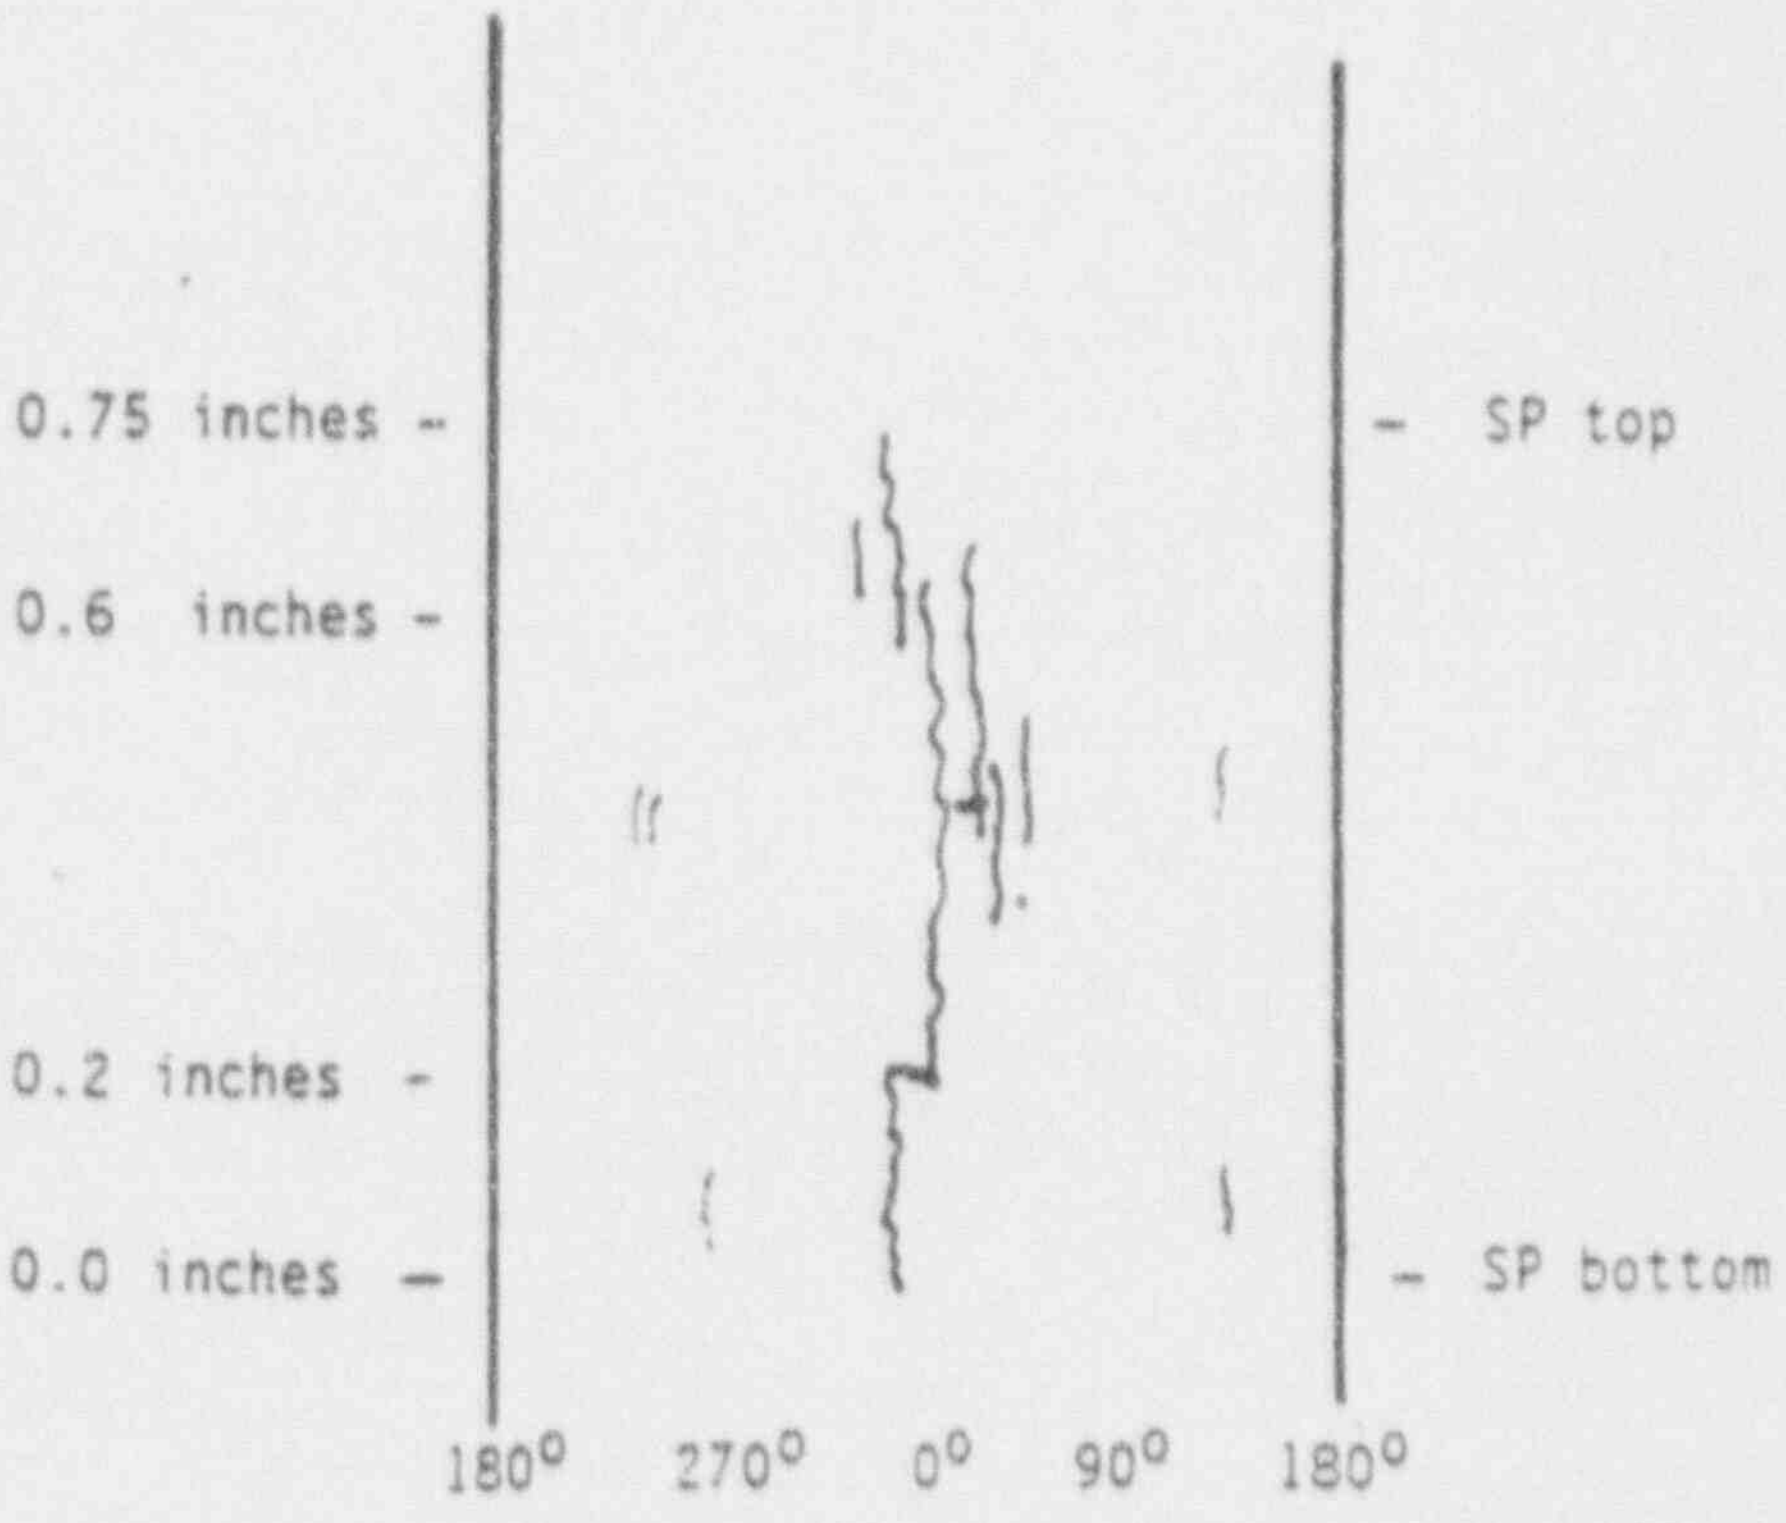
Morphology = IGSCC

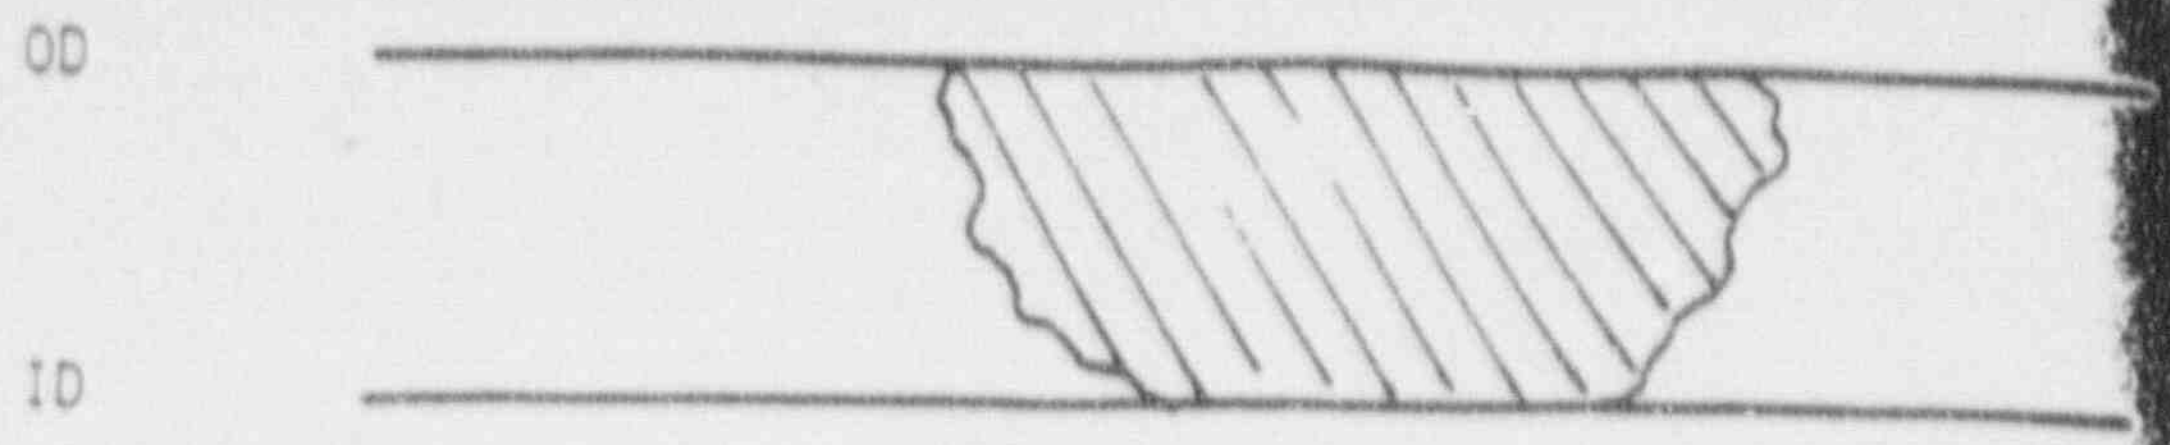
Macrocrack Length = 0.30 inch

Figure 10-36 Summary of burst crack observations and the overall crack distribution observed within the crevice region of tube 576-2.

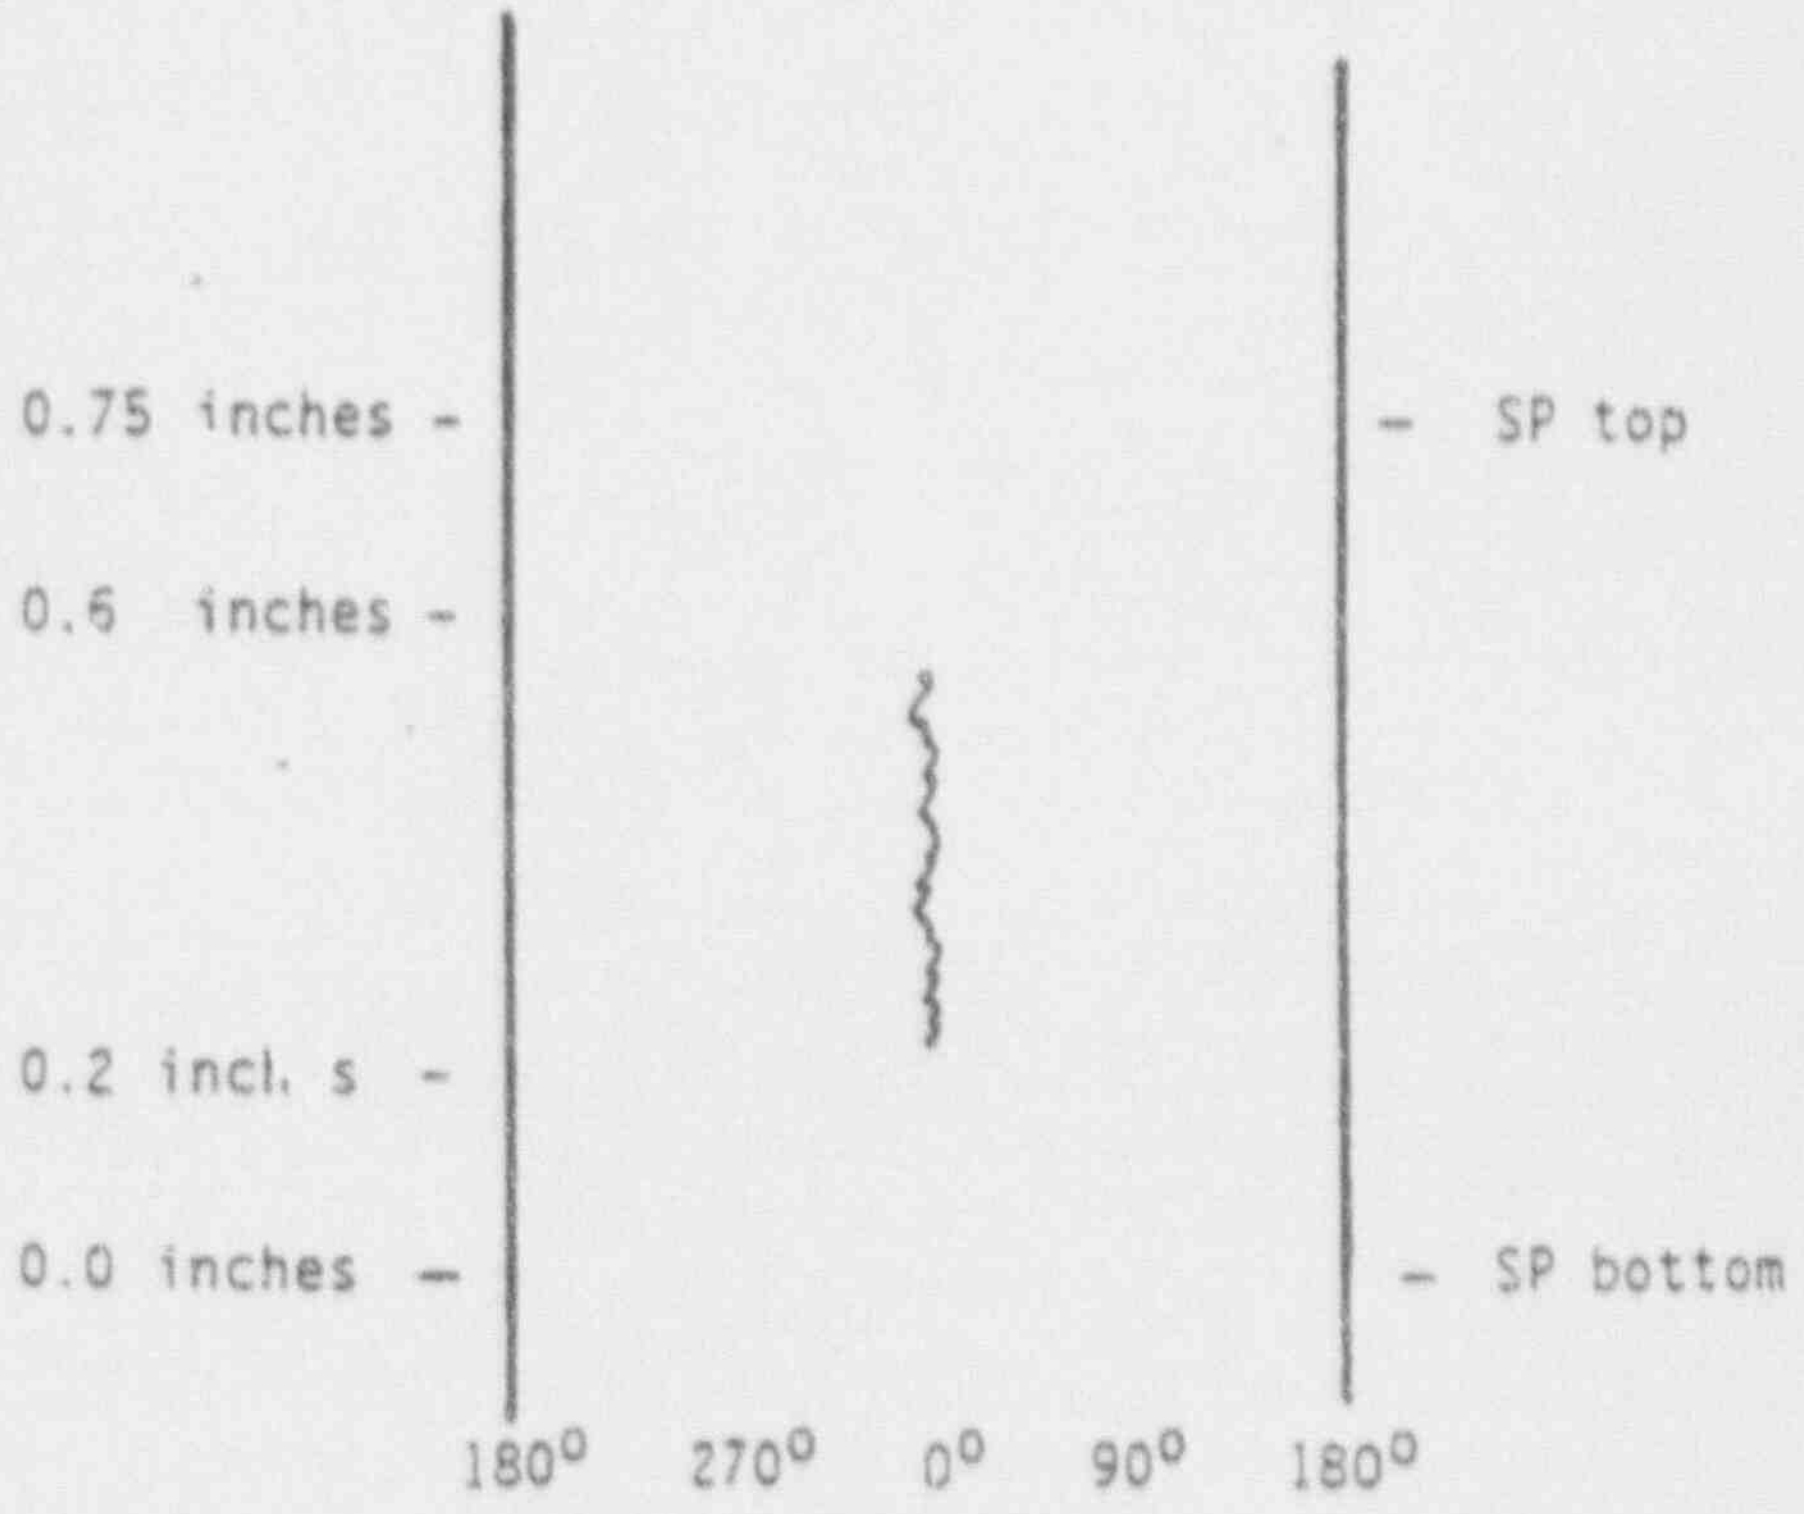
Morphology = IGSCC

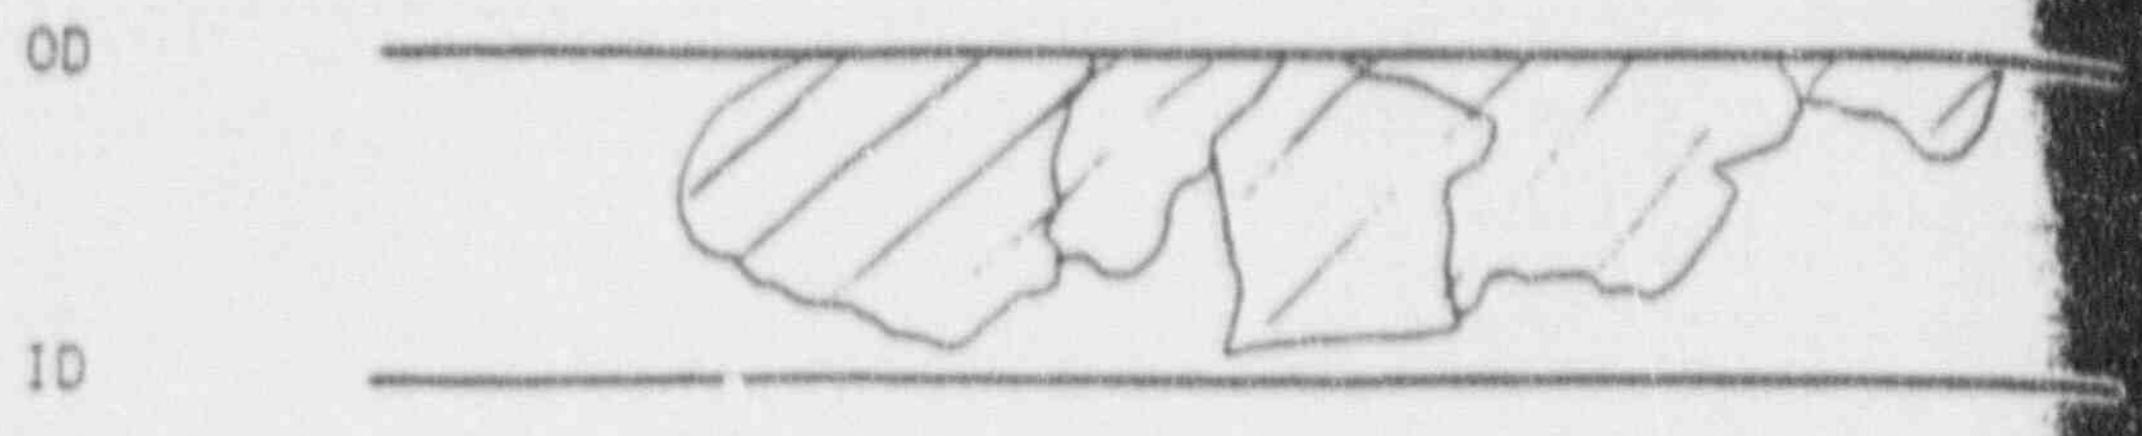
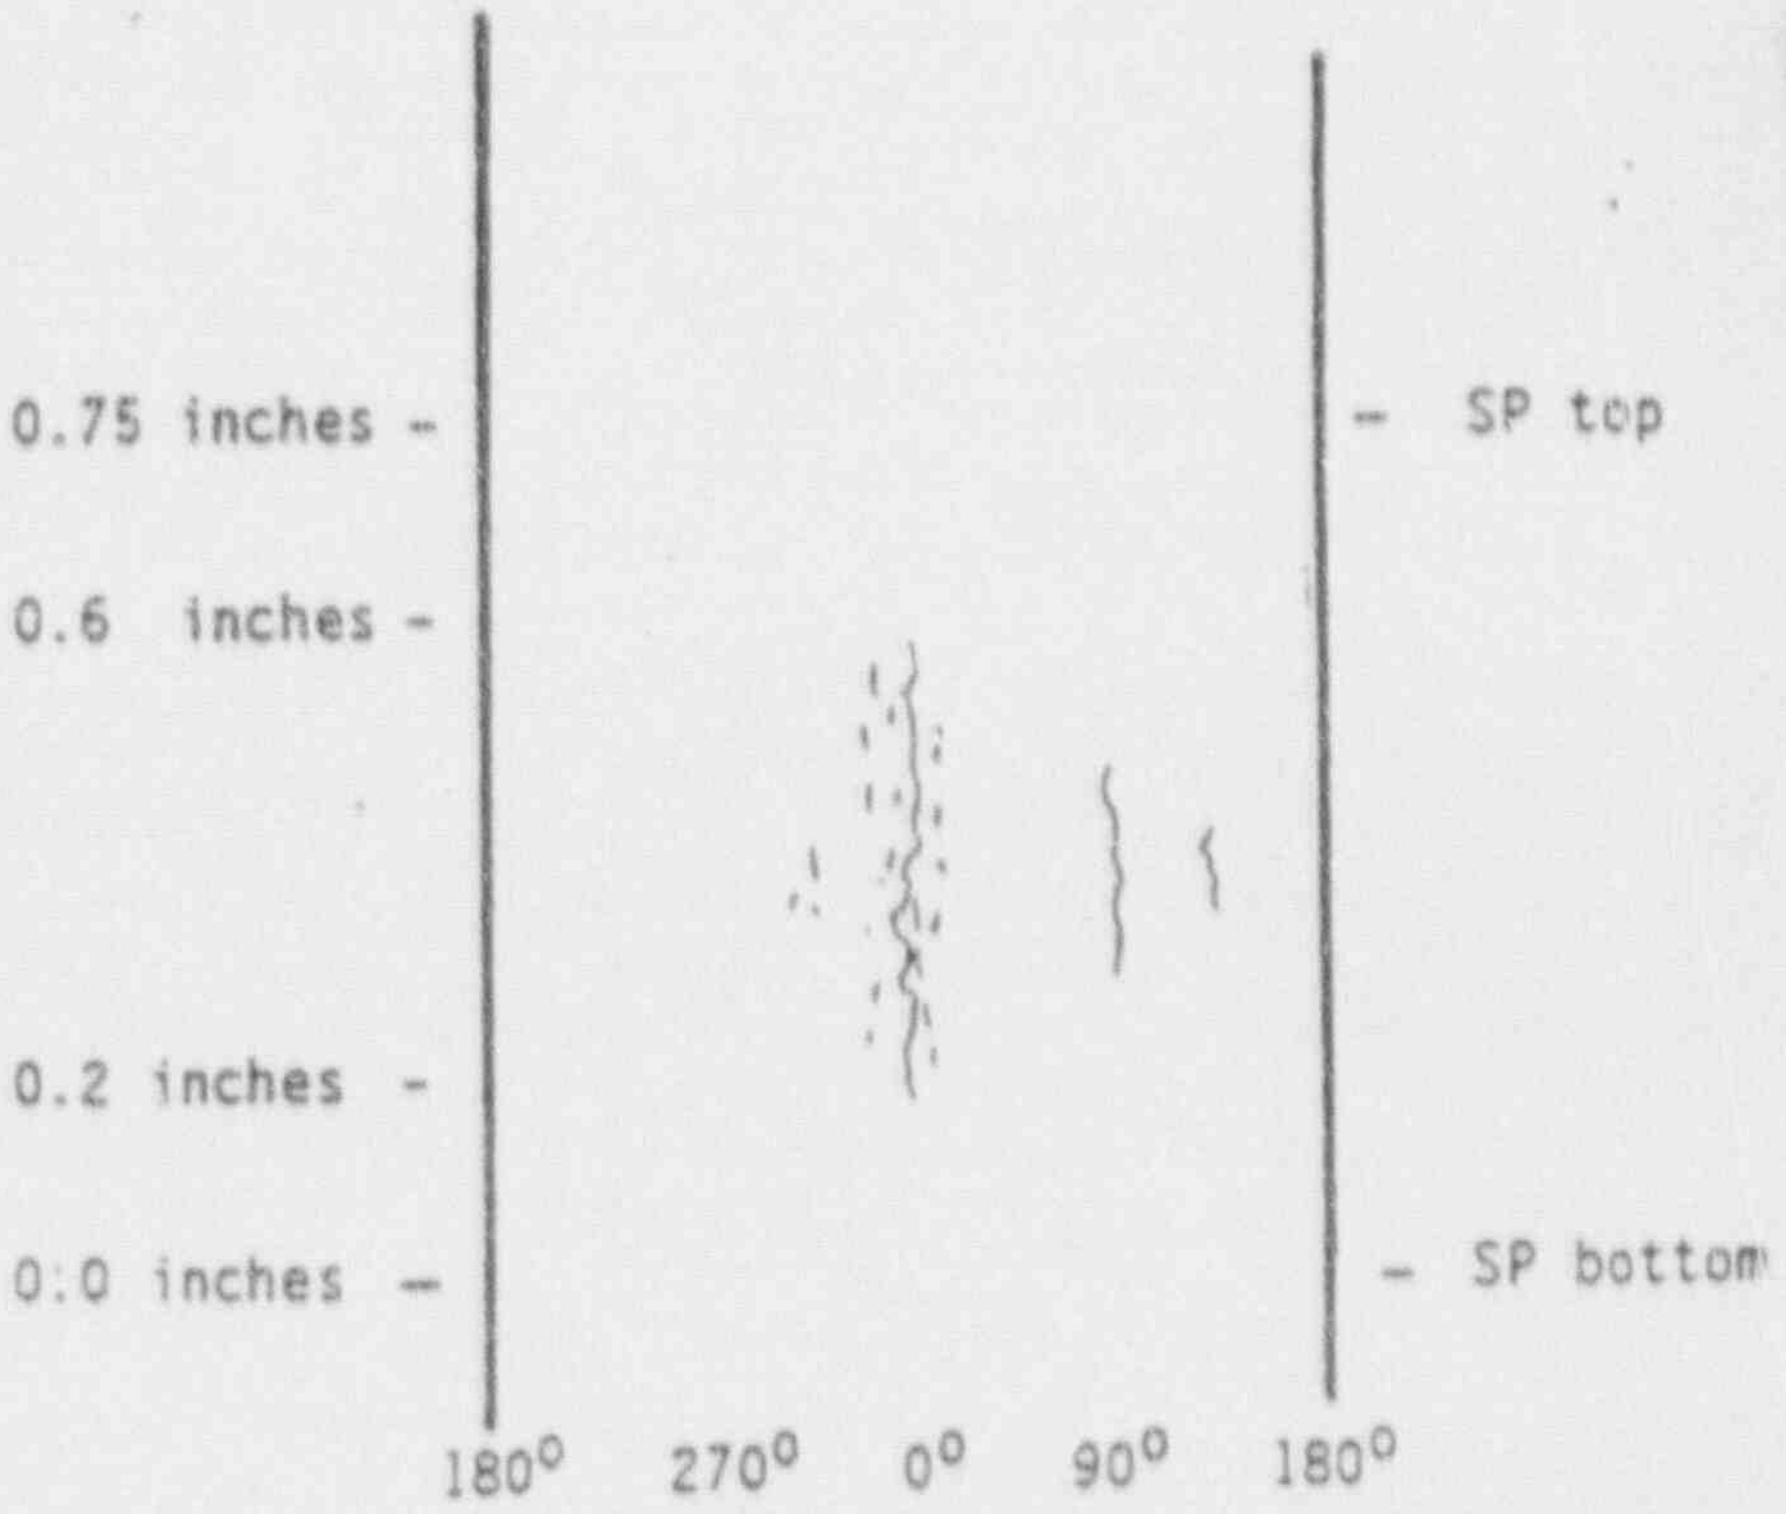
Macrocrack Length = 0.4 inches

Number of Microcracks = 5 (ligaments have mostly ductile features)

Morphology = IGSCC

Figure 10-8 Summary of crack distribution and morphology observed on Tube 536-1.
