SUBJECT: COMMENTS ON "EVALUATION OF DIESEL GENERATOR FAILURE AT
SHOREHAM UNIT 1, INTERIM REPORT ON PHASE 2, FAILURE
CAUSE EVALUATION" (NRC CONTRACT-NRC-03-81-130)

COMMENTS ON FRANKLIN RESEARCH CENTER REPORT
PHASE 2 - CRANKSHAFT FAILURE CAUSE EVALUATION

EVALUATION OF DIESEL GENERATOR FAILURE
AT SHOREHAM UNIT 1

FINAL REPORT, FAILURE CAUSE EVALUATION

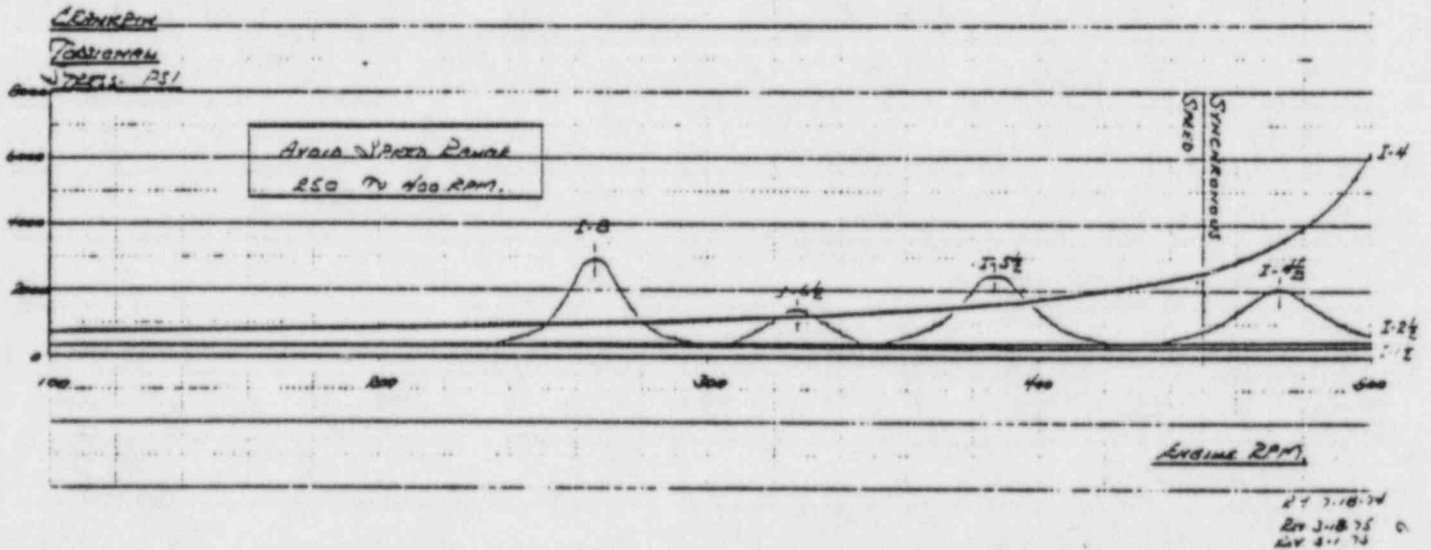
Figure 1. TDI Torsional Stress and Critical Speeds
[from Reference 14]

When received, the torsional analysis report [14] indicated that the 30-Hz firing rate of the engine (4th order) would be sufficiently close to the first mode natural frequency, 35.5 Hz, to build moderately high amplitudes of oscillation at 30 Hz, which is one-half the electrical generation frequency. Accordingly, recommendations were made [13] to ensure that any possible electrical-mechanical interaction would not be missed by the recording of data. These recommendations are included in Appendix C.
