REACTOR CONTAINMENT BUILDING
INTEGRATED LEAKAGE RATE TEST

TYPES A, B, AND C
PERIODIC TEST

VIRGINIA ELECTRIC AND POWER COMPANY
NORTH ANNA POWER STATION
UNIT NO. 1

SEPTEMBER 1984

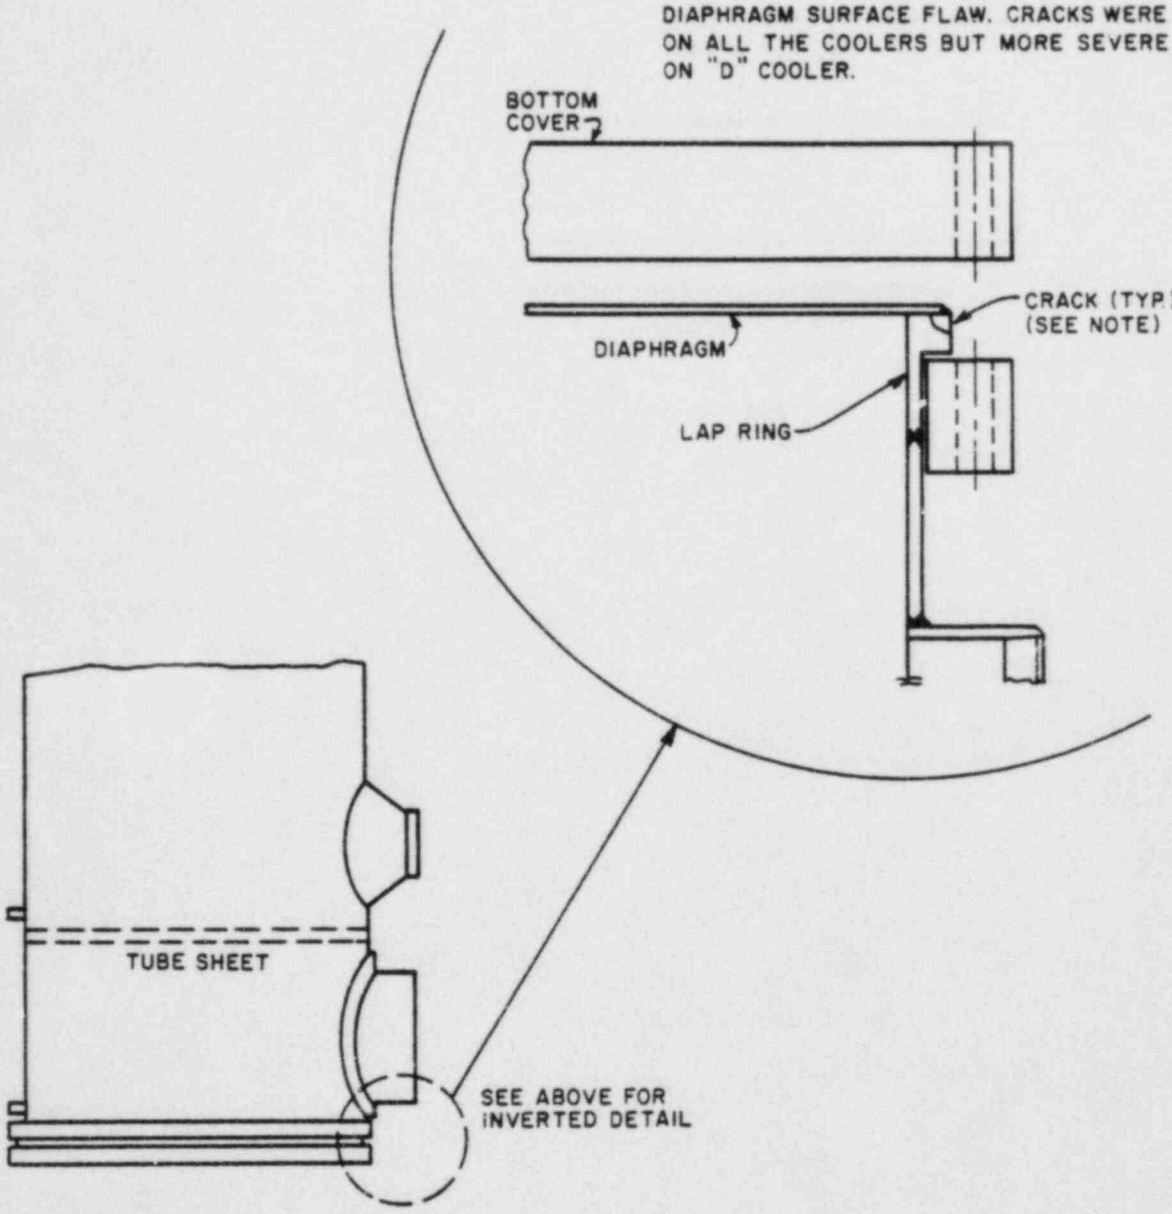
After a series of tests, it was determined that the probable air leakage path was through cracks in the RSHX lap ring (Attachment 2.1A). As reported by VEPCO (Reference 4), these cracks were caused by a Crevice Corrosion and Stress Corrosion Cracking condition. The repairs to the RSHX were completed prior to the September 1984 CILRT. VEPCO is currently evaluating potential modifications for the recirculation spray coolers to address this condition.

NOTE
RADIAL FLAWS WERE FOUND IN THE OUTER 5/8" REGION OF THE 1" THICK LAP RING. THE TYPE A LEAKAGE PATH WAS THROUGH THESE CRACKS AND THROUGH THE "D" COOLER DIAPHRAGM SURFACE FLAW. CRACKS WERE ON ALL THE COOLERS BUT MORE SEVERE ON "D" COOLER.

COOLER LOCATED INSIDE CONTAINMENT, INSTALLED IN VERTICAL POSITION

Note: All four bottom diaphrams were replaced.
