Multirod Burst Test Program Progress Report for April–June 1978

OAK RIDGE NATIONAL LABORATORY

MULTIROD BURST TEST PROGRAM PROGRESS
REPORT FOR APRIL—JUNE 1978

Manuscript Completed — October 13, 1978
Date Published — November 1978

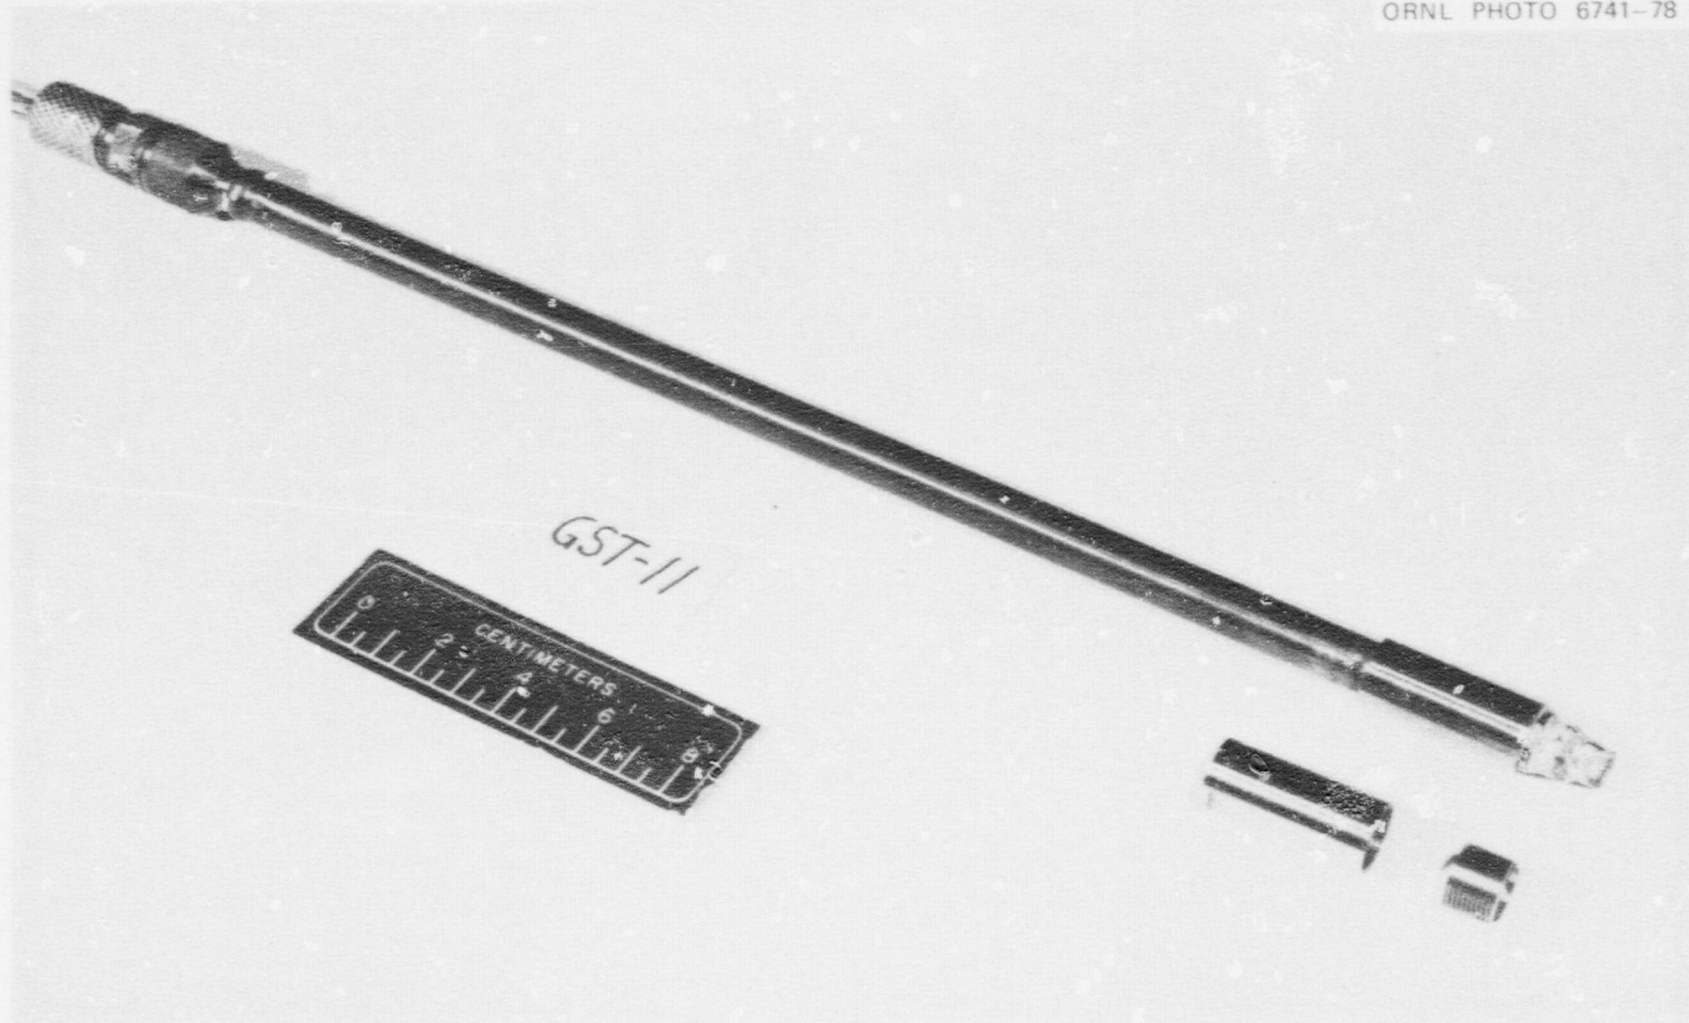
The epoxy system, containing about 68 wt % aluminum powder for added strength, showed good performance in a single unit for several temperature cycles up to a limited temperature of 260°C. However, difficulty was encountered in the preparation and testing of a multiple-unit mockup of the bundle. A typical single-unit test assembly is shown in Fig. 3.1, and the multiple-unit mockup is shown in Fig. 3.2. This system was abandoned for another when it became apparent that several time-consuming iterations might be necessary before it could be applied to the B-3 repair.

Fig. 3.1. Typical single-unit epoxy and sleeve system assembly ready for autoclave testing.

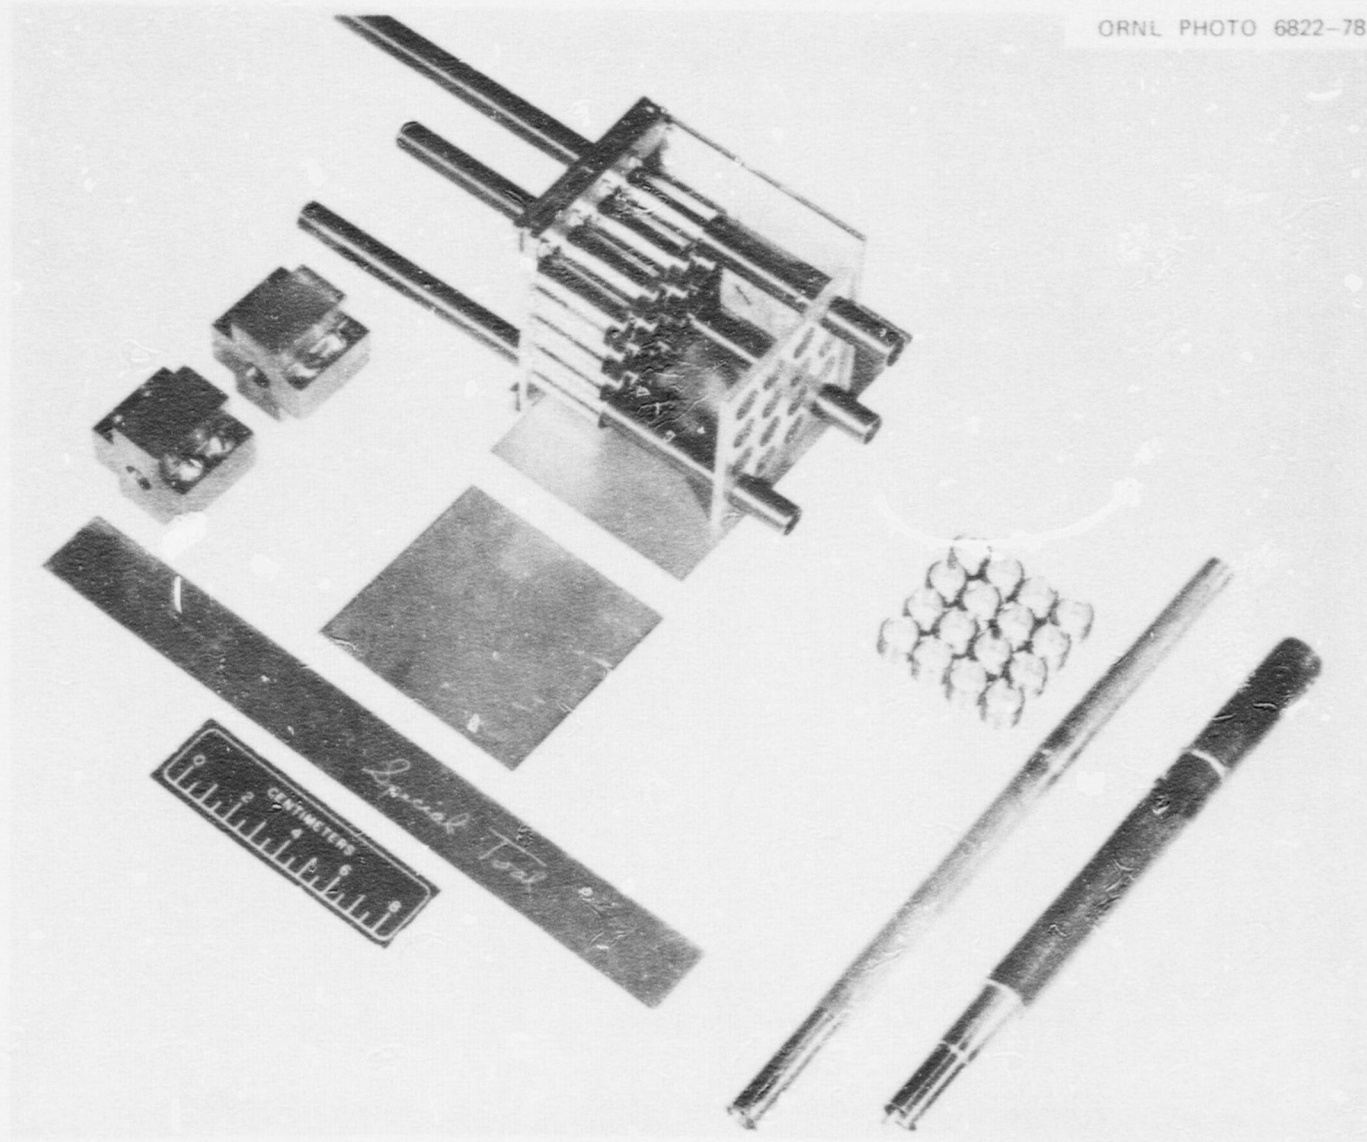
A number of tests were outlined and executed to evaluate various gasket materials and geometries. During the same period, the use of an epoxy-filled seal sleeve assembly external to the leaking gaskets was investigated. The epoxy approach was attractive because of the low risk it would place on disruption of the thermocouples attached to the inside of the Zircaloy tubes; a disadvantage was that simultaneous treatment of all 16 seals would be required and that no retreat would be possible after the epoxy was applied.

Fig. 3.2. Multiple-unit epoxy and sleeve system mockup for B-3 repair. Tools necessary for application and confinement of epoxy are also shown.

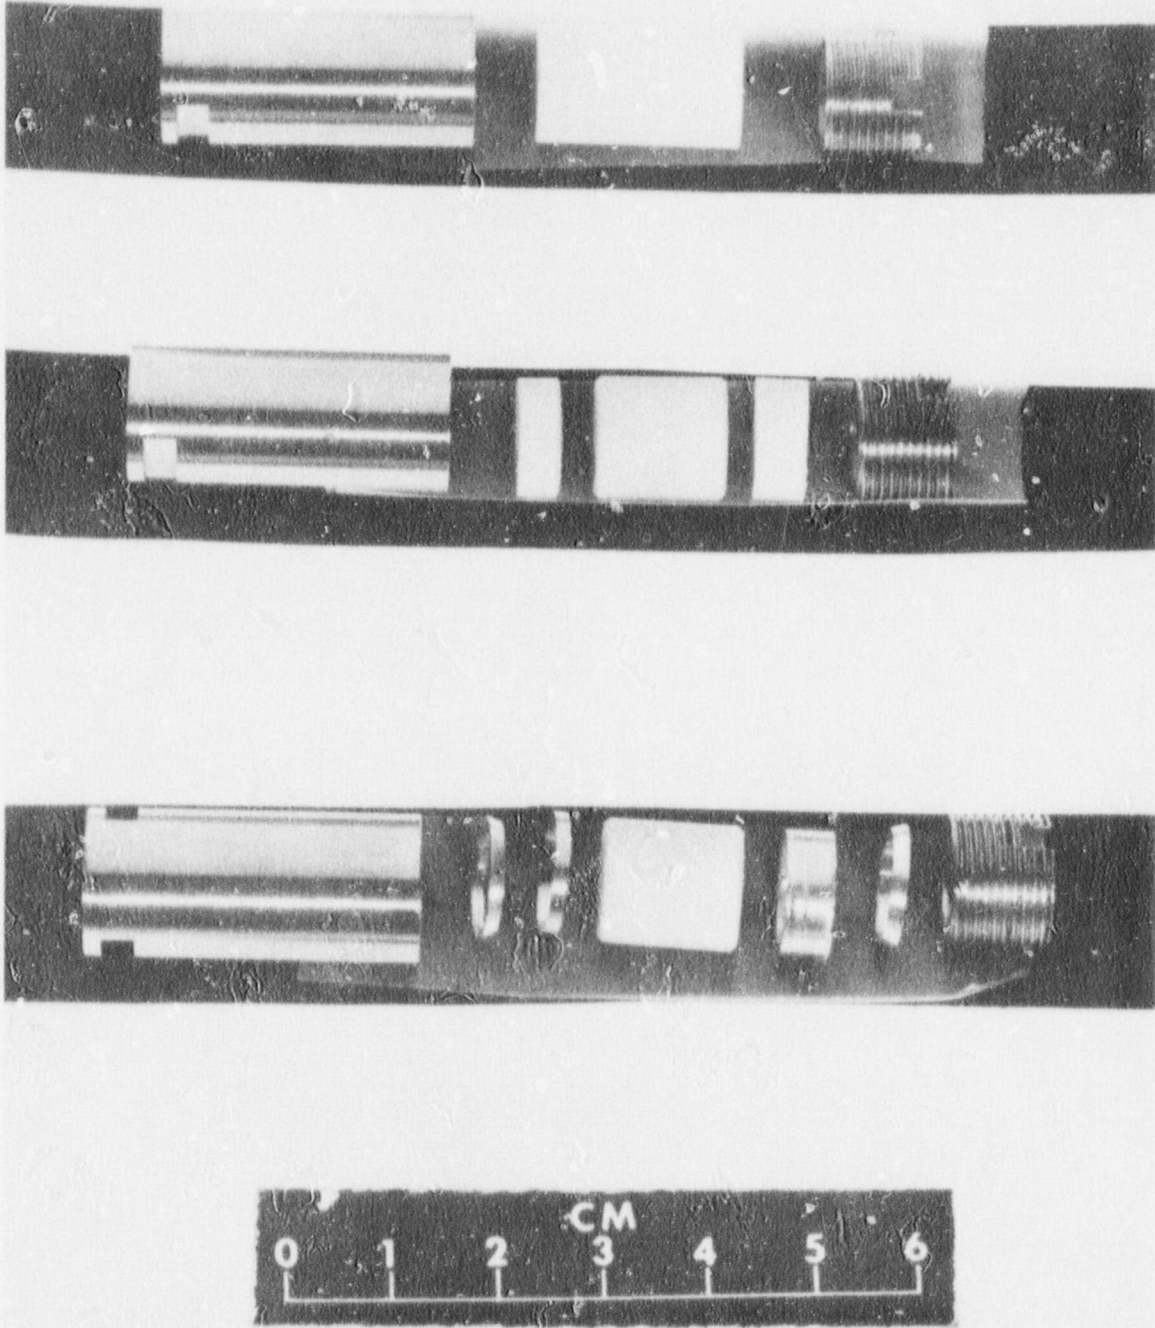
Other sleeve assemblies external to the gasket area were tested with various combinations of Teflon inserts and aluminum cones. However, the best of these combinations survived only $\sim$9000 kPa internal pressure (B-3 would require $\sim$12,000 kPa) at 340°C; Fig. 3.3 shows some of these combinations.

Fig. 3.3. Three sleeves and subassemblies tested for possible use in B-3 repair. Top — Teflon insert; center — Teflon insert with Teflon cones; bottom — Teflon insert with aluminum cones.

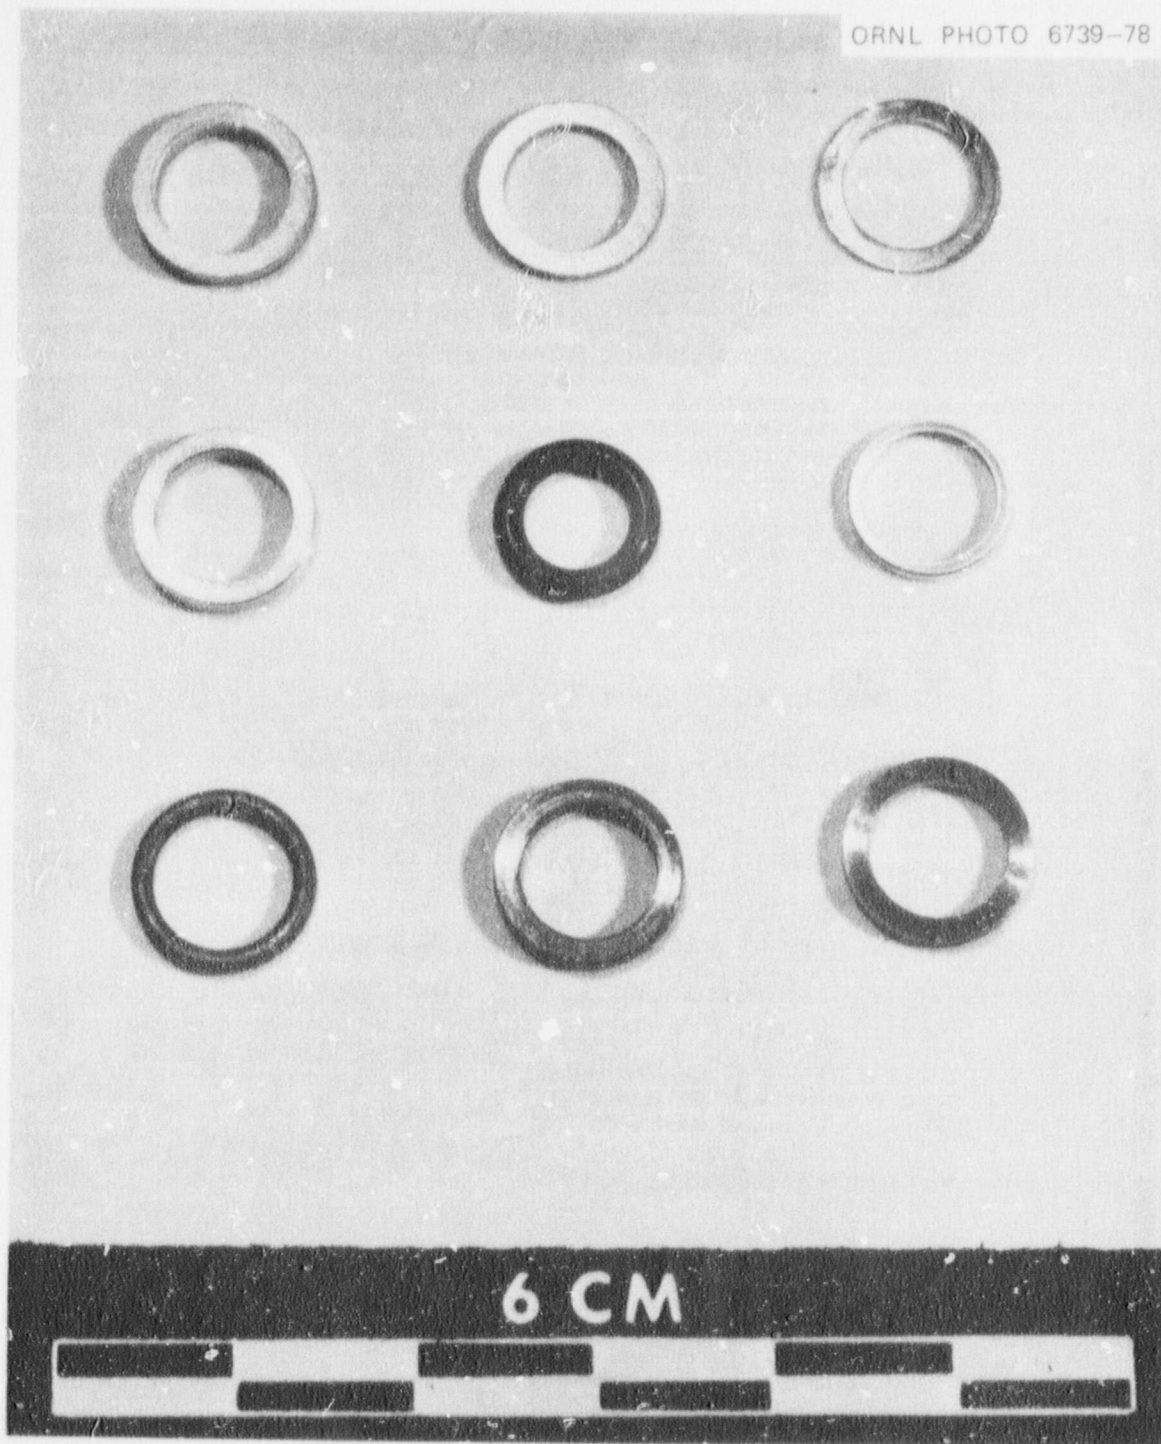
The gasket used in B-3 (and some of which had been used in B-1 and B-2) was a copper "O" ring which has nonstandard dimensions but is manufactured commercially. Before being used in the assembly of FPS, this type of gasket had been successfully tested at the expected temperature and pressure for single cycles. However, more extensive tests done after the abortion of the B-3 test revealed that multiple thermal cycles generally caused leakage. In most tests, leakage occurred after heatup on the second thermal cycle, while others survived as many as six cycles with no leakage problem. A detailed evaluation of numerous tests led to the conclusion that the commercial copper gasket, as used in the B-3 configuration, was marginal at best. (Note: Subsequent development tests have indicated that gasket confinement geometry is at least as important as the gasket itself; however, for the B-3 repair, a revision of the seal geometry was not an available option.)

Fig. 3.4. Some seals tested for use in B-3 repair. Top — gold-plated stainless steel; center — aluminum washer, elastomer "O" ring, and metal "V" ring; bottom — copper "O" ring and washers.

The search for improved gasket materials and configurations included variations of copper, silver, aluminum, gold-plated stainless steel, and several high-temperature elastomers. Some of these materials and shapes are shown in Fig. 3.4. A combination of materials, consisting of a flat copper washer with Teflon backing on the ID, was selected for use on B-3. The Teflon, applied as a tape wrapping, held the washer concentric during installation; more importantly, it was found that the Teflon served as a sealant, flowing into the small crevice that apparently develops under the copper washer on repeated thermal cycling. This method was pursued and successfully demonstrated as an adequate solution for B-3 both in several single-unit tests and in a seven-unit assembly subjected to the pressure, temperature, and steam atmosphere which must be withstood by B-3. The use of this method during the B-3 repair will be attempted in July and will be described in the next progress report.

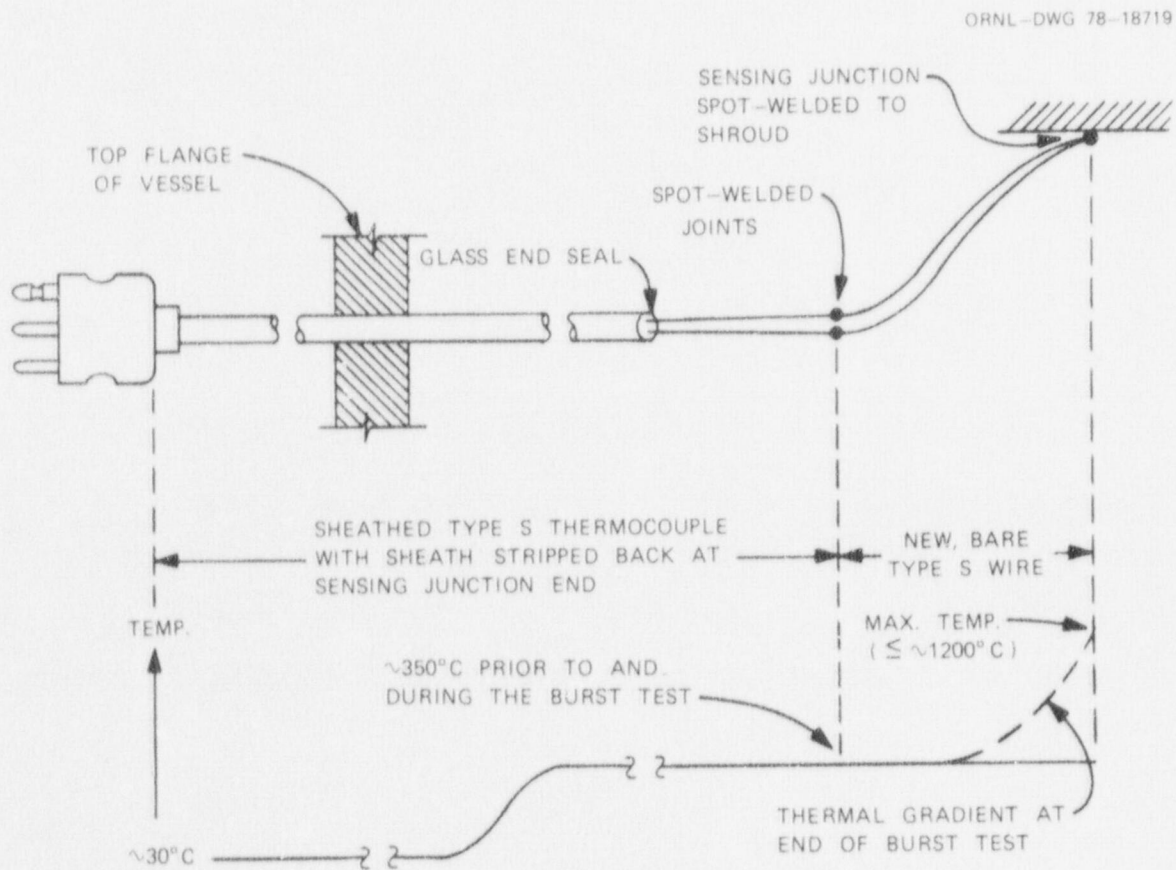
ORNL-DWG 78-18719

The problem of decalibration of the type S shroud thermocouples was described in an earlier report,[3] along with two possible solutions. One solution, that of replacing the wire near the sensing junction with new uncontaminated wire, was implemented for 4 × 4 Bundle 3 and will be used for subsequent bundles. The principal features to be considered for analysis in this method are shown in Fig. 3.5. Prior to the burst test,

Fig. 3.5. Shroud thermocouple installation for 4 × 4 bundle B-3 and subsequent bundles.

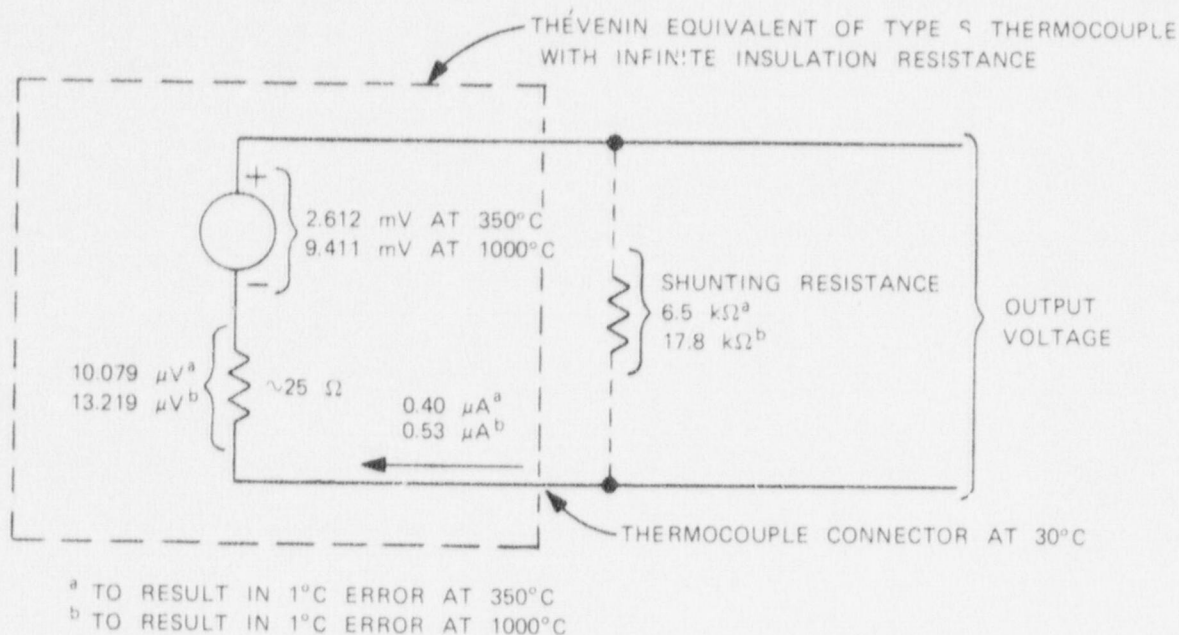
3. A wire-to-wire insulation resistance of sufficiently low magnitude would shunt the thermocouple output signal and result in temperature measurement error, although the shunting resistance would have to be as low as a few kilohms to cause 1°C error, as shown in Fig. 3.6. One possible approach is to omit end seals on these thermocouples altogether, remove (bake out) moisture from the thermocouples just before installation in a test bundle, and verify the absence of moisture or other electrically

Fig. 3.6. Analysis of shunting resistance effects on temperature measurements with type S thermocouples.
