FAQ 23-02 Peach Bottom
PI Interpretation Issue Request

Plant:	**Peach Bottom**		
Date of Event:	**5/16/22**		
Submittal Date:	**5/12/23**		
Licensee Contact:	**Wade Scott**	Tel/Email:	**717-456-3047 wade.scott@constellation.com**
NRC Contact:	**Scott Rutenkroger**	Tel/Email:	**717-456-3313 Scott.Rutenkroger@nrc.gov**

Performance Indicator: Unplanned Scrams with Complications

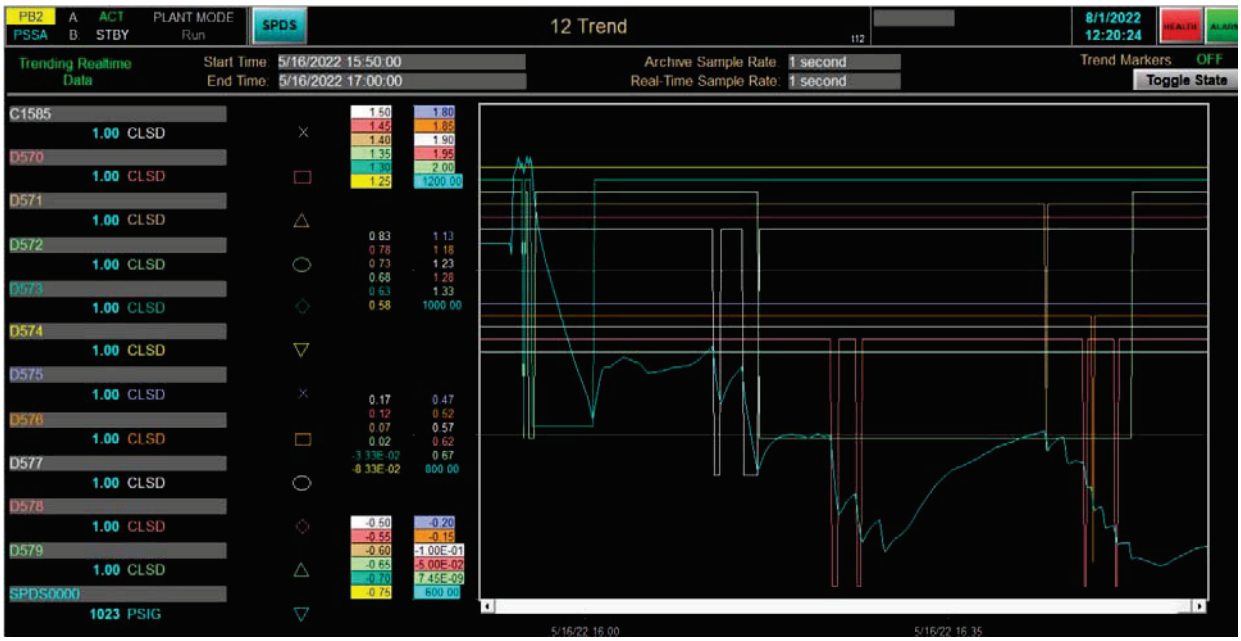
The initiating event for the scram was de-energization of both buses of the reactor protection system (RPS). This resulted in a reactor scram and Group I isolation, closing all main steam isolation valves (MSIVs). All control rods inserted as expected during the scram. Four safety relief valves (SRVs) (of 11 SRVs) opened to mitigate the reactor pressure rise, as expected. Following the initial transient, operators established pressure control in accordance with T-101, "RPV Control", which is entered as part of a normal scram response. Additionally, the response was aligned with procedure OP-PB-101-111-1001, "Strategies for Successful Transient Mitigation". Reactor Core Isolation Cooling (RCIC) was the primary method of level control with initial supplementation from High Pressure Coolant Injection (HPCI). Operators utilized SRVs manually in addition to HPCI in pressure control mode to maintain reactor pressure, as outlined in station procedures. No SRVs cycled automatically subsequent to the initial transient, and no SRVs failed open.

With HPCI in pressure control mode and by manual use of SRVs, operators executed a controlled depressurization to condensate injection. Condensate is able to inject with RPV pressure less than 600 psig, which allows for securing of HPCI and RCIC pumps for injection purposes. The effort to reduce pressure to condensate injection began approximately 40 minutes into the event, which accounts for some of the manual use of SRVs within the first hour.

Use of bypass valves to control pressure and feedwater to control level was not immediately available because the initiating event closed the MSIVs. There was no damage or failed equipment that would have prevented the use of bypass valves or main feedwater. Although several actions would be required to realign the systems, such as reopening of MSIVs and re-establishing condenser vacuum, the systems were available using normal alignments and existing procedures. Restoration of feedwater was not immediately pursued during this event, as level was adequately maintained with RCIC and later condensate, and containment cooling was in service and sufficient. As such, MSIVs were reopened approximately 9 hours after the scram. It is estimated that opening of the MSIVs and feedwater restoration could be completed within 90 minutes if needed.
