August 31, 2001

Subject: Catawba Nuclear Station Units 1 & 2
Docket Nos. 50 -413, 414
McGuire Nuclear Station Units 1 & 2
Docket Nos. 50 -369, 370
Response to NRC Bulletin 2001-01:
Circumferential Cracking of Reactor Pressure Vessel Head Penetration Nozzles

ENCLOSURE I
CATAWBA NUCLEAR STATION'S RESPONSE
Response to NRC Bulletin 2001-01

ENCLOSURE II
McGuire NUCLEAR STATION'S RESPONSE
Response to NRC Bulletin 2001-01

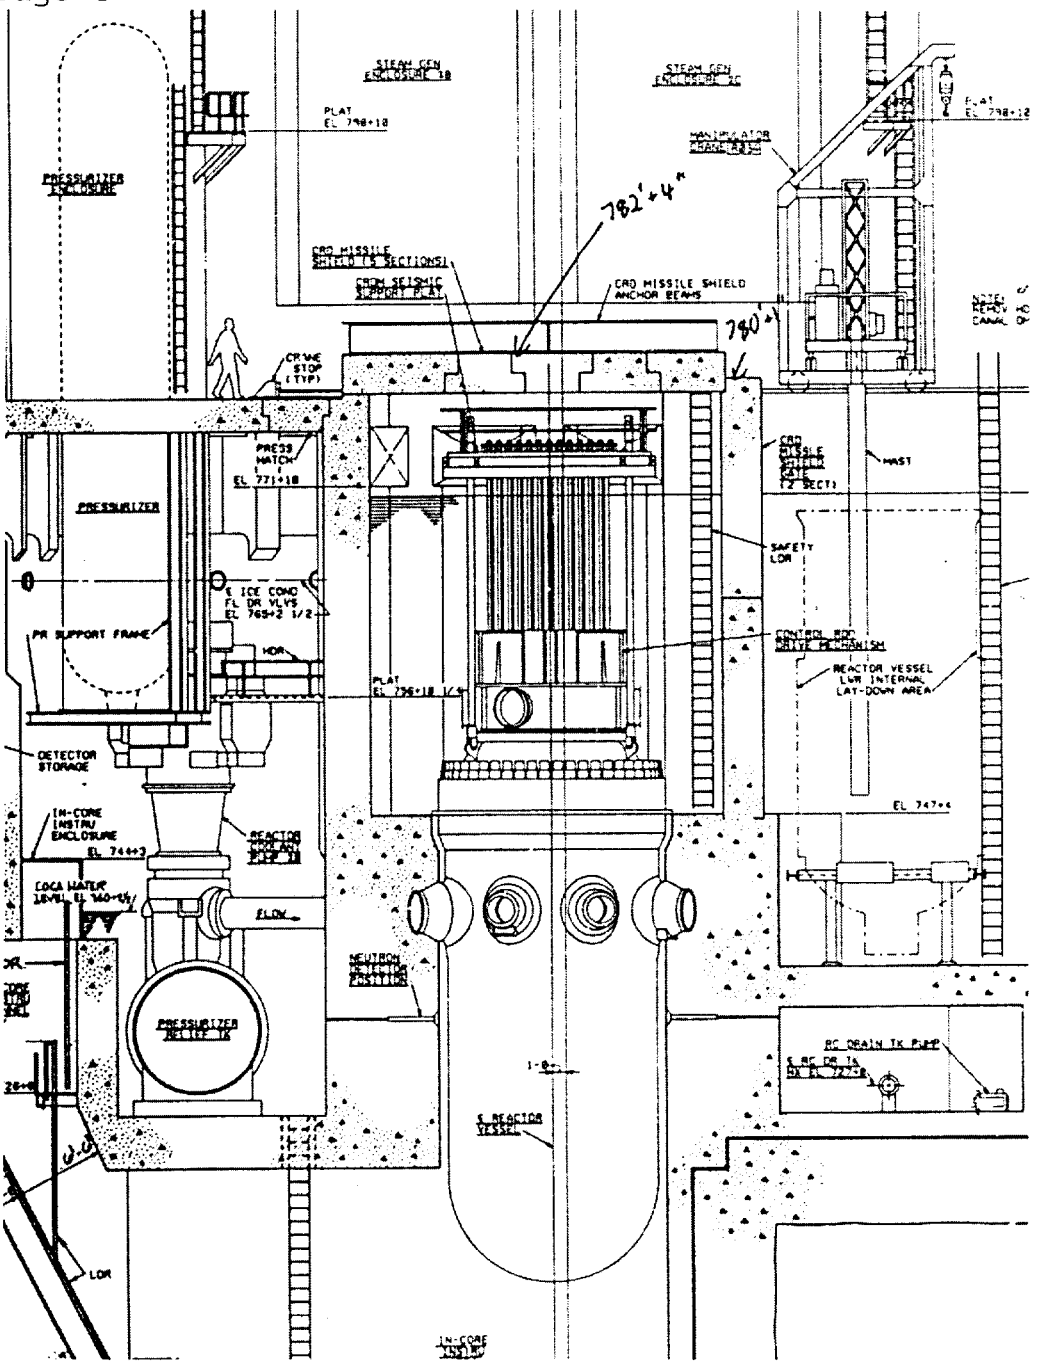
Figure 1 Schematic showing the position of the missile shield relative to the RV head service structure.

Response:
The general arrangement for the missile shield and the reactor vessel head support structure are approximately the same for Catawba and McGuire. The horizontal missile shields consist of 5 sections centered over the reactor vessel that are 3 feet thick. The approximate vertical distances from the bottom of the missile shield to various locations are given in Table 1. A schematic of the reactor vessel head service structure and the missile shield are shown in Figure 1.

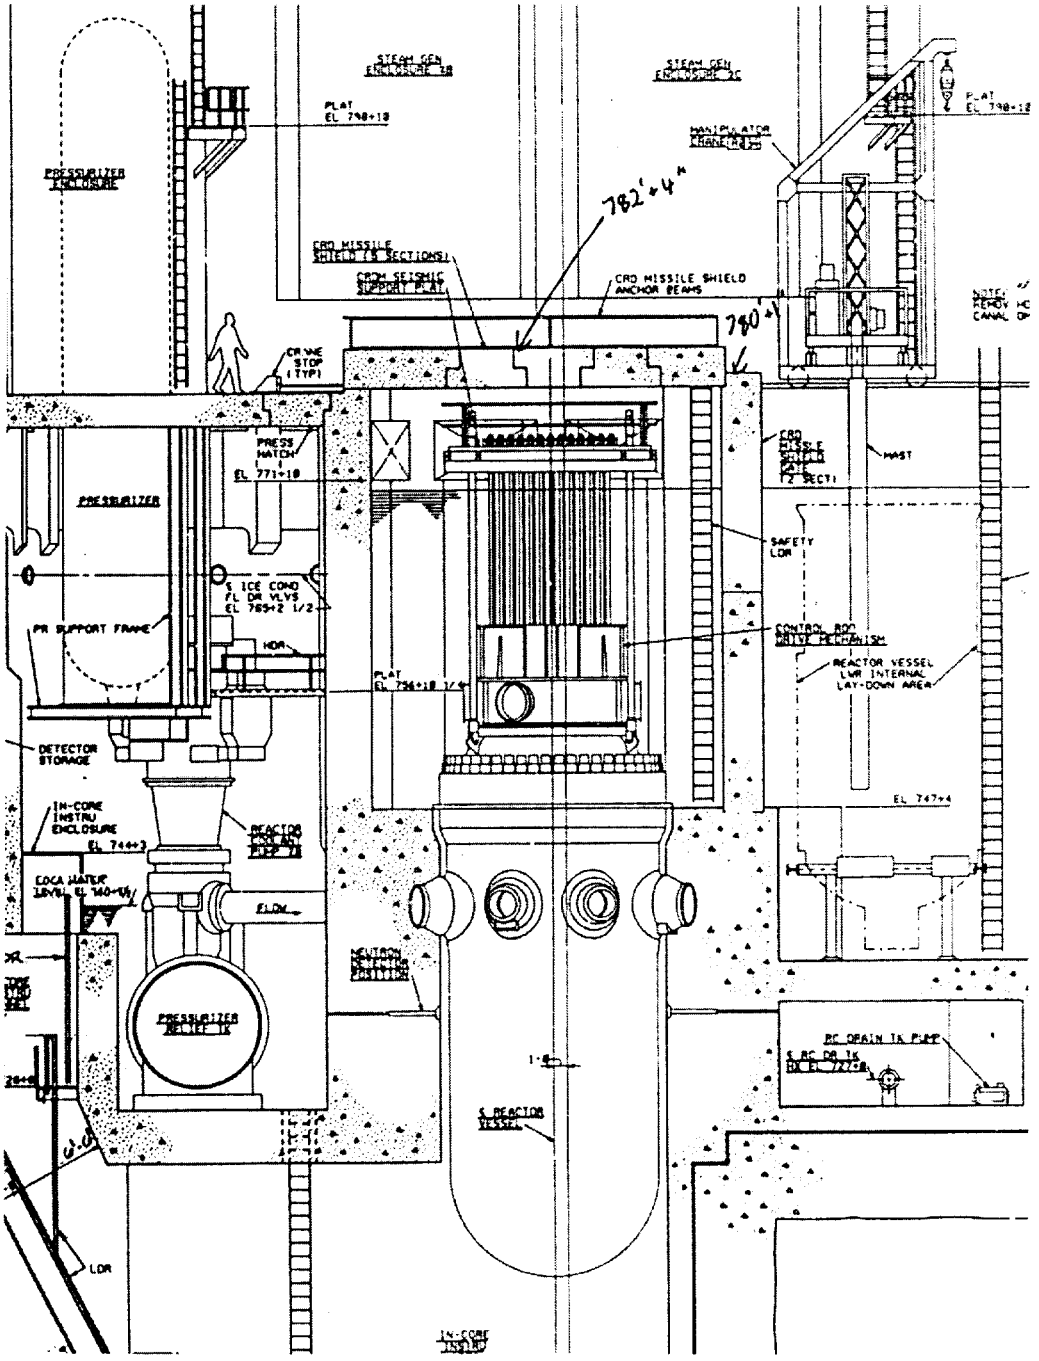
Figure 1 Schematic showing the position of the missile shield relative to the RV head service structure.

The general arrangement for the missile shield and the reactor vessel head support structure are approximately the same for Catawba and McGuire. The horizontal missile shields consist of 5 sections centered over the reactor vessel that are 3 feet thick. The approximate vertical distances from the bottom of the missile shield to various locations are given in Table 1. A

schematic of the reactor vessel head service structure and the missile shield are shown in Figure 1.
