# **ANALYSIS OF RAIL CAR COMPONENTS EXPOSED TO A TUNNEL FIRE ENVIRONMENT**

**U.S. Nuclear Regulatory Commission  
Contract NRC-02-02-012**

**Center for Nuclear Waste Regulatory Analyses  
San Antonio, Texas**

**November 2002**

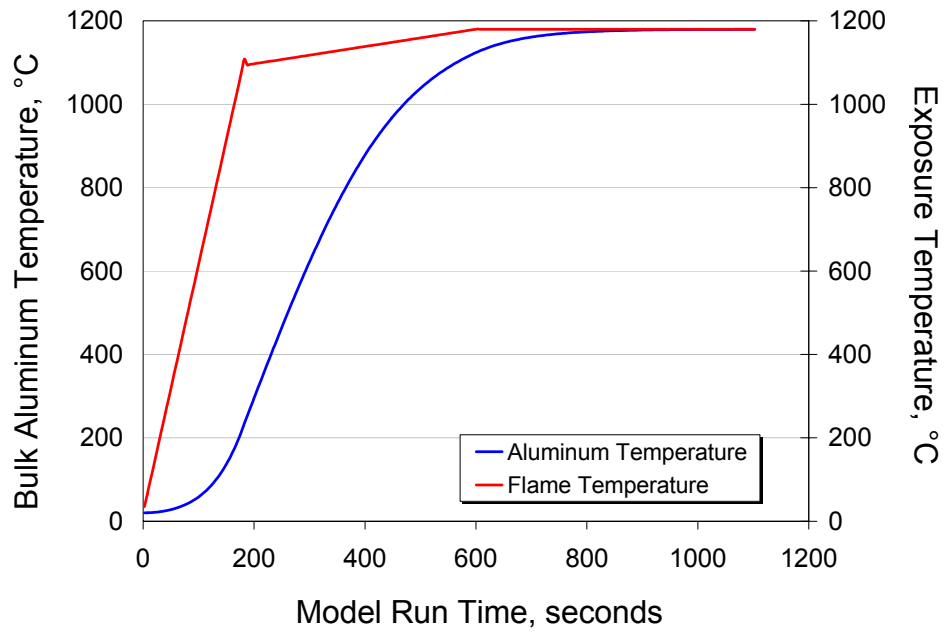
When modeled using this fire exposure, the sample aluminum element exhibits melting at 300 seconds into the exposure (see Figure 5-1).

**Figure 5-1. ASTM E 1529 (1993) Ramp Function and Corresponding Aluminum Thermal Profile (Melting Predicted at 300 seconds)**

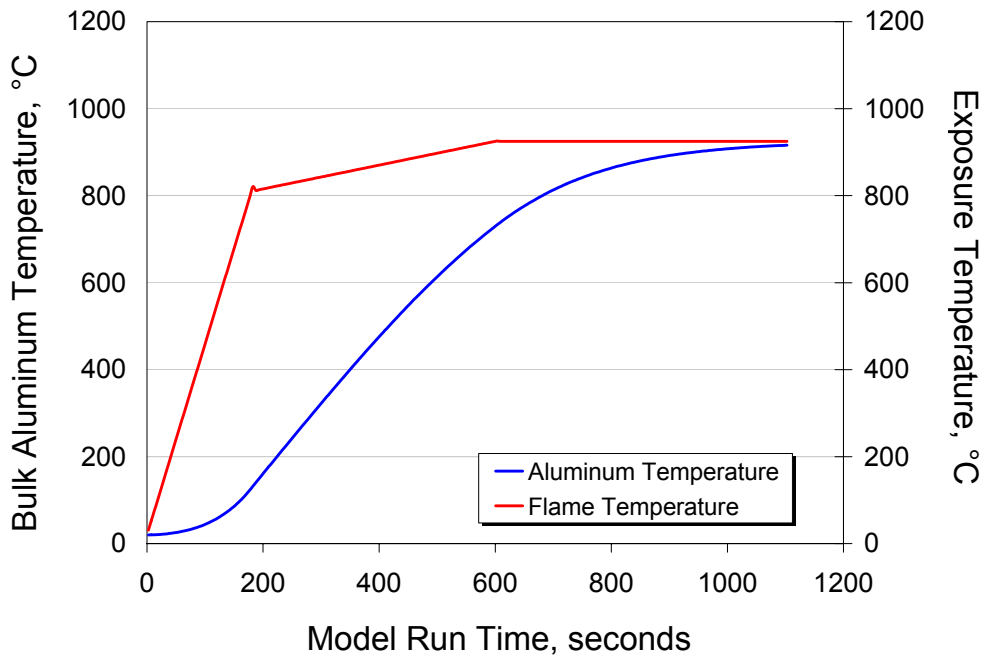
Figure 5-2 illustrates that, when taking the published flame temperature as the maximum temperature experienced by the valve, any exposure time greater than 360 seconds will produce melting conditions.

**Figure 5-2. Published Flame Temperature Ramp Function and Corresponding Aluminum Thermal Profile (Melting Predicted at ~500 seconds)**

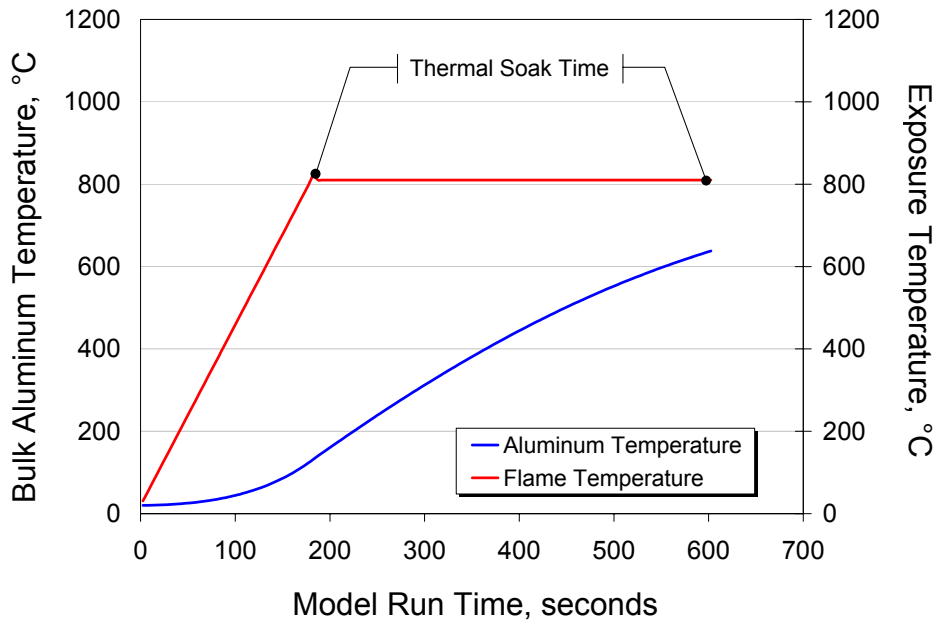
**Figure 5-3. Ramp-Plateau Function Demonstrates Melting at Published Flame Temperature for Exposure Times Greater than 360 Seconds**

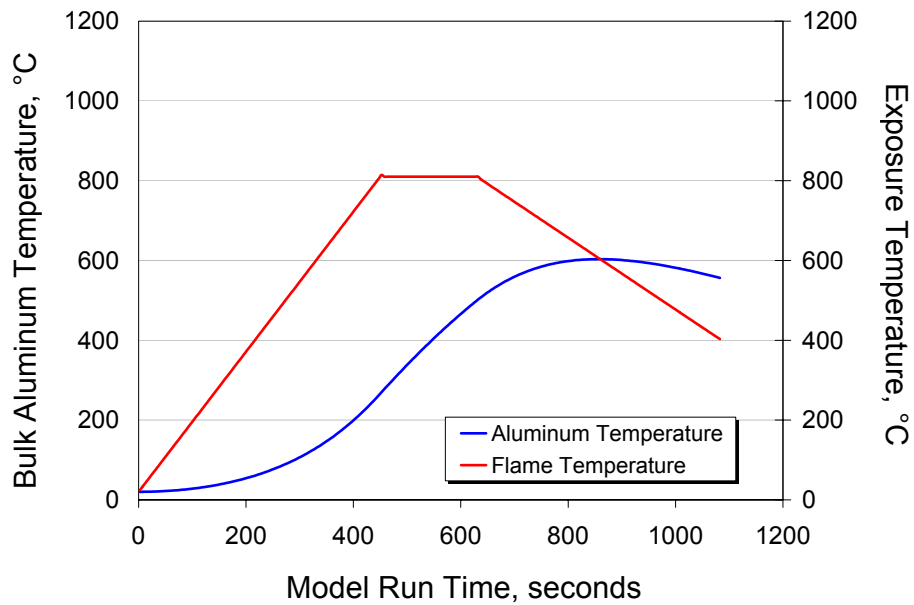
**Figure 5-4. Ramp-Plateau-Decay Function and Corresponding Aluminum Thermal Profile (Melting Predicted at ~800 seconds)**

The conditions depicted in Figure 5-4 may be more difficult than originally assumed because 810 °C [1,490 °F] is the actual, published flame temperature of the fuel. The valve would have had to be completely engulfed in flames for it to realize these temperatures. Considering the location of the valve, 10 m [33 ft] uphill, and its position in the tunnel (low to the floor), total flame engulfment may have only occurred intermittently and, possibly, for only a short duration.
