# Three Selected Accidents

# Samut Prakarn

# Istanbul

# Goiania

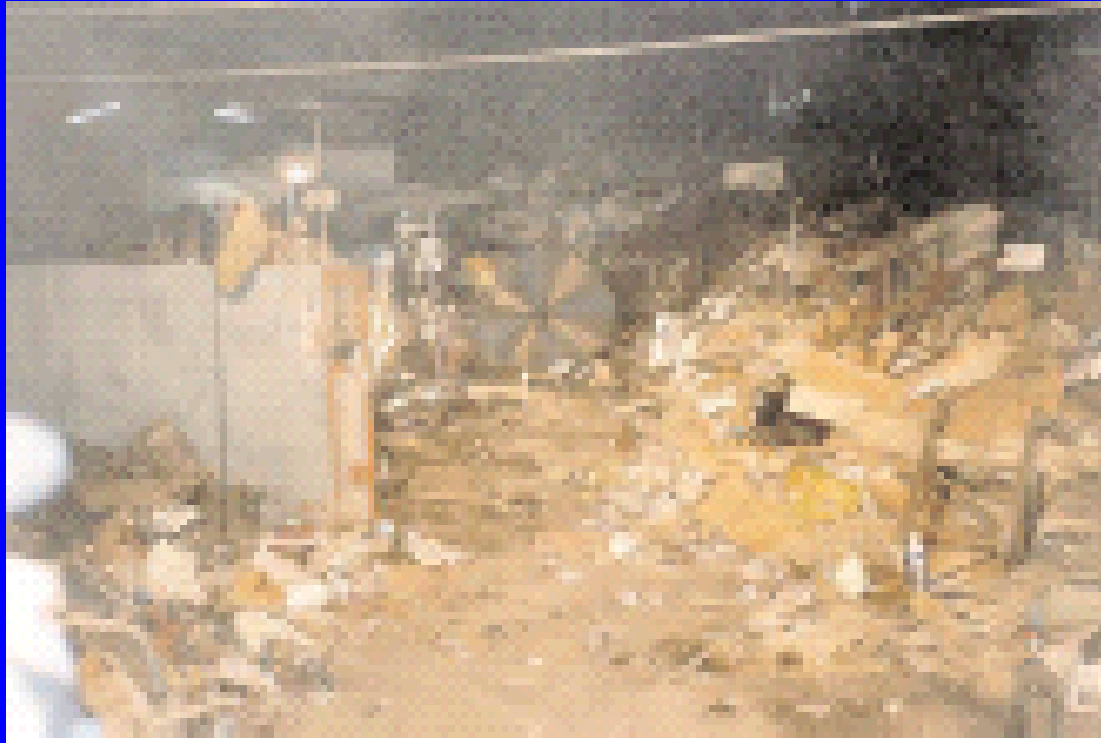
Scrap metal/junk yard at night

Responders practiced retrieval techniques using dummy sources.

Used front loader to move a lead shield near the source.

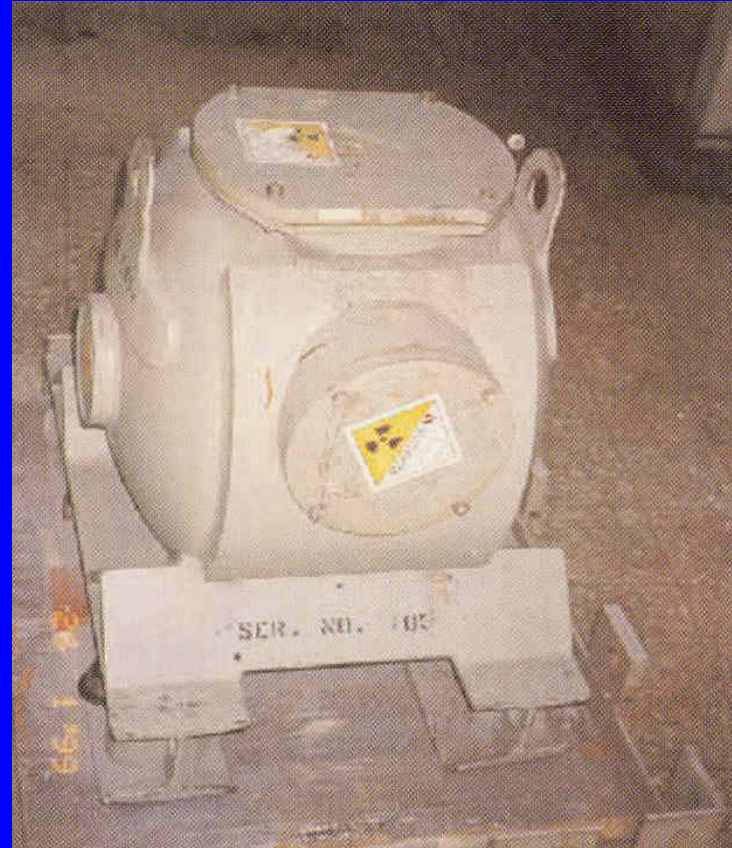
Source Exchange Container

The scrap metal workers opened up the shielded container.
