SUBJECT: NATIONAL INSTITUTE OF STANDARDS AND TECHNOLOGY – REPORT ON  
THE REGULATORY AUDIT RE: RESTART REQUEST FOLLOWING  
EXCEEDANCE OF CLADDING TEMPERATURE SAFETY LIMIT  
(EPID: L-2021-LLN-0000)

REGULATORY AUDIT REPORT

REGARDING REVIEW OF THE RESTART REQUEST

NATIONAL BUREAU OF STANDARDS TEST REACTOR

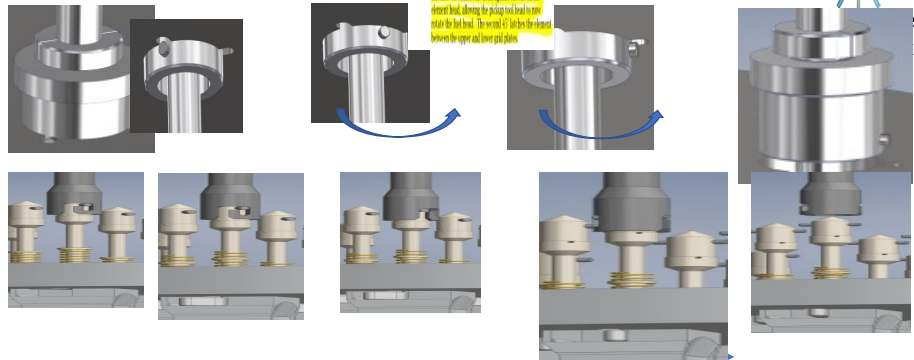
21.11.0. Continue to lower element until the tool stops. At this time the pin on the element should be visible from the lower grid plate.

21.11.0. Depress and rotate the pinning tool counter-clockwise until it stops. At least 90° of rotation should be achieved. The back of rotation the tool against the case on the element head, allowing the pinning tool head to come inside the tool head. The vertical of latching is evident between the upper and lower grid plates.

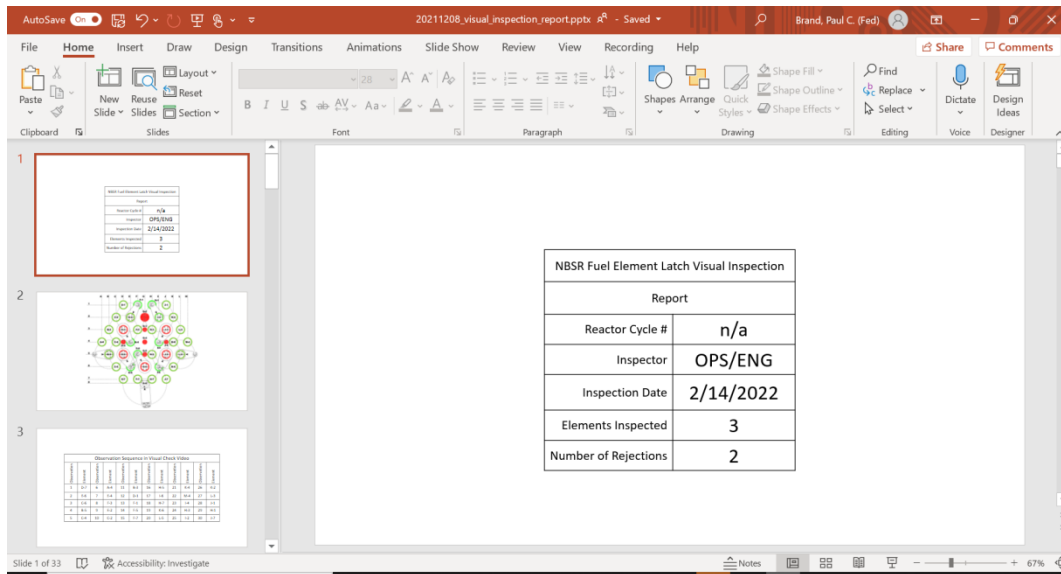
Figure 15, “NBSR Fuel Element Latch Visual Inspection Report”

Section 7.10, “Completing the Template,” in OI 6.1.9 states that when all elements that are a part of the subject inspection have met the disposition of either accepted or rejected, the required table will be completed as part of a report as shown in Figure 15. Section 7 in OI 6.1.9 concludes by stating that the reactor may not be started until there is visual proof that all fuel elements are properly latched as required by the NBSR Technical Specifications.
