**Bottom Mounted Instrument  
Penetration Tube Condition Update**

6/5/03

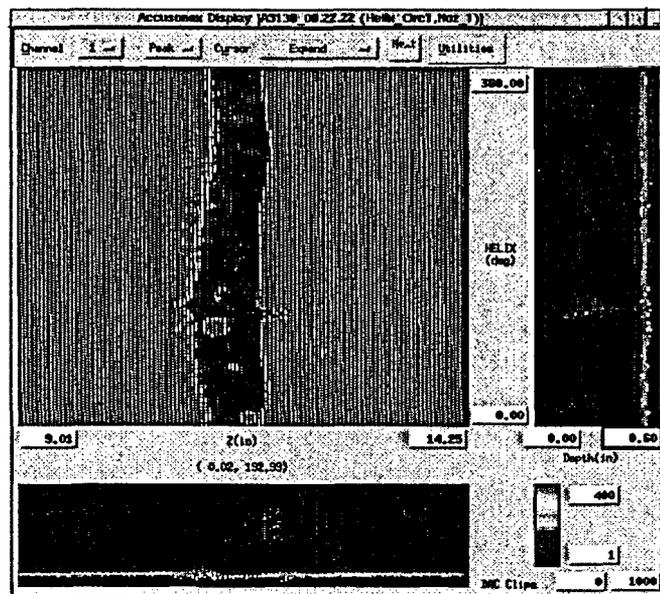
## Penetration #1 Weld Profile

- Penetration #1
  - Three axial indications, one leak path
  - No crack-like indications on J-Groove weld
  - Visual grinding marks in side of tube
- Penetration #46
  - Two axial indications, one leak path
  - No crack-like indications on J-Groove weld

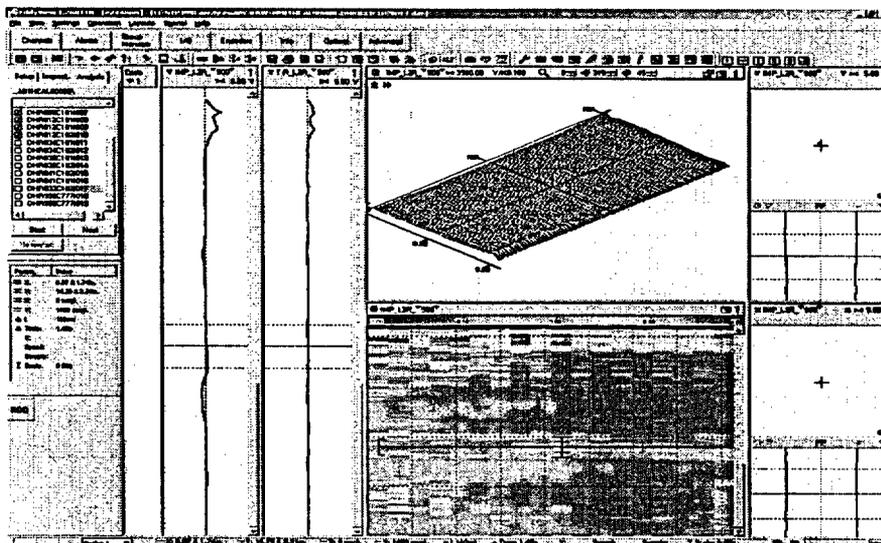
# Penetration 33 J-Groove exam

- No flaws in the 55\* other nozzles
- No evidence of circumferential cracks
- No evidence of ID initiated cracks

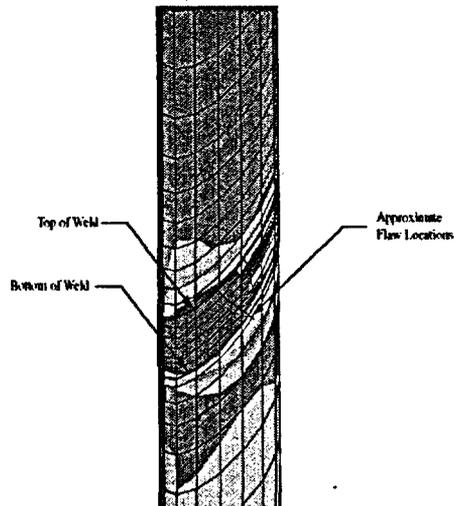
## Flaw Locations and Stresses

- Residual stresses favor axial crack orientation
- No circumferential cracks

Nozzle Alone, Showing Approximate Flow Locations and Stresses in the Direction Parallel to the Plane of the Weld

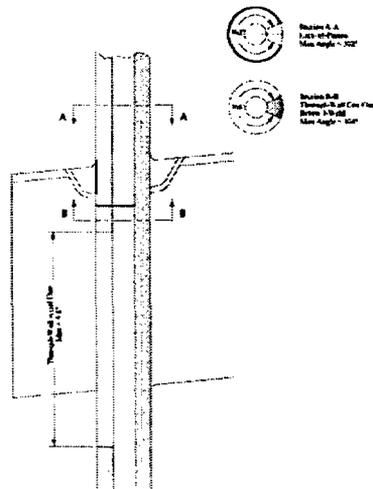
Figure 4-1

- Residual stresses favor axial crack orientation
- No circumferential cracks
- Robust design
- Limiting flaw size

Locations of Analyzed Axial and Circumferential Flaws
