7. FENOC/Davis-Besse Response to CRDM Cracking and Boric Acid Corrosion Issues

7.1 Davis-Besse Actions and Responses to Key US NRC and Industry Initiatives

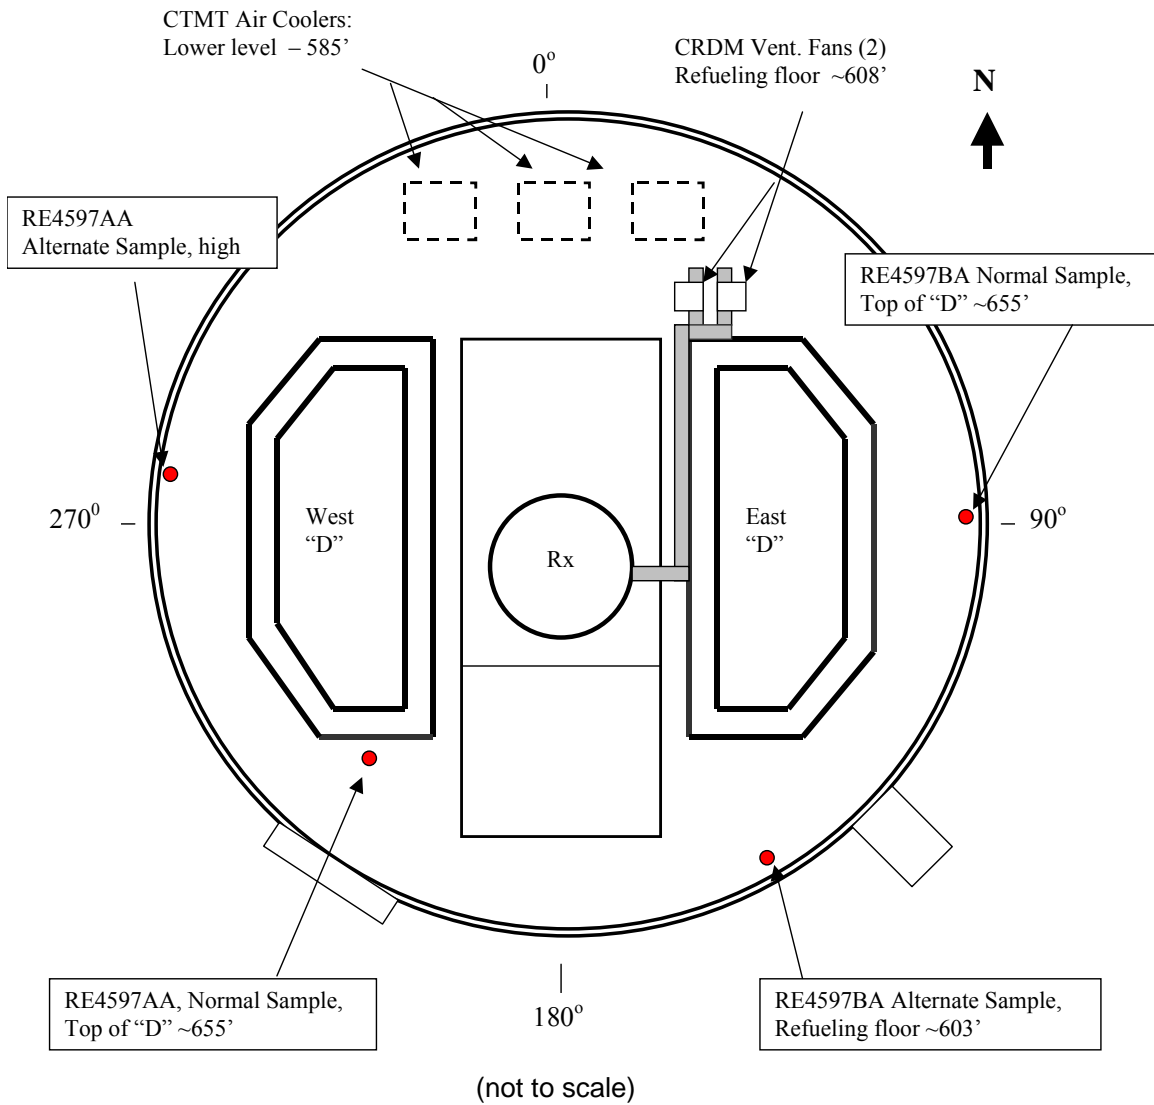
Figure 7.5 Location of radiation monitors RE 4597AA and RE 4597BA.⁷⁰

Radiation monitors RE 4597AA and RE 4597BA are two identical containment air sample monitoring systems. These monitors provide a means to detect RCS leakage through particulate and noble gas activity detection. These detector systems draw a continuous sample from containment and pass this sample through a fixed particulate filter and an iodine cartridge through the use of a pump. The sample then passes through a noble gas chamber and is discharged back to containment atmosphere. The containment radioactive gas monitor is less sensitive than the containment air particulate. The location of radiation monitors RE 4597AA and RE 4597BA is shown in Figure 7.5.⁷⁰
