10. The Unique Nature of the Davis-Besse Nozzle 3 Crack and the RPV Head Wastage Cavity

10.1 Wastage Cavities at Nozzles 3 and 2

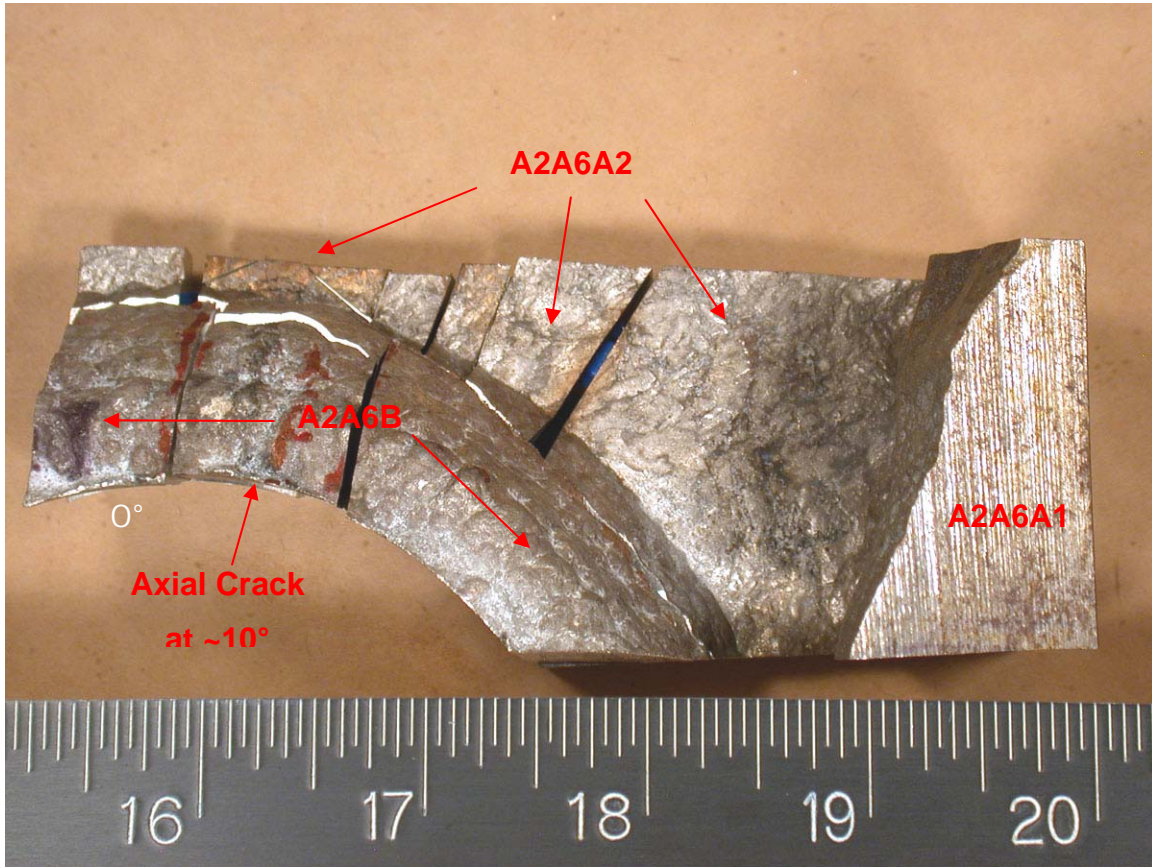
Figure 10.12 Piece A2A6 was first sectioned into Pieces A2A6A and A2A6B. Piece A2A6A was further sectioned into Pieces A2A6A1 and A2A6A2. Both cuts were made on the same plane, parallel to the paper. The first cut line is partially visible; Piece A2A6B is the upper portion of the weld. The second cut line between Pieces A2A6A1 and A2A6A2 is obscured by Piece A2A6A1

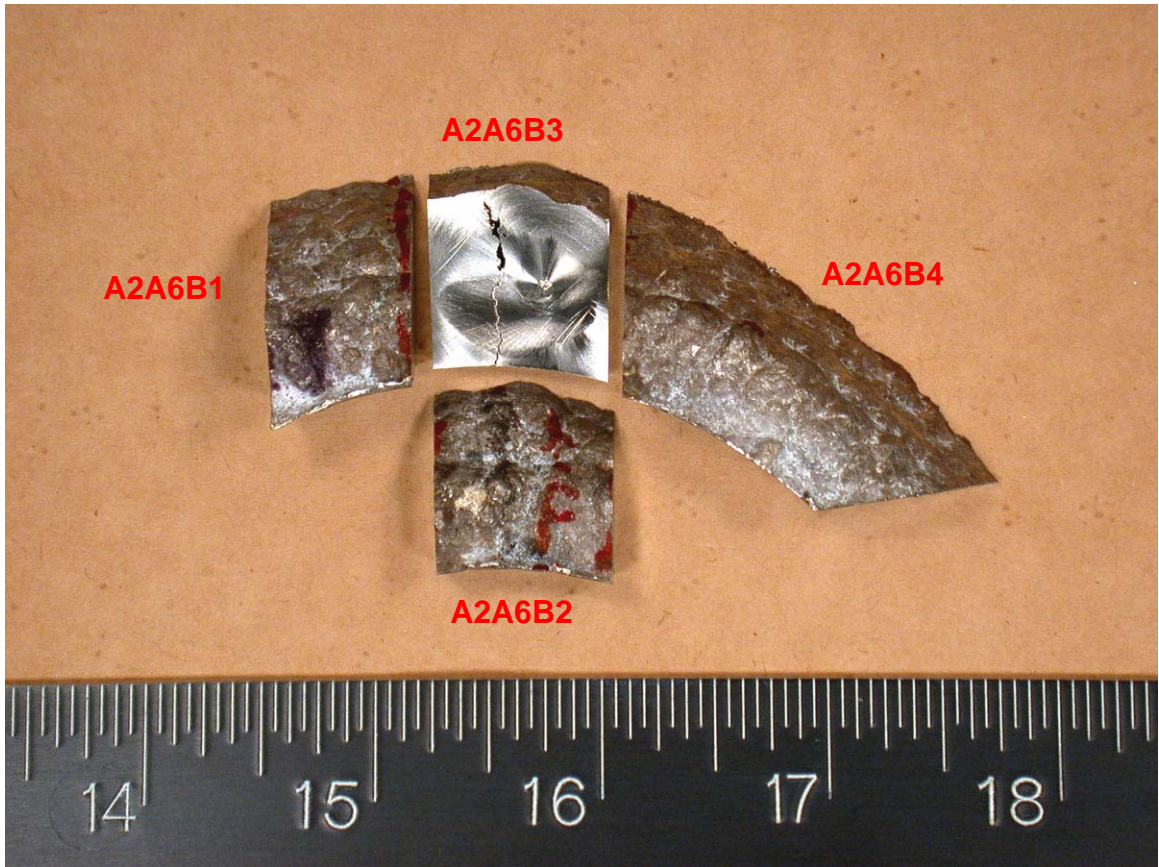
Figure 10.13

Piece A2A6B after sectioning. The bottom surface of A2A6B2 was mounted. The axial crack in A2A6B3 was opened up for SEM.
