V. C. SUMMER NUCLEAR STATION

Alpha Hot Leg Evaluation and Repair

**Presented at the
V.C. Summer Nuclear Station
Jenksville, SC
January 18, 2001**

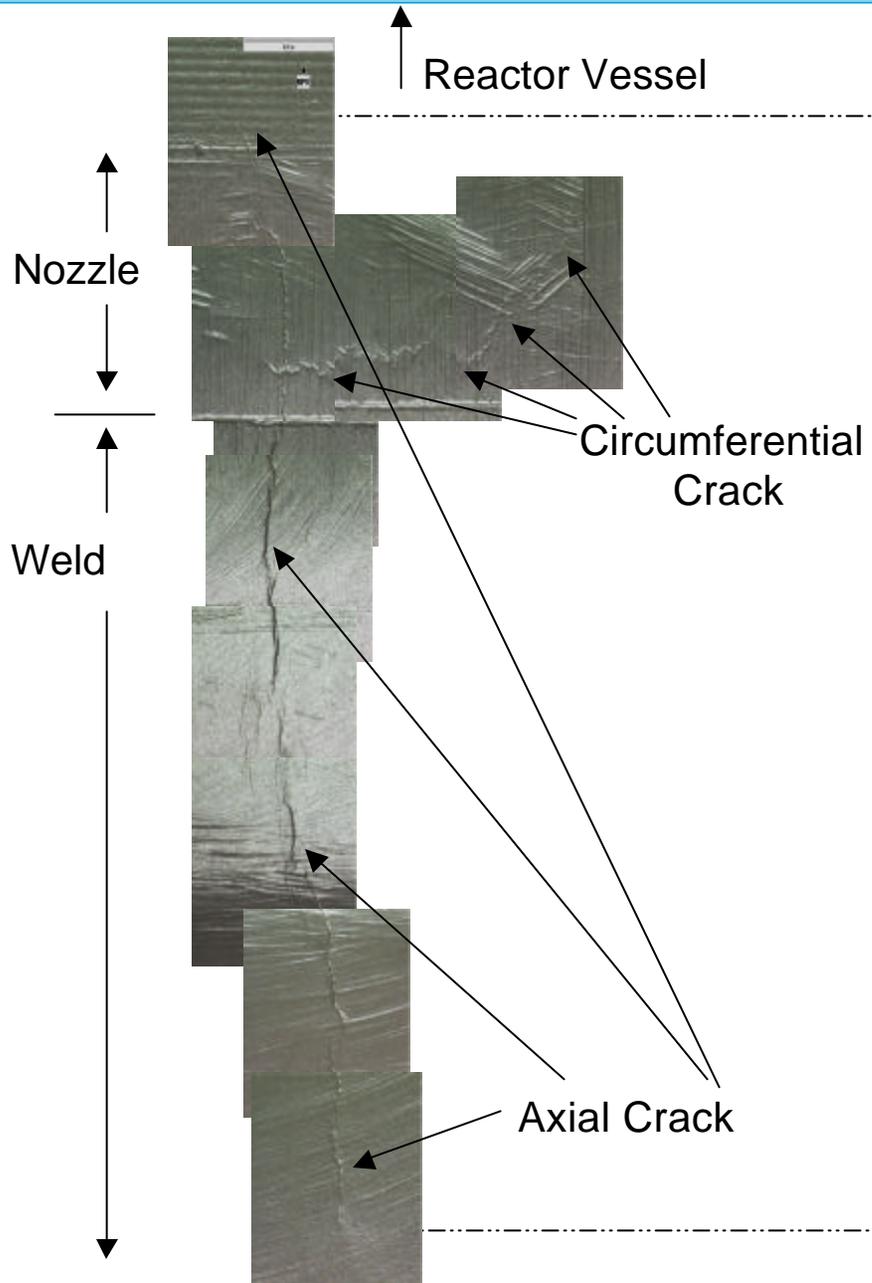
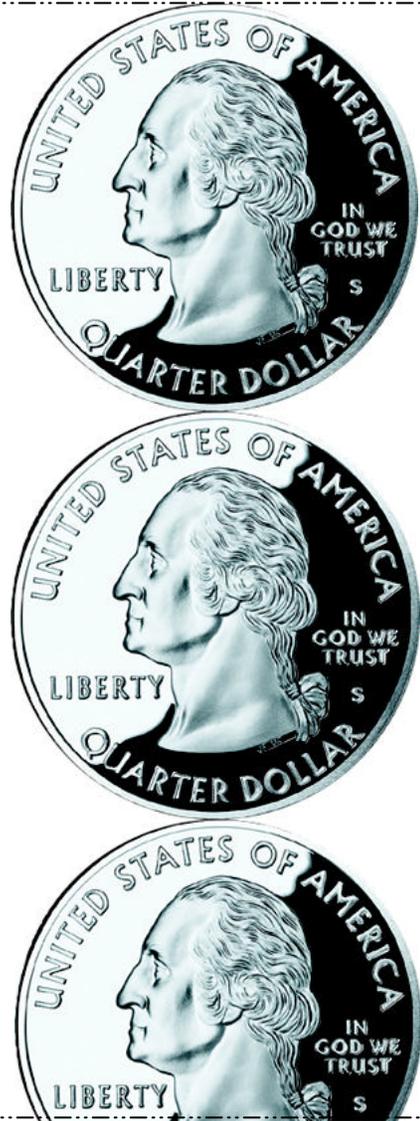
Cross Section of Weld Showing Crack

- Some ET Indications Confirmed -- PWSCC Cracks Following Interdendritic Morphology.
- Some ET Indications Were Not Cracks
- Axial Through Wall Crack - Multiple Initiation Sites.
- Axial Crack Contained Within Weld, Butter, HAZ.
- Circumferential Crack Contained in Cladding.

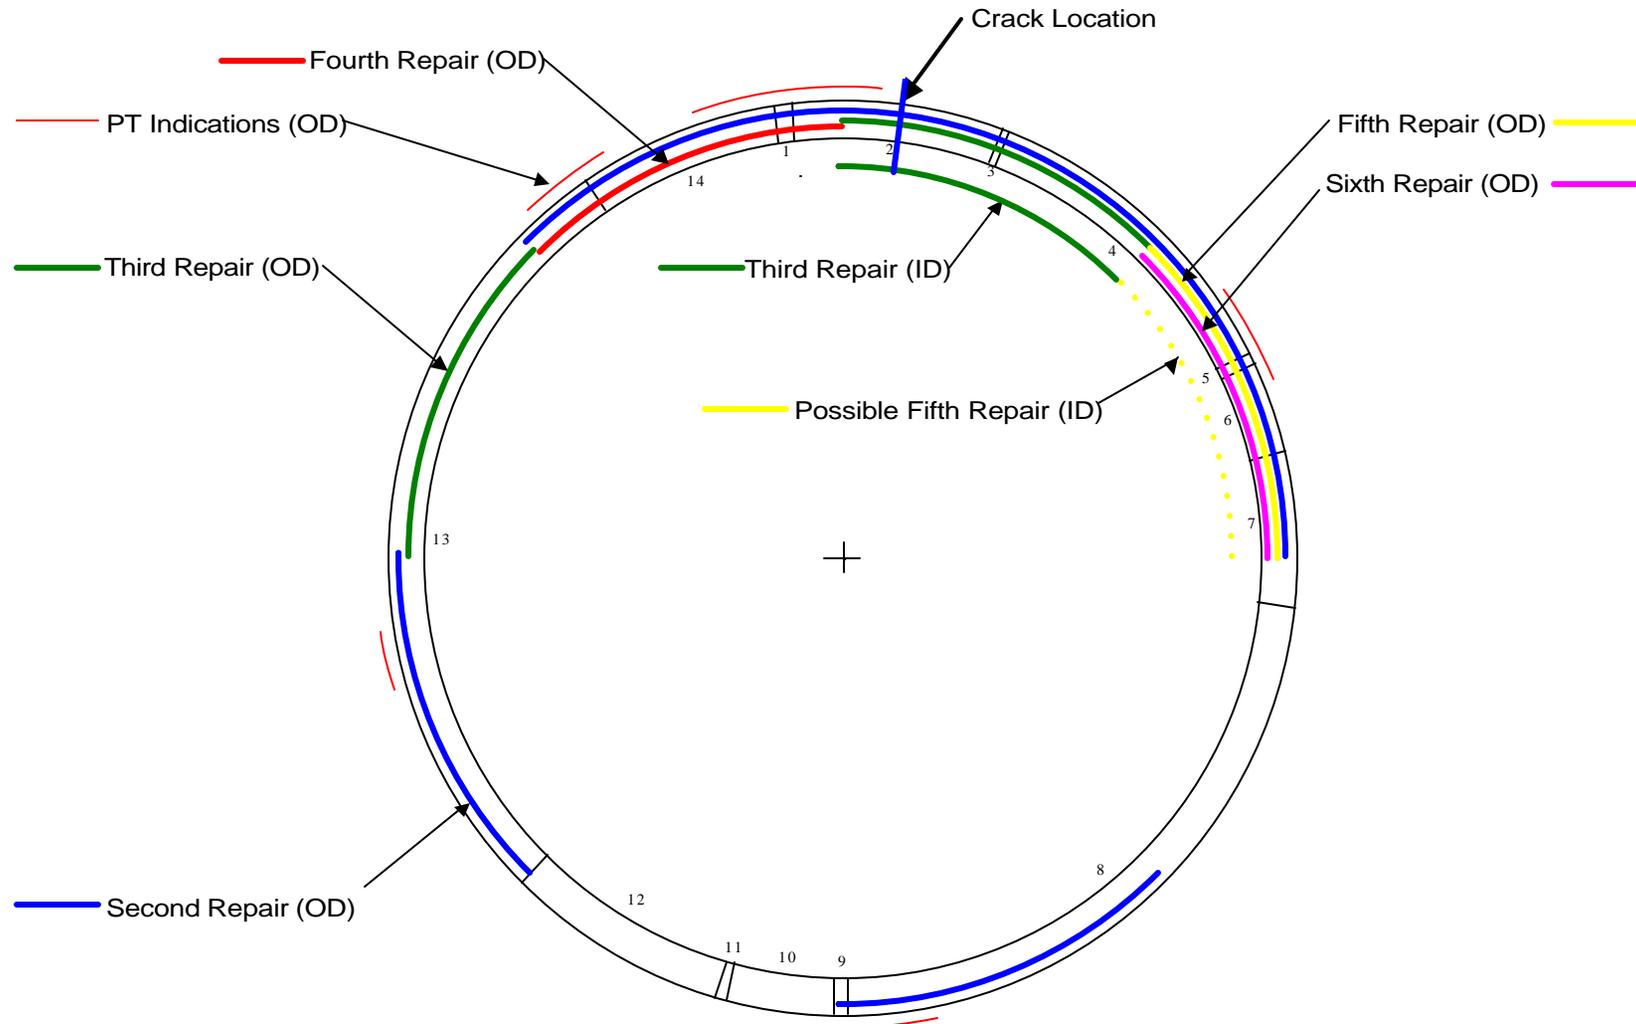
EPRI Typical Weld Finite Element Analysis Result

- The Through Wall Crack in the Alpha Hot Leg Occurred Due To:
 - Primary Water Stress Corrosion Cracking
 - High Residual Stresses From Original Welding / Fabrication
