**DAVIS-BESSE REACTOR VESSEL HEAD DEGRADATION
LESSONS-LEARNED TASK FORCE REPORT**

On March 12, 2002, the NRC dispatched an Augmented Inspection Team (AIT) to gather facts surrounding the circumstances associated with the March 5, 2002, discovery of a cavity in the DBNPS RPV head. The discovery of the cavity occurred following a plant shutdown for a refueling outage, during which the licensee was conducting inspections for reactor pressure vessel head penetration (VHP) nozzle cracking due to primary water stress corrosion cracking (PWSCC). These inspections were being conducted in response to an NRC bulletin. During these inspections, the licensee discovered cracks in several VHP nozzles. Subsequent to the machining process to repair VHP Nozzle 3, the nozzle was observed to displace, or tip in the downhill direction as the machining apparatus was withdrawn. The displacement led DBNPS personnel to examine the region adjacent to VHP Nozzle 3. The licensee discovered a cavity with a surface area of approximately 20-30 square inches. Upon further examination, the licensee identified that the cavity extended completely through the 6.63 inch thick carbon steel RPV head down to a thin int

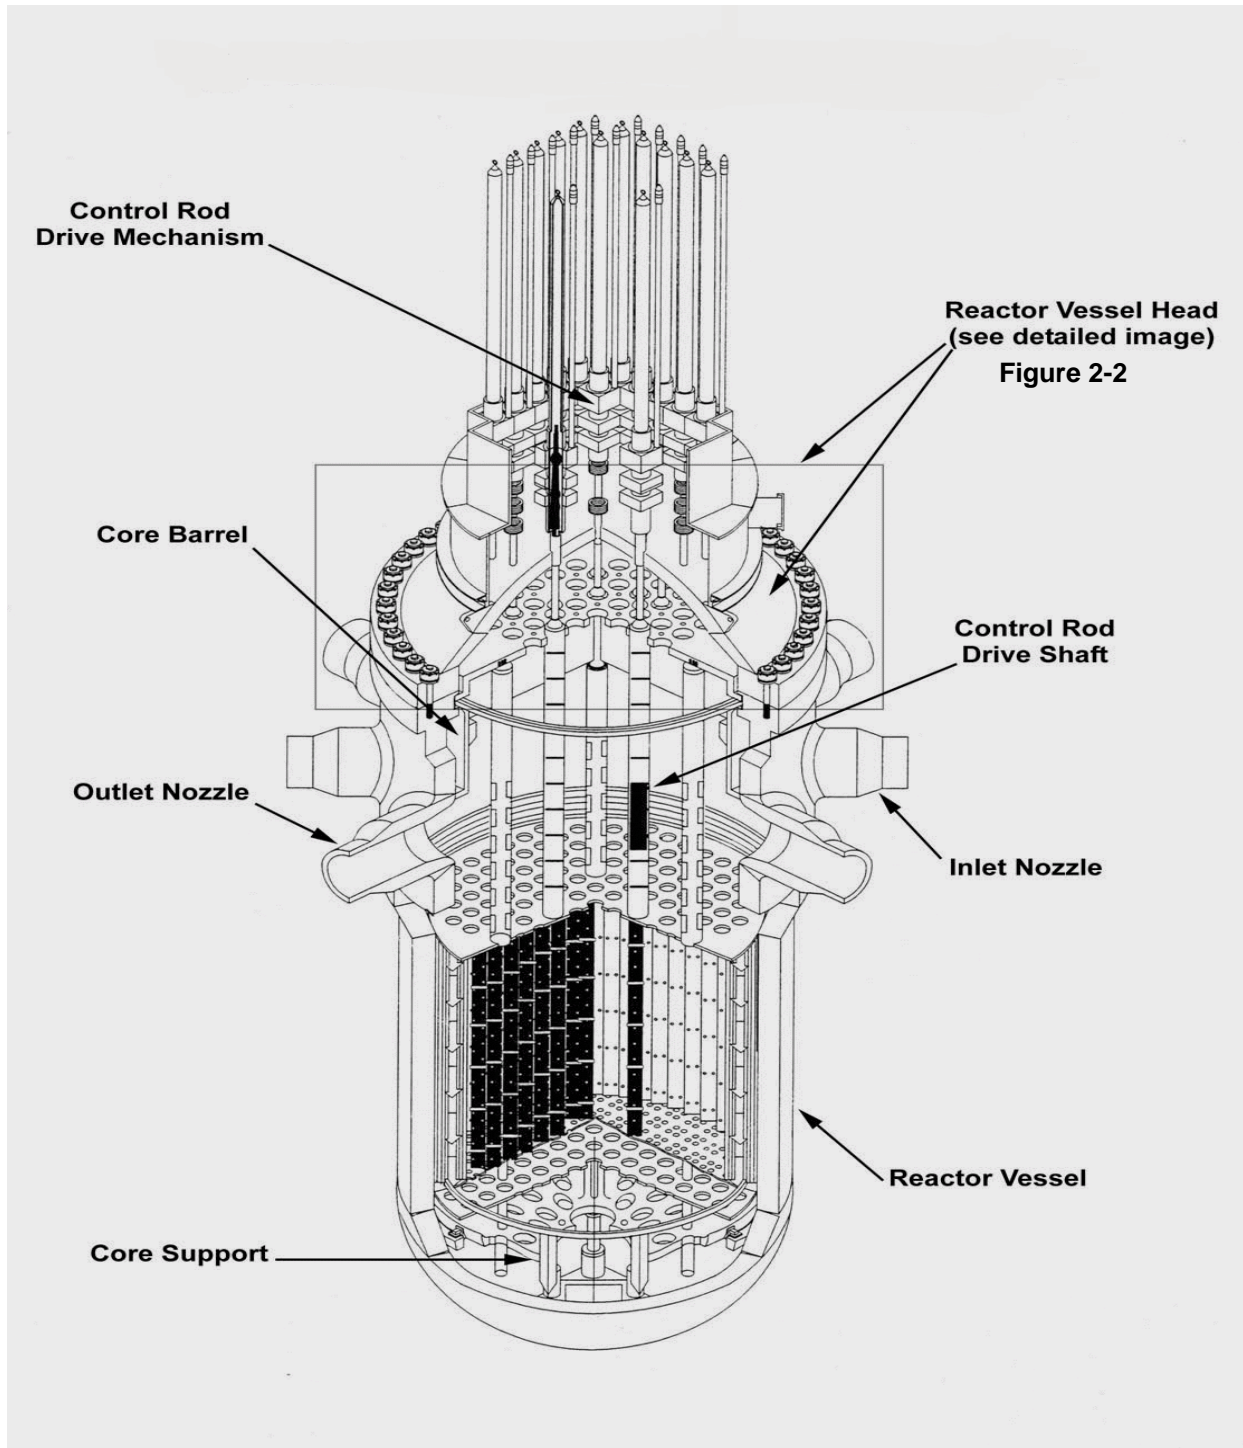
Figure 2-1 **TYPICAL PWR REACTOR**

On March 5, 2002, the licensee for DBNPS in Oak Harbor, Ohio, discovered a cavity in the RPV head, adjacent to VHP Nozzle 3. Davis-Besse Nuclear Power Station is a pressurized water reactor (PWR) plant. A schematic of a typical PWR reactor is shown in Figure 2-1. The DBNPS Nuclear Steam Supply System (NSSS) was fabricated by the Babcock & Wilcox (B&W) Company. Typical B&W RPV head and VHP nozzle design and fabrication details are depicted in Figures 2-2 and 2-3. Details of the degradation cavity in the DBNPS RPV head are shown in Figure 2-4.

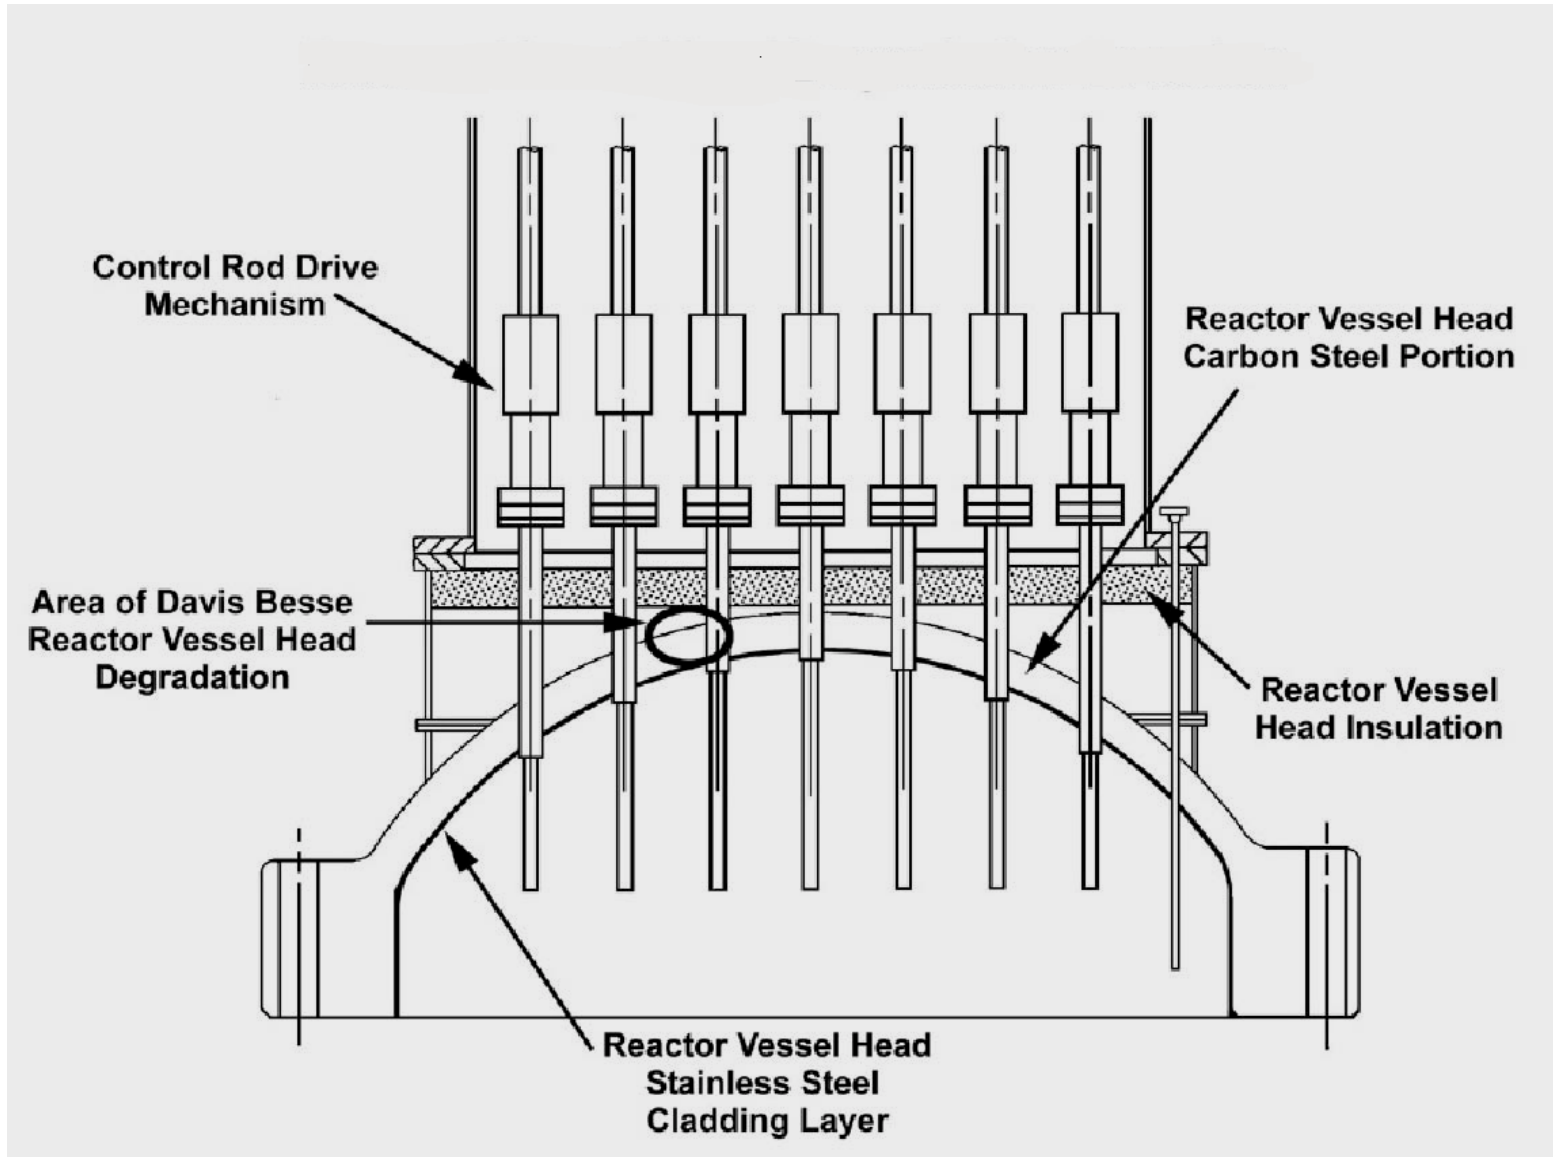
Figure 2-2

At DBNPS, a service structure is attached to the RPV head. It is approximately 18 feet high and 10 feet in diameter. This structure stabilizes and houses the CRDMs and contains a horizontal layer of metallic, reflective insulation approximately 2 inches above the center of the RPV head. The VHP nozzles welded to the RPV head pass through the insulation layer and attach to the CRDM housings with bolted flanges. These flanges are located approximately 9 inches above the horizontal insulation layer. Details of a typical service structure, B&W RPV head insulation, and flanges are shown schematically in Figures 2-1 and 2-2.
