NUREG/CR-4596
SAND86-0394
RP
Printed June 1986

Screening Tests of Representative Nuclear Power Plant Components Exposed to Secondary Environments Created by Fires

Mark J. Jacobus

Abstract

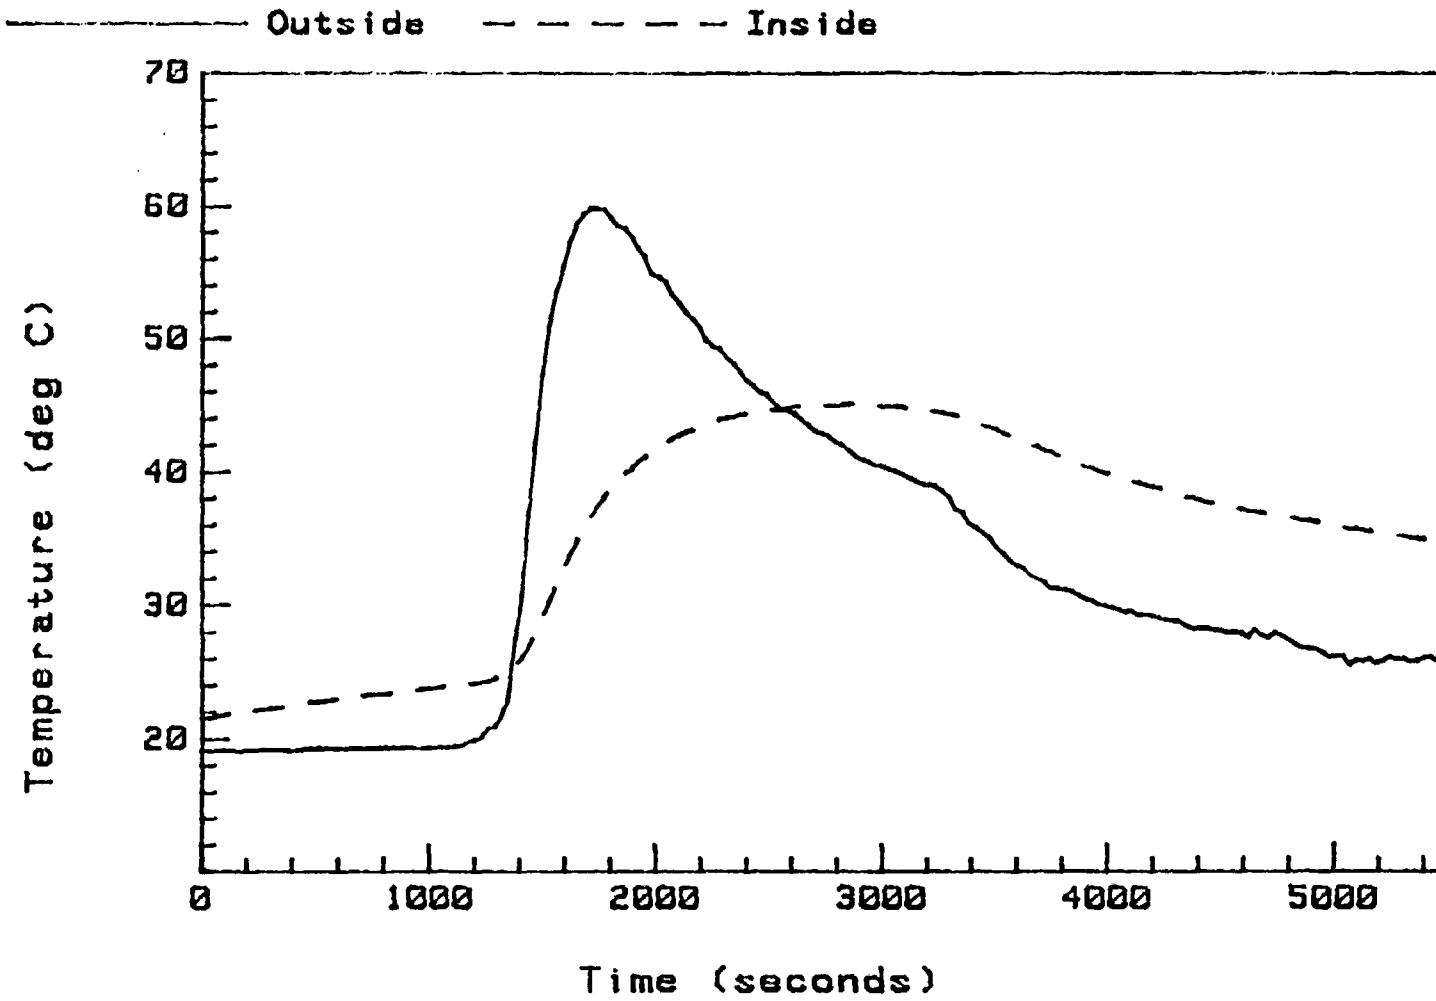
Fig. 9 Air Temperature Inside and Outside of Relay in Test 4

Plots of the temperature environment outside the relay and inside the relay near the contacts from test 4 are shown in Fig. 9. These plots give an idea of the amount of thermal lag caused by the cover being on the relay. The current flowing to the load on the relay contacts is shown in Fig. 10. The relay was operated in both directions every minute, accounting for the drop to zero load current every minute. The two sections of lost load current shown on the plot were the result of a sticking relay on the datalogging system and are not failures of the test relay. (The datalogger relay was found with severely pitted contacts and was verified to be sticking after the test.) A similar plot for the relay in test 5 is shown in Fig. 11. The relay in test 5 was operated every 5 minutes. Neither plot showed any indication of failure of the relay to pick up and carry its load. In neither test did the leakage currents measured to the normally-closed contact (open when the relay was energized) ever exceeded the detection threshold of the ac current sensors used (0.25 mA). The coil currents showed expected behaviors and are not shown. The values of coil current when energized were nominally 50 mA for the Agastat GPI relays and 210 mA for the General Electric HFA series relay.

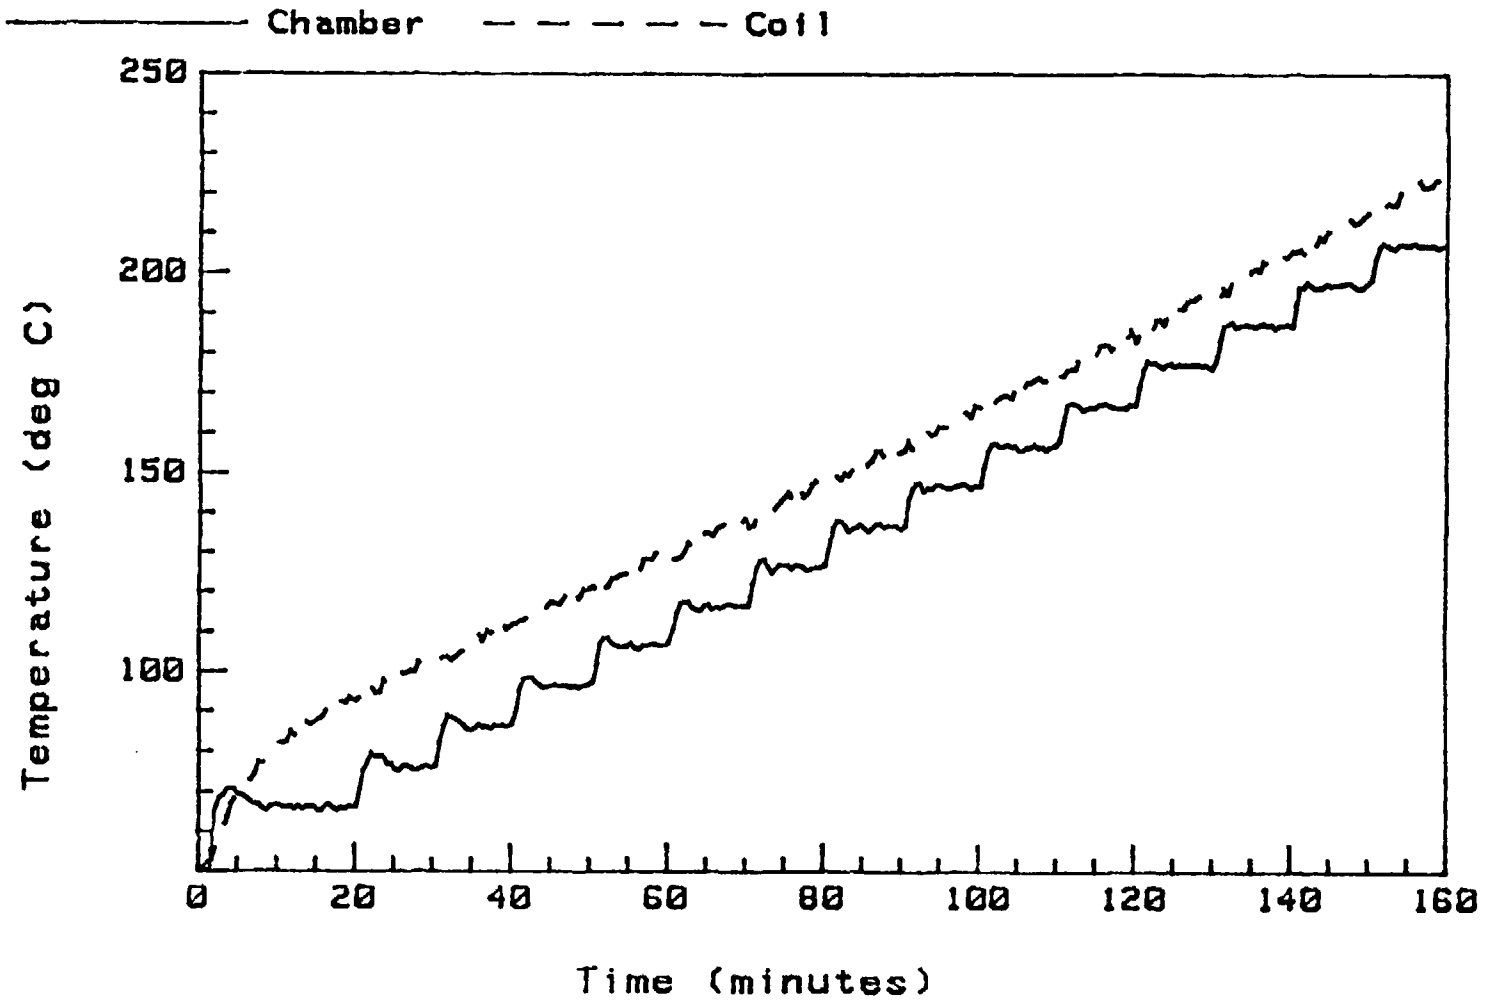
Fig. 12 Coil and Chamber Temperatures for First Thermal Failure Test

The temperature profile for the first relay is shown in Fig. 12. The coil temperature is higher than the chamber temperature because of self-heating effects. Fig. 13 shows the leakage current for contact #2 as a function of time, Fig. 14 shows the coil current as a function of time, and Fig. 15 shows the motor starter current as a function of time. These plots (Figs. 13,14,15) show that at approximately 155 minutes into the test, the contact #2 leakage current went from 0 to 0.84 amps (maximum value limited by the 120 ohm resistor), the motor starter current went to 0, and the coil current jumped to about 0.94 amps from an initial value of about 0.03 amps. Operation of the motor starter became erratic and the test was terminated. It should be noted that the location of the sensor measuring motor starter current really measures the current supplied to the contact #2 common connection.

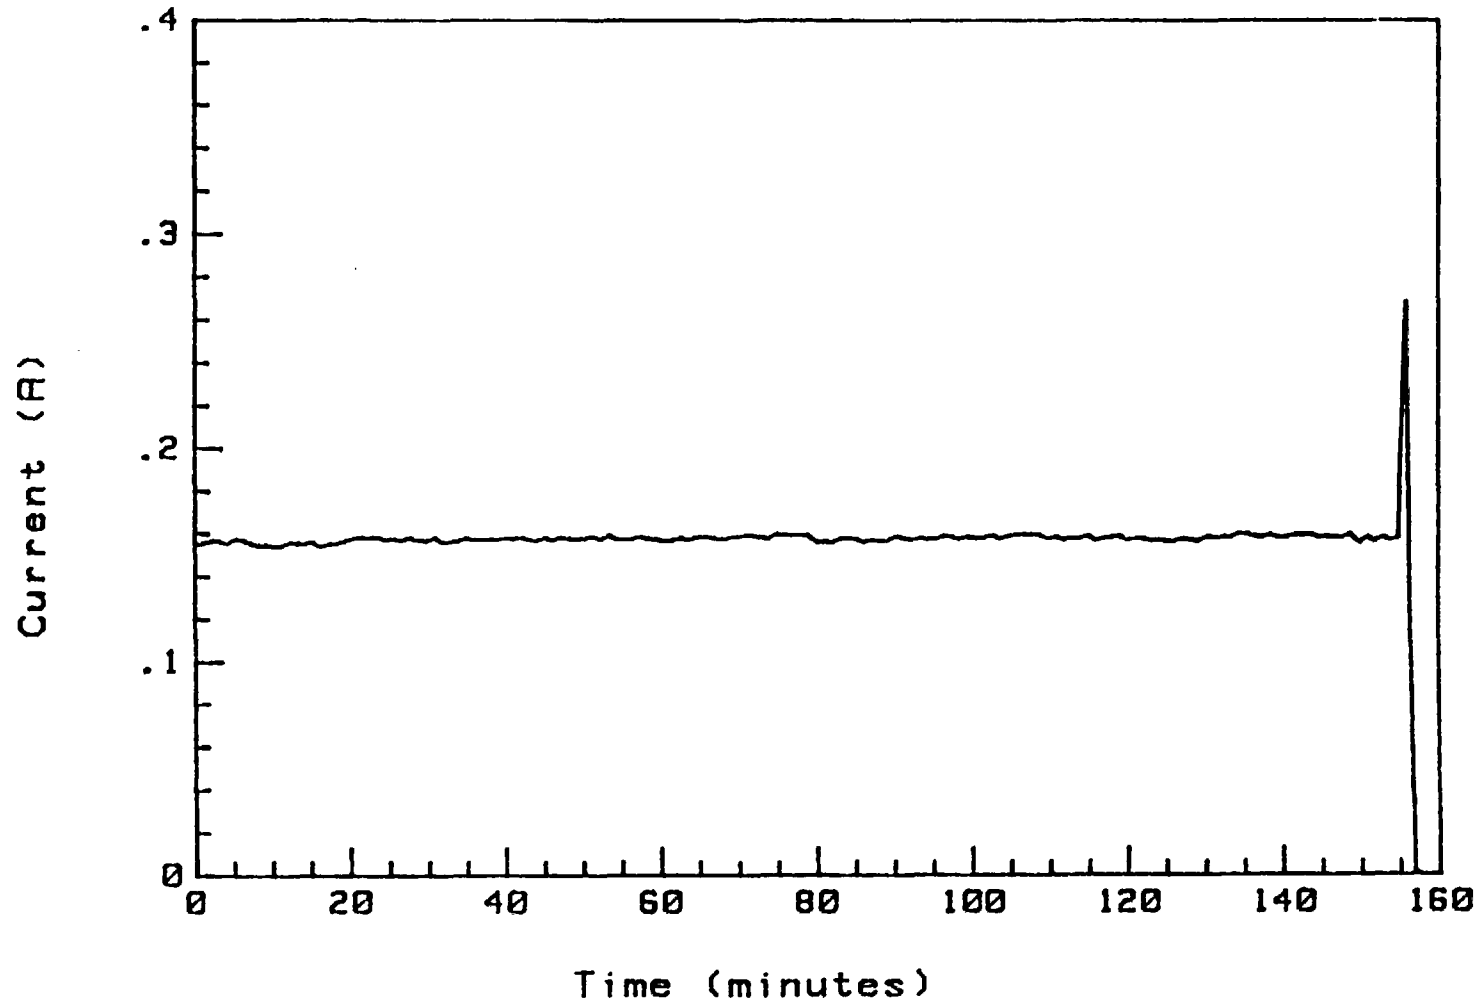
Fig. 15 Motor Starter Current for First Thermal Failure Test

The failures discussed thus far cannot account for the primary failure which resulted in the test being terminated. The cause of the primary

failure had to be a short between the hot side of the relay coil and the normally closed terminal of contact #2. No such failure could be found in examining the relay after the test. However, the base of the relay was so severely warped that apparently two or more of the terminal screws on the socket came into contact with the metal baseplate and shorted together. This was partially confirmed by checking continuity of different terminals when the socket was held onto a metal plate; several definite possibilities of shorting terminals were found.

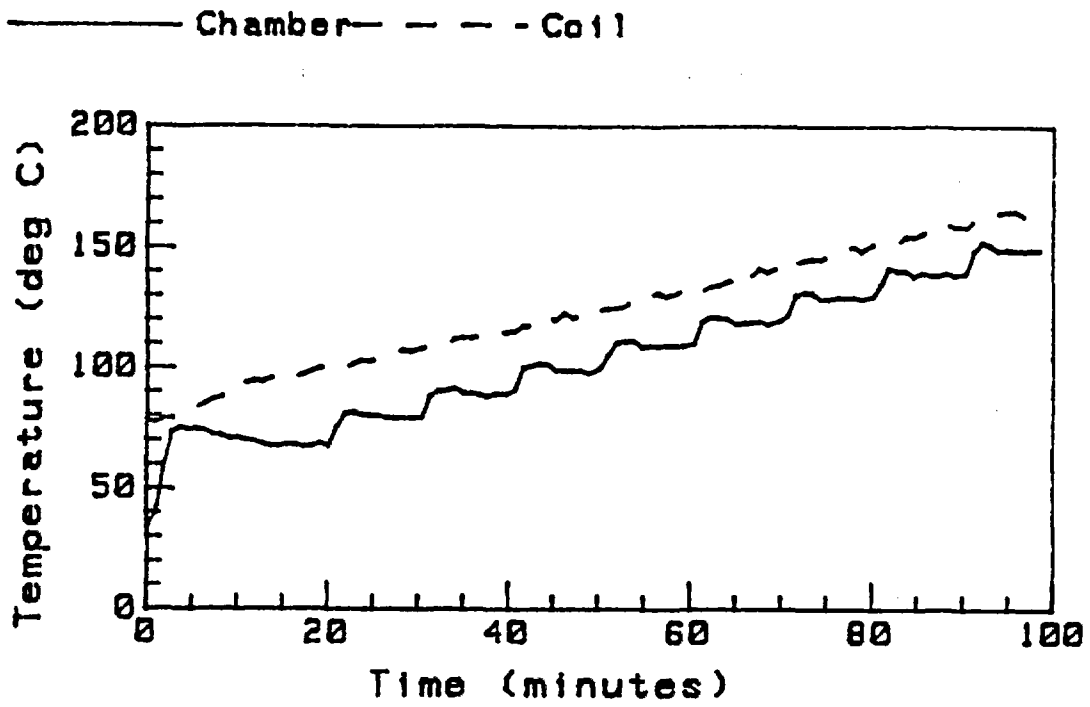
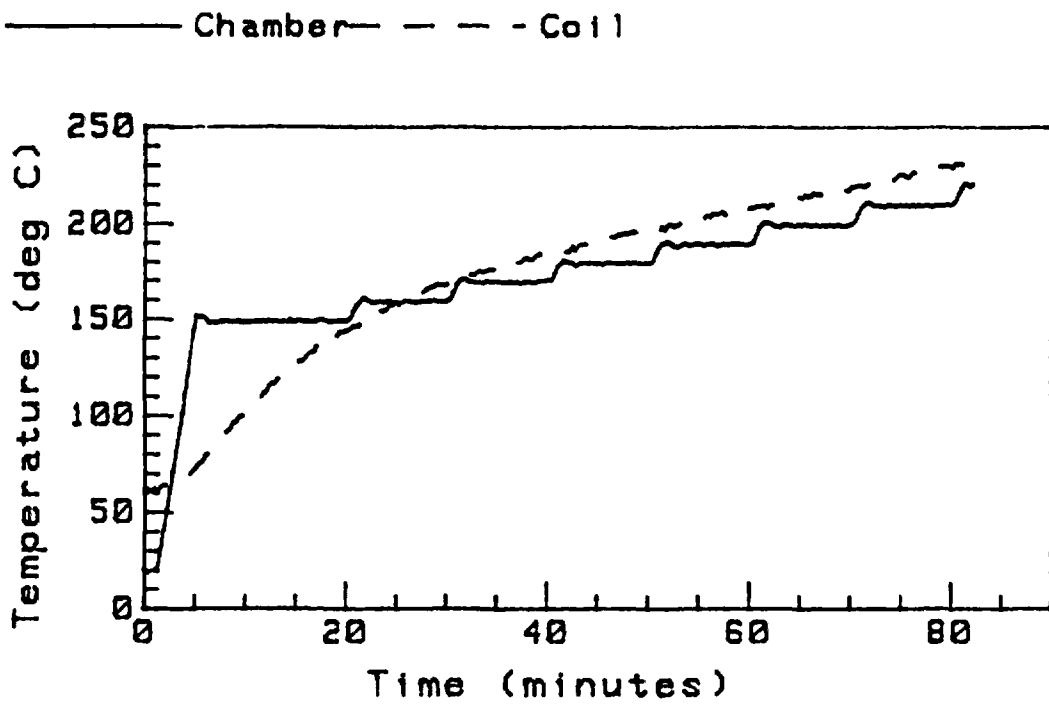
Fig. 17 Coil and Chamber Temperature for Second Thermal Failure Test

During the test of the second relay, a fuse blew at 99 minutes into the test. The cause of the blown fuse was traced to a relay in the datalogging system having fused contacts. The fuse and datalogger relay were replaced and since the test relay still seemed to be operating normally, the test was continued. The temperature profiles for the test and the coil temperature are shown in Fig. 17.

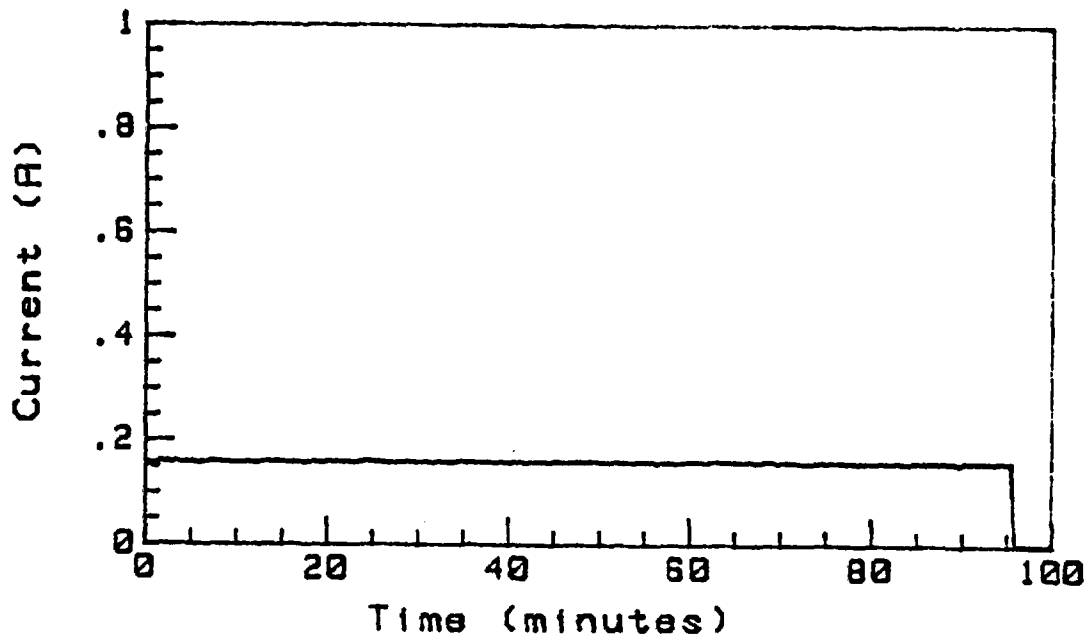
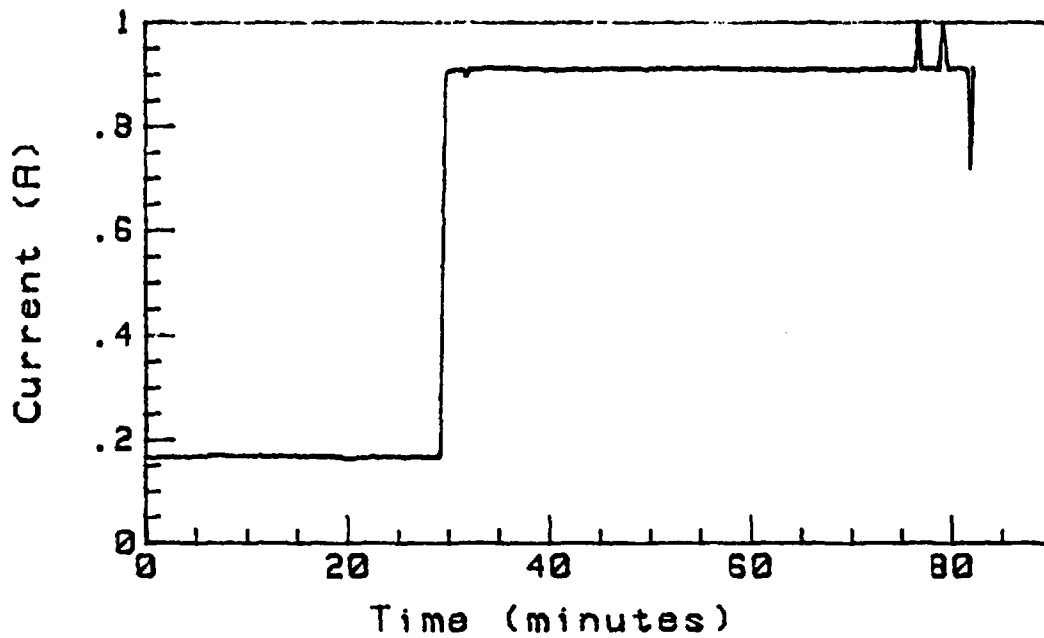
Fig. 18 Motor Starter Current for Second Thermal Failure Test

A plot of the motor starter current (actually current supplied to common terminal of contact #2) is shown in Fig. 18, the contact #1 load current is shown in Fig. 19, the coil current is shown in Fig. 20, and the contact #2 leakage current is shown in Fig. 21. About 30 minutes into the second part of the test, the current supply to contact #2 and the contact #2 leakage current both increased by approximately the same amount, indicating a dead short connecting the common and normally closed (open at the time) terminals of contact #2. The test was continued until between 75 and 80 minutes, the load current was lost twice and the test was terminated.

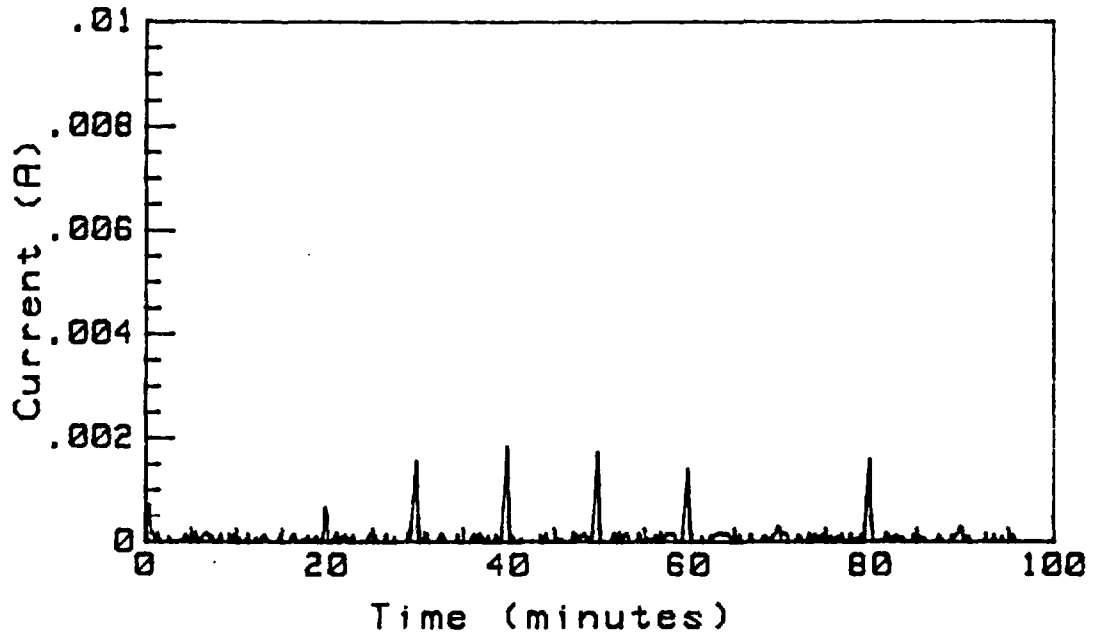
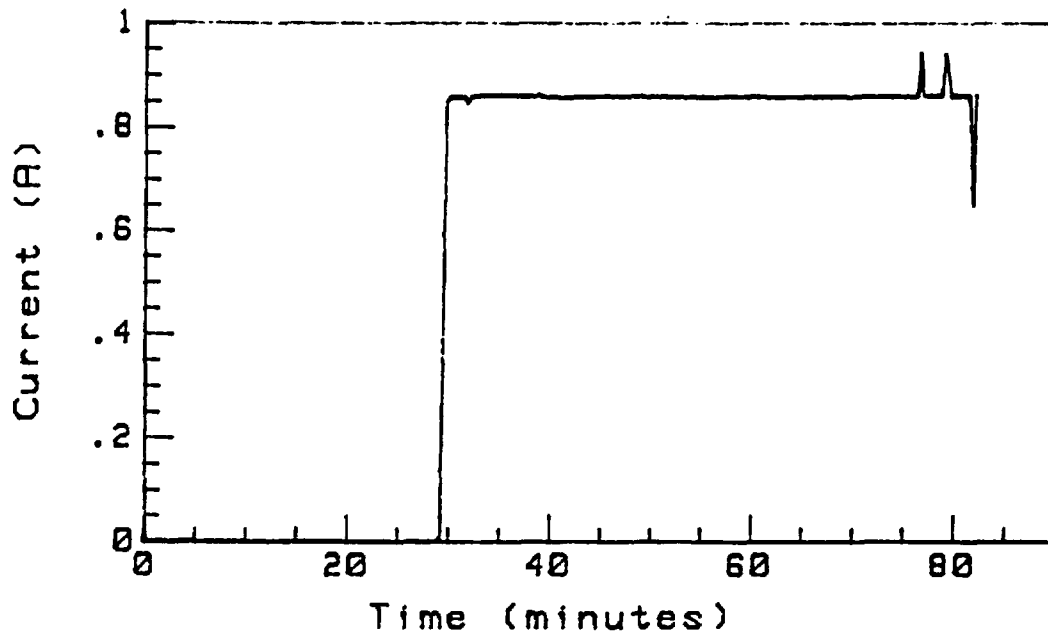
Fig. 21 Contact #2 Leakage Current for Second Thermal Failure Test

should have been connected indicated open on an ohmmeter and all of the contact #3 terminals were effectively shorted together. This short was later found to be in the socket. Insulation resistance measurements on the socket produced what appeared to be breakdown at some dc voltage levels (different locations appeared shorted at all test voltages including the low voltage of a hand-held meter and all voltages of the insulation resistance tester: 50, 500, and 1000 Vdc). However, the apparent breakdown would come and go at different voltage levels and sometimes even at the same voltage level after applications of other voltages. Shorting of terminal screws to the baseplate was not observed in the second test because of the different socket design. However, a new failure mode was observed. The contact support of contact #1 (the contact carrying the nominal 3 A load current) had become hot enough to melt as shown in Fig. 22. The melted support was the cause of the loss of load current observed at 75 to 80 minutes into the second part of the test. Because of the melted support, the coil would no longer energize after the test although it did draw rated current at rated voltage.

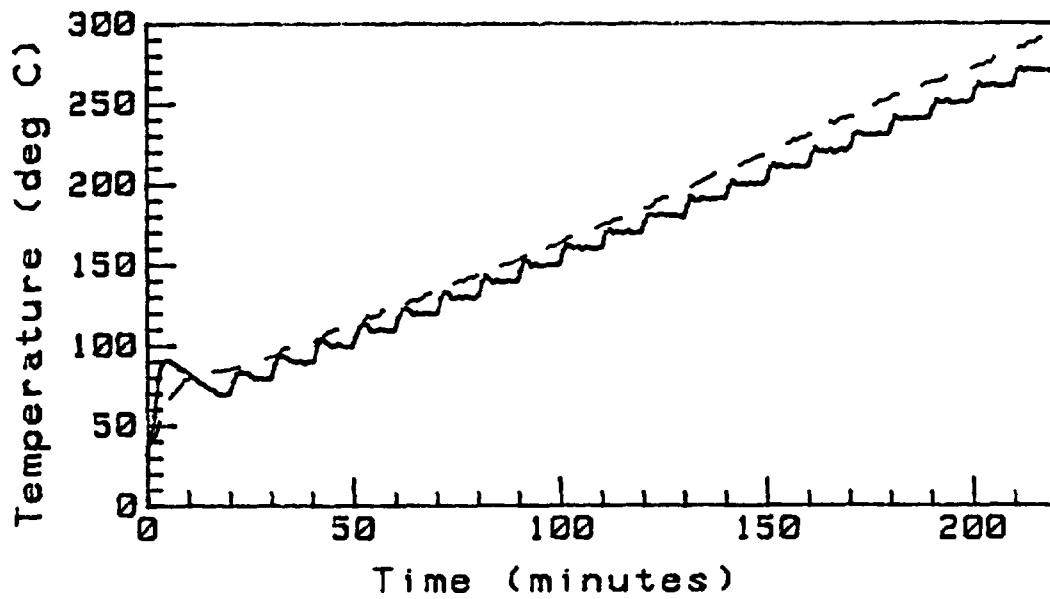
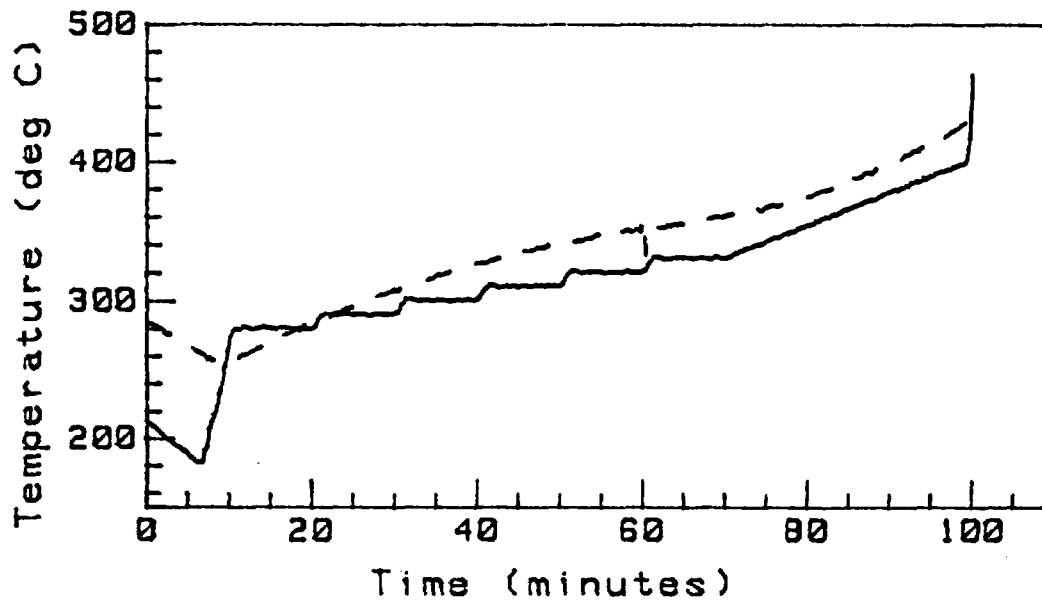
Fig. 23 Coil and Chamber Temperatures for Third Thermal Failure Test

One General Electric relay was tested in the environmental chamber. The relay was a model 12HMA111B9. Two profiles were run as shown in Fig. 23. The second profile was run because failure of the relay was not observed up to the first programmed maximum temperature of 270°C and the objective of the test was to continue until the relay failed. As can be seen from Fig. 23, the second profile was started when the chamber temperature was slightly above 200°C shortly after completion of the first profile. The coil current is shown in Fig. 24 and the load current is shown in Fig. 25. Leakage current is not shown since it never exceeded the ac current sensor detection limit of 0.25 mA. At about 92 minutes into the second test, the load current was lost and the coil current jumped significantly. The test was discontinued and when the chamber was opened, the lead wires to the relay were burning. After extinguishing with carbon dioxide and cooldown of the chamber, the relay was removed. The fire and extinguishment caused significant damage to the relay, as shown in Fig. 26. The fire was caused by the two coil lead wires shorting together and fusing as shown in Fig. 27. The fire apparently started at about 98 minutes, about 2 minutes after the load current was lost. The cause of the loss of load current could not be determined because of the fire damage.

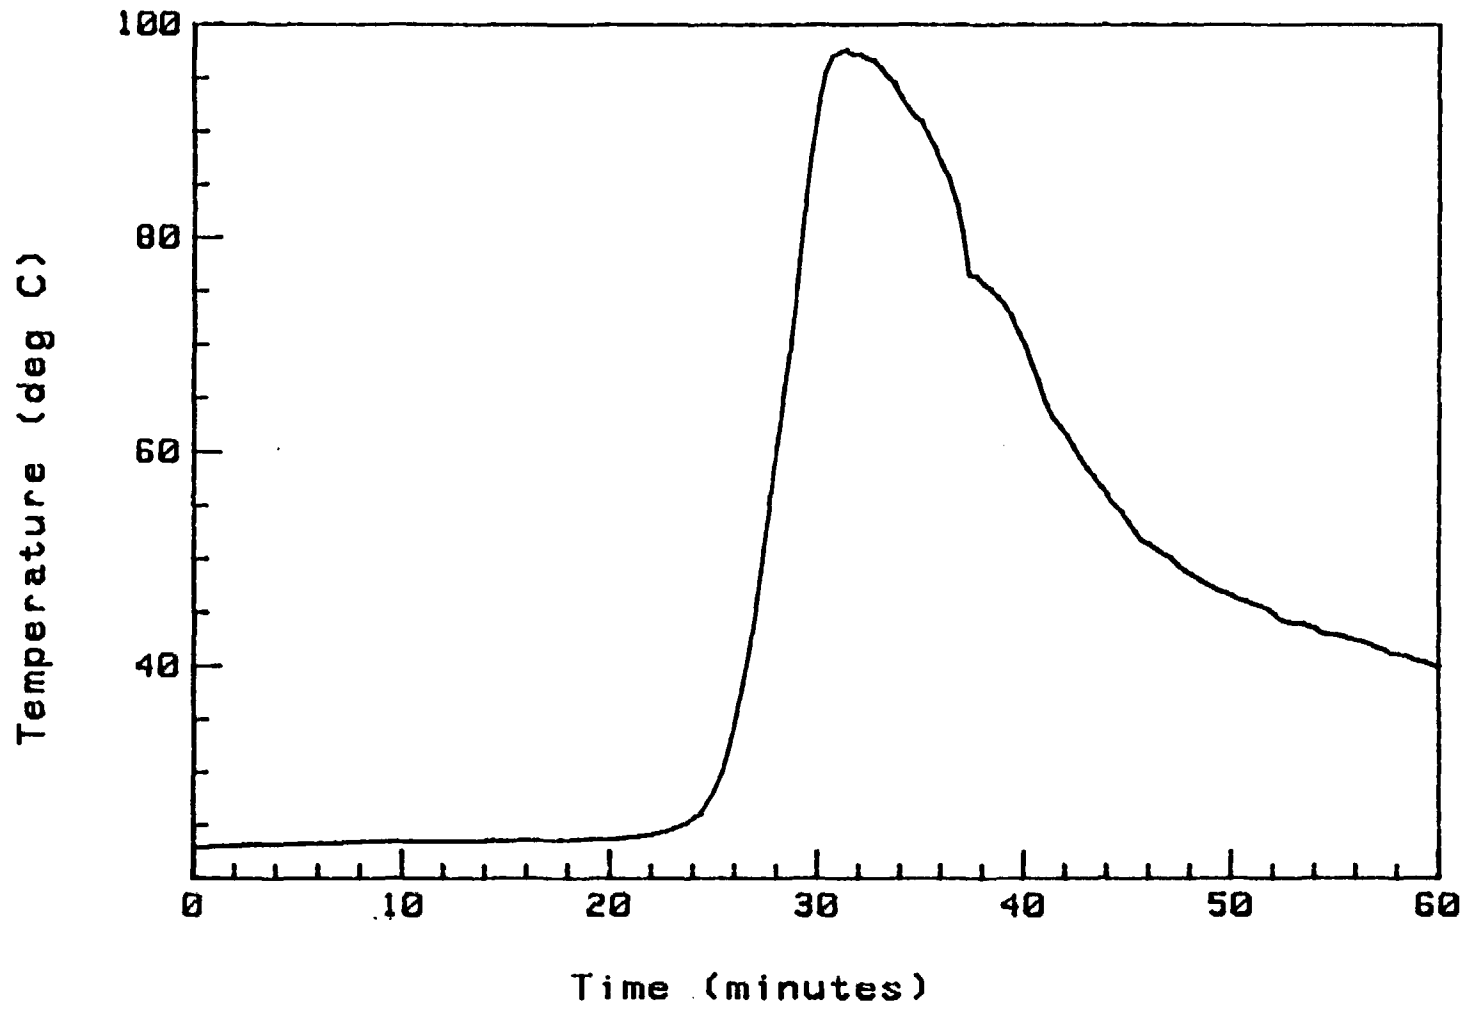
Fig. 28 Temperature Near Strip Chart Recorder in Test 3

Two strip chart recorders, Bailey Controls Series 77, were tested. The first was tested in test 3 and was located about 8' from the burning cabinet near the burn room door and about 5' from the floor (see Fig. 1). The covers were removed from the recorder and it was not powered. The temperature profile that the recorder was exposed to is shown in Fig. 28. As a result of the fire environment, the strip chart recorder failed to function. The failure mode was particulate buildup on the pen sliders with the pens unable to move in either direction. After an attempt at cleaning with a solvent, the pens would still not move. The rest of the recorder, including the electronics and motor drives seemed to work properly. A photograph of the failed slider is shown in Fig. 29.

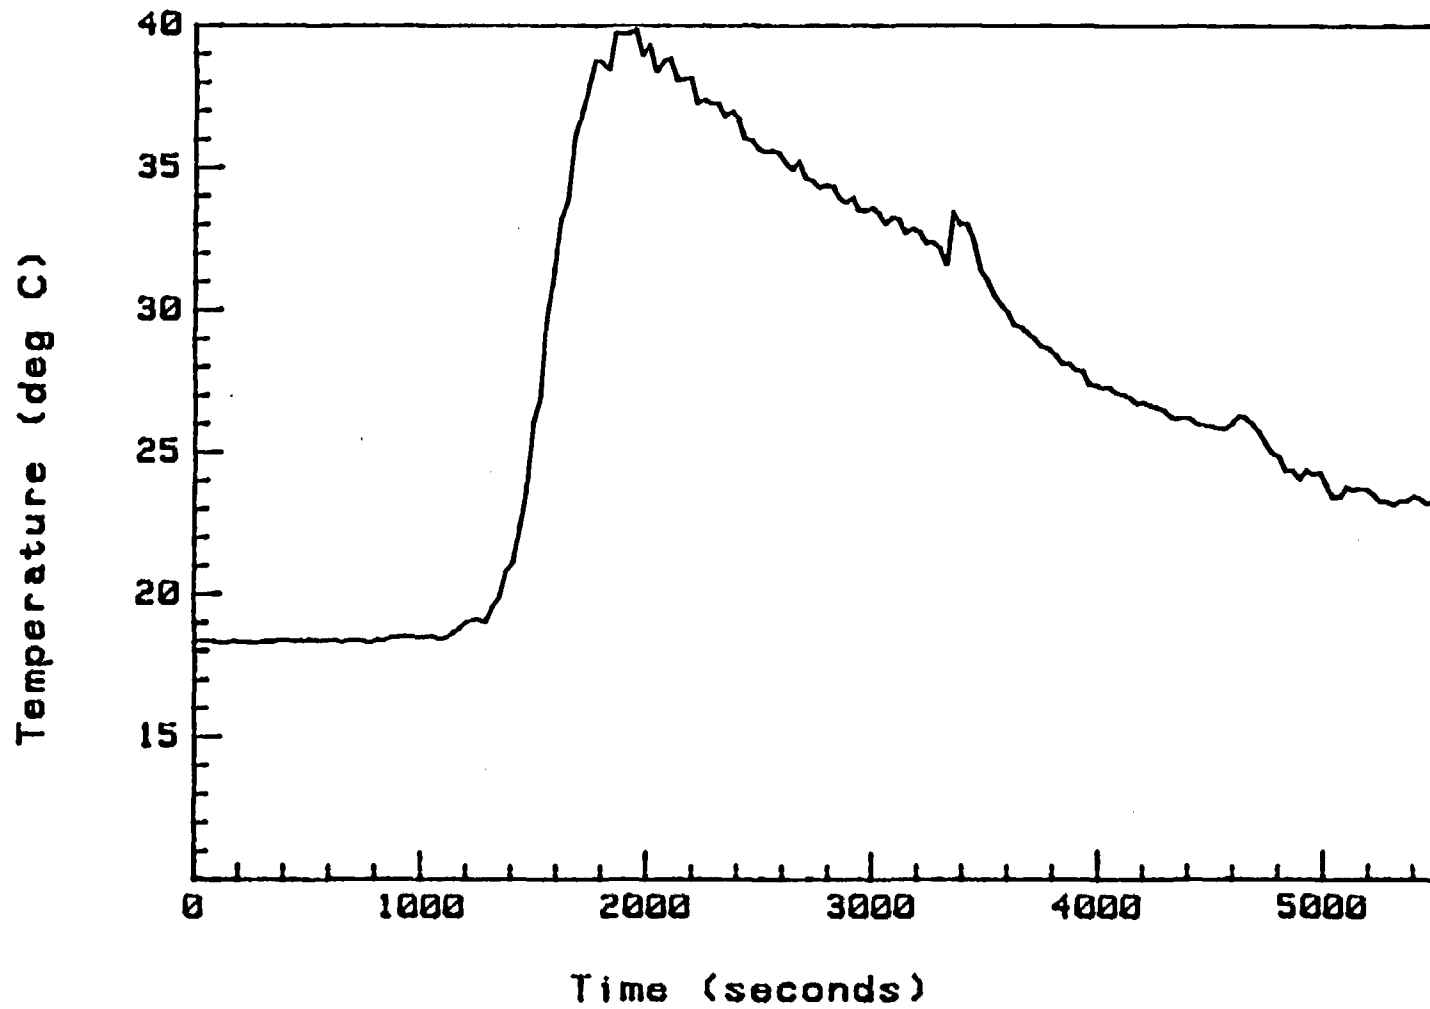
Fig. 31 Temperature Near Counter in Test 4

The second counter was tested in test 4 and the top cover was removed. The counter was located in the bottom of the corner cabinet and was exposed to the temperatures shown in Fig. 31. The result of the exposure was a limited amount of particulate deposited on the circuit board, almost none when compared to the counter in test 3. No loss of function occurred as a result of the test.

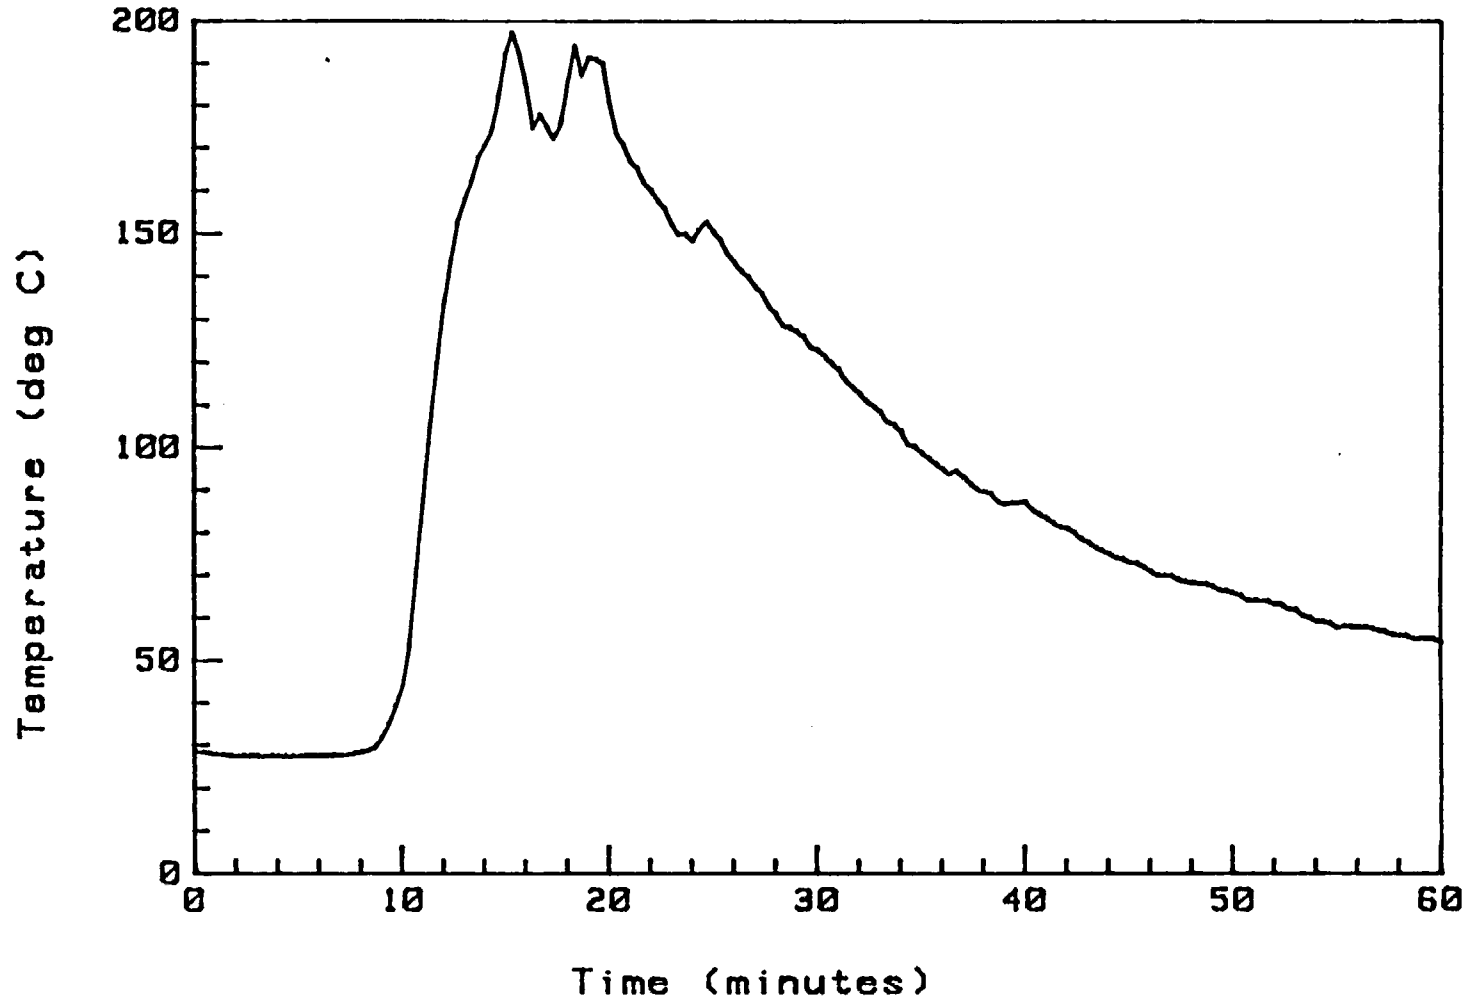
Fig. 32 Temperature Near Power Supply in Test 2

The power supply no load output voltage was monitored throughout all three tests and did not vary by more than 1.5% in test 2 and 0.05% in tests 4 and 5. The temperature profile from test 2 is shown in Fig. 32. The peak temperatures in tests 4 and 5 were about 40°C and 25°C, respectively. Tests 4 and 5 were intended primarily to see if any corrosive vapors might condense on the power supply in the cooler regions low in the room. No evidence of any damage to the power supply was found during or after any of the tests.

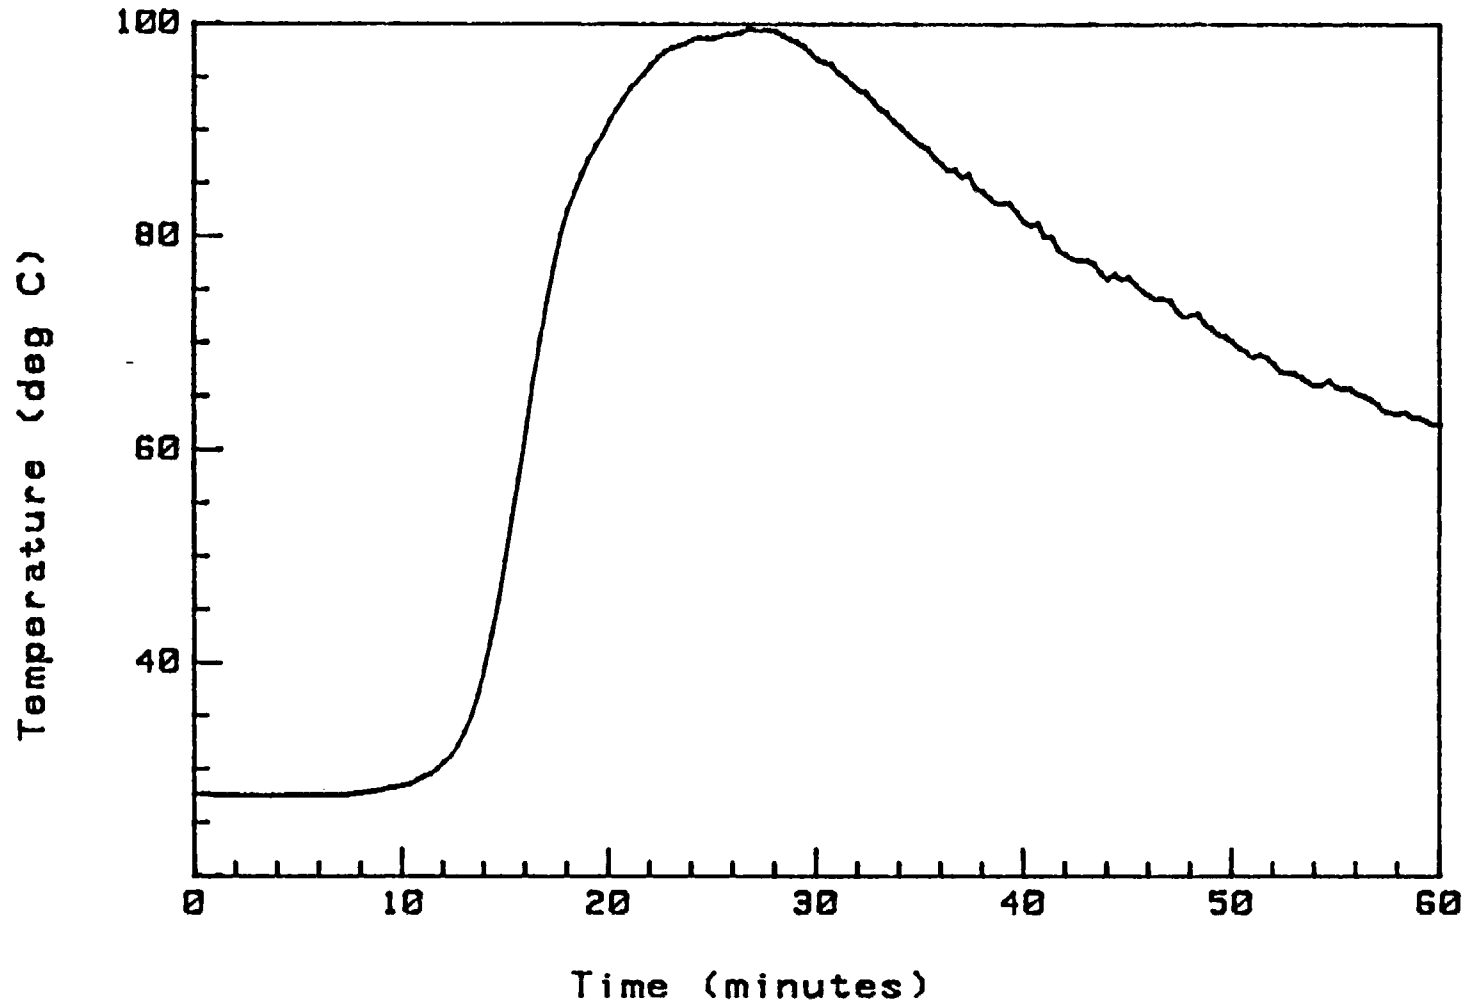
Fig. 33 Average Temperature Near Power Amplifier in Test 2

The power amplifier was powered with an input voltage of nominally 1 V and its output was monitored after amplification by 5. The average of the temperatures about 2' above and below the amplifier is shown in Fig. 33. The temperature profile at the amplifier would be close to this average. The amplifier output matched the input (multiplied by five) with an accuracy of better than 0.5% throughout the test. Post-test measurements soon after the test and after several days verified correct operation of the amplifier in both dc and ac applications.

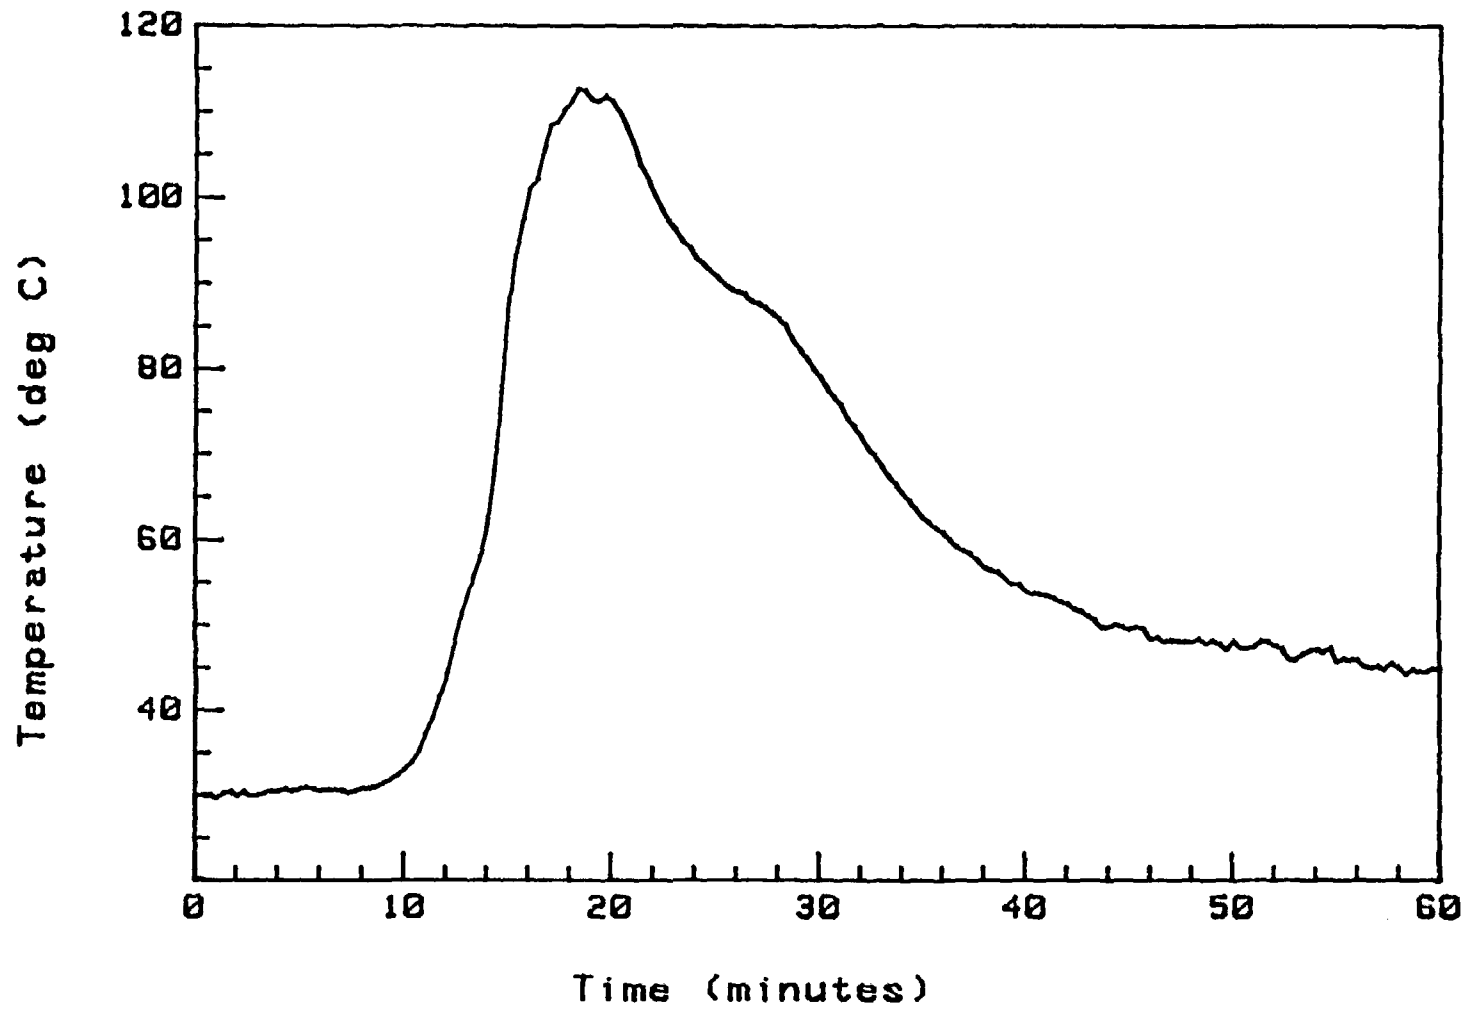
Fig. 34 Temperature Near Oscilloscope 4-channel Amplifier in Test 2

The 4-channel amplifier and power supply was powered with the same nominal 1 V input as the power amplifier. The temperature profile near the 4-channel amplifier is shown in Fig. 34. One channel of the amplifier was set for an amplification of 5 and the output was monitored. As the test progressed, the output signal error increased to about 20% and then was lost. After the test ended, the output returned for about 6 minutes with an initial error of less than 1% but increasing with time to about 16% after which the signal was again lost. After the test, the amplifier power light was found on and the cooling fan was running but no output was being produced. Post-test measurements soon after the test and several days later indicated the amplifier was working on both dc and ac with minimal error. Examination of the plug in unit power supply schematic led to the discovery of a thermal cutout switch which cuts the power off to everything except the on indicator and the cooling fan when the temperature exceeds 58°C (137°F). Fig. 34 shows that the temperature in the vicinity of the amplifier did exceed 58°C, resulting in the cutoff. No instances of similar thermal cutoffs being used in nuclear power plant components are known.

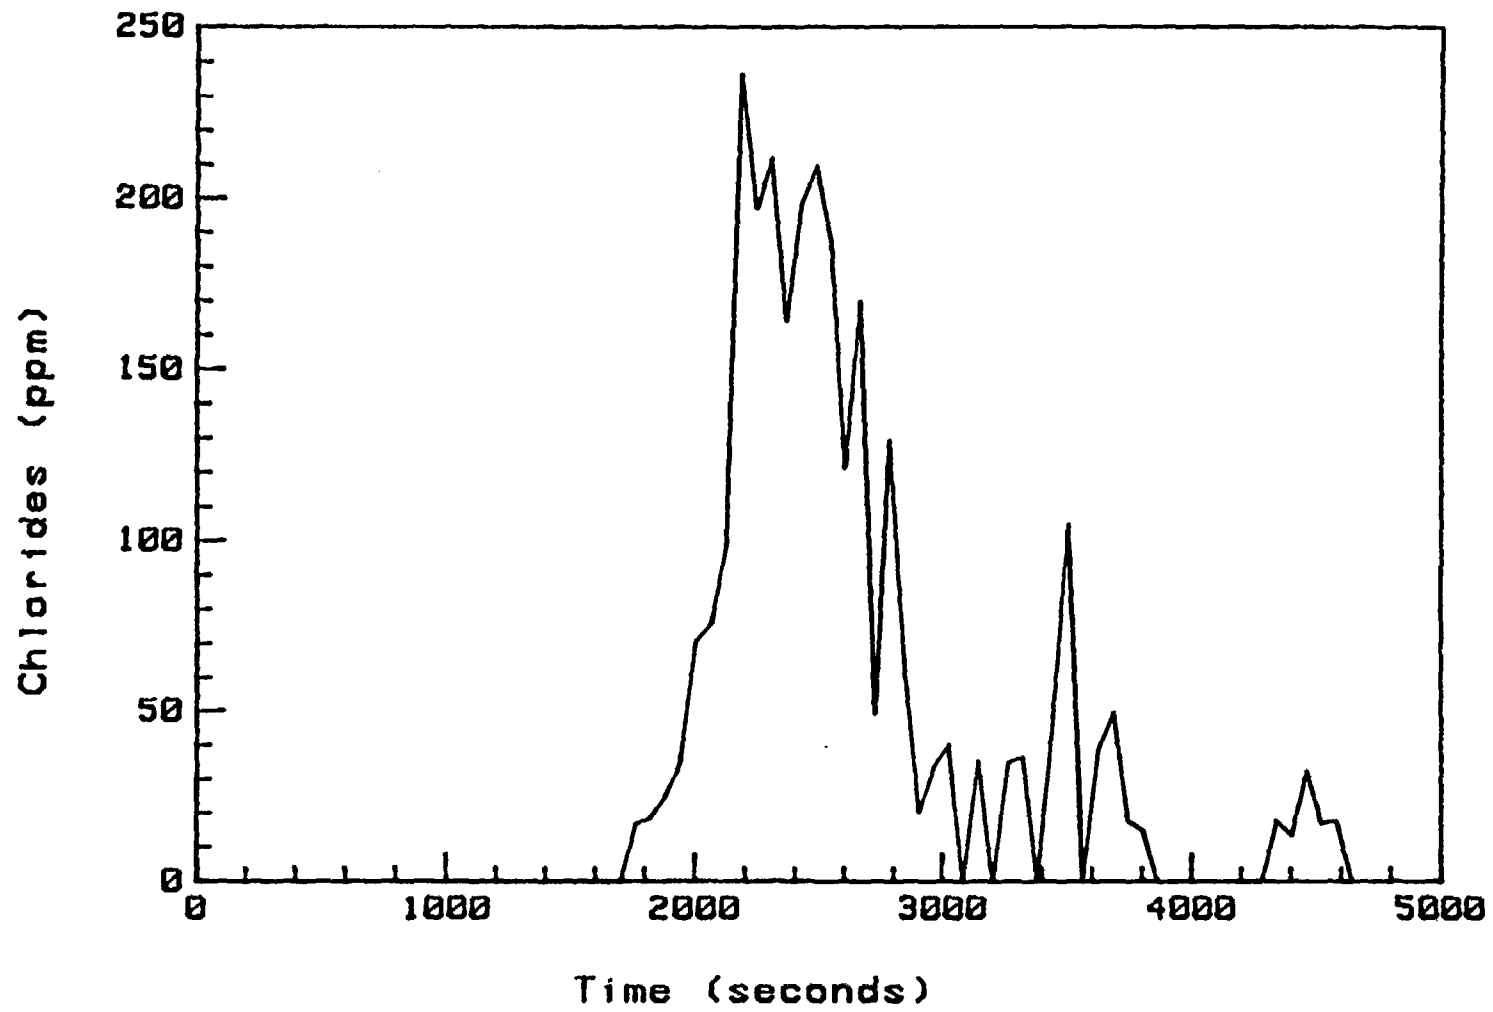
Fig. 35 Chloride Ion Concentration in Exhaust Duct vs. Time for Test 3

The chloride ions measured in the exhaust gas as a function of time for test 3 are shown in Fig. 35. This figure was obtained after first processing the raw data to filter the signal, but the data is still somewhat variable for two major reasons: 1) the chloride ion concentration is found by using the derivative of the total chloride ions collected as a function of time and derivatives of experimental data greatly amplify errors in the measurement and 2) the amount of chloride ions collected was far below what was expected so the chloride ion probe did not work in its optimal range, causing further difficulty in obtaining the derivative of the signal. The data does give an indication of the levels observed as a function of time. The variation of chloride ion concentration as a function of time for test 4 was not recorded because of a problem encountered with the datalogging system. For test 5, the amount collected was so small that derivative data was impossible to obtain with any accuracy. Consequently, only the total amounts collected are presented for the last two tests. These totals, along with other pertinent data for each test is given in Table 6.

Table 6 shows the low percentage of theoretical chloride ions collected in all the tests. The data also shows that as the ventilation rate (expressed in air changes per hour) is increased, the percentage of theoretical chloride ions increases. Another likely conclusion is that the smaller the room, the larger the amount of chloride ions collected. Both these observations seem to make sense. As the ventilation rate is increased, less time is available for hydrogen chloride/particulate reactions, and hence more chloride ions are collected. Also, the higher ventilation rates tend to clean out the room more quickly at the end of the test, leaving fewer chloride ions lost in the room environment at the end of the test. For example, with one room change per hour, the exponential decay time constant for reducing the chloride ion concentration in the room is one hour if the concentration is assumed uniform at all times. Obviously uniform concentration is not a good
