NUREG/CR-6095
SAND93-1803

Aging, Loss-of-Coolant Accident (LOCA), and High Potential Testing of Damaged Cables

Prepared by
R. A. Vigil/SEA
M. J. Jacobus/SNL

Manuscript Completed: January 1994
Date Published: April 1994

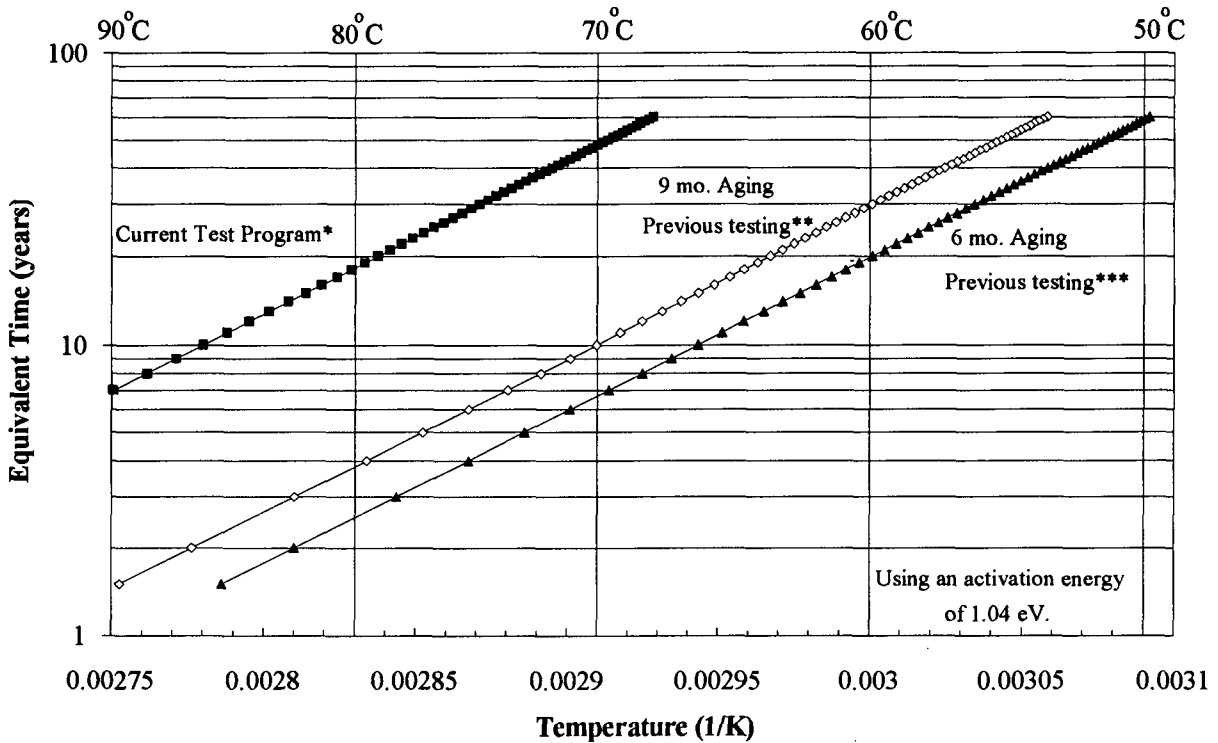
Figure 7 Equivalent Time-Temperature Corresponding to the Thermal Aging in this program and Previous Sandia Testing

To apply the data to lifetimes of other than 40 years, the Arrhenius theory can be used to equate the test conditions to a temperature for any given lifetime (or conversely, a lifetime at any given temperature). This is shown in Figure 7, where the thermal aging data from the previous testing and the current testing is compared, using an activation energy of 1.04 eV. The top curve is based on the current testing and is obviously the most severe of the thermal aging conditions. The middle curve corresponds to 9 month of aging at 98°C (208°F) and the lower curve corresponds to 6 months of aging at 98°C (208°F). Assuming the Arrhenius theory to be valid, any time-

temperature point on a given curve represents the same thermal aging as any other point on the same curve. Thus, for example, at 50°C for 60 years, no failures would be expected; at 54°C for 60 years, some failures would be expected; and at 68°C for 60 years, almost certain failure would be expected (with the radiation and accident profile used in this testing).

- * All Okonite cables failed.
- ** 1 of 4 Okonite cables failed.
- *** 0 of 3 Okonite cables failed.

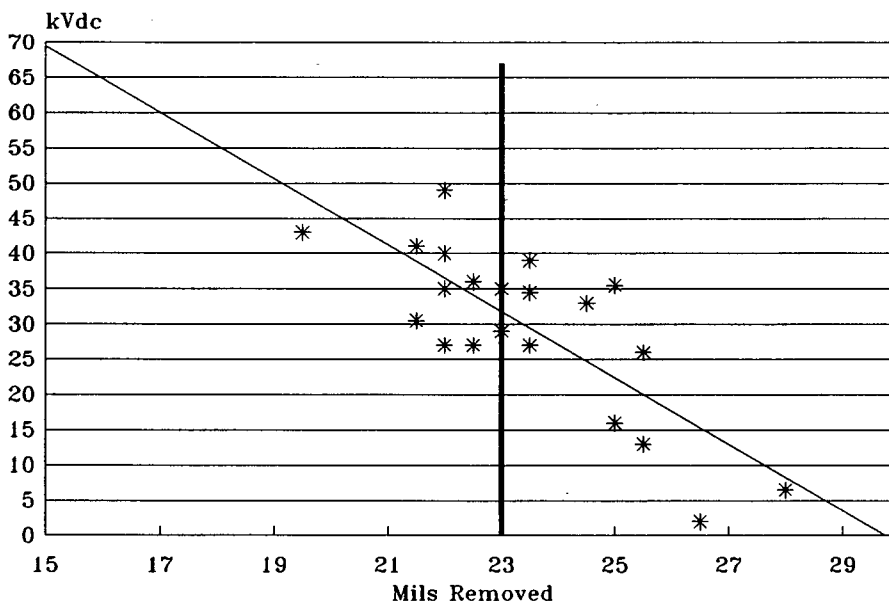
Figure 9 Breakdown Voltages for Damaged Brand Rex Cables Tested in Water

The results from the Phase III testing show the differences in breakdown voltages between Brand Rex cables cycled at 35 kVdc and the uncycled Brand Rex cables from Phase I. The 35 kVdc cycling voltage criterion was determined by examining the results of numerous breakdown tests of damaged (milled) Brand Rex cables as shown in Figure 9 and from previous Sandia tests [2]. The 35 kVdc test voltage will detect when Brand Rex cables have insulation damage greater than 23 mils provided that the cables are tested in water. Twenty-five cables were cycled as in Phase I for a total of 60 minutes at 35 kVdc (30 minutes
