Event # 43663

POTENTIAL FAILURE TO COMPLY WITH SPECIFICATION CONFIGURATION

Subject: 10CFR Part 21 Notification of Deviation re. Electroswitch Corp. P/N 700034K01 L-2 Auxiliary Switch Assemblies

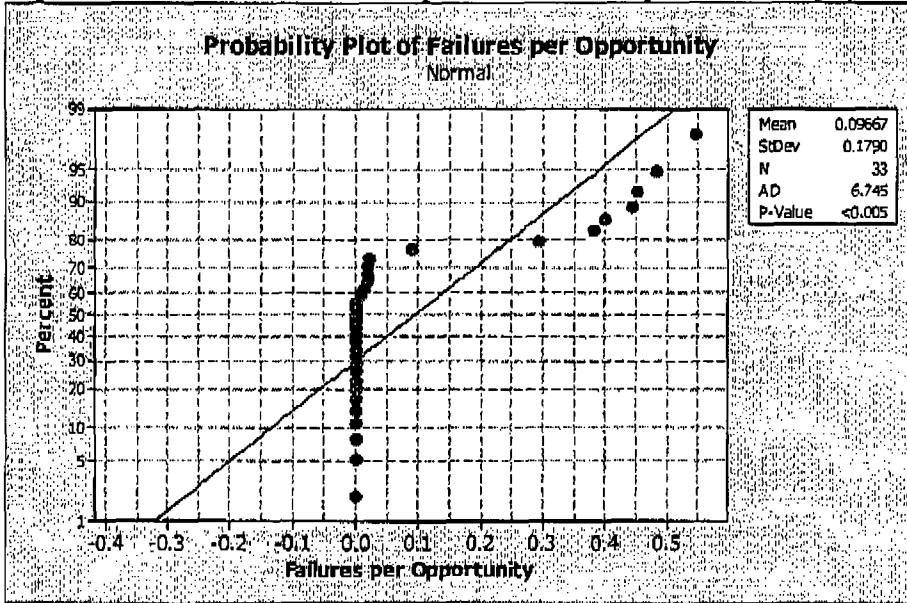
Figure 1

- 3.4.1 There is no apparent correlation between number of missing spacers in a switch, barrel position or contact function ('a' or 'b') to failure probability.
- 3.4.2 The entire population, including those barrels which never failed and those which did experience some failures do not present a normally distributed population.

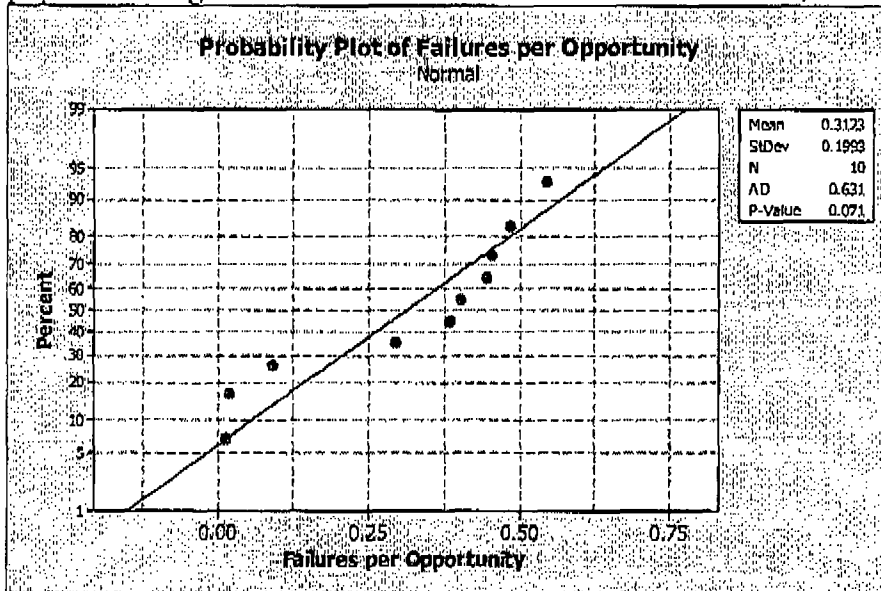
- 3.4.3 Excluding those 23 barrels which either never failed (57%) or only experienced a single failure, and taking only those 10 barrels which had more than one failure, the Failure per Opportunity measure presents a reasonable approximation of a normally distributed population. Figure 2 illustrates the distribution. Mean=0.312, Std. Dev.=0.199, P=0.07.
