Subject: 10CFR21 Reporting of Defects and Non-Compliance -
Engine Systems, Inc. Report No. 10CFR21-0106, Rev. 0

EMD (Detroit Switch) Temperature Switch – Potential Missing Set Screw

Report No. 10CFR21-0106

SYSTEM: Emergency Diesel Generator

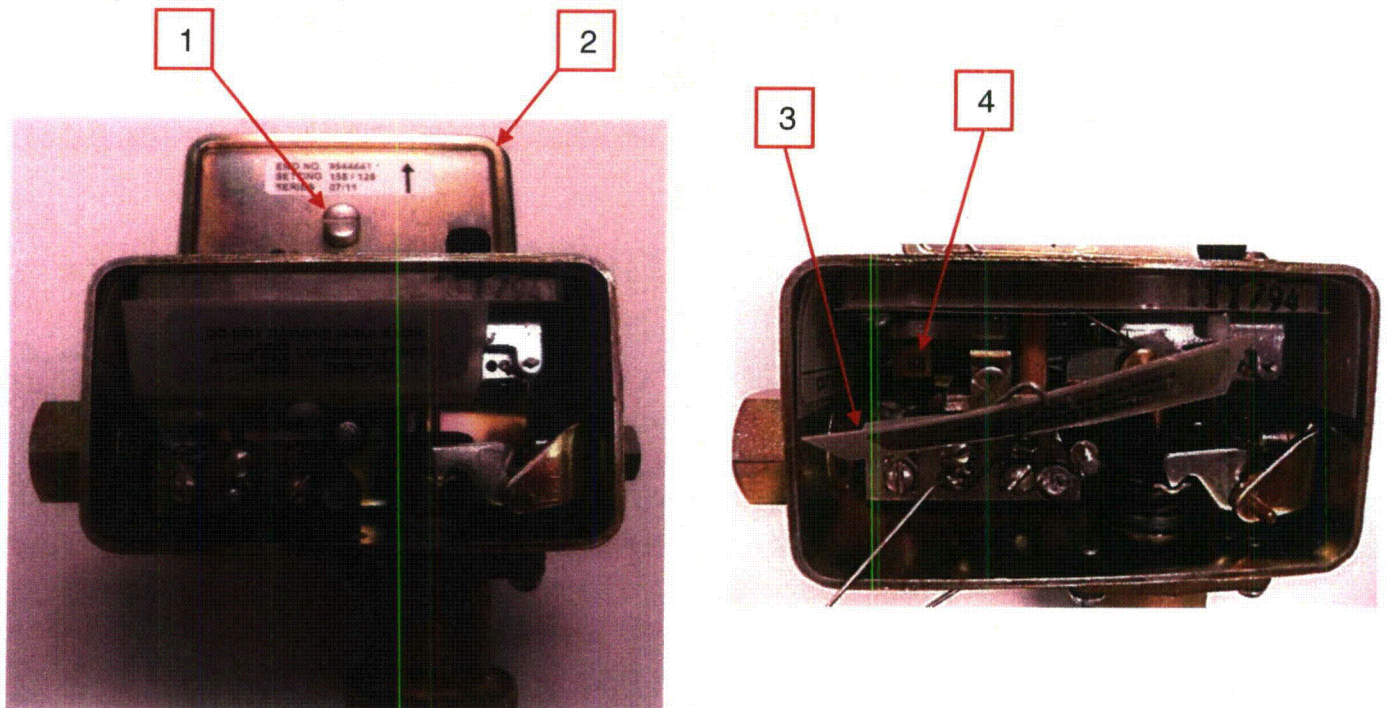
The set screw found in the temperature test fixture oil bath is 1/8" long with #6-32 threads. This is the same length, thread size and style as the set screw used in EMD/Detroit temperature switches to lock the differential adjustment screw.

To inspect the switch, perform the following:

1. Loosen the screw located in the center of the temperature switch cover.
2. Remove the cover, the mounting screw and cover gasket will remain attached to the cover.
3. Look behind the insulator to access the differential adjust screw.
4. Verify that set screw is installed.
 - a. If installed, re-install the cover; temperature switch is acceptable.
 - b. If not installed, return the temperature switch to ESI for rework.
