PART 21 REPORT - FOXBORO POWER SUPPLY POTENTIAL FAILURES DUE TO DEFECTIVE TIE WRAPS AND HOLDERS

Subject: 10 CFR Part 21 Report Notification, Foxboro, Co. N-2ARPS-A6 Power Supplies
Common Mode Failure of Thomas and Betts Model TC105A Ty-Rap Mounting Plates Adhesive
Final Report.

Title: FINAL REPORT ON IRI FOXBORO METER CO., POWER SUPPLY MODEL N-2ARPS-A6 SERIAL NUMBER 4935949 TIE WRAP HOLDERS.		Document Number: TMI-1201-100
Document Type: Technical Evaluation		Project No: TMI-1201
Client: Three Mile Island Nuclear Station	Purchase Order No: 80 046008	Page 1 of 5

FOXBORO NUCLEAR SPEC200 POWER SUPPLY POTENTIAL FAILURES DUE TO DEFECTIVE CABLE TIES AND CABLE TIE HOLDERS

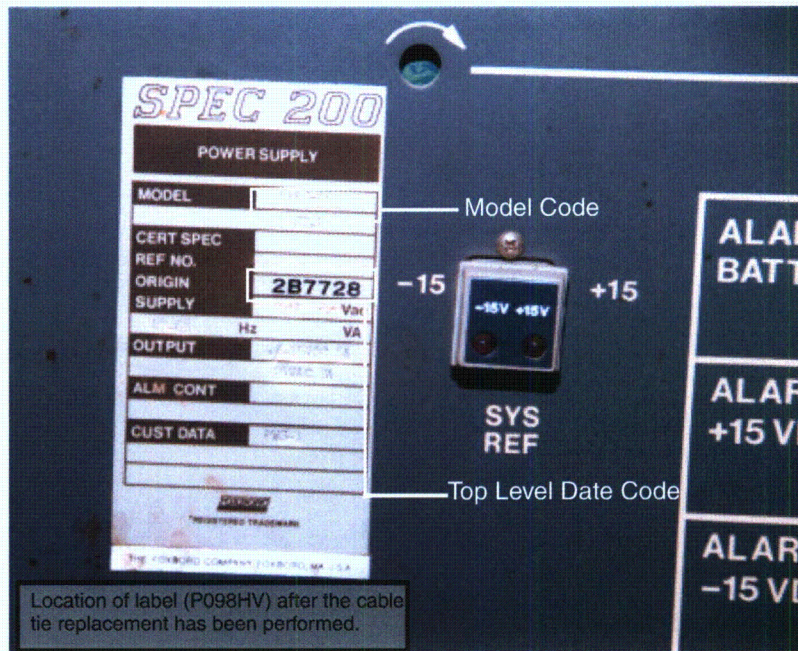
Figure 3. Product Type and Model and Top Level Date Code

Recommendation is for inspection of power supplies with year date codes 1995 and earlier. The probability of occurrence of adhesive failure would appear to be high for this age group of equipment. (See Figure 3 and Figure 4.)

1. Verify the product type and model on the front of the Power Supply as shown in Figure 3. Verify the product date codes as shown in Figure 3 and/or Figure 4.

To determine if the instrument is affected by this issue, examine the origin number on the data plate (e.g. 2A9501).

- a. The origin code of affected units is between 2A9501 (January 1995) and prior. The manufacturing date format is PPYYWW where:
 - ◆ PP = Plant of manufacture code (in this example, 2A, 2B)
 - ◆ YY = Year of production
 - ◆ WW = Week of production
- b. If the date code is beyond the manufacturing year of 1995, then no action is necessary.
