Challenges for Fuel debris retrieval with Robotics technologies at Fukushima Daiichi NPS

February 3, 2016

*Fukushima Daiichi Decontamination & Decommissioning Engineering Company,
Tokyo Electric Power Company*

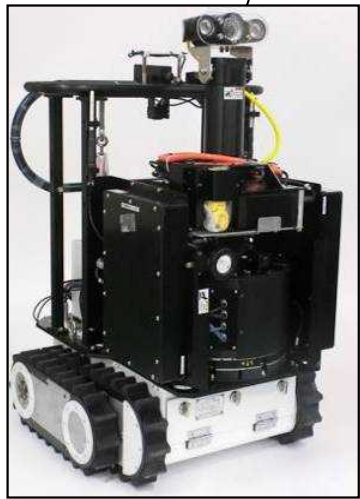
Vacuum breaker line

- Water leakage was found at the bellows cover on the vacuum breaker.
- No other leaks were found. line (May 2014)

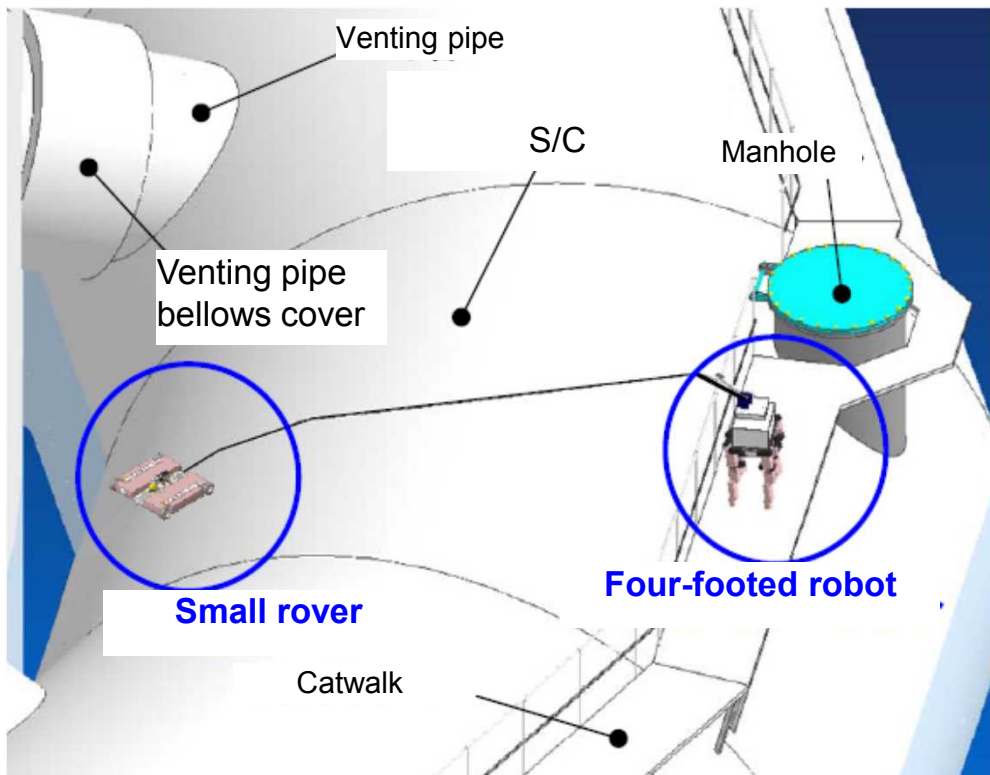
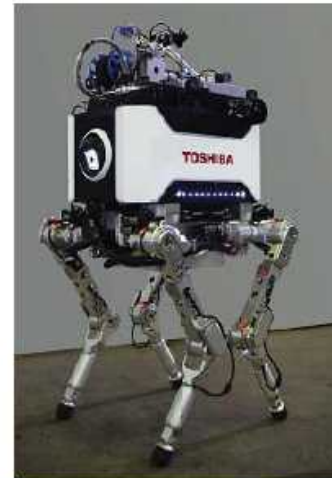
- A pair of Four-leg walking robot and small rover was used for survey.
- No leak was found.(December 2013 to March 2014)

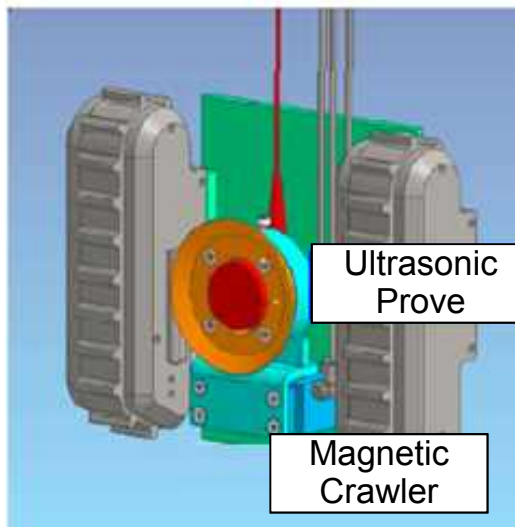
S/C water level measurement device (ATOX)

- Water level in S/C was same as in Torus room. (January 2014)
- It suggests a leakage at submerged parts of S/C or connecting pipes.

【Addendum】 It is assumed that water levels inside the S/C are being affected by the level of accumulated water in the torus

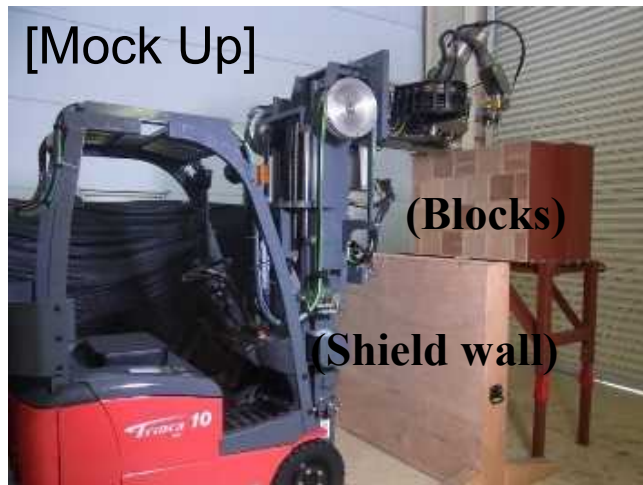
(Shield block removal at X-6, Unit 2)

Some Block Remained

By block stuck and unexpected steel plate

- Unexpected stack of concrete blocks. Rust condition was difficult to predict.
- Unexpected steel plates.
- Unexpected structure of floor groove under the blocks.

Man-Operated Work

With heavy machinery
