**Flow Control Division**

Subject: Spring Deflection Causing Potential Hang-Up of the Flapper (Disc), Worcester Series 44 Swing Check Valve

This is to notify the US Nuclear Regulatory Commission that, in accordance with the provisions of 10CFR Part 21, we have identified a potential issue and are submitting our evaluation of the event.

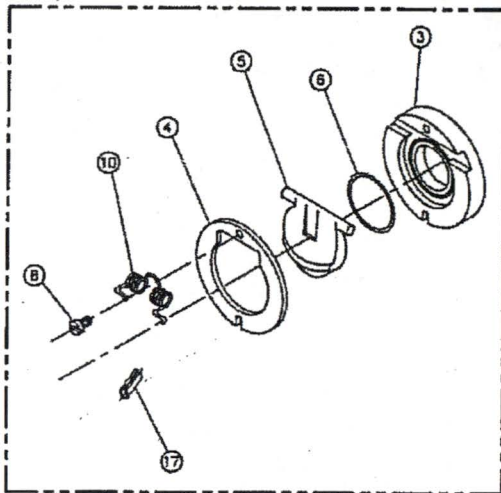
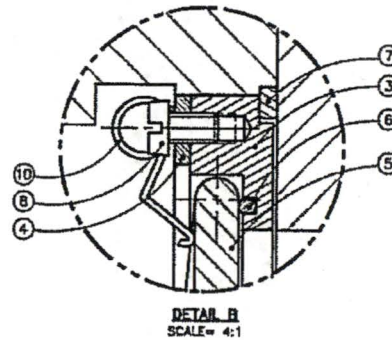
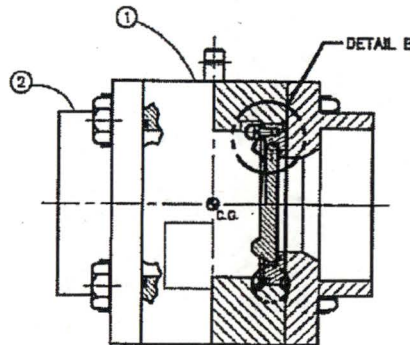
General Assembly Views

Evaluation: Shop inspections of the returned valves confirmed the potential for the spring legs to rotate outwards and potentially wedge between the flapper and seat retainer. Of the five valves evaluated, two of the valves had the spring legs rotate outward and after repeated cycles got caught between the flapper and disc; on one of the instances the spring legs prevented full closure of the flapper.

The evaluation determined the cause is an inadequate spring design which allows the spring to deflect and permit the legs to move outward.

- Owner's may remove the springs. The valves will check-off and seal under low pressure conditions without the assistance of the spring; this was demonstrated in shop tests using tap water pressure (approximately 60 psig) and will initiate closure when full open without the assistance of the spring.
- Flowserve is evaluating alternate spring designs along with the possibility of adding guides to prevent the undesired spring movement. Any new design will be proof tested.
