Subject: 10CFR21 Reporting of Defects and Non-Compliance -
Engine Systems, Inc. Report No. 10CFR21-0126, Rev. 0

EMD Fuel Injector – Cracked Spray Tip, P/N 5229250

Report No. **10CFR21-0126**

**10CFR21 REPORTING OF DEFECTS
AND NON-COMPLIANCE**

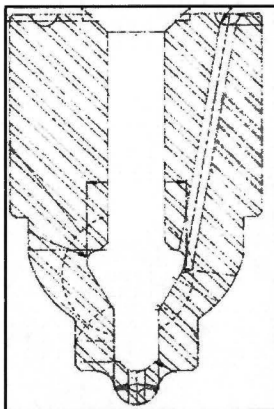
The section was made to bisect the spray tip through one of the fuel feed holes, as shown below. See Photo #2 for end view of sections.
