**Technical Letter Report  
TLR-RES/DE/CIB-2021-06**

**Technical Assistance to Review American Society of  
Mechanical Engineer's Boiler and Pressure Vessel Code  
Case and Licensee Relief Requests for Carbon Fiber Repairs  
Task-3: Mockup Testing and Physical Evaluation of Proposed  
Carbon Fiber Reinforced Polymer Repair  
Technical Letter Report**

Engineering Mechanics Corporation of Columbus (Emc<sup>2</sup>)  
3518 Riverside Drive - Suite 202  
Columbus, OH 43221-1735

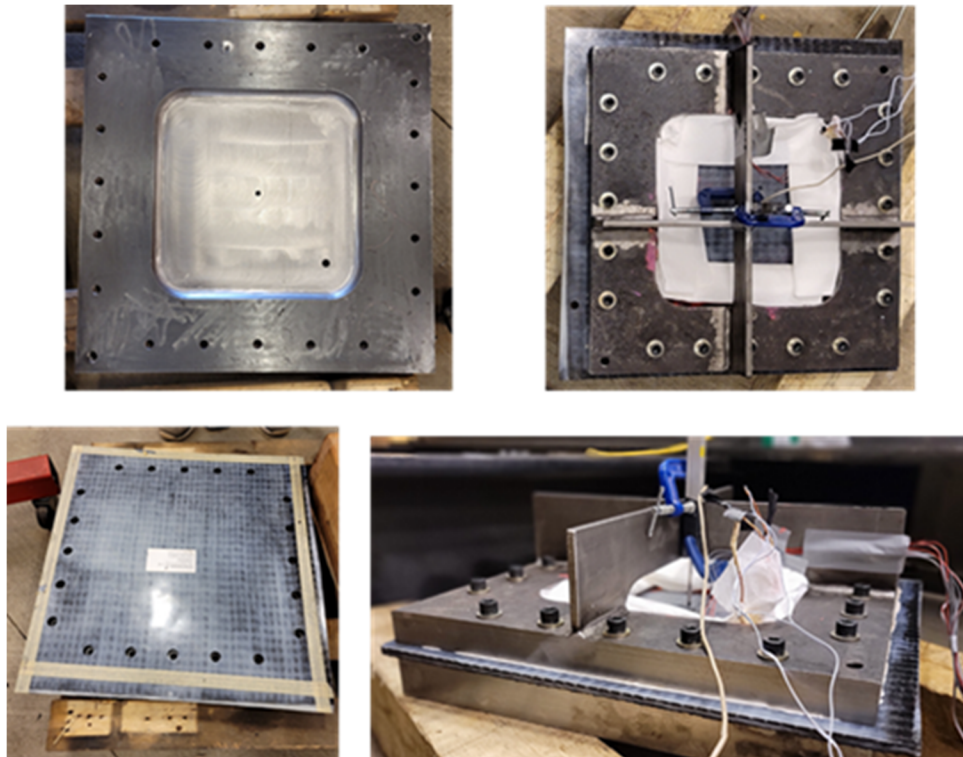
**Figure 11 The watertightness fixture built a Eme<sup>2</sup>**

Table 9 shows the watertightness test results where the maximum pressure for Test-2 and Test-3 were 460 psi and 550 psi respectively. In both tests, the watertightness pressure was significantly higher than the minimum requirement of twice the design pressure ( $2 \times 84 \text{ psi} = 168 \text{ psi}$ ). However, the onset of leak for Test-2 was through the sealant while the failure mode for Test-3 was a leak through the CFRP system. However, both test specimens showed “river-like” matrix cracking on the Cut-out region as shown in Figure 12. In that regard, Test-3 represents the watertightness pressure more appropriately which showed higher watertightness pressure than Test-2. A summary video of Test-3 watertightness test is also attached with the report. As discussed later, the failure mode for Test-3 was very similar to the failure mode observed in the full-scale hydrostatic test.

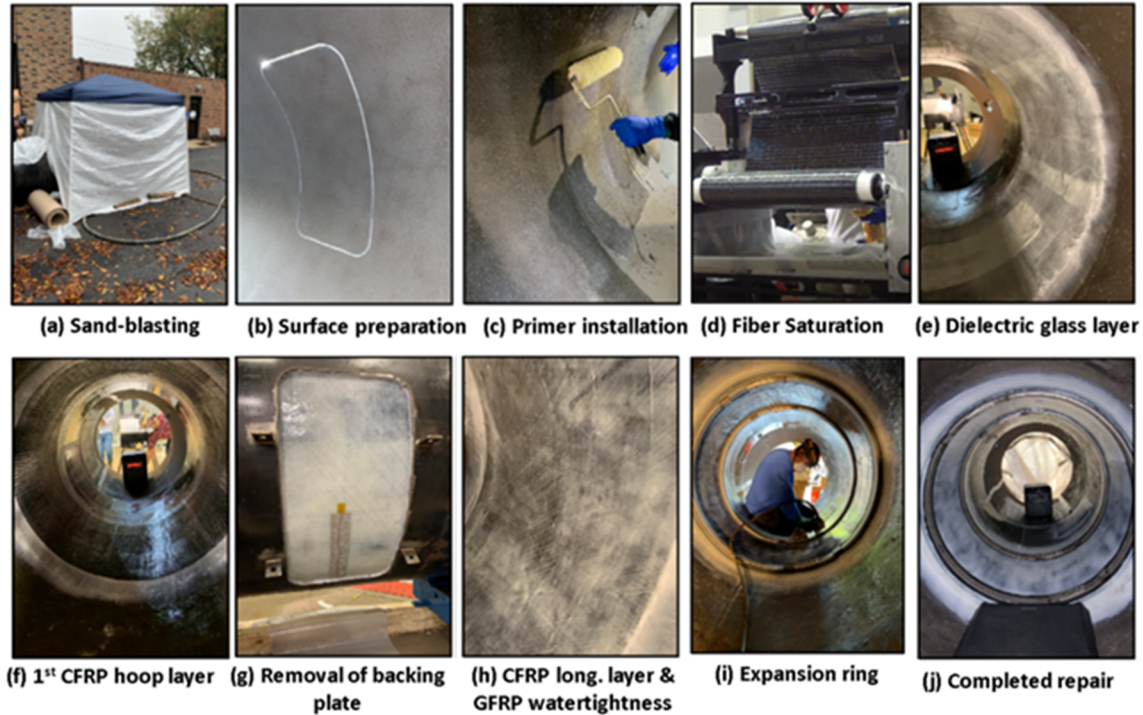
**Figure 20 The key steps in CFRP repair installation process**

1. After visually inspecting the host pipe to remove any sharp edges, weld irregularities, rust etc., sand blasting (Figure 20a) was used to prepare the inner surface (Figure 20b) of the host pipe repair area (including the backing plate) as per design requirements. Adhesion tests were performed on as-prepared surface to ensure that it met the design requirement.

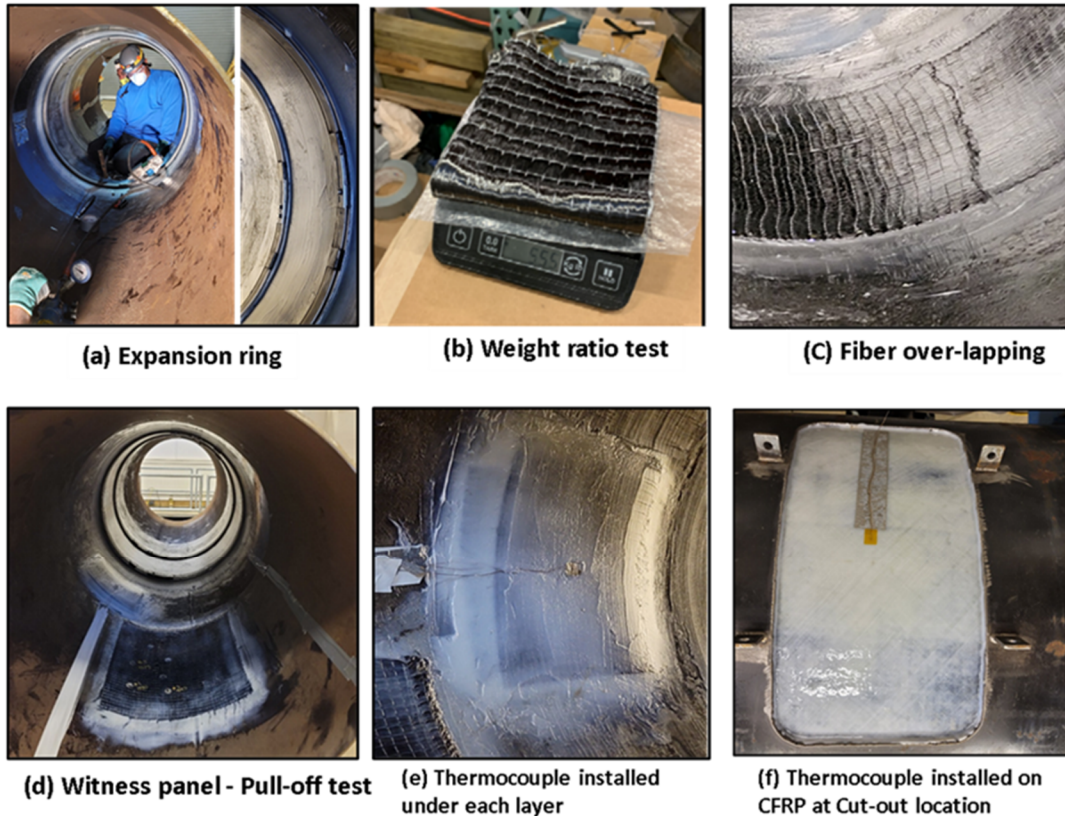
**Figure 21 Some other steps in CFRP repair installation process**

- The expansion rings consist of a stainless-steel ring, shims and an ethylene propylene diene monomer (EPDM) rubber strip were placed onto CFRP repair system at both terminal ends and were expanded using hydraulic expander as per design requirements (Figure 21a). The detailed installation is given in Appendix D.

- Figure 21b shows the weight ratio test machine where each saturated fabric was tested to ensure that the correct amount of epoxy was applied in each layer.

- Figure 21c shows how the ends of each composite layer overlap after wrapping 360° around the circumference. Thickened epoxy was applied on top of each layer before installing the next layer which provided a smooth surface over the overlap area.

- Figure 21d shows the location of witness panel which was installed away from the repair area after preparing the surface of the host pipe. Pull-off tests were conducted on this panel to ensure that the adhesive strength met the design requirements.

- Figure 21e shows the location of witness panel that was installed per Emc<sup>2</sup> guidance (not required by CC N-871). This witness panel was installed to monitor the curing temperature during installation. Emc<sup>2</sup> personnel installed one thermocouple on top of each layer (total of five layers) including one on the pipe, one on the top coat. These thermocouples were installed to investigate how the curing temperature varies for each composite layer as the curing progressed over 7 days.

- Figure 21f shows another thermocouple installed at the center of the cut-out on the inner-most epoxy layer.

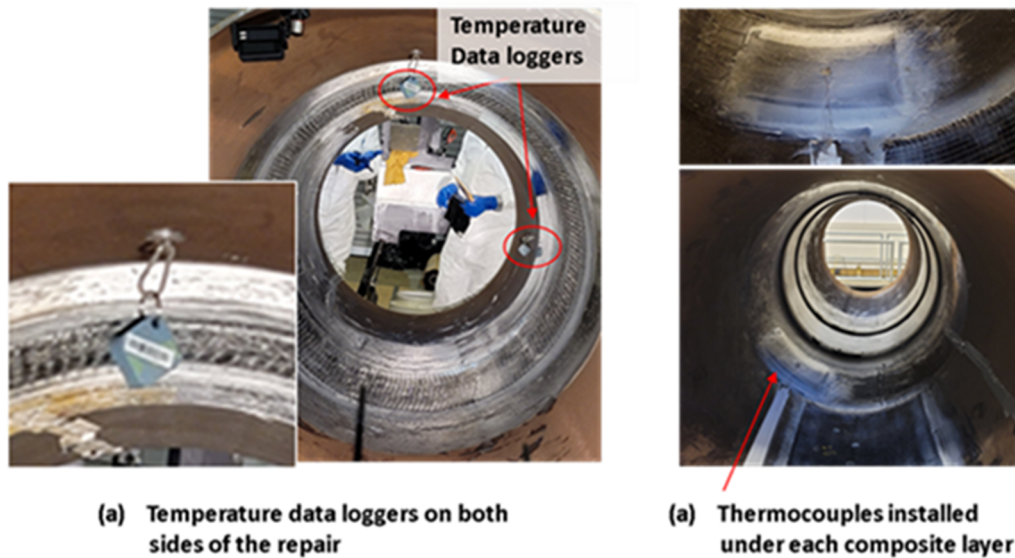
**Figure 22 Temperature data loggers and thermocouples installed to monitor curing and post-curing temperatures**

Curing and post-curing temperatures were monitored in two ways – 1) using two temperature/humidity data loggers installed by the CFRP installer, and 2) using thermocouples placed under each layer of composites installed by Emc<sup>2</sup> personnel as shown in Figure 22. A space heater inside the pipe was used to cure and post-cure the CFRP repair system.

Two temperature/humidity data loggers were located inside the host pipe on either side of the CFRP repair as shown in Figure 22(a). The data loggers were suspended from the inside surface of the pipe that measured the air temperature over the entire period of curing and post-curing as shown in Figure 23. As seen in Figure 23, both curing and post-curing temperatures range between 85 F and 95 F on either side of the CFRP repair system over the entire period of curing and post-curing. Note that the heater was removed during installation of each layer as indicated by the sudden drops of temperature during “installation and curing” process.

To monitor how the curing and post-curing temperatures vary for each composite layer over the entire period of curing and post-curing process, thermocouples were installed under each layer of composite layer by Emc<sup>2</sup> personnel (Figure 22b). Thermocouples were also installed on the pipe surface, top coat and cut-out window on the outside surface. Figure 24 shows the temperature data from all eight thermocouples installed under each layer of CFRP repair. *The main take away*

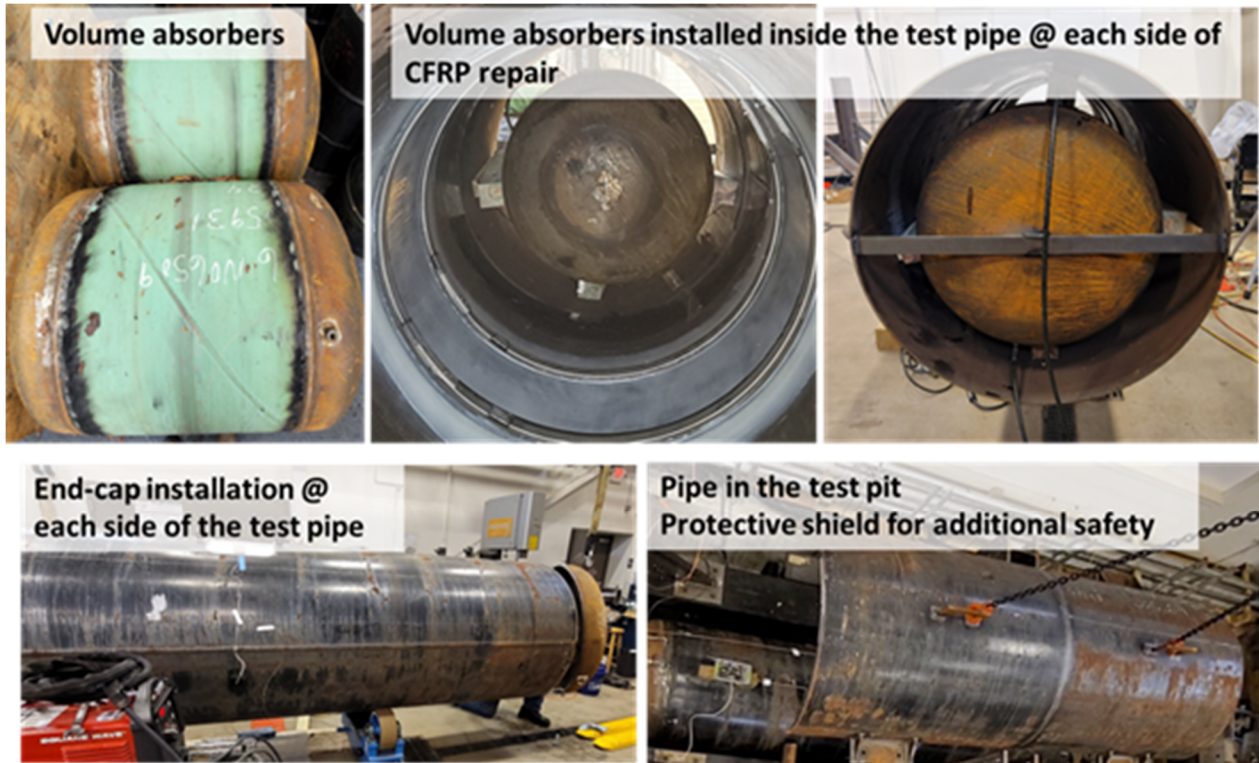
**Figure 27 Photographs showing various steps of the test setup**

Figure 26 shows the schematic of the full-scale hydrostatic test of a 40-inch diameter 13-ft long steel pipe with a 12-in  $\times$  24-in hole at the center of the axial length of the host pipe which was repaired by CFRP system with 24-inch length as per ASME BPV CC N-871 as described previously. Photographs of various steps during the test setup are shown in Figure 27. As seen in Figure 26 and Figure 27, two volume absorbers, each 30-inch diameter and 4-ft long were inserted inside the test pipe to reduce the energy release in the event of any catastrophic failure during the test. The volume absorbers were placed on either side of the repair and were welded to each end of the host pipe to restrict them from moving as shown in Figure 27. After securing the volume absorbers, two end-caps were welded on either side of the host pipe as shown in Figure 27. The test pipe was secured inside a test pit with strong I-beam structure inside the Emc<sup>2</sup> laboratory and a protective shield (made of large diameter steel) was secured over the test pipe for additional safety during the hydrostatic test, see Figure 27 and Figure 28.

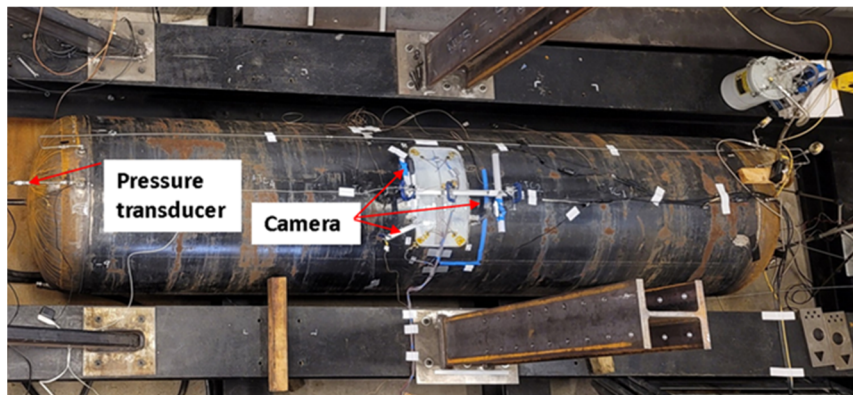
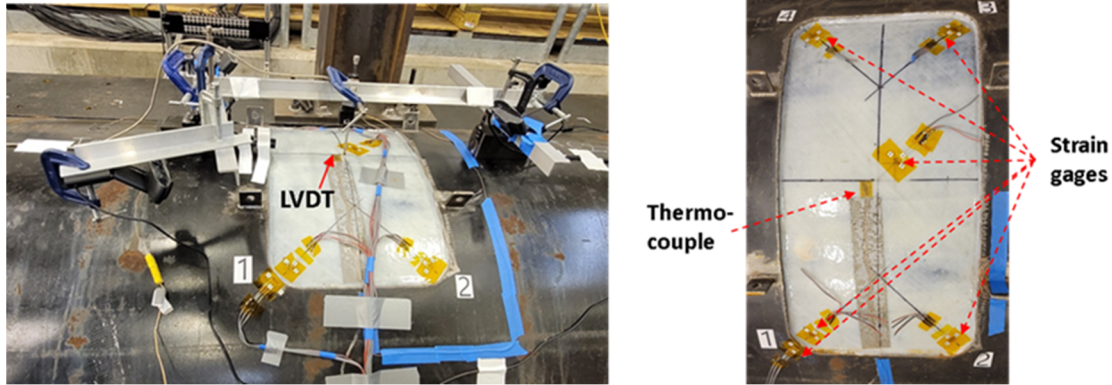
**Figure 28 Instrumentation for the full-scale hydrostatic test**

Figure 28 shows the detailed instrumentation installed on the host steel pipe and CFRP repair system. There was one pressure transducer, one LVDT on the CFRP at the center of the cut-out measuring the bulging of CFRP system and one thermocouple at the cut-out location measuring the test temperature. There were 15 strain gages mounted on CFRP – 3 strain gages forming a triaxial set on each of four corners of the cut-out and another triaxial set at the center of the cut-out on CFRP. Each triaxial set was placed to measure hoop, longitudinal and 45° strains on CFRP. The 3 strain gages forming a triaxial set were mounted on the steel host pipe at one of the corners of the cut-out. The strain values from these strain gages were monitored live during the test to ensure the strain on the pipe material would not exceed the yield strain. Four cameras and LED light strips were installed underneath the shield to record the video covering the whole area of the cut-out and instrumentation. Several NRC staff were originally planning to visit Emc<sup>2</sup> to witness the full-scale hydrostatic test. Due to COVID-19 pandemic and travel restrictions, the entire full-scale hydrostatic test was live streamed to NRC staff via multiple cameras.

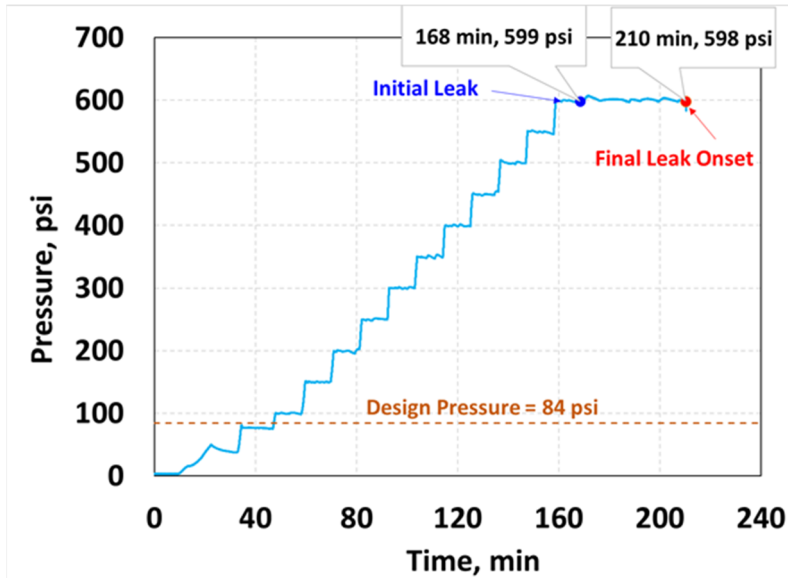
Figure 29 Pressure versus time data from the full-scale hydrostatic test

Figure 29 shows the pressure versus time plot for the full-scale hydrostatic test which took about four hours to complete. As seen in the figure, the onset of initial leak started at 600 psi after about 168 minutes. At initial failure, a low energy water leak occurred through a small pinhole near the edge of the cut-out between Corner 1 and 4 as shown in Figure 30 (a). After initial leak, the pressure was held at 600 psi (leak pressure) for another 40 minutes when a significant cracking noise in the matrix was heard followed by the observation of several pinhole type leaks in the area between Corner 1 and 2 as shown in Figure 30 (b). At this stage, the pressure started to drop and at around 580 psi, the release valve was opened to quickly drain the water to preserve the failure modes in the CFRP for post-test analysis. This failure was designated as final leakage failure. The failure mode for the full-scale hydrostatic test with CFRP repair was designated as a “leak” preceded by significant matrix cracking noise, and the failure (leak) pressure for this test was 600 psi. A summary video of the full-scale hydrostatic test is also attached with the report.

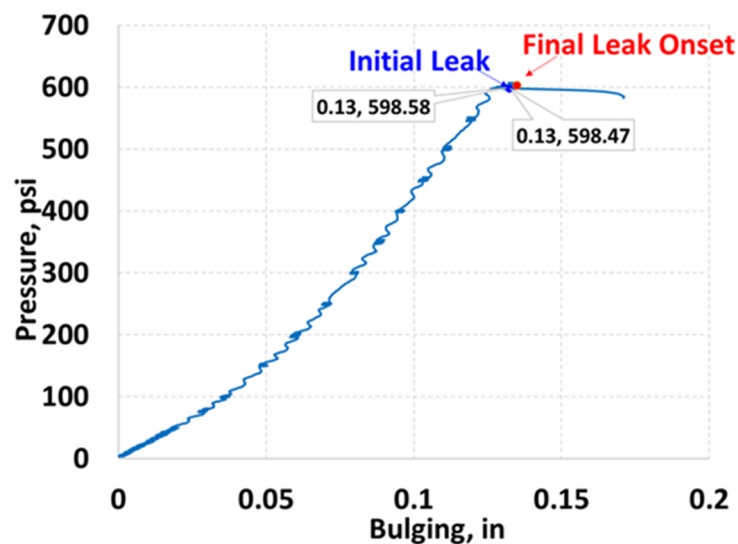
Figure 31 Pressure versus bulging during the hydrostatic test

Figure 31 shows the pressure versus bulging data and Figure 32 shows the temperature data during the hydrostatic test. As seen in Figure 31, maximum bulging of the CFRP repair system at the center of the cut-out was 0.13 inch at 600 psi failure (leak) pressure. The test temperature was 72 F for the entire period of the hydrostatic test.

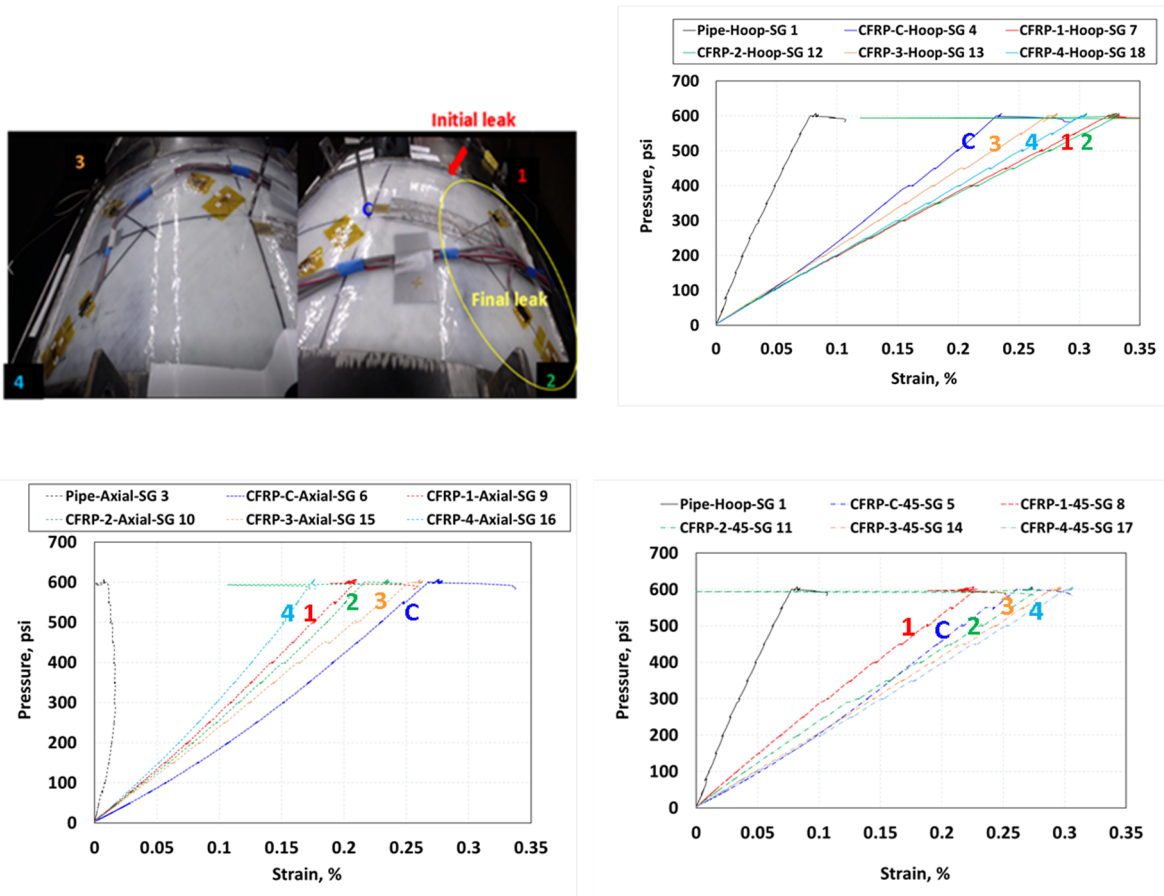
Figure 33 Strain gage data on host pipe and CFRP during the hydrostatic test

Strain gage data on both host steel pipe and CFRP system as a function of pressure is shown in Figure 33. Figure 33(a) shows the photograph of CFRP repair system through cut-out indicating the locations of initial and final leak as well as the identifications of four corners where strain gages were mounted. Figure 33 (b), (c), and (d) show pressure versus strain plots for host steel pipe and four corners of CFRP in hoop, axial, and 45° directions respectively. As seen in the figure, strain values were less than 0.1% for both axial and hoop directions for steel pipe ensuring that the pipe material did not yield (0.2% yield strain) during the hydrostatic test. Note that one strain gage (45° direction) on the pipe was lost before starting the hydrostatic test. At all four corner locations for CFRP repair system, hoop strains were the largest and dominating with a range of 0.27%-0.33% whereas the axial strains were within a range of 0.17-0.26%. The initiation of leak occurred at a location near Corner 1 (see Figure 30) and final leak occurred in the vicinity of Corner 1 and 2 where the hoop strains (for both Location 1 and 2) were maximum (about 0.33%). These strain data coupled with matrix cacking noise indicate that the matrix of CFRP repair system cracked at a strain value of around 0.33%, potentially creating a leak path through the matrix, CFRP and GFRP watertightness layers. Post-test analysis of the test specimen revealed several river-like cracking marks on the CFRP repair system on the inner or top (from inside the pipe) surface of the CFRP repair system behind the cut-out area (especially near Corner 1 and 2) indicating that the potential failure mode was matrix cracking and hence, leak through the CFRP system (see Figure 34). There was no evidence of water found near the edge at the bonded area between the host pipe and CFRP repair suggesting that the leak did not occur within the bond. Also, no evidence of fiber breakage was noticed at 600 psi leak failure pressure.

The failure mode in the CFRP repair system was essentially a pinhole leak through the repair preceded by matrix cracking. Longitudinal and hoop strain data on CFRP during full-scale hydrostatic test revealed that the maximum strain in any direction at failure (leak) pressure (600 psi) was about 0.33% which is significantly lower than the tensile strain at break of about 1.5% for single-ply and multi-ply laminate (See Figure 1 and Appendix B) indicating that the matrix

cracking did not occur due to the hoop or longitudinal tensile stresses from pressure loading. It is surmised that the cracking occurred due to the longitudinal bending of CFRP system near the cut-out edges as the CFRP system bulged out through the cut-out. However, as the full-scale hydrostatic test was not conducted beyond the leak pressure (which would require very different test design), any additional margin (beyond 7) that is available for any other failure such as rupture, fiber breakage was not evaluated.
