## Operational Assessment of ANO-2 Steam Generator Tubing for the Remainder of Cycle 14

February 3, 2000

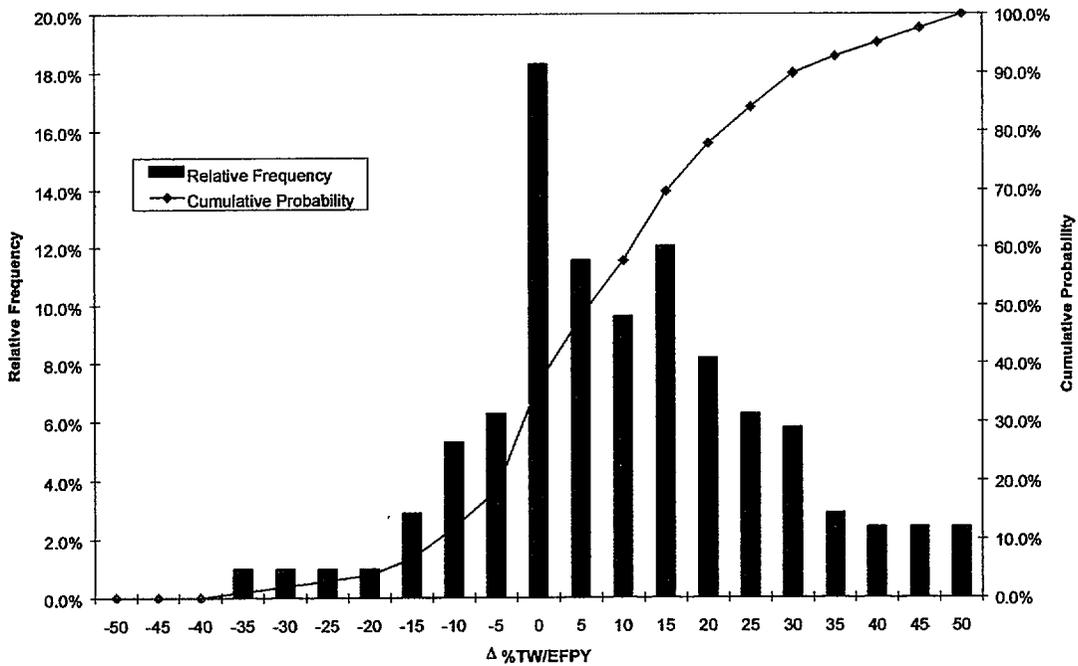
**Figure 5.1**  
ANO Axial Flow Growth/EFPY (2P99 – 2R13)

A depiction of the ANO growth data from 2P99 is presented as Figure 5.1 where negative growth values are explicitly indicated. Data from both SGA and SGB are included in Figure 5.1.

Figure 5.1 is normalized to the 1.48 EFPY of operation from 2P98 to the most recent inspection at 2P99. The data suggests the presence of a significant non-destructive examination (NDE) uncertainty component. That is, the overall shape of the distribution, its symmetry about a small growth value near zero and the preponderance of negative values, are consistent with a measurement process where NDE uncertainty is the dominant statistical component for the bulk of the distribution. The empirical data therefore suggest that apparent growth is the superposition of an NDE uncertainty distribution and a "true" depth growth distribution.

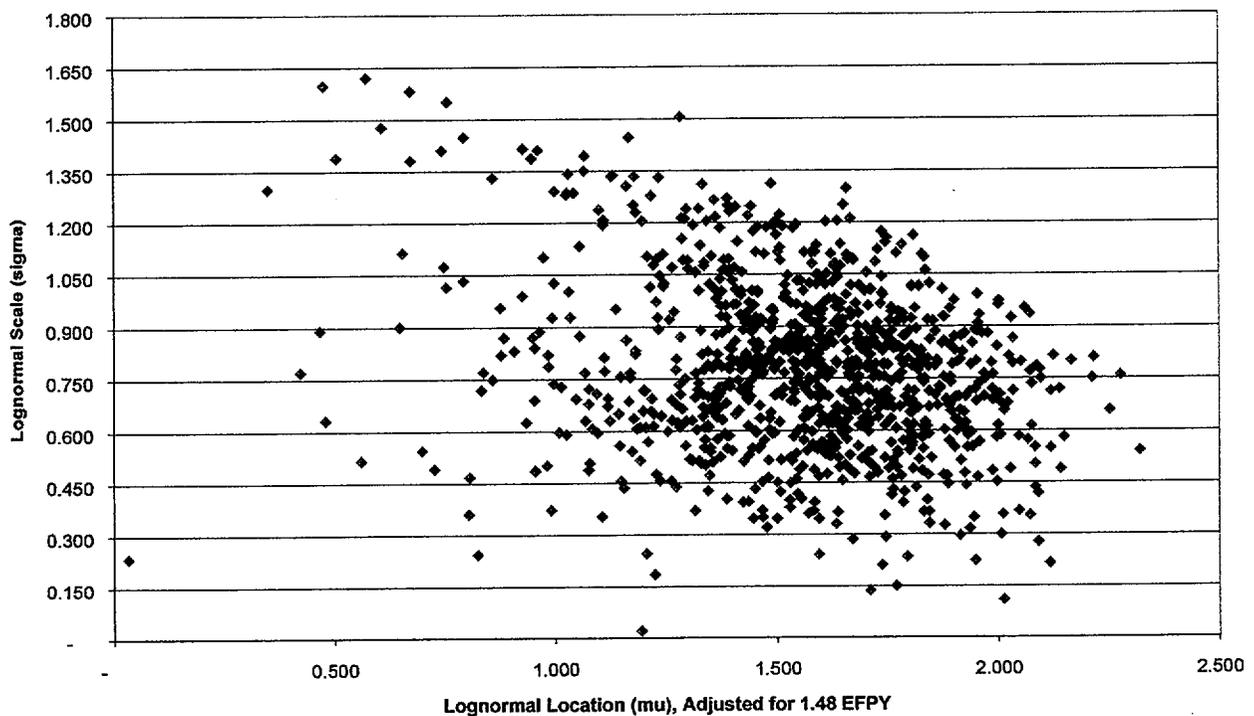
**Figure 5.2**

To eliminate the uncertainty of sizing, a series of 1000 models were performed using the ANO-2 data from SGB during 2P99. From this data set, an optimization process was performed to minimize the effects of the negative growth rates or uncertainty in sizing. The resulting actual growth parameter super-set is indicated in Figure 5.2. If the center value was taken from the scatter plot, the value taken would be consistent with values seen at other Combustion Engineering plants.

**ANO-2 Axial Flow Growth Rate Model Parameters  
ITERR=20, JMAX=50**

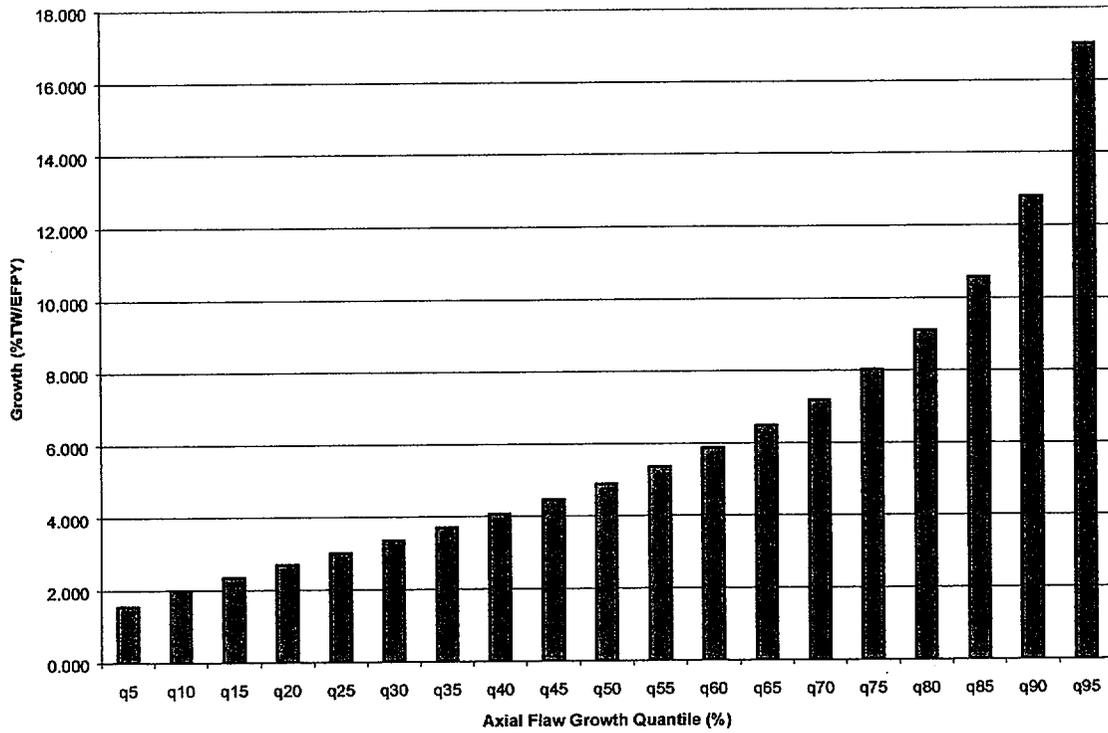
**Figure 5.3**  
**ANO Axial Flaw Actual Growth Model**

The superset of ANO-2 axial flow growth model parameters are an important input to the probability of burst calculation. This family of lognormal models accounts for uncertainties in the relative contribution to the observed (apparent) growth data from NDE uncertainty and actual growth. The equivalent distribution of actual growth rates that corresponds to this model is provided in Figure 5.3.

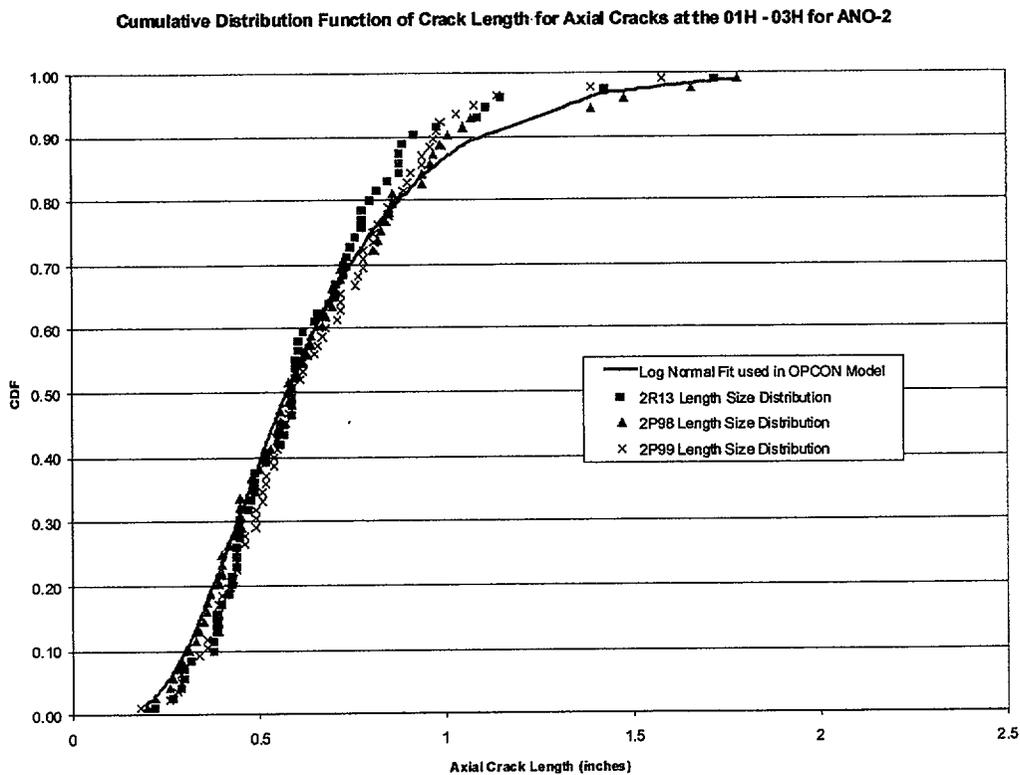
**Figure 5.4**

Figure 5.4 confirms that the distribution on crack lengths has not changed significantly in the last three outages.

The length values were obtained directly from the raw MRPC data. This is a conservative method of determining extent due to the eddy current field look ahead and fall behind, which is defined as the influence of the flaw seen prior to the coil reaching the metal loss and after the coil passes the flaw. Therefore, the MRPC values used are, on average, longer than what actually exists as confirmed by previous ANO-2 tube pull data. Of the five axial flaws pulled from ANO-2, the MRPC axial extent oversized the flaws by an average of 15% indicating that a conservative distribution is being used for axial lengths. A comparison between the field MRPC length and the length determined by the destructive analysis (DA) is given in Table 5.1. Depth distributions for axial eggcrate flaws are provided in Figure 5.5.

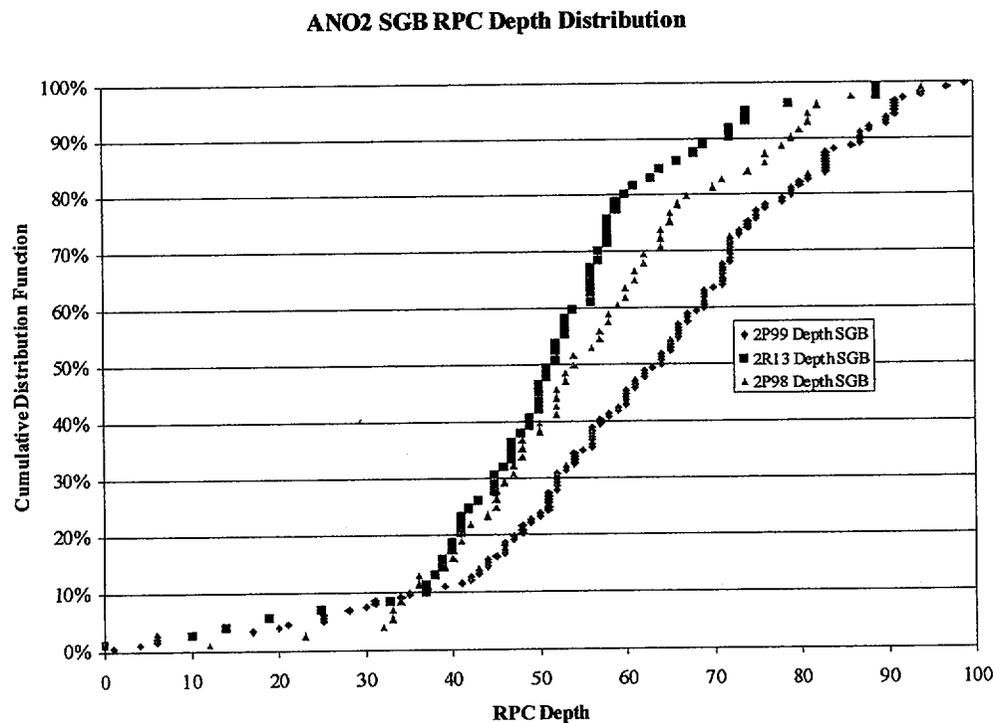
**Figure 5.5**

Figure 5.5 represents the distributions of maximum depths as measured by MRPC for the last three outages which was previously submitted in the condition monitoring report (2CAN129911)<sup>3</sup>. It is apparent in this figure that in the most recent outage (2P99), the depths were approximately 10-15% deeper than those sized in previous outages. Further investigation into the rationale for this result determined that several of the analysts were using channel 1 (300 KHz) instead of the mix channel P1 (300/100 KHz) to perform sizing of the flaws. This data was re-analyzed using the P1 mix. Both the 2P98 and 2R13 outages were performed using the P1 channel for sizing. This resulted in a reduction in depth consistent with the two previous outages. This is depicted in Figure 5.6:
