February 28, 2000

1CAN020008

Subject: Arkansas Nuclear One - Unit 1
Docket No. 50-313
License No. DPR-51
Supplemental Information Regarding Hot Leg Nozzle RC-1071/1072

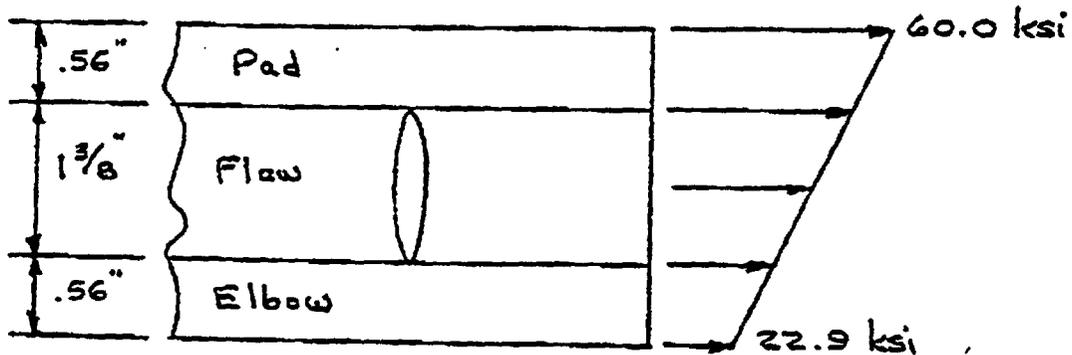
The total average remote tensile stress applied to the CCP model to evaluate the postulated embedded flaw between the weld pad and elbow is obtained as follows:

At weld pad surface:	60.0 ksi
<u>At elbow surface:</u>	<u>22.9 ksi</u>
Average stress:	41.5 ksi
