VIRGINIA ELECTRIC AND POWER COMPANY
NORTH ANNA POWER STATION UNIT 1
ASME SECTION XI RELIEF REQUESTS NDE-9 AND NDE-15

ASME Section XI Relief Request NDE-9

North Anna Power Station Unit 1

NES MATERIALS ENGINEERING LABORATORY
FAILURE ANALYSIS REPORT

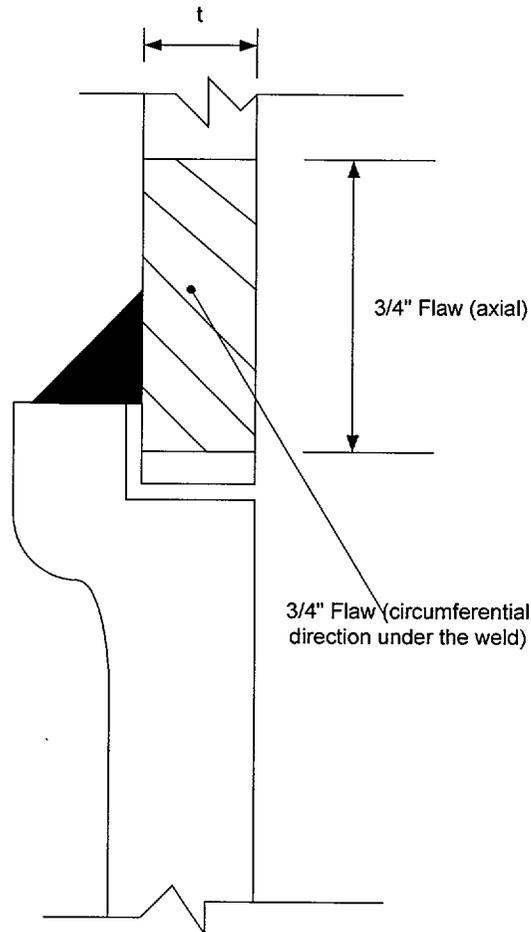
Figure 1
Flaw location

Structural analysis methodology for MIC flaw in vicinity of socket weld.

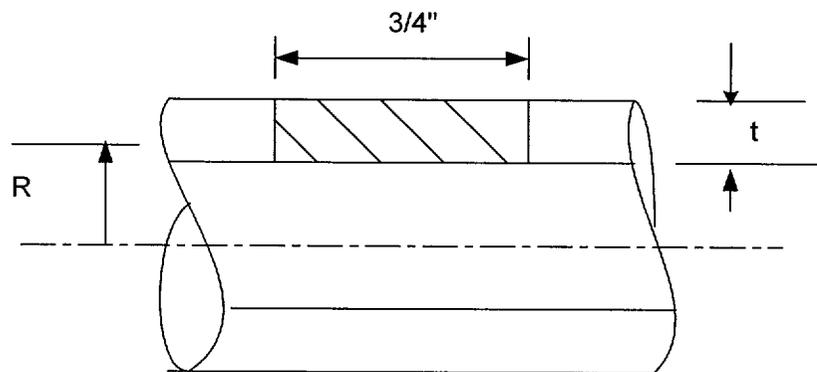
Figure 3
Axial Flow

- i) A $\frac{3}{4}$ " long through-wall circumferential flaw (Fig 2).
- ii) A $\frac{3}{4}$ " long through-wall axial flaw (Fig 3).
- iii) A $\frac{3}{4}$ " diameter hole.

The analysis will be performed using the guidance from the ASME Code Case N-513 and ANSI B31.1 Power Piping Code paragraph 104.3. The analysis will treat the flawed location as equivalent to the nominal pipe of the same size containing the enveloping flaw. The required margins in the Code Case will be demonstrated using the loadings due to pressure, deadweight, thermal expansion, seismic OBE and DBE conditions as appropriate. A residual stress equal to the yield stress in the material will be used in the analysis to address the influence of the weld. The $\frac{3}{4}$ " hole will be evaluated using the area replacement method of the ANSI B31.1 Code.

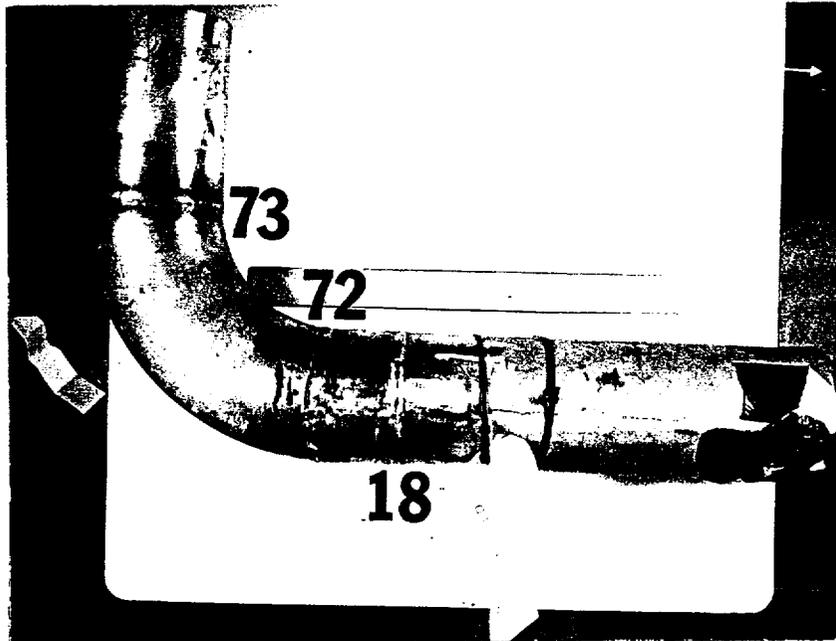
Figure 1: Photograph showing the segment of pipe containing field weld 18W.

4"-WS-46-163-Q3-18W: The segment of pipe that was submitted to the lab containing this weld is shown in *Figure 1*. The initial inspection of the ID surface revealed approximately seven nodules along the circumference of the weld. Six were small to medium in size but the remaining nodule was fairly large. *Figure 2* shows the large nodule along the ID surface of the weld after the pipe was sectioned in half. Evident in the photo is a circular area of discoloration next to the large nodule that may have been the location of another large nodule that had been dislodged. Cleaning of the surface and microscopic inspection revealed that two of the smaller nodules were actually areas of weld metal melt through that had become covered with deposit. The weld contained several pits, some of which were in the center of the weld, *Figure 3*, while others were closer to the edge of the weld near the heat affected zone (HAZ), as shown in *Figure 4*. A metallographic cross section was prepared on the pit shown in *Figure 4*. The results are presented in the two views shown in *Figure 5*. The top photo shows the damage as it first appeared upon inspection, approximately 1/3 of the way through the weld. The bottom photo shows how the pit expanded and branched out towards the pipe base metal. This subsurface branching was observed in several of the pits and is a classic indicator of MIC damage.

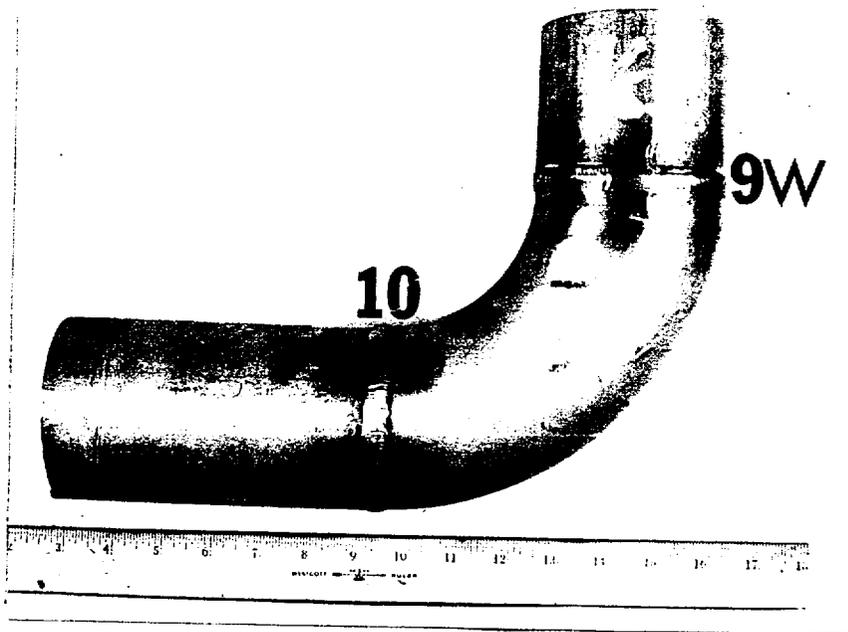
3"-WS-74-163-Q3-FW9W: The section of pipe submitted to the lab for analysis that contained this weld is shown in *Figure 14*. This section of pipe displayed evidence of staining on the OD indicating an apparent through wall leak at the weld. The ID surface showed the remnants of three nodules, one appeared to be large and corresponded with the apparent leak location on the OD. The other two appeared to be moderately sized. All three were located on the weld as shown in *Figure 15*. Cleaning of the pipe surface revealed a very rough and irregular weld profile, making it difficult to determine if pits and cavities present under the removed nodules, displayed in *Figure 16*, were related to MIC or the welding operation. Two areas thought to be small nodule-like areas were actually determined, after cleaning, to be areas of weld melt through. A metallographic cross section was prepared through the weld in the area shown in *Figure 16* which corresponded to the area under the largest nodule. This section revealed corrosion damage that was not only similar to the damage at several of the other welds but was again a classic example of microbiologically influenced corrosion attack. *Figure 17* is a photographic montage showing the corrosion pit at this weld. The pit appears to have propagated along the weld/base metal interface, and to have undergone extensive lateral expansion (roughly ½ inch in total length) into the pipe wall.

Figure 14: View of the section of pipe containing field weld 9W.

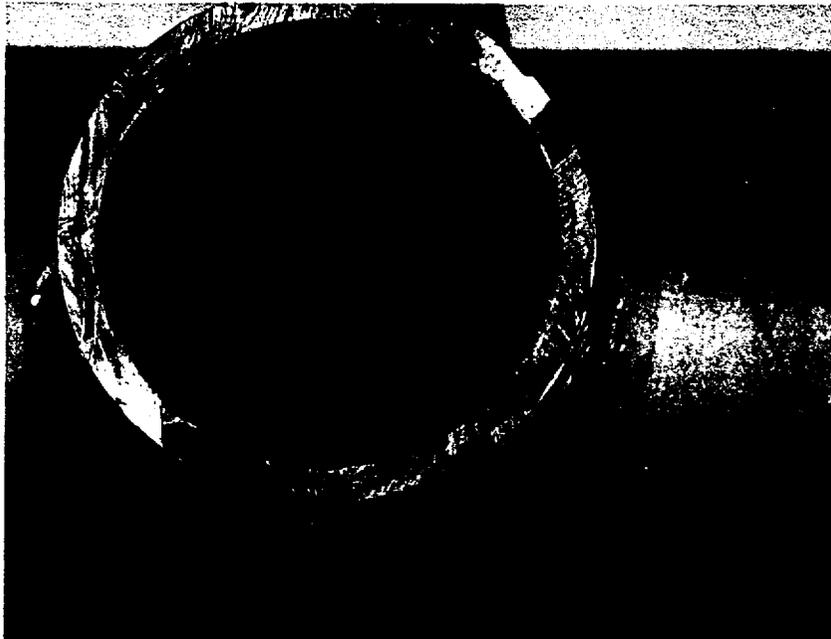
Figure 23: Photograph showing the tubercles along the ID of weld 58.
