**Report on the preliminary  
fact finding mission  
following the accident at the  
nuclear fuel processing  
facility in Tokaimura, Japan**

INTERNATIONAL ATOMIC ENERGY AGENCY, VIENNA, 1999

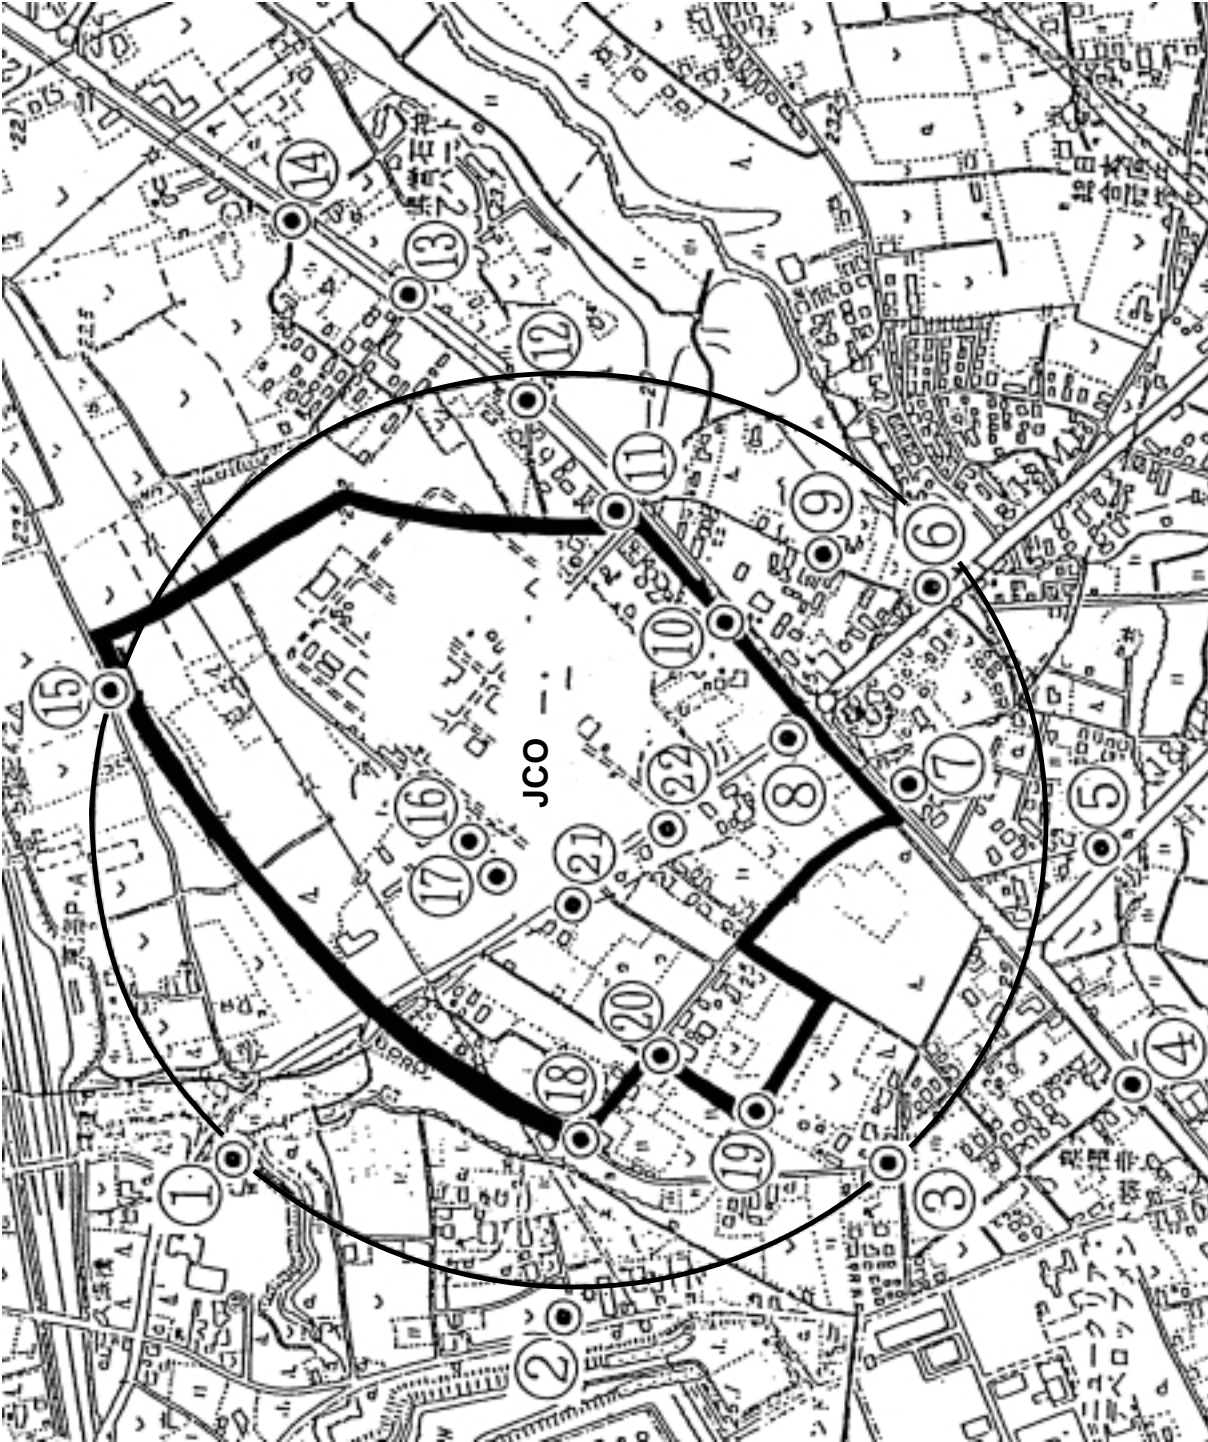
Fig. 3. Local map indicating the area (enclosed by the bold line) within a 500 m radius of the facility (circle) for which evacuation was implemented.

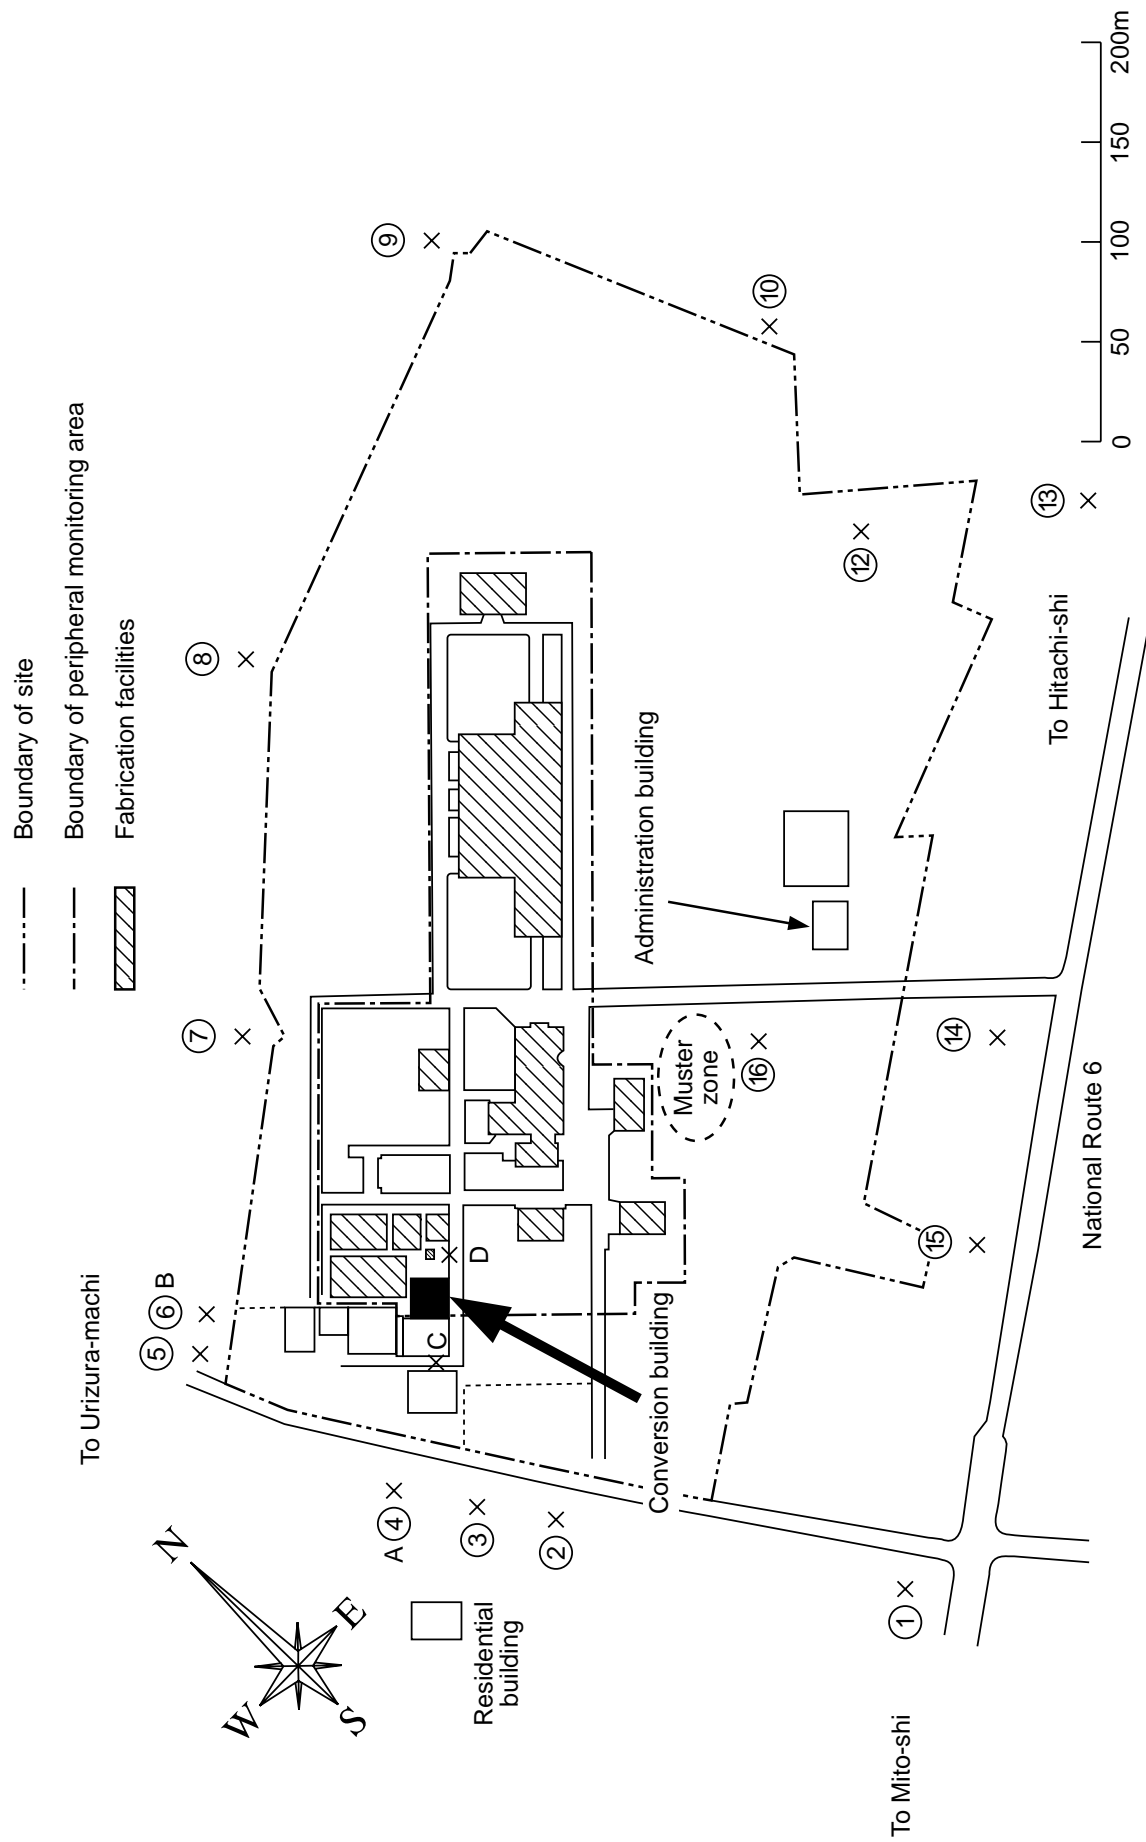
Fig. 4. Plan of the JCO site with location of monitoring points (circled numbers).

At around 10:35 on 30 September (all times are local times unless otherwise stated), when the volume of solution in the precipitation tank reached about 40 L, equivalent to about 16 kg U, a critical mass was reached. At the point of criticality, the nuclear fission chain reaction became self-sustaining and began to emit intense gamma and neutron radiation [14]. The area gamma monitoring device detected a high level of gamma radiation and the area alarms sounded. The three workers concerned evacuated the building (there was apparently no explosion). They were subsequently given assistance by emergency service workers. The other workers on site assembled in the muster zone (Fig. 4).

The criticality in the precipitation tank in the conversion building is considered to have continued for about 20 hours, from 10:35 on 30 September to about 06:30 on 1 October. In this period, the neutron dose rates at the site boundary (Fig. 4), measured at point A (about 90 m southwest of the conversion building) and point B (about 110 m northwest of the conversion building) fell from 4.0 and 4.5 mSv/h at the start of measurement at these locations (19:09–19:22 on 30 September) to below the detection limit when the criticality ceased. Gamma radiation dose rates decreased over time from the first gamma measurement between 11:35 and 11:50 on 30 September recorded at point A (0.84 mSv/h) to 0.001 mSv/h when criticality ceased. The neutron dose rates at around 20:45 on 30 September were found to decrease steadily with distance from the conversion building. The neutron dose rate decreased from about 3 mSv/h at 100 m from the JCO site to about 0.02 mSv/h at 500 m, a factor of about 100. The reduction factor with

At around 11:40, a maximum dose rate of 0.84 mSv/h was measured at point A on the map (see Fig. 4 and Section 4.2.1). At around 13:40, the Nuclear Material Regulation Division of STA requested the dispatching of emergency monitoring staff. At around 14:00, the Mito Atomic Energy Office of STA began monitoring [13].

Once criticality had ceased, neutron dose rates fell below the detection limit and gamma dose rates decreased to almost normal levels after sandbags were piled around the conversion building on 2 October. The IAEA Secretariat team's measurements of the gamma dose rate confirmed that levels were normal outside the JCO site boundary and dose rates on the site were slightly higher [29], e.g. 0.84  $\mu\text{Sv/h}$  at about 12 m east-northeast of the conversion building (point D), with no concrete blocks or sandbags along the line-of-sight between the detector and the conversion building (Fig. 4).

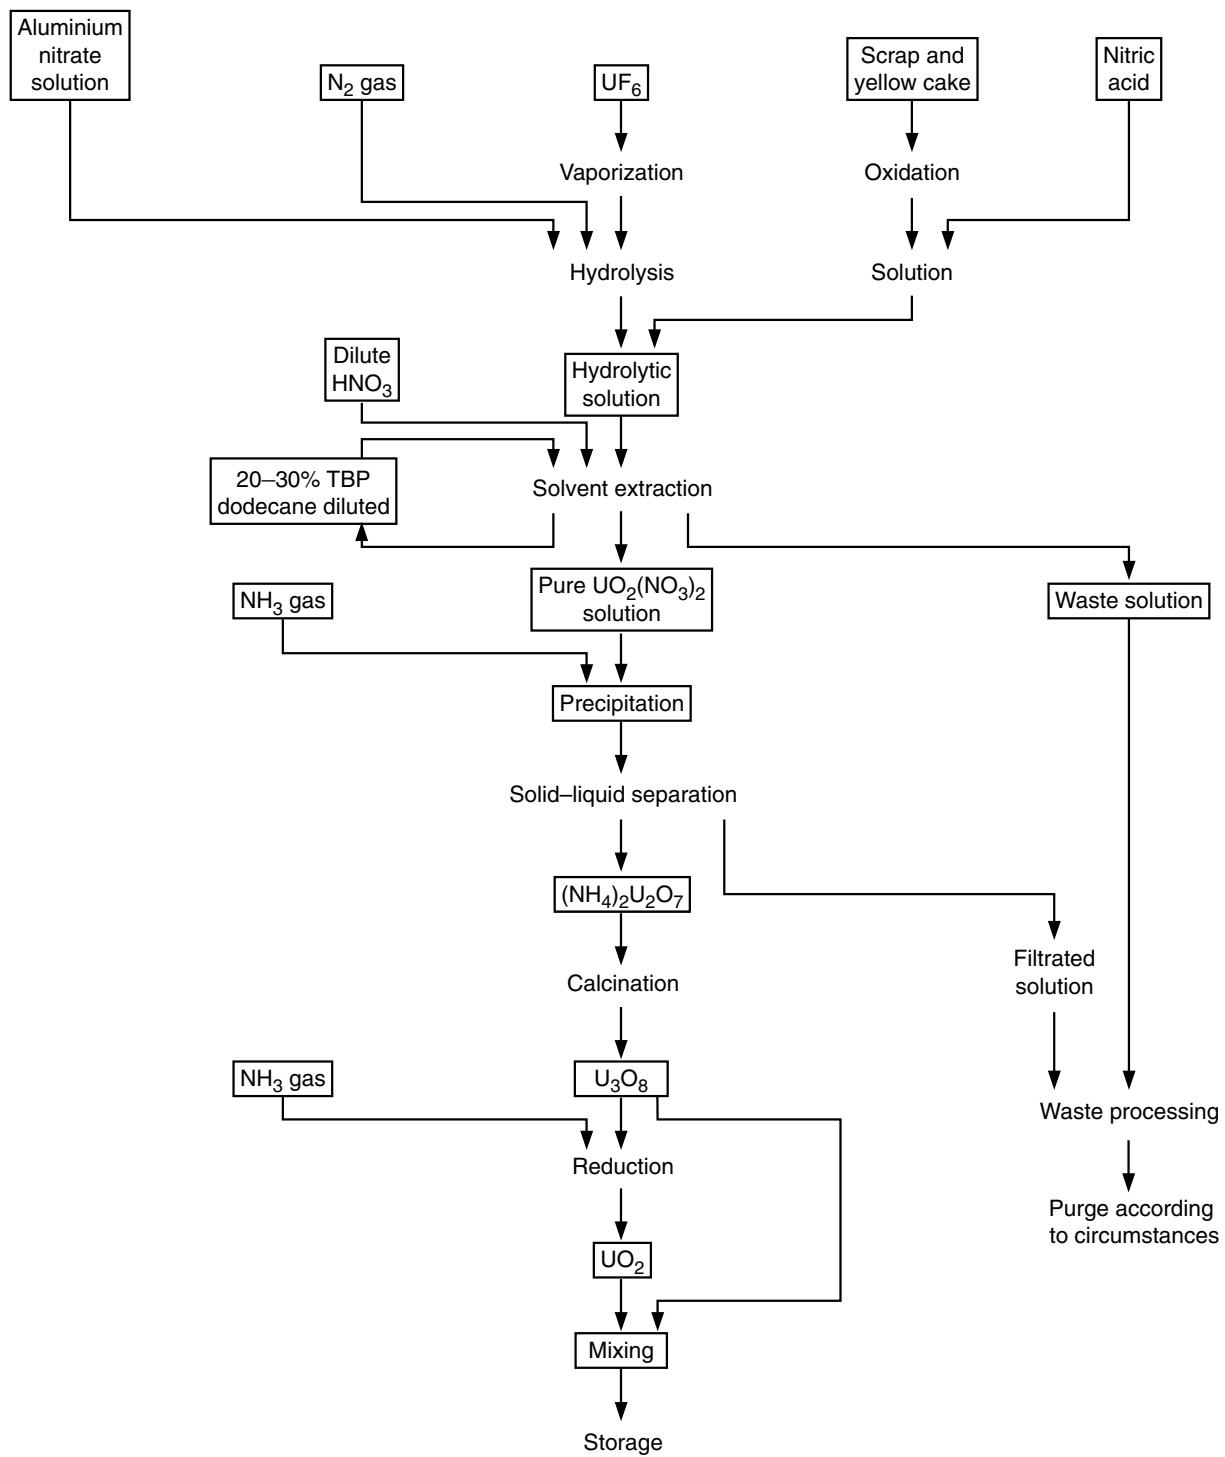
( $HNO_3$ ), homogenization of the solution and precipitation with ammonia to produce ammonium diuranate ( $(NH_4)_2U_2O_7$ ) [14] (Fig. 5). The facility is not operated continuously but is used for immediate and short batch production (30–200 kg U with an average of around 100 kg U), produced mainly for the Joyo fast research reactor. Its cumulative use has been about two months per year [14].

Fig. 5. Schematic diagram of the JCO reconversion process (TBP: tributyl phosphate).
