UNITED STATES
NUCLEAR REGULATORY COMMISSION
WASHINGTON, D.C. 20555-0001

SUBJECT: FINAL SNL LETTER REPORT, "CIRCUIT FAILURE MODE AND
LIKELIHOOD ANALYSIS"

Circuit Analysis - Failure Mode And Likelihood Analysis

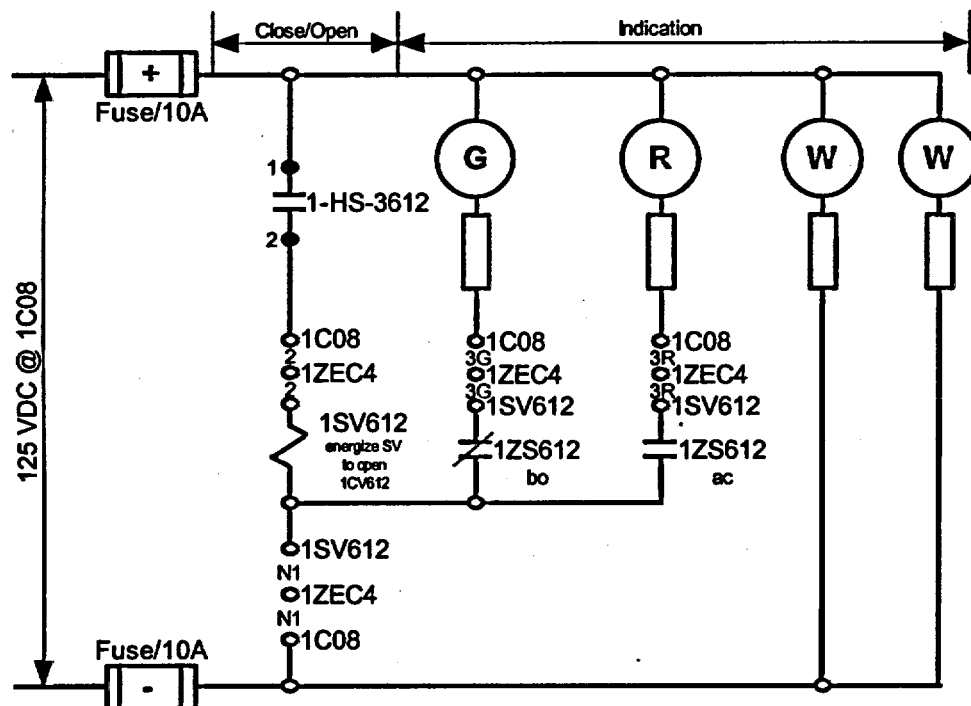
Scheme 1CV612

Of the 27 SOV circuit fault scenarios studied in the FMECA, two cases were identified where the OPEN and CLOSED indicating lights remain lit no matter what the valve position is. This would provide conflicting information to the operators on the position of the valve.

Figure 4-2: Example solenoid-operated valve (SOV) control circuit.

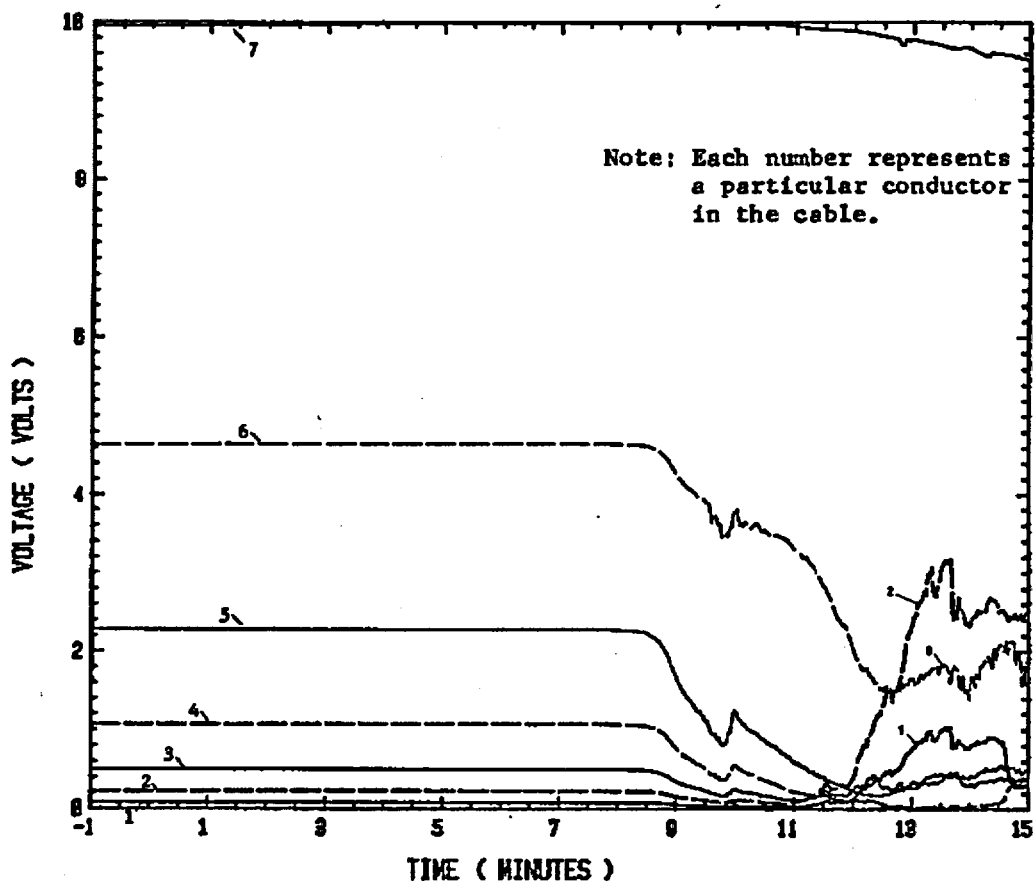
Ultimately, failures were only detected in one of the five cable tray tests (test 28). Some interesting insights can be gained by examining the response of the failed cable. In this test the instrumented cable was an IEEE-383 qualified, EPR/hypalon, 7-conductor, 9 AWG cable. For the test, a single continuous length of cable was looped repeatedly through the cable tray to form the total tray fill. Thus, the instrumented cable actually makes numerous passes through the fire zone. The response of this cable during the test is illustrated in the EPRI report in Figure 3-11 which is reproduced here as Figure A-2.

Figure A-2: Figure 3-11 from EPRI NP-1675 illustrating cable functionality measurements during FMRC Test 28.

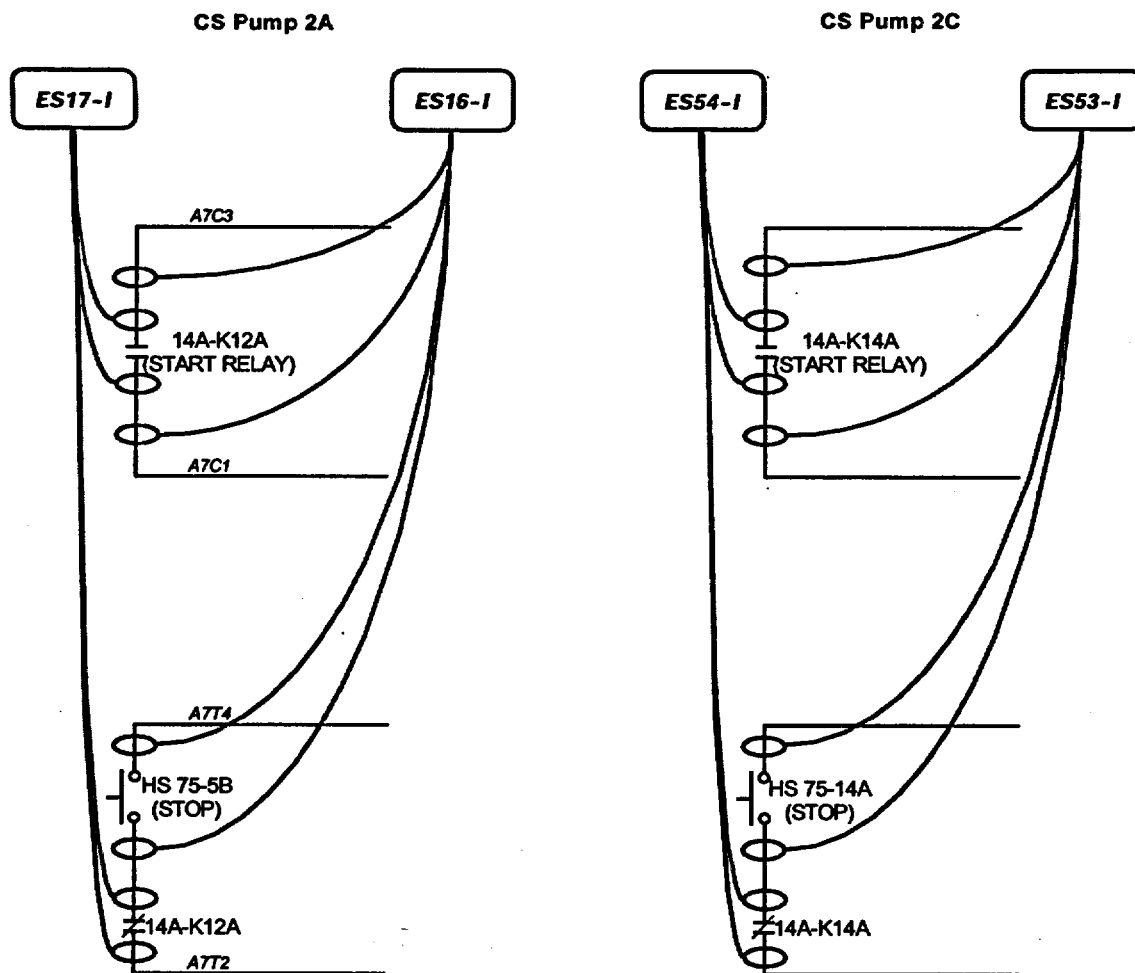
Figure C-6. Partial schematic of the relay and hand switch branches for the core spray pump control circuits.

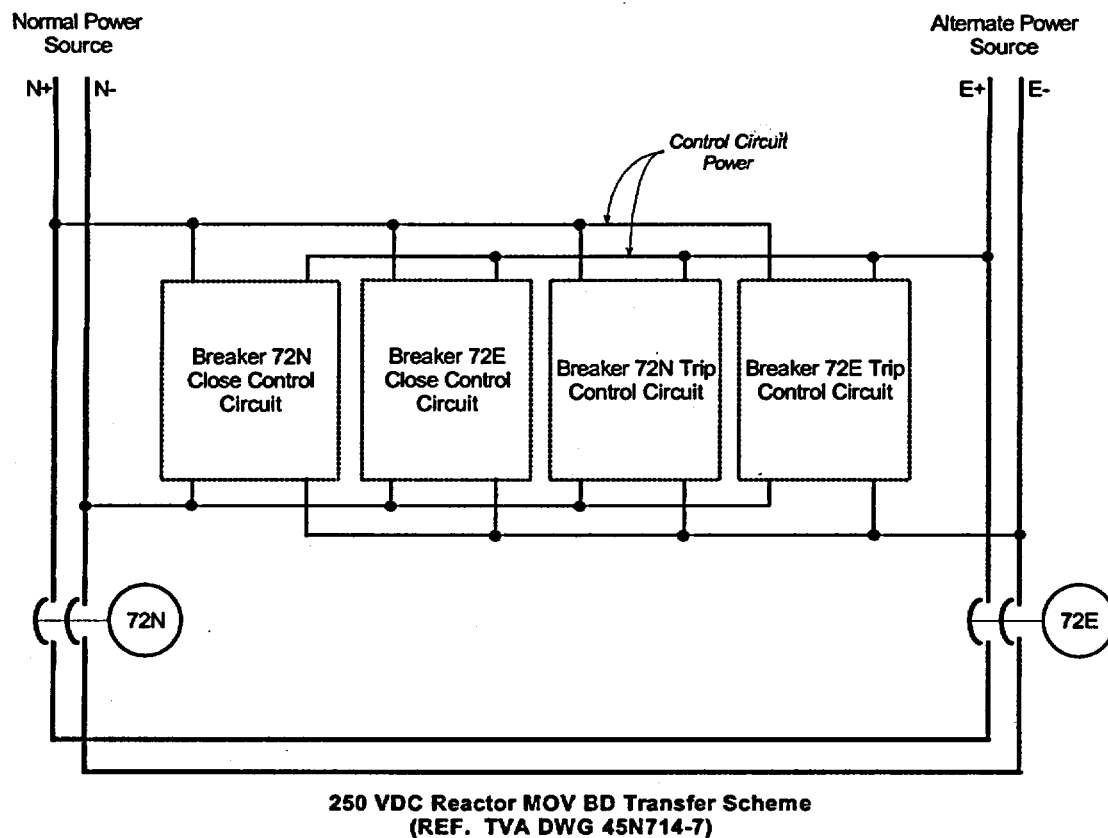
Figure C-7. Breaker control circuit block diagram. Note control power is tapped off both sources. (Detail of the 72N Trip Control Circuit is provided in Fig. 8.)

Power to the trip control circuit (Fig. 8) is selectable by setting device 43 to the normal (N) or alternate (E) power supply. This closes the 43N or 43E contacts to the control circuit power supply buses. The breaker is usually tripped manually by a control switch on the switchboard (72 CSN) which allows control power to energize the trip coil (TC) through the closed 72N contacts. These contacts are closed whenever the 72N circuit breaker is closed. In this case, however, both circuit breakers (72N and 72E) were open, thus it is not reasonable to postulate that the trip coil was continuously energized by a current backfed through the indicating light during the fire. On the other hand it is reasonable to suppose that a hot short on the indicating light circuit energized the upstream connection to the 72N contacts and only allowed the trip coil to be energized each time the breaker was closed. This, of course, caused the 72N breaker to immediately trip open again. The same scenario applies to the alternate feeder breaker 72E as well as to the normal and alternate feeder breakers on the 480-volt MOV boards.
