Indian Point 2 Condition Monitoring Operational Assessment Plan

Tom Pitterle Westinghouse Electric Company

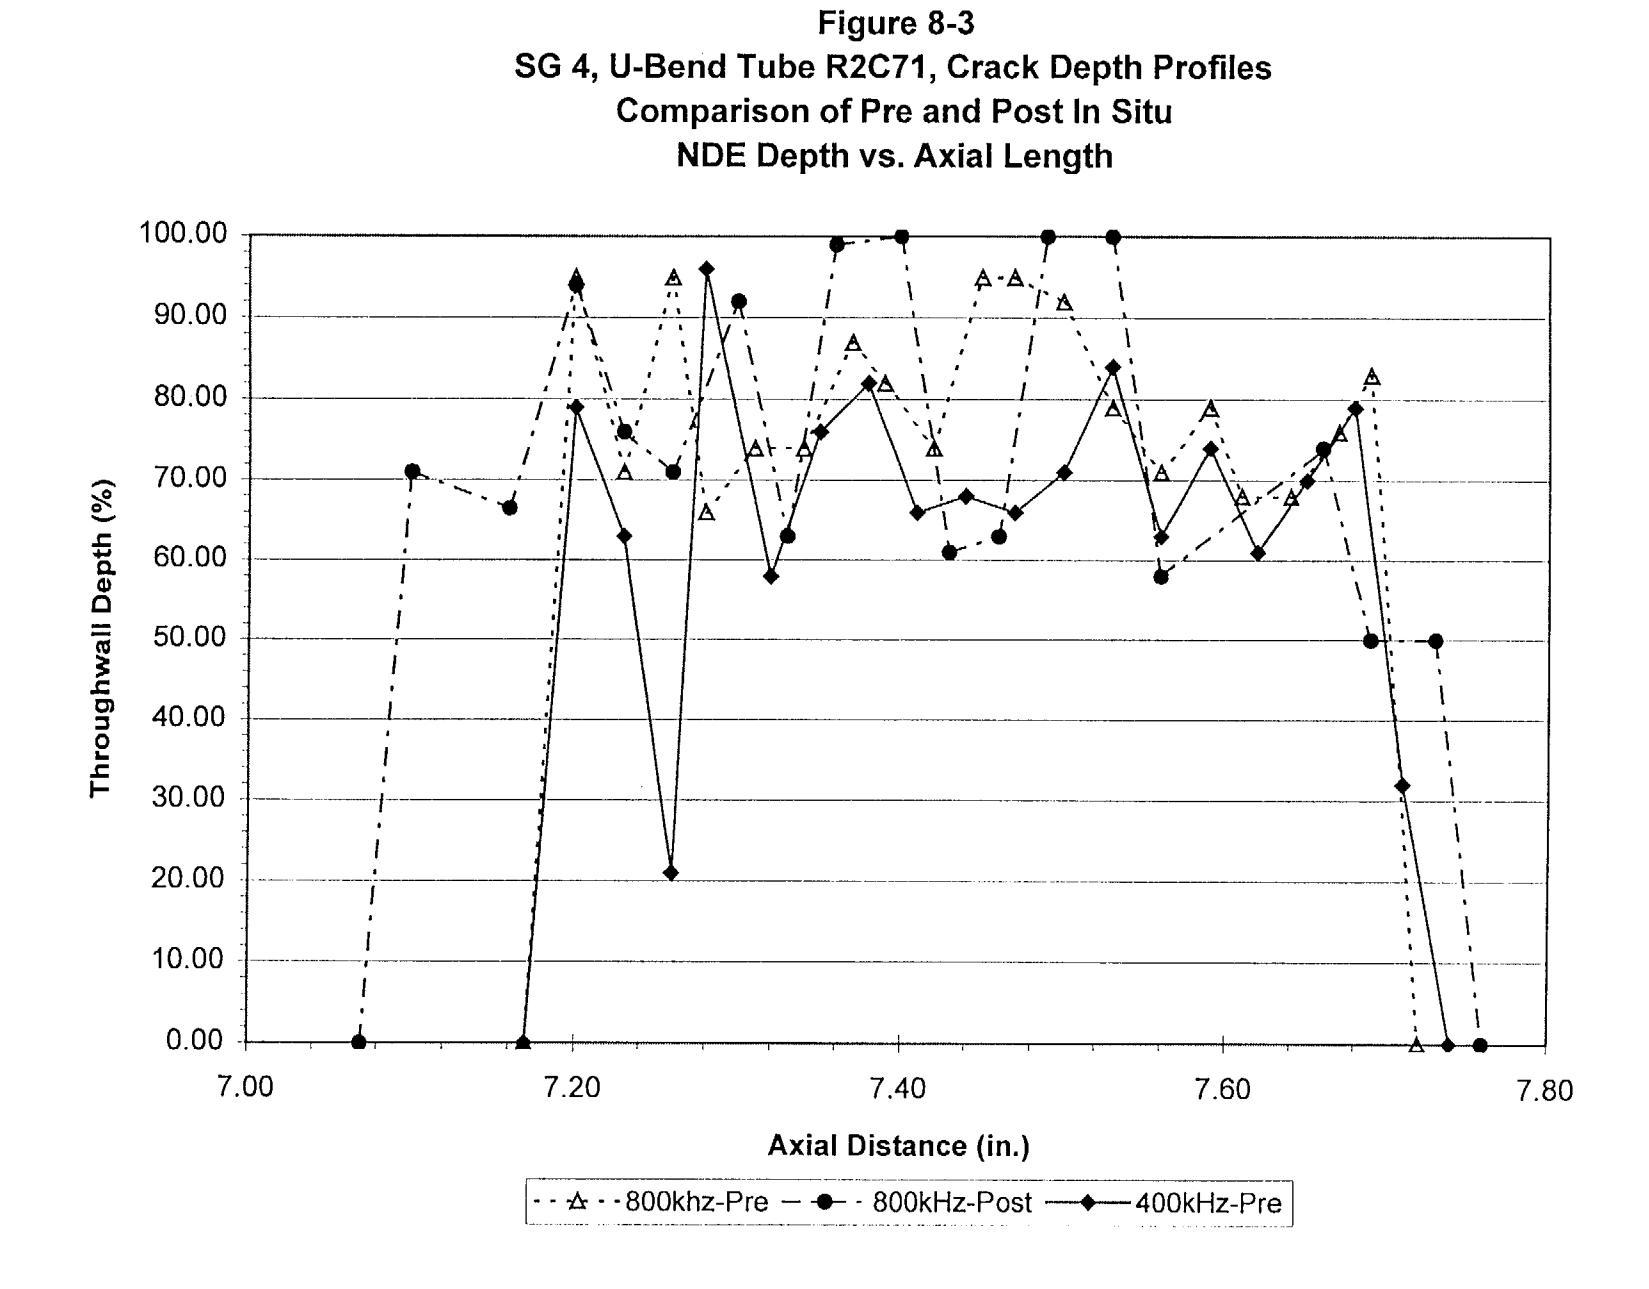
- In-Situ testing--total 10 tubes
 - Tested to as high a pressure as possible to demonstrate margin (5500 psi.)
 - Test results used to benchmark tube integrity analysis methods
- Tested all indications
 - Test results met NEI-97-06 Criteria ($3\Delta P_{NO} = 4617$ psi, hot)
- R2C71 in situ test
 - Test limited to 4206 psi (hot) by progressively increasing leakage
 - NDE and post peak pressure leak rates show short TW (<0.39")
 - Indication has not reached full ligament tearing of deep section (≈0.5") and burst pressure would be about 300 psi above tearing
- Tested 3 NDD tubes to $>3\Delta P_{NO}$ (5173psi)
 - 2 Row 2 tubes, 1 Row 3 tube
 - No leaks & no indications in post test NDE
