LA-13638

# A Review of Criticality Accidents

2000 Revision

**Issued: May 2000**

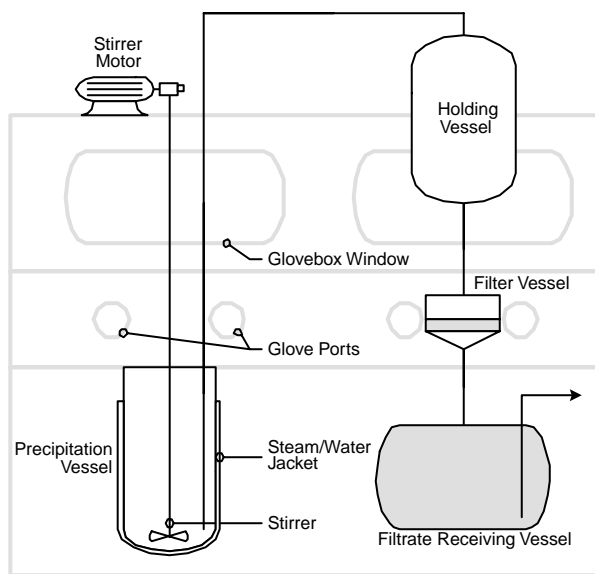
Figure 7. Equipment layout for the oxalate precipitation and filtration process.

for the U(90) mass per batch to be less than 800 g. The fissile mass was determined from the known volume and concentration of the uranyl nitrate. Historically this had resulted in relatively accurate fissile mass control. However, in spite of the fact that the operator followed the available procedures and did not violate criticality controls, there were several factors which contributed to the accumulation of uranium far in excess of that expected:

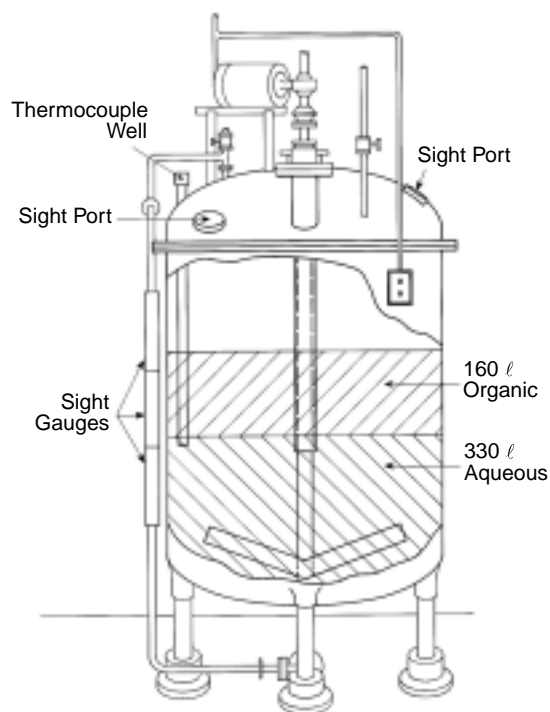
Figure 11. Configuration of solutions (aqueous and organic) in the vessel before the accident.

mixing of the layers. The average plutonium content in the fully mixed solution was 6.8 g/ℓ, a value less than the limiting critical concentration for an infinite homogeneous metal-water system.

From these time intervals and the estimate that initially the system was 5 \$ subcritical, the reactivity insertion rate would have been about 5 \$/s. Using coefficients appropriate for the solution, this insertion rate leads to a spike yield of  $2.2 \times 10^{17}$  fissions with the spike completed in 1.65 seconds, that is, 0.45 seconds after prompt criticality was reached. To obtain the observed yield ( $1.5 \times 10^{17}$  fissions) in a single spike, the reactivity insertion rate would have to be reduced to about 2 \$/s. Because this is inconsistent with the time involved (about 3 seconds before complete mixing), the only alternative is to assume that the rate was somewhat less than 5 \$/s and that the excursion was terminated in about 3 seconds by the stirring action. One can surmise that the initial action was thickening of the upper layer at the same time reflection was added by the aqueous liquid. This was followed almost immediately by distortion into a less critical, vortex-like shape by the action of the stirring blades and then permanent shutdown due to a uniform concentration of less than 7 g/ℓ.

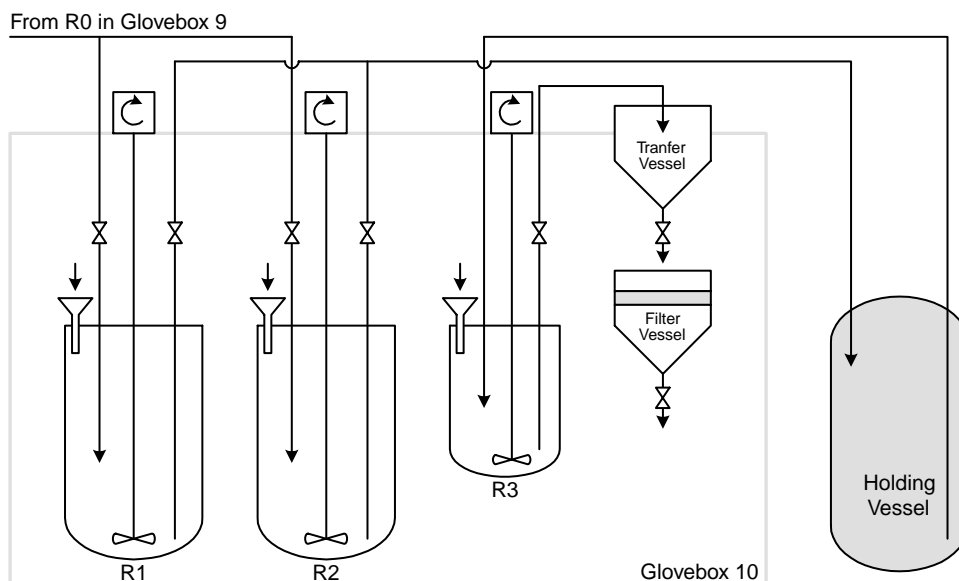
Figure 13. Layout of vessels in Glovebox 10 and the holding vessel external to the glovebox.

Figure 13 (not to scale) shows the five vessels located in glovebox 10 and the holding vessel located outside but connected directly to vessels inside the glovebox. Table 4 lists the seven vessels related to the reconstruction of the accident, along with their locations, dimensions, and function in the recovery operation. The operation began with a transfer of plutonium nitrate waste solution to vessel R0 in glovebox 9 where the first purification step was performed. This involved an oxalate precipitation of the plutonium, followed by a decanting of the supernatant liquid containing the impurities as well as some plutonium, and then re-dissolution of the plutonium into a carbonate solution. The end product from R0, the plutonium carbonate solution, was then transferred to either vessel R1 or R2 in glovebox 10 for the second purification (oxalate precipitation, supernatant decanting, re-dissolution) step. Vessels R1 and R2 were identical in dimensions and functions and were operated in parallel to increase productivity. The end

product from vessels R1 or R2 (again a plutonium carbonate solution) was then transferred to the holding vessel in preparation for batch transfer to vessel R3 where the last purification step was performed. The product from vessel R3, an oxalate precipitate slurry, was then vacuum transferred to the filter vessel via the transfer vessel. The oxalate precipitate collected by the filter vessel was then sent to another location for calcination.

Vessels R1 and R2 were equipped with transfer lines from R0 and to the holding vessel. The vessels also had stirrers and openings on top where a funnel could be used to add powdered reagents. The supernatant discharge lines (to vessels where the plutonium was concentrated by boiling and eventually returned to the recovery process) and the liquid chemical reagent supply lines are not shown. The supernatant typically had plutonium concentrations of about 0.1 g/l. Both vessels were shielded with 25 mm of lead. The holding vessel was unshielded and located about 400 mm above the concrete floor. The holding vessel was equipped with receiving lines from vessels R1 and R2, a transfer line to vessel R3, a vacuum line, and a compressed air line. Vessel R3 had lines and equipment identical to those of vessels R1 and R2. However, in the case of vessel R3, were solutions were received from the holding vessel and then sent out to the transfer vessel. Vessel R3 was also shielded by 25 mm of lead.

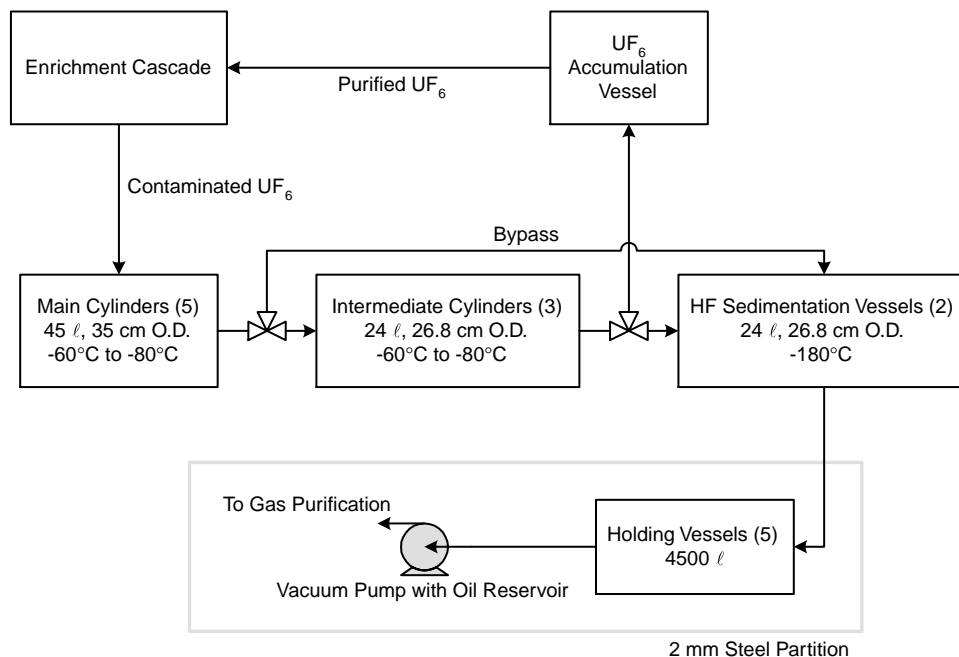
Figure 14. Layout of DSS-6.

The initial  $UF_6$  sublimation, introduction into the cascade, intermediate purification, and its final desublimation to the solid phase (in cylinders) was conducted in desublimation/sublimation stages (DSS). DSS-6 (Figure 14), occupied a large room (7.2 by 18 m) and was an intermediate purification stage (the enrichment was 22.6% by weight at this point in the cascade). This stage was used to remove contaminants such as air and excess hydrogen fluoride (HF) from the  $UF_6$ . This process was accomplished by

During normal operations, most of the  $UF_6$  desublimated in the main and intermediate cylinders. The HF, containing only trace amounts of  $UF_6$ , passed on and collected in the 2 HF sedimentation vessels. The air and any other non-condensable impurities were collected downstream in a bank of 5 holding vessels, about 4,500  $\ell$  in capacity each. The contents of these holding vessels were then transferred to the gas purification equipment by the action of a vacuum pump (Figure 15) that used oil as its working fluid. About once every 15 days, it was necessary to replace the oil because accumulation of  $UF_6$  caused an increase in density (from 0.9 to  $\sim 0.92$ , with a concentration of  $\sim 20$  g U/ $\ell$ ) reducing the pump's efficiency. While clearly having some criticality safety significance, this replacement schedule was motivated primarily by operational considerations.

Both the main and intermediate cylinders were cooled by liquid nitrogen flowing through a coil embedded in iron-shot filled jackets surrounding the cylinders. When there was an adequate supply of liquid nitrogen, its flow was actuated automatically by a signal from thermal transducers (resistance thermometers). However, when in short supply, liquid nitrogen was fed manually from portable dewars. The sublimation (heating) cycle was activated automatically by a pressure sensor in the  $UF_6$  accumulation vessel.

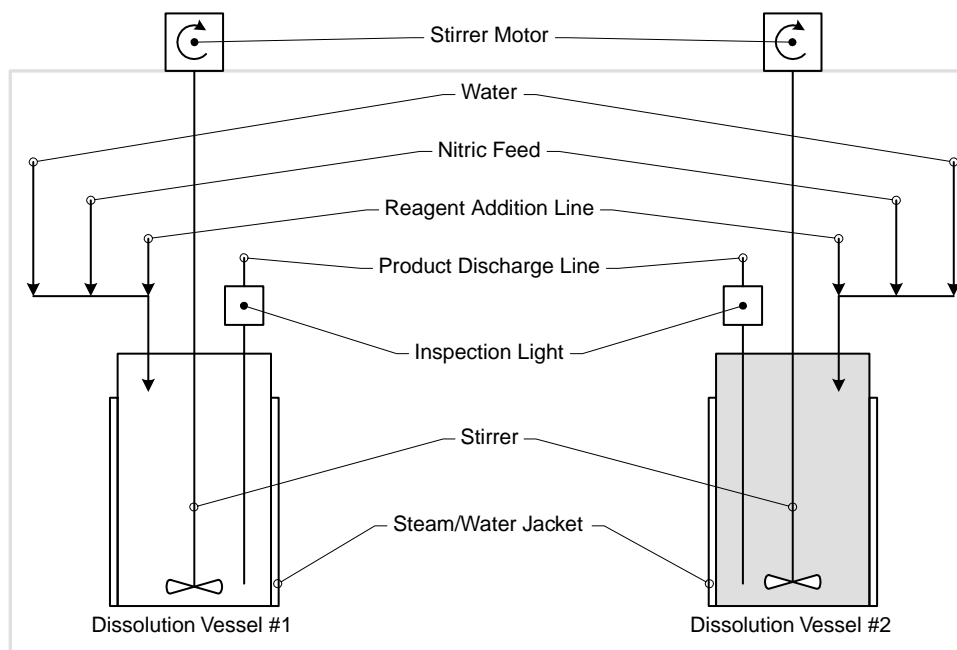
Figure 17. Layout of glovebox equipment.

The first step in the recovery process was to dissolve the slag and residues in nitric acid. Typically five cans of residue were combined as the feed for a dissolution batch; procedures limited the number of cans to six. The glovebox used for this had two identical dissolution vessels, shown in Figure 17. While not bearing on this accident, it is interesting to note that this glovebox was an early, conservative design; it was made of 8 mm thick steel and had 50 mm of lead shielding.

Fifteen minutes after the first excursion, unsuccessful attempts were made to remotely open a line and drain vessel 2. Further attempts at remote recovery included heating and mixing of the solution, temporarily lowering the reactivity of the system. A short while later the

heater and stirrer were turned off again, leading to a second excursion at 01:10. This was apparently no larger than the first, as it did not trip detectors that had not tripped during the first excursion.

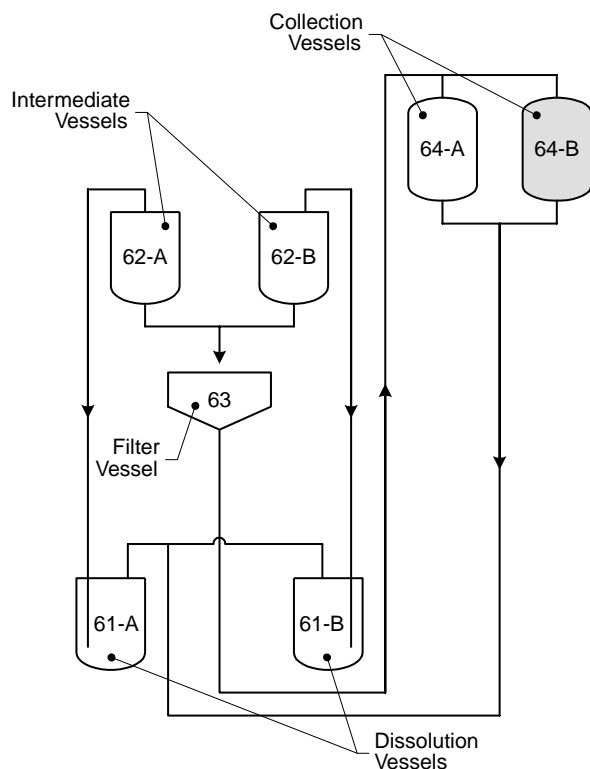
Figure 18. Process vessels and material flow diagram.

Using the erroneous work orders, an operator loaded 2 kg of precipitate from one container and 5 kg from another into dissolution vessel 61-A, believing the total uranium content to be 126 g when it was actually about 1,260 g. Because of a shift change, a different operator completed the dissolution process. The solution was then filtered and transferred to collection vessel 64-A, where a sample was taken to determine the concentration. Later during that same shift, the operator asked for the sample results by telephone. While this normally would have led to the discovery of the original recording error, the laboratory erroneously reported the results for a vessel other than 64-A. By an unfortunate coincidence, this other vessel contained solution with a uranium concentration 10 times lower than that in 64-A, thus reinforcing the operator's expectations.

The supervisor for the second shift, relying on this erroneous information, decided to recycle this supposedly low concentration solution to dissolve the next batch of dry precipitate. This next batch, still subject to the original recording error, contained ~1,255 g of uranium, about the same as that of the preceding batch. The dry precipitate was loaded into dissolution vessel 61-A and then the solution from collection

vessel 64-A was added. The dissolution vessel thus had over 2,500 g of uranium, an amount close to the unreflected critical mass for this diameter vessel. The solution was then filtered in 10 ℓ batches and transferred to the larger diameter collection vessel 64-B. In the course of this filtering/transfer operation, the solution exceeded the critical height in 64-B, and the first excursion occurred at 18:10 on 30 January 1963. The criticality alarm system sounded and all personnel evacuated. The  $\gamma$ -ray detectors were set to activate at 110 mR/h. Several of the personnel were directed to undergo medical assessment.

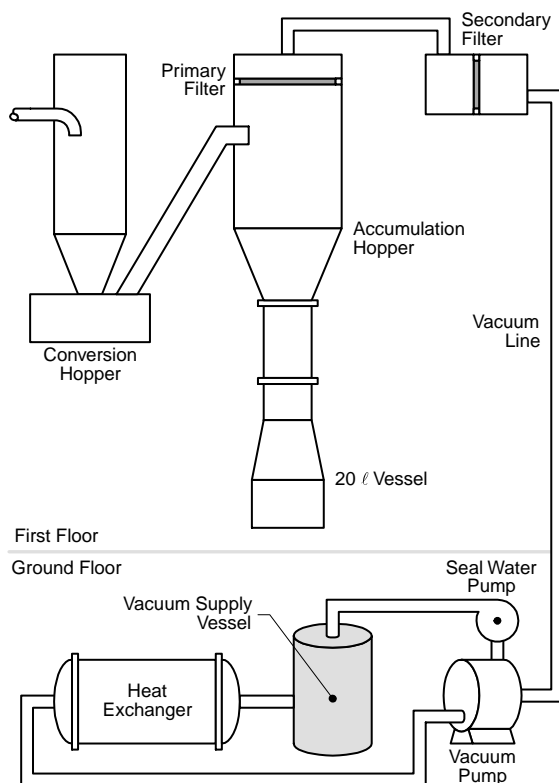
Figure 20. Layout of  $UF_6$  to uranium oxide conversion equipment and associated vacuum system.

Figure 20 is a layout of the Building 242 uranium hexafluoride to uranium oxide conversion system and associated vacuum system. The uranium hexafluoride was burned in a hydrogen-air atmosphere in the conversion hopper. The resulting uranium oxides were collected at the bottom of the conversion hopper and then transferred by vacuum to the accumulation hopper. The vacuum system was then switched off and the oxides were loaded into geometrically favorable 20 ℓ vessels by gravity. The vessels were then transferred from Building 242 to another location where the oxides underwent defluorination and complete reduction to  $UO_2$  in a rotating calcination furnace.

On 3 November 1965 at 11:10, the criticality accident alarm system sounded in Building 242. All personnel in Building 242 immediately evacuated. The alarm systems of the adjacent buildings did not activate. The facility's chief physicist made the first re-entry into Building 242 about 50 minutes after the building had been evacuated. Using a portable gamma-ray detector, he quickly determined that an accident had occurred in the vacuum supply vessel. At this time he recorded a gamma exposure rate of 3.6 R/h at a distance of 1.5 m from the surface of the vessel.

Recovery operations, performed by operations personnel under the direction of a health physicist, were conducted in a manner that minimized the likelihood of causing additional excursions. A long rod

was used to break the glass site gauge on the side of the vessel. Geometrically favorable collection trays were positioned so as to collect the draining liquid. The draining operation resulted in the collection of about 60 ℓ of liquid. Analysis showed that the liquid contained 85 g of uranium per liter or a total of 5.1 kg of uranium. Eight days after the accident (11 November 1965), the vacuum supply vessel was opened and an additional 51 kg of uranium was recovered. The total material recovered from the vacuum supply vessel was 56.1 kg of uranium or, at 6.5% enrichment, about 3.65 kg of  $^{235}\text{U}$ . An additional 13.9 kg of uranium was recovered from the shell-and-tube heat exchanger and connecting lines. The total material recovered was 70 kg of uranium or about 4.6 kg of  $^{235}\text{U}$ .

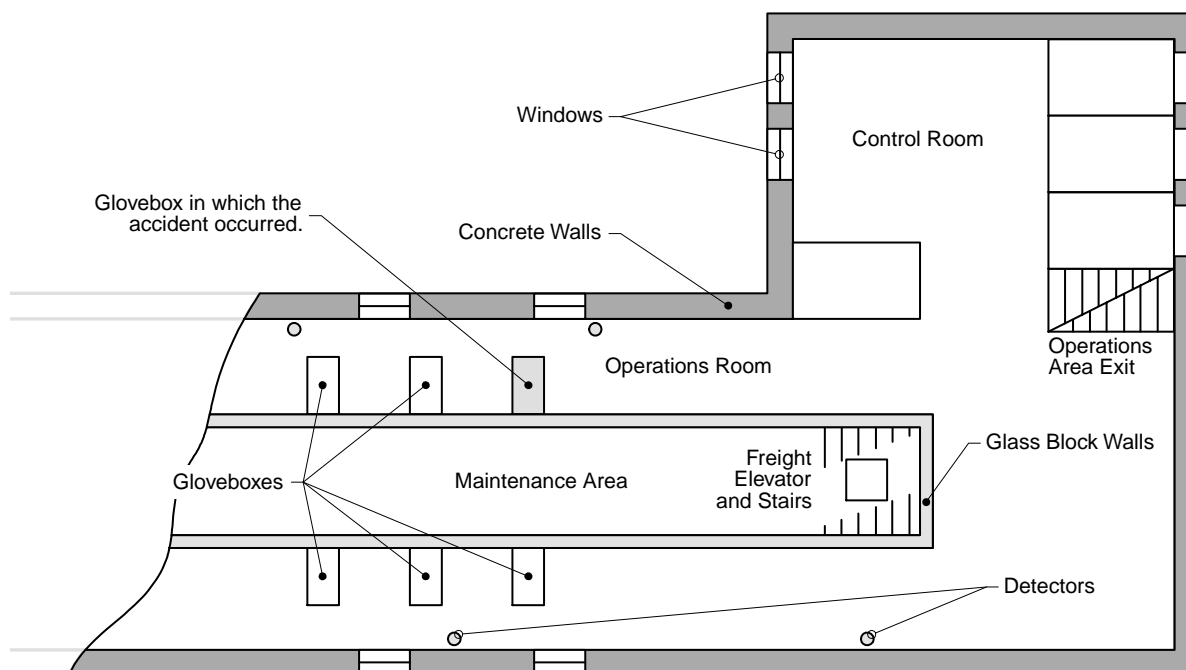
Figure 21. Residue recovery area layout.

This accident occurred in a residue recovery area of a metal and fissile solution processing building. The residues being recovered were produced from dissolution, precipitation, and reduction processes. A schematic of the residue recovery area is shown in Figure 21. The residues, which were difficult to dissolve, were first calcined to convert the uranium content, usually less than 1% by weight, to  $U_3O_8$ . Residues with abnormally high uranium content, which were occasionally generated (failed castings, cracked crucibles, etc.), were directed by operating procedures to other handling areas subject to special requirements.

based on a radiation survey, that the central control room (Figure 21) could be safely occupied by personnel even during the excursions. Consequently, surveillance and recovery management operations were moved to this location.

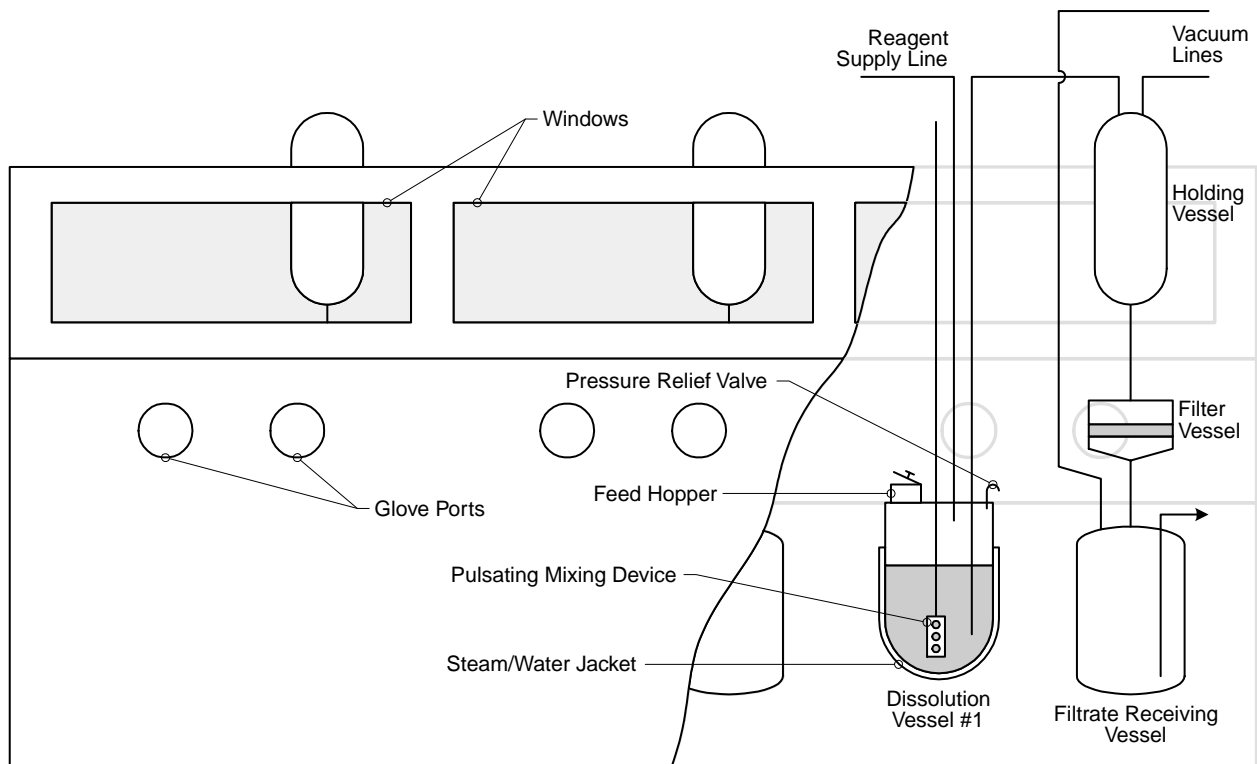
Figure 22. Layout of dissolution glovebox.

The residue dissolution glovebox where the accident occurred had three identical sets of process equipment as shown in Figure 22. Each set was equipped with a cylindrical dissolution vessel, a holding vessel, a filter vessel, and a filtrate receiving vessel. The dissolution vessels had elliptical bottoms, were 100 l in volume, and 450 mm in diameter, and were equipped with a pulsating device for mixing, a flat cover plate with a feed hopper, and a pressure relief valve. Heating of the dissolution vessels was accomplished with a 25 mm thick, steam-water jacket. Solution was moved within the system through a transfer line by drawing vacuum.

The residues were loaded into the dissolution vessel via the feed hopper located on the cover plate. The feed hopper was equipped with a lid that was sealed and locked in place during dissolution. Dissolution was accomplished by adding acid and heating the solution while mixing with the pulsating mixing device. Once dissolution was complete, the resulting solution was vacuum transferred to the holding vessel. The solution was then passed through the filter vessel (to remove non-dissolved solids) to the filtrate receiving vessel.

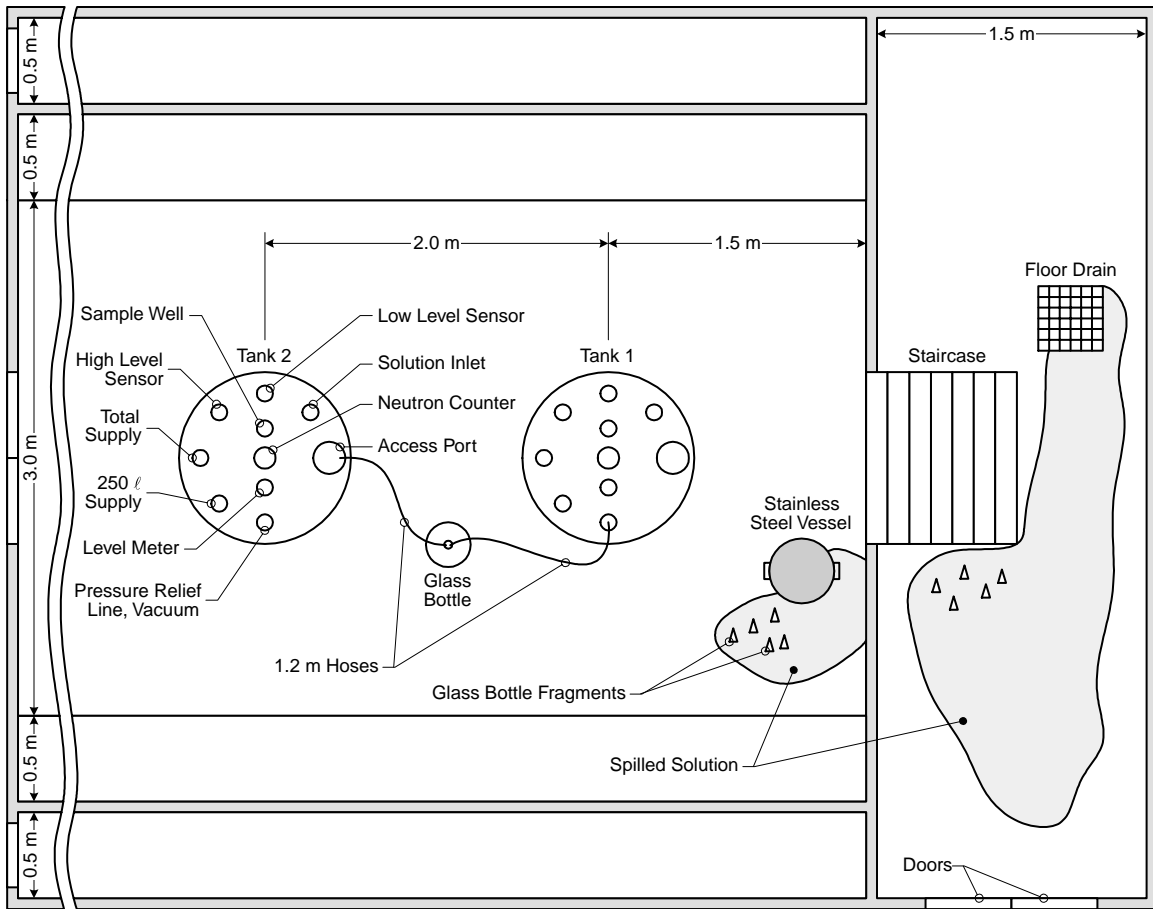
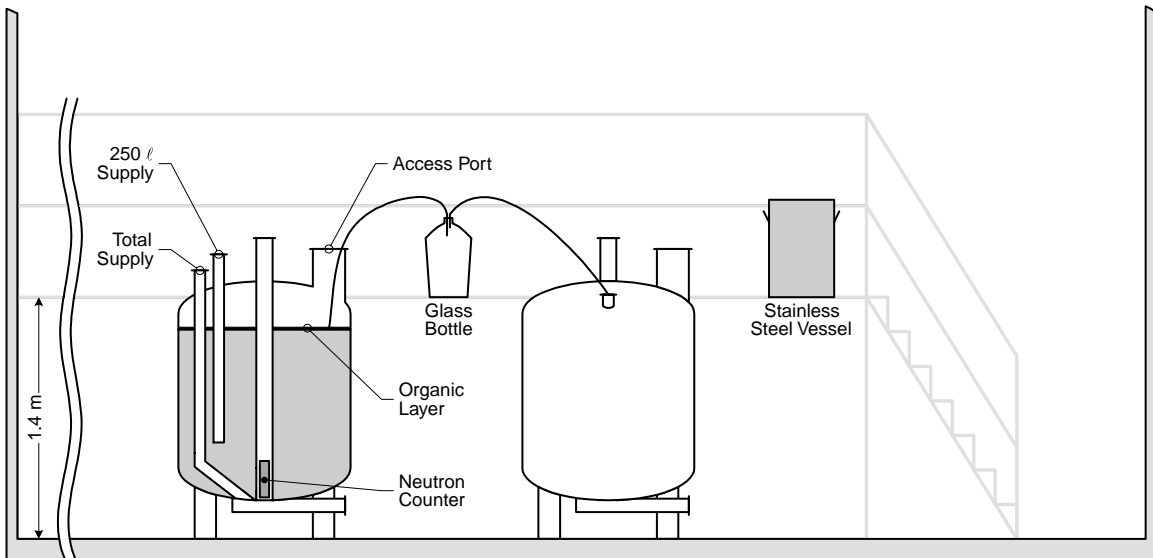
Figures 23 and 24 show plan and elevation views of these tanks, and the other vessels involved in the accident by their location in the basement room. Each tank had an operating volume of 800 ℓ. Each was equipped with neutron detectors located near the bottom to monitor the plutonium concentration and to detect any sediment accumulation.

On 10 December, the 19:00 shift supervisor instructed an operator to sample the contents of tank 2 before transferring it to recovery operations. Since the sampling device was out of order, the sample was taken by lowering a glass vial on a thin line through one of the upper level sensor ports [Figure 24]. The results of the analysis indicated that the plutonium concentration was ~0.6 g/ℓ. Since the total volume of solution in the tank was ~800 liters, the total plutonium mass was ~480 g, which exceeded the criticality safety mass limit of 400 g. According to regulations, the shift supervisor then ordered that two additional confirmatory samples be taken.

The temporary arrangement of equipment used to remove the organic solution from tank 2 is shown in Figures 23 and 24. Two reinforced rubber hoses, 1.2 m in length and 13 mm in internal diameter, were fixed into the neck of a 20 ℓ glass bottle (usually used for chemical reagents) with a cloth plug. One hose was connected to the vacuum line on tank 1 and the other was lowered into tank 2 through its access port. If the 20 ℓ bottle became full, it was decided that the contents would be poured into a 60 ℓ vessel usually used for the collection of very low concentration wastes before reprocessing. The bottle and vessel were placed on the platform above tanks 1 and 2. The use of these types of temporary, improvised, setups as well as the use of unfavorable geometry vessels were strictly prohibited by existing regulations.

In the presence of and under instructions from the shift supervisor, two operators used the improvised setup to begin decanting the dark brown (indicative of high plutonium concentration) organic solution. The shift supervisor then left to tend to other duties. After having filled the bottle with approximately 17 liters the operators noted that there was still some amount of organic solution remaining in tank 2. The bottle was then emptied by pouring the contents into the 60 ℓ vessel. During the second filling of the bottle, a mixture of aqueous and globules of organic solution were being drawn into the bottle. As a result the operators stopped filling the bottle. One operator then went on to other duties while the other went to the shift supervisor for further instructions.

operator was again able to fill the bottle, this time to nearly 20 ℓ. Having disconnected the bottle from the hoses, the operator then poured its contents in the 60 ℓ vessel for a second time. After almost all of the solution had been poured out of the bottle, the operator saw a flash of light and felt a pulse of heat. Startled, the operator dropped the bottle, ran down the stairs and from the room. The bottle, which had only a small amount of solution remaining, broke, splashing the remaining contents around the base of the 60 ℓ vessel.

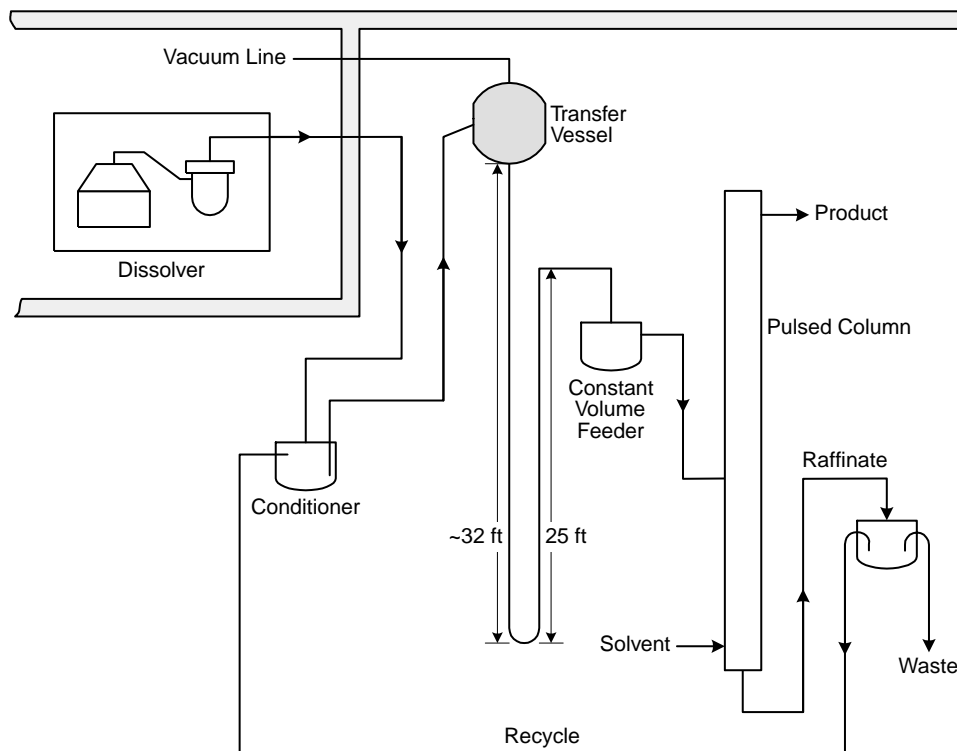
Figure 25. Process equipment related to the criticality accident.

completed, the vacuum was broken and the transfer vessel contents were allowed to drain into a constant volume feeder that supplied a favorable geometry, pulsed, solvent extraction column. The connection from the transfer vessel to the constant volume feeder was through a trap 25 feet (7.6 m) in depth, that prevented any potential backflow and thus controlled contamination.

The excursion occurred on completion of the transfer of a 50 ℓ batch of solution from the conditioner to the transfer vessel. The small size ( $10^{15}$  fissions) and brief duration (less than 10 s) of the excursion precluded the termination of the excursion

due to any energy based shutdown mechanism. Radiation measurements indicated that the excursion occurred in the transfer vessel, but the solution from the conditioner was too lean to sustain criticality, and the total quantity of plutonium in the batch (300 g) was about 50% of the minimum critical mass. Thus, it was feared that the transfer vessel might contain large quantities of solids, perhaps tens of kilograms and that any disturbance of the system might cause another, possibly much larger, excursion.

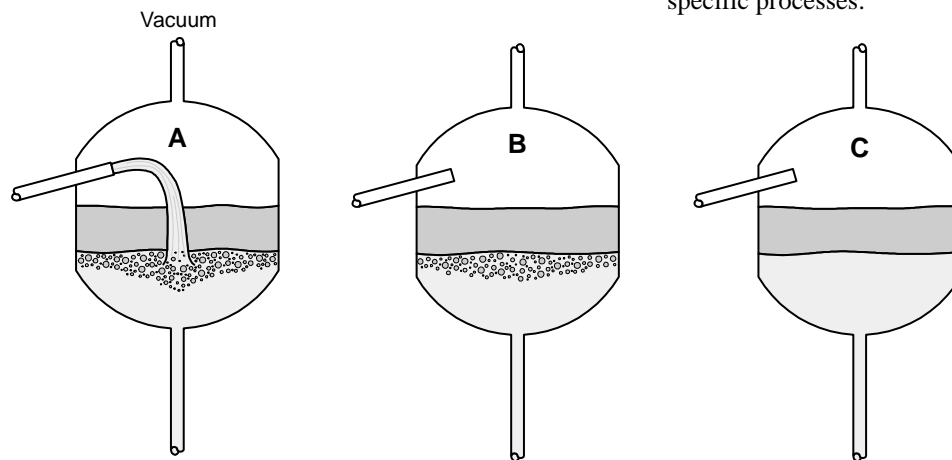
This excursion illustrates the subtle ways in which accidents can occur during solution processing. Although the deep trap was considered a safety feature for the control of contamination, it contributed directly to the criticality accident. The difficulty of understanding what had happened, even after it was known in which vessel the excursion occurred, is an excellent example of the impracticability inherent in attempting to calculate criticality accident probabilities for specific processes.

Figure 26. Solution transfer as reconstructed from the transparent plastic mockup of the transfer vessel. Configuration (B) is the postulated state at the time of the accident.

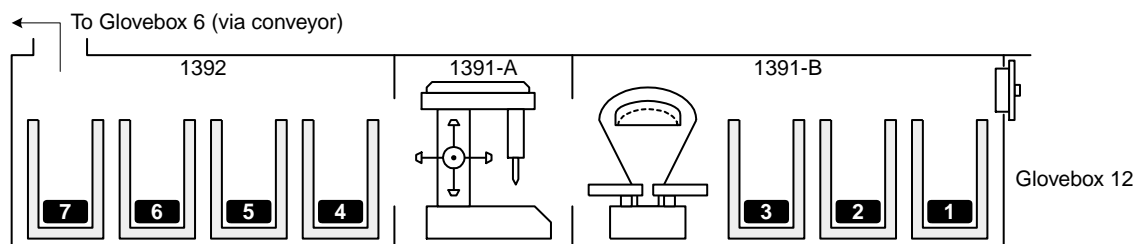
At the beginning of the shift on 13 December 1978, three containers were in workstation 1391-B, and four containers were in workstation 1392, each with one ingot. The ingots are numbered sequentially in Figure 29 for the purpose of the discussion that follows. Although the containers are depicted as being linearly arranged, in actuality the containers holding ingots 4 and 5 were behind those with ingots 6 and 7, making visual inspection of the contents more difficult

Figure 29. A simplified layout of Glovebox 13.

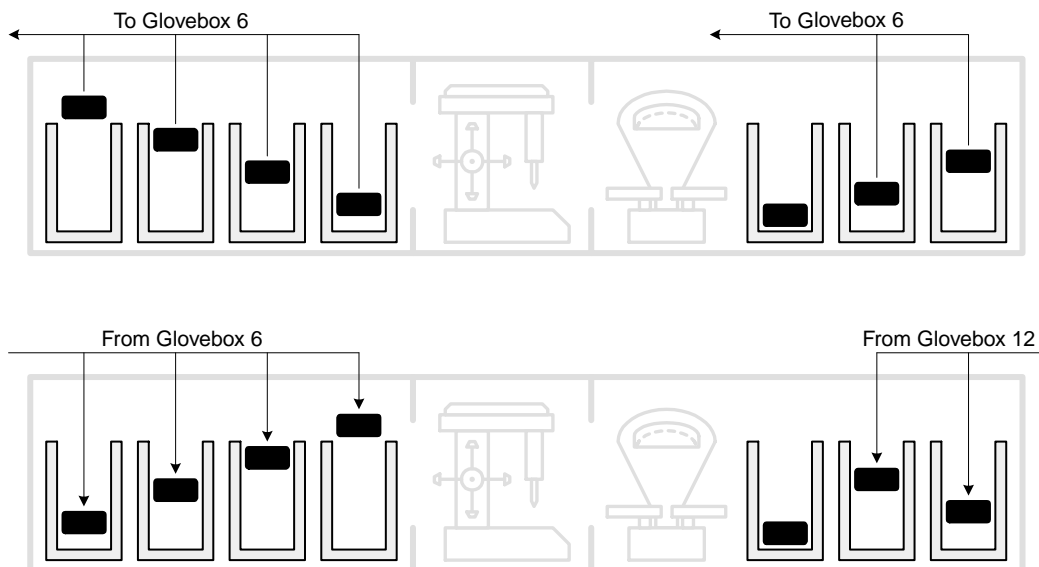
The intended order of ingot transfers, as specified in the shift instructions, is illustrated in Figure 30. The actual order of ingot transfer is shown in Figure 31, Frames 1 through 6. Operator A transferred two ingots, 6 and 7, from workstation 1392 to glovebox 6. These ingots were replaced in workstation 1392 by two ingots, 8 and 9, from glovebox 6. Both of these actions were in accordance with the shift instructions.

Figure 30. Intended sequence for the transfer of ingots from and to Glovebox 13.

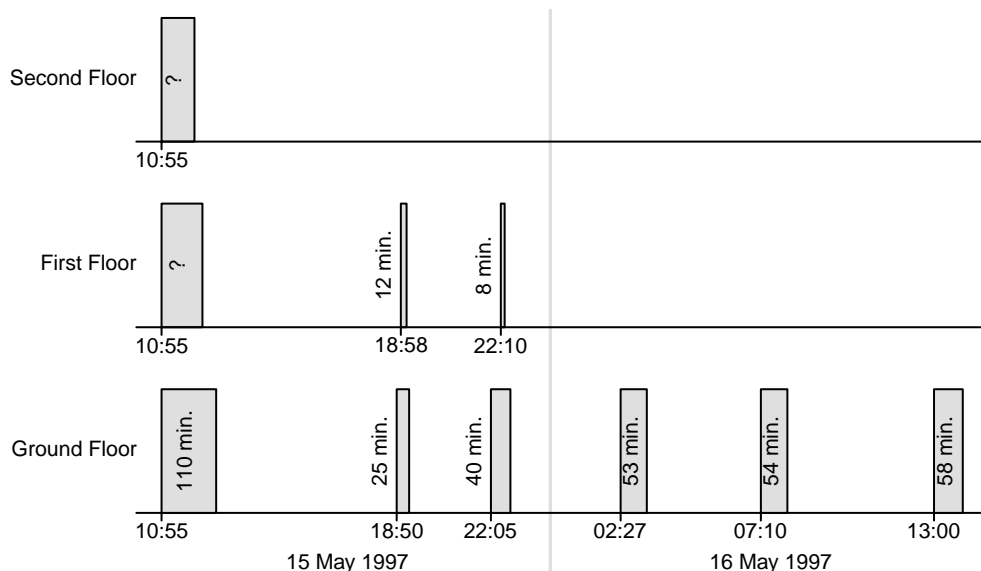
samples of the  $\text{UO}_2$  particles taken on 20 May. The detectors were located at 12 monitoring stations. However, during the excursions, at most only three of the monitoring stations alarmed, indicating very low peak power for each excursion. These three stations were located on the ground, first, and second floors directly above one another. From the central control room, health physicists documented the sequence of excursions, the response of the detectors, and the length of time that the detector alarm threshold ( $36 \text{ mR/h}$ ) was exceeded (Figure 33).

Figure 33. Sequence of alarms and duration that the radiation levels exceeded the alarm level ( $36 \text{ mR/h}$ ).

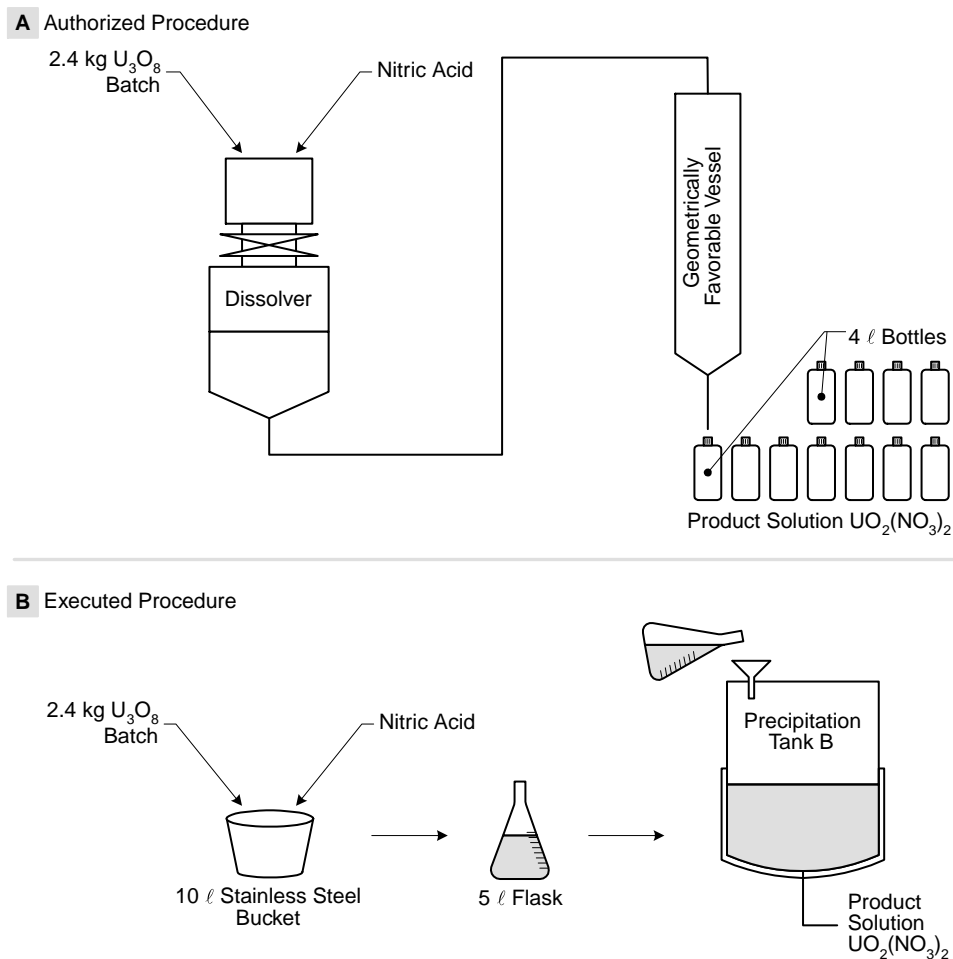
Three operators had begun the task on 29 September, the day prior to the accident, but were operating according to the procedure indicated in Figure 34-B. There were basically two deviations from the license-authorized procedure that were associated with the actual operations. First, the company procedure that the operators were to have followed, specified that the dissolution step was to be conducted in open, 10-liter, stainless steel buckets instead of the dissolution vessel indicated. This change was known to have saved about one hour in dissolution time.

The much more serious procedural departure, however, was the transfer of the nitrate solution into the unfavorable geometry precipitation vessel instead of the prescribed, favorable geometry columns. This deviation was apparently motivated by the difficulty of filling the product containers from the storage columns. The drain cock below the columns was only about 10 cm above the floor. The precipitation vessel had not only a stirrer to assure a uniform product but greatly facilitated the filling of the product containers.

Figure 34. Authorized and executed procedures.

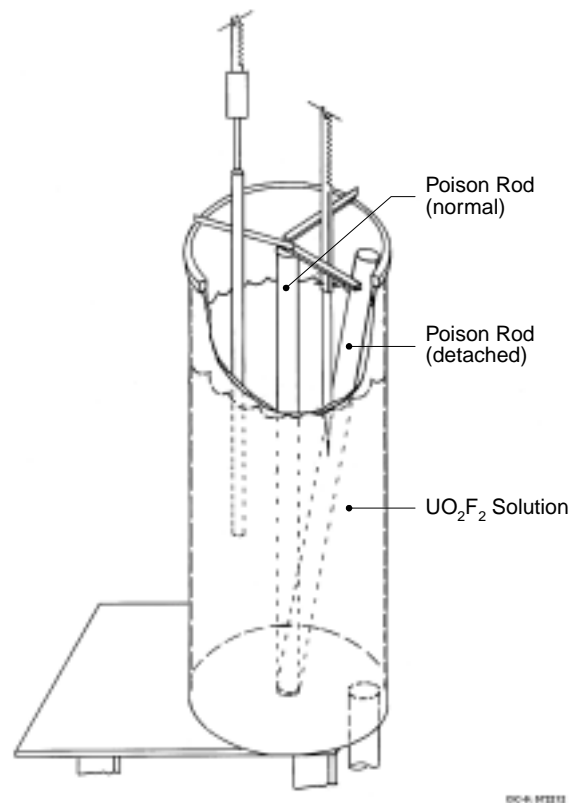
3.33  $\$/\text{s}$ , which continued well into the prompt critical region. Using known coefficients and generation times, an initial power spike of  $5.1 \times 10^{16}$  fissions can be calculated. Since development of the power spike would require only about 0.07 seconds after the system reached prompt criticality (0.43 seconds after the cylinder began to tip), the cylinder was still tilting. It is characteristic of such accidents that after an initial spike, the power balances the reactivity insertion rate. For this solution, the required power was a few megawatts, and it must have been fairly constant until the inner cylinder reached its maximum displacement 0.91 seconds after inception of the transient. At this time, the power dropped sharply and when the liquid began to drain, the system became far subcritical.

Figure 40. The Oak Ridge National Laboratory uranium solution assembly showing the normal and detached positions of the central poison rod.

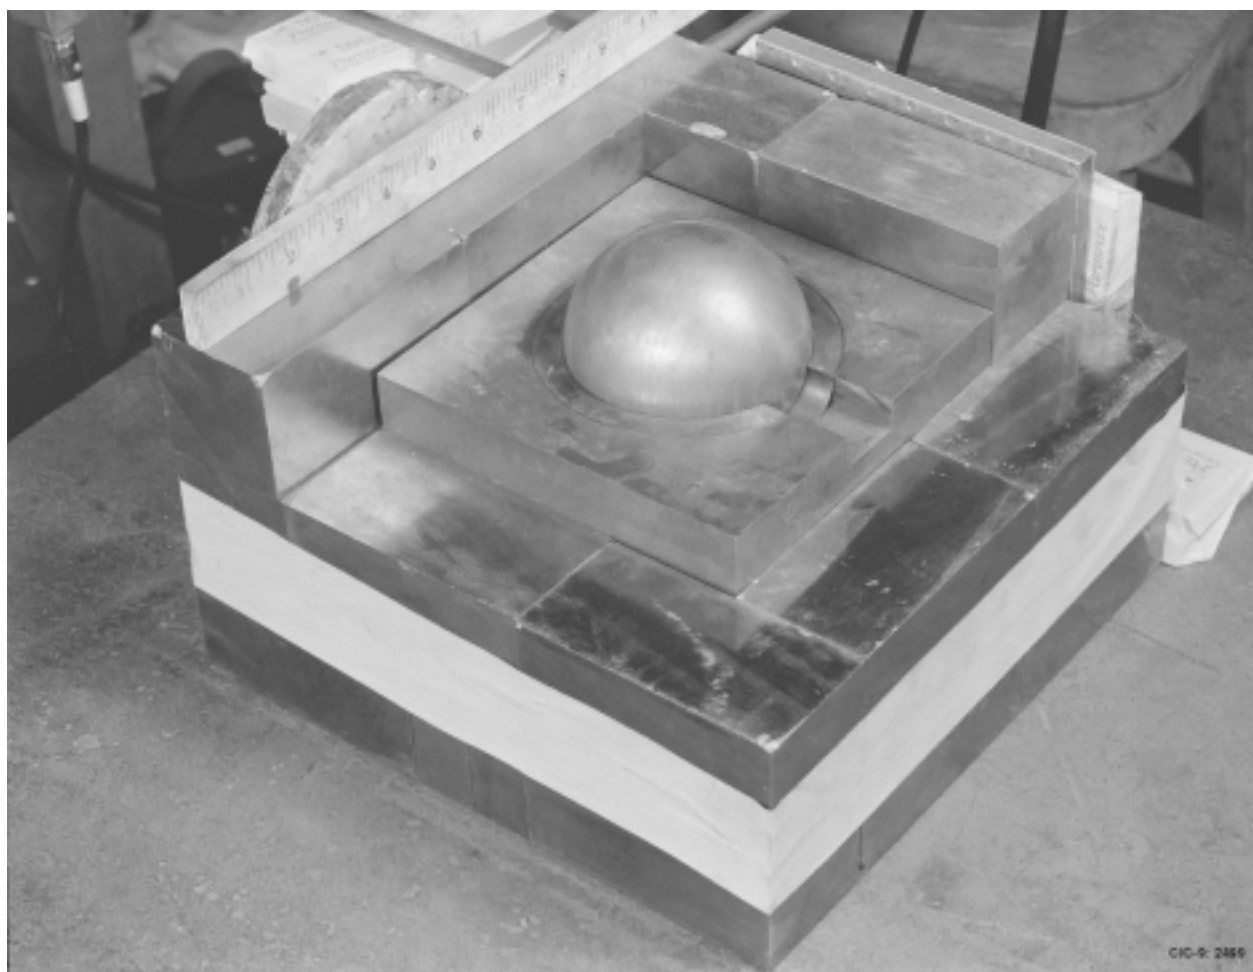
In the first accident, a critical assembly was being created by hand stacking 4.4 kg tungsten carbide bricks around the plutonium core. Figure 41 shows a reenactment\* of the configuration with about half of the tungsten blocks in place. The lone experimenter was moving the final brick over the assembly for a total

Figure 41. Plutonium sphere partially reflected by tungsten-carbide blocks.

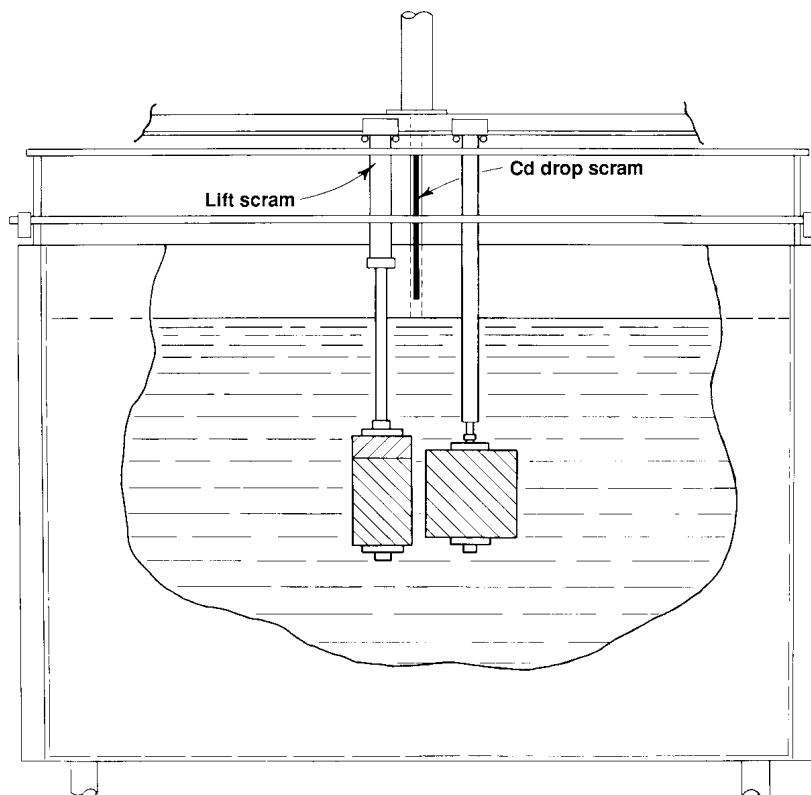
At the completion of the critical separation experiment (at a multiplication of 65.5), the assembly was scrammed. The water started draining, the cadmium screen dropped, the solid cylinder (left-hand body in Figure 45) was lifting, and an excursion (later deter-

Later reconstruction of the accident showed that the pneumatic tangential scram was the first to be effective and led directly to two types of difficulty. First, the center of reactivity of the left-hand cylinder (Figure 45) proved to be below that of the stationary cylinder; second, the rapid lift through the water created hydrodynamic forces that swung the cylinders closer together. The combination of the two effects was enough to drive the assembly prompt critical and to have maintained at least this much reactivity for 0.2 seconds if the power excursion had not occurred. The first power spike is estimated to have contained  $6 \times 10^{15}$  fissions. It is possible that one or more excursions into the prompt region followed because boiling was the primary quenching mechanism.

Figure 45. The Los Alamos Scientific Laboratory assembly machine employed for measurements of critical separation distances.

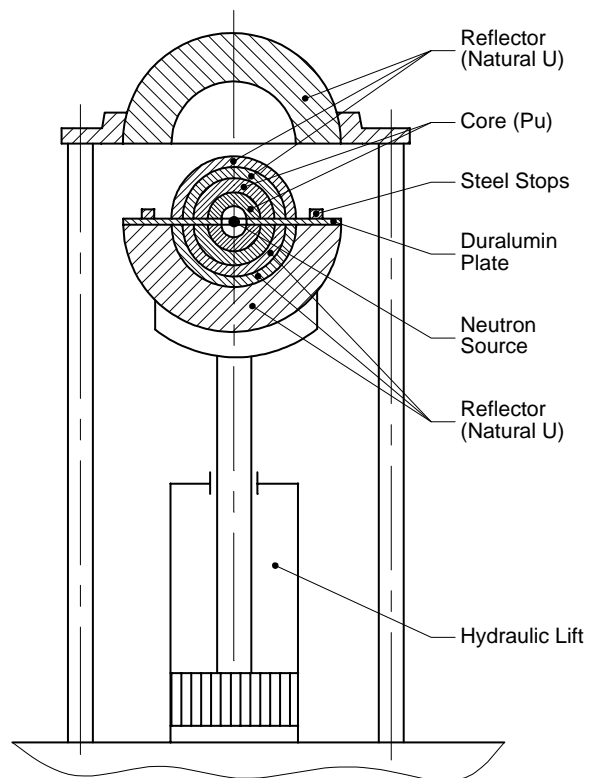
This accident occurred on 9 April 1953 as an experiment was being conducted on a critical assembly constructed on a vertical split table, FKBN (Figure 46). FKBN, designed and built in 1950, had a hydraulically driven vertical table as its main feature. It was not, however, equipped with a fast acting, gravity driven scram mechanism. FKBN located in Building B (Figure 47), was operated remotely from an adjacent control room.

Figure 46. FKBN and assembly involved in the 9 April 1953 accident.

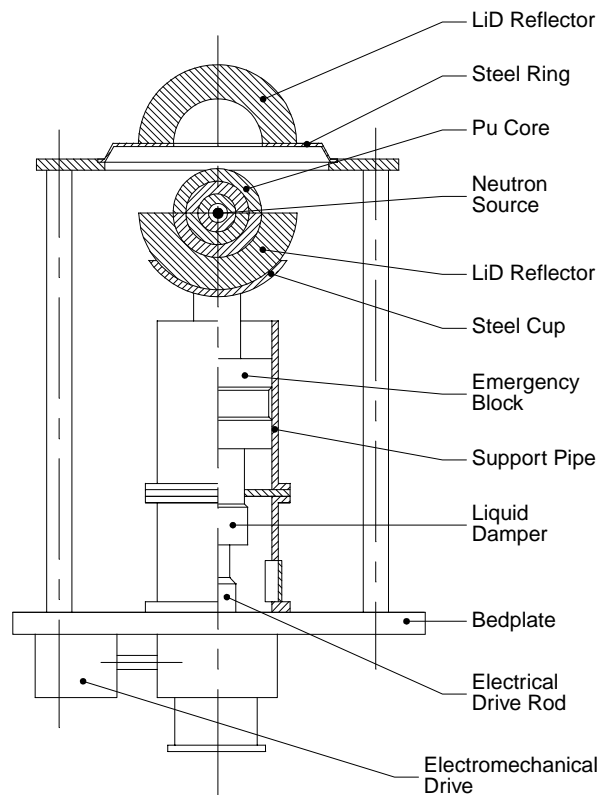
Figure 51. MSKS and assembly involved in the 11 March 1963 accident.

On 11 March 1963, the facility chief and the operations engineer proceeded with pre-experiment operations with the assembly pieces still in place. The experimentalists attempted to make adjustments to the machinery of MSKS using unauthorized attachments in violation of the operating procedures. As they worked on MSKS adjusting the electromechanical lift mechanism, an excursion occurred. Seeing a flash of light, the experimentalists immediately exited and went to the control room, where the facility chief pushed the control button lowering the table. The automatic scram system did not activate because the detectors to which it was tied were not operating.

The accident was the result of gross violations of the MSKS operating procedures by the facility chief and operations engineer. The excursion was due to the inadvertent closure of the assembly by the experimentalists. As a result of the accident investigation and analysis, it was judged that the assembly had approached or possibly even exceeded the prompt critical

state. The number of fissions was estimated to be  $\sim 5 \times 10^{15}$  fissions. The nickel clad of the plutonium was not breached and therefore no contamination resulted. MSKS itself was undamaged and remained in long-term service.<sup>54</sup>

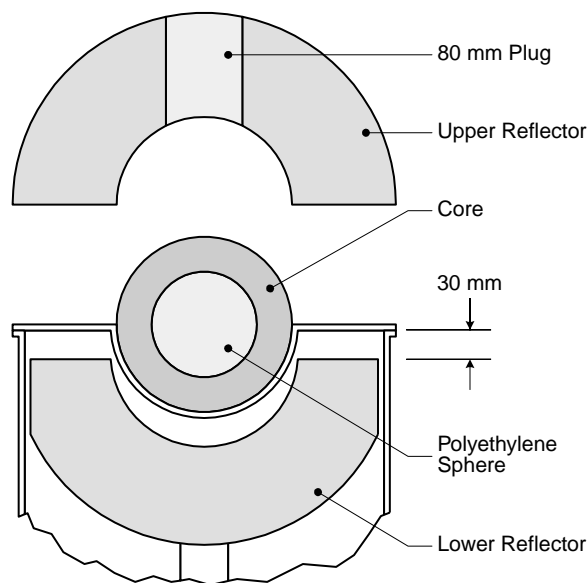
The FKBN assembly machine and system components, as configured at the time of the accident, are shown in Figure 53. The core of the assembly consists of a U(90) spherical metal shell with an internal cavity.

Figure 53. Approximate accident configuration of the FKBN vertical lift assembly machine and core.

The core could be surrounded by a thick, spherical, natural uranium metal reflector. Figure 53 illustrates that the external reflector is split into upper and lower halves. The accidental excursion resulted in the death of two knowledgeable nuclear criticality specialists standing near the assembly at the time of the excursion. A criticality alarm system was not installed at the time of the accident. The upper reflector was natural uranium metal having a total uranium mass of 308 kg. The inside radius was 91.5 mm and outside radius was 200 mm. The core was a 90% enriched uranium metal spherical shell having an inside radius of 55 mm and an outside radius of 91.5 mm. The core uranium mass was 47.7 kg of uranium or 43.0 kg of <sup>235</sup>U. The uranium core was constructed of nested, close fitting, hemispherical components with radii of 55 mm, 67.5 mm, 75.5 mm, 83.5 mm, and 91.5 mm. A polyethylene sphere had an outside radius of 55 mm. The lower reflector was natural uranium with an inside radius of 91.5 mm and an outside radius of 200 mm.

established that in addition to the error in judgment, the specialist violated several operational procedures. For the evening assembly, the lower half of the uranium reflector was not positioned 20 mm above its lower stop as required to ensure an adequate margin of criticality safety for the assembly process. Instead, the lower reflector was positioned 90 mm above its lower stop which is 30 mm below its upper stop. The upper stop corresponds to the lower reflector making contact with the lower core. The failure to reposition the lower reflector following the daytime assembly was identified as the primary cause of the accident.
