LA-13638

# A Review of Criticality Accidents

2000 Revision

**Issued: May 2000**

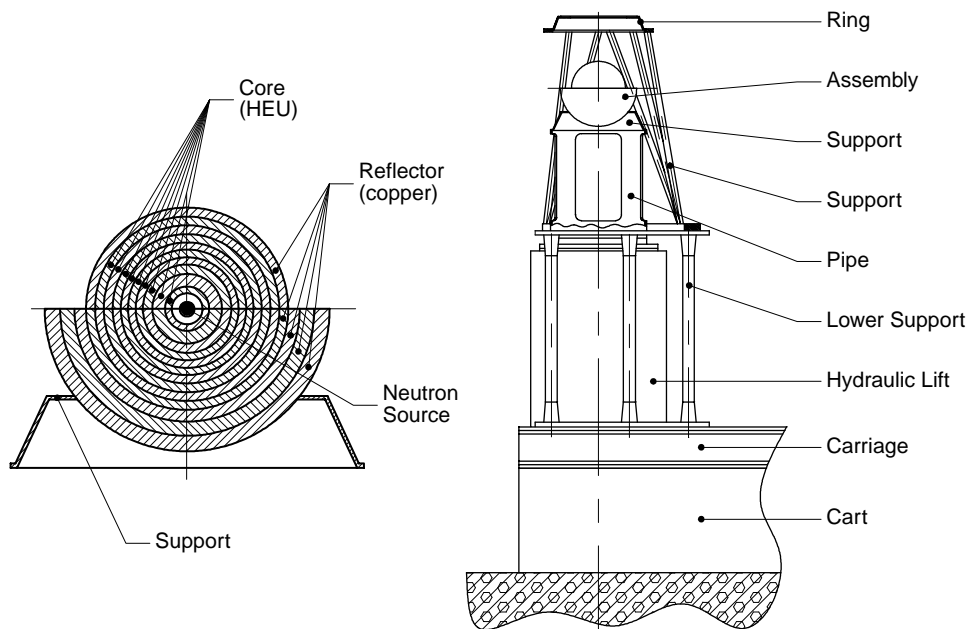
completed the construction of the lower half of the assembly on the table (Figure 56). This lower half consisted of the copper reflector (with an outside diameter of 258 mm since that was all that was available) and a uranium core (9 spherical layers, with an inside diameter of 28 mm and an outside diameter of 167 mm) with a neutron source ( $\sim 10^5$  n/s) placed in its center. As he went to position the first upper copper hemishell (with an inside and outside diameters of 167 mm and 183 mm, respectively) into place it dropped onto the bottom assembly. This led to the initial prompt critical spike and the  $\sim 6.5$  day excursion. The automatic scram system activated and dropped the table to its down position<sup>60</sup> but otherwise had no effect on the supercritical assembly. After the initial fission burst, the assembly eventually reached steady state power conditions.

Figure 56. Accident configuration.

The main cause of the accident was the erroneous judgment of the experimenter as to the state of the experimental assembly he was constructing. The accident resulted in virtually no damage to the machinery or equipment in the facility. The experimental cell was not contaminated. The experimenter received estimated absorbed doses of 4,500 rad from neutrons, and 350 rad from gamma-rays.<sup>61, 62, 63</sup> That same day he was transported to a specialized clinic in Moscow, where he died during the night between 19 and 20 June, 1997. No other personnel were injured or received significant exposures. Radiation levels inside the control room and in the vicinity of the building remained at normal levels. The total energy released was estimated to be equivalent to  $10^{19}$  fissions. After the accident, experiments with FKBN-2M were stopped to implement safety upgrades to the research operations.

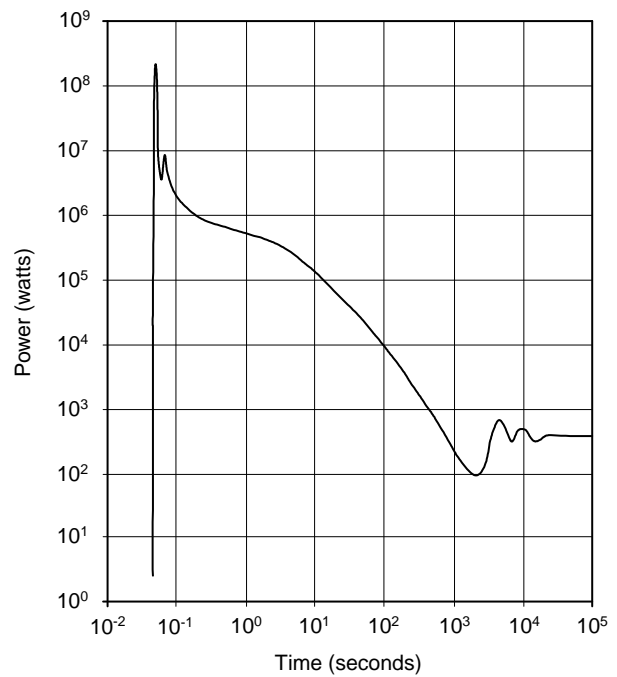
The accident burst conditions were reproduced from measurement of the assembly's neutron flux (19 June 1997) and from computations shown in Figure 57

Figure 57. Calculated power history for the accident.

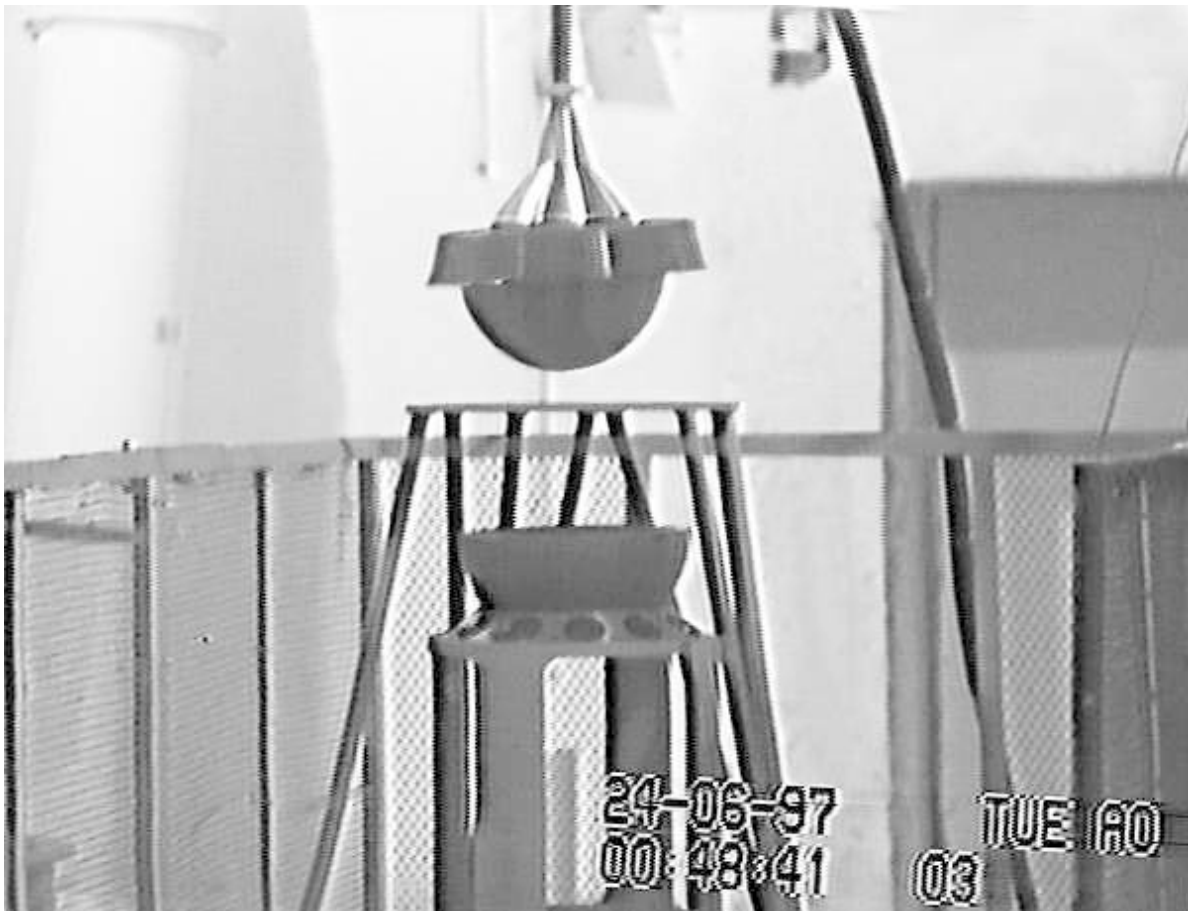
The excursion was terminated around 00:45 on 24 June 1997 when a vacuum gripper was used to remove most of the assembly from the stand, leaving only the outermost lower copper hemishell in place. The removed portion of the assembly was placed onto a support stand in the room (Figure 58). All the recovery operations were done remotely.

Later, another two hemishells from the lower reflector were removed, and the system was then separated into two parts and packaged into containers. After the  $\gamma$ -radiation decreased to allowable levels, it was planned to further disassemble the system (into single components) to restore the damaged copper-nickel protective coating on fissile material parts.

Figure 58. Removal of the main core of the assembly from the lower copper hemishell reflector.

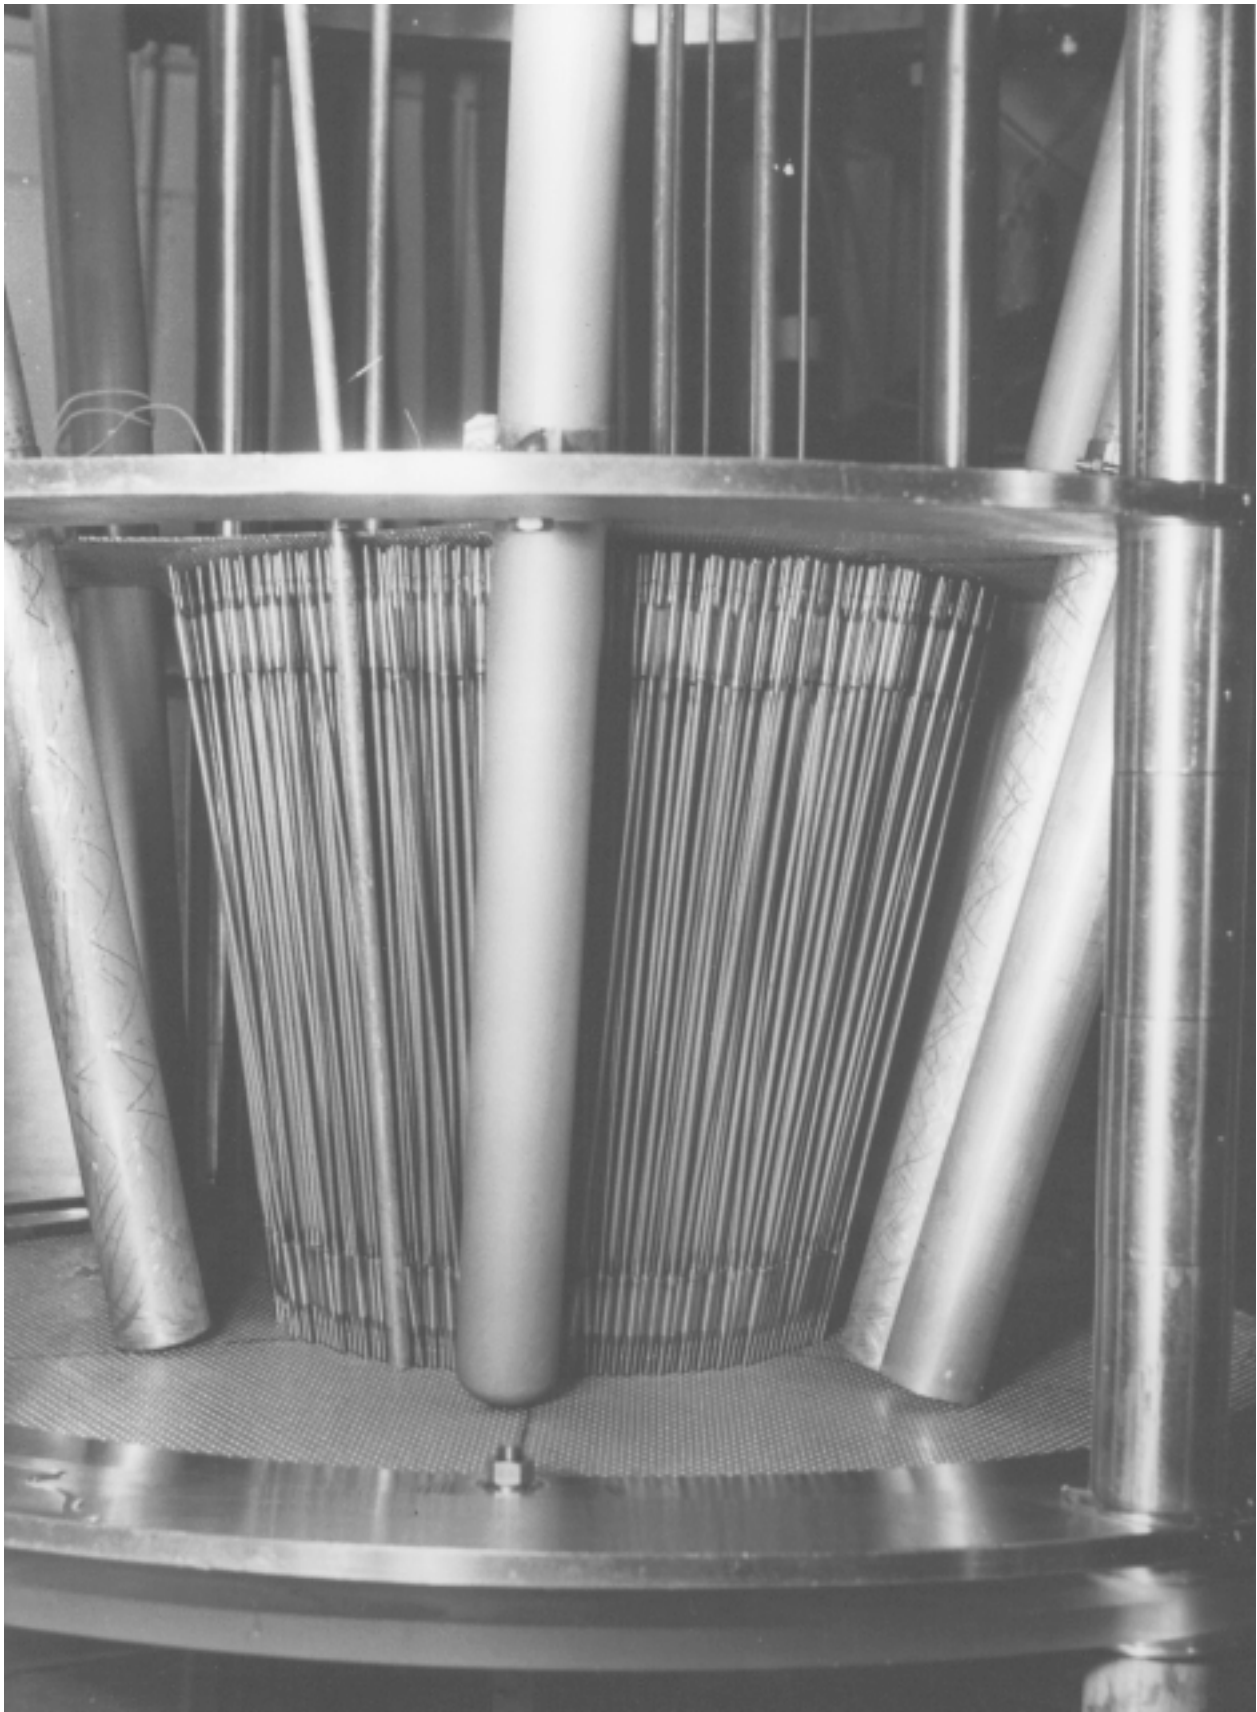
Figure 61. Mockup of the accident configuration for the 26 May 1971 accident.

The plexiglas support plate almost completely covered the tank section, and the size of the gap between the plate edge and tank wall was less than the size of the fast dumping valve outlet. For this reason, upon initiating the fast dumping operation, the Plexiglas base plate sagged and the fuel rods fell out of the upper lattice plate (Figure 61). The fuel rods separated into a fan shaped array in which the pitch between the rods came close to optimum and the lattice went highly supercritical. The rate of reactivity insertion was calculated to have reached  $\sim 2 \beta_{\text{eff}}/\text{s}$ .

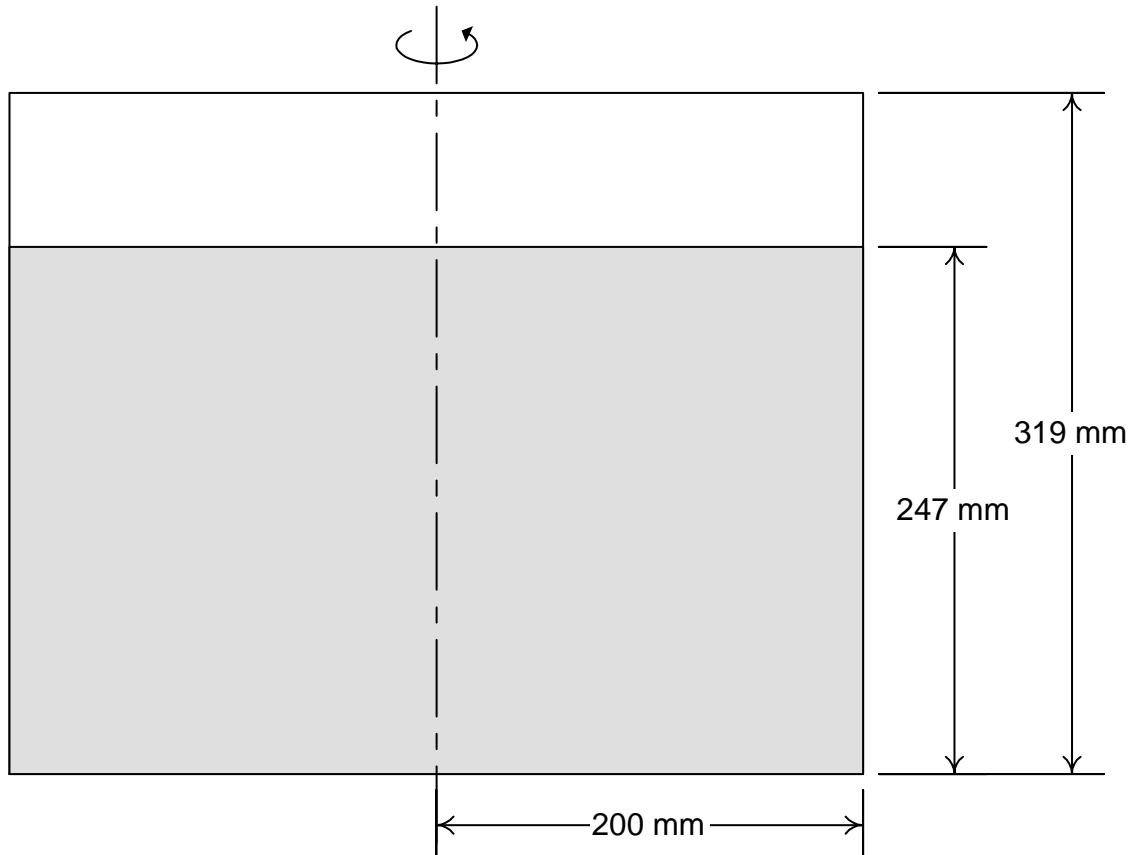
*Plutonium nitrate solution in an interim storage vessel; single excursion; one serious exposure, one significant exposure.*

Vessel Volume	40.0 ℓ
Fissile Volume	31.0 ℓ
Fissile Mass	0.81 kg
Fissile Density	26.1 g/ℓ

Estimated Spherical Critical Mass	0.67 kg
First Spike Yield	unknown
Specific Spike Yield	unknown
Total Yield	$\sim 2.0 \times 10^{17}$

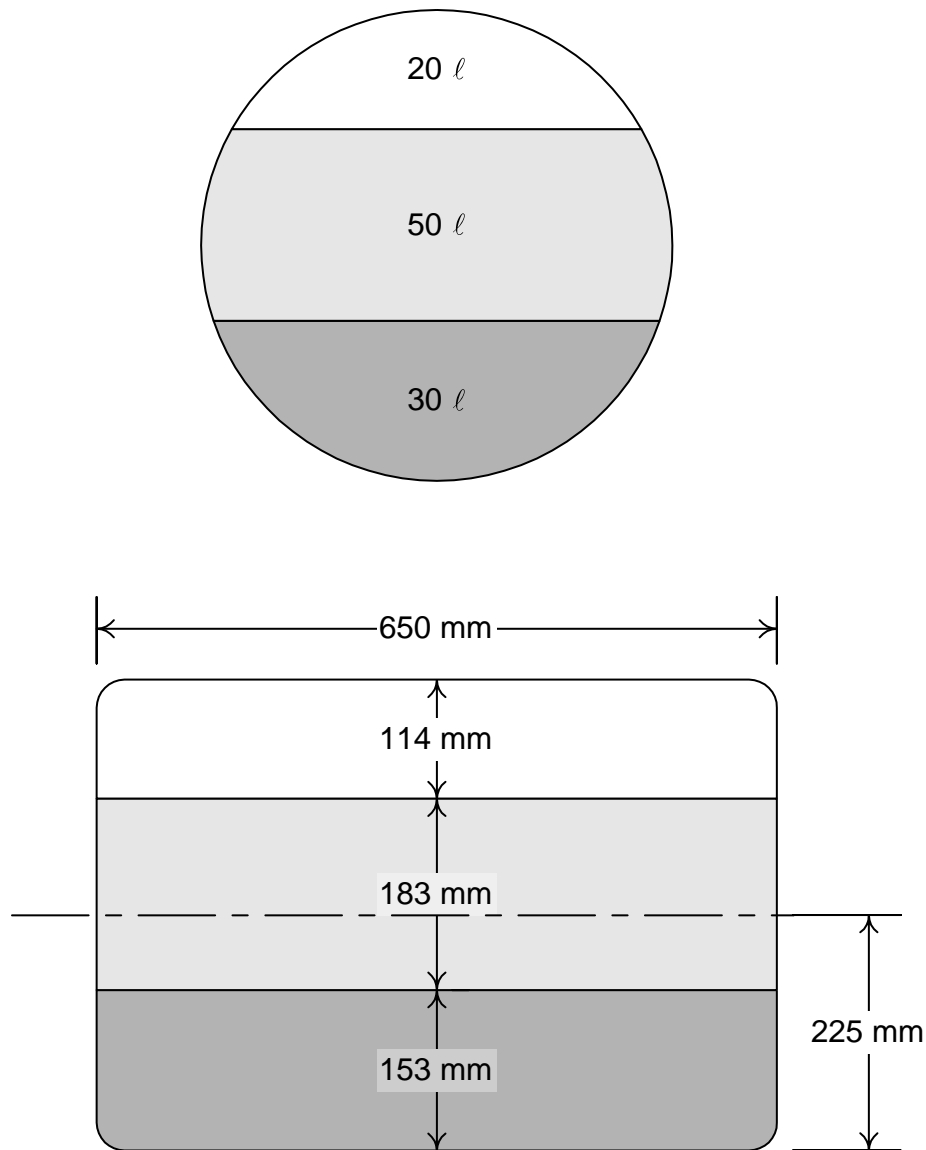
*Uranium precipitate, U(90), buildup in a filtrate receiving vessel; excursion history unknown; one fatality; five other significant exposures.*

Vessel Volume	100.0 ℓ
Fissile Volume	30.0 ℓ
Fissile Mass	3.06 kg
Fissile Density	102.0 g/ℓ

Estimated Spherical Critical Mass	1.09 kg
First Spike Yield	unknown
Specific Spike Yield	unknown
Total Yield	$\sim 1.0 \times 10^{17}$

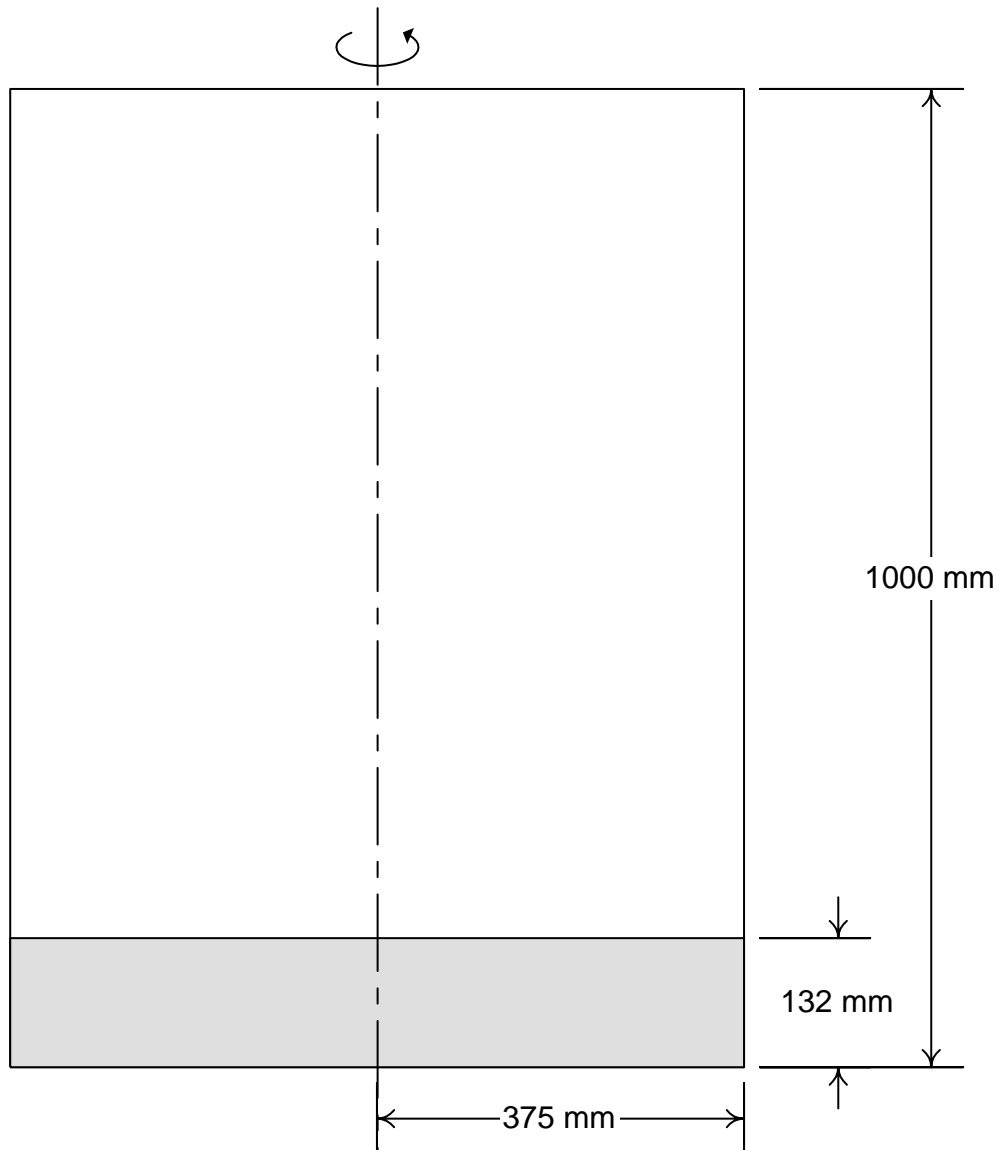
### 3. Mayak Production Association, 2 January 1958

*Uranyl nitrate solution, U(90), in an experiment vessel; one prompt critical burst; three fatalities; one serious exposure.*

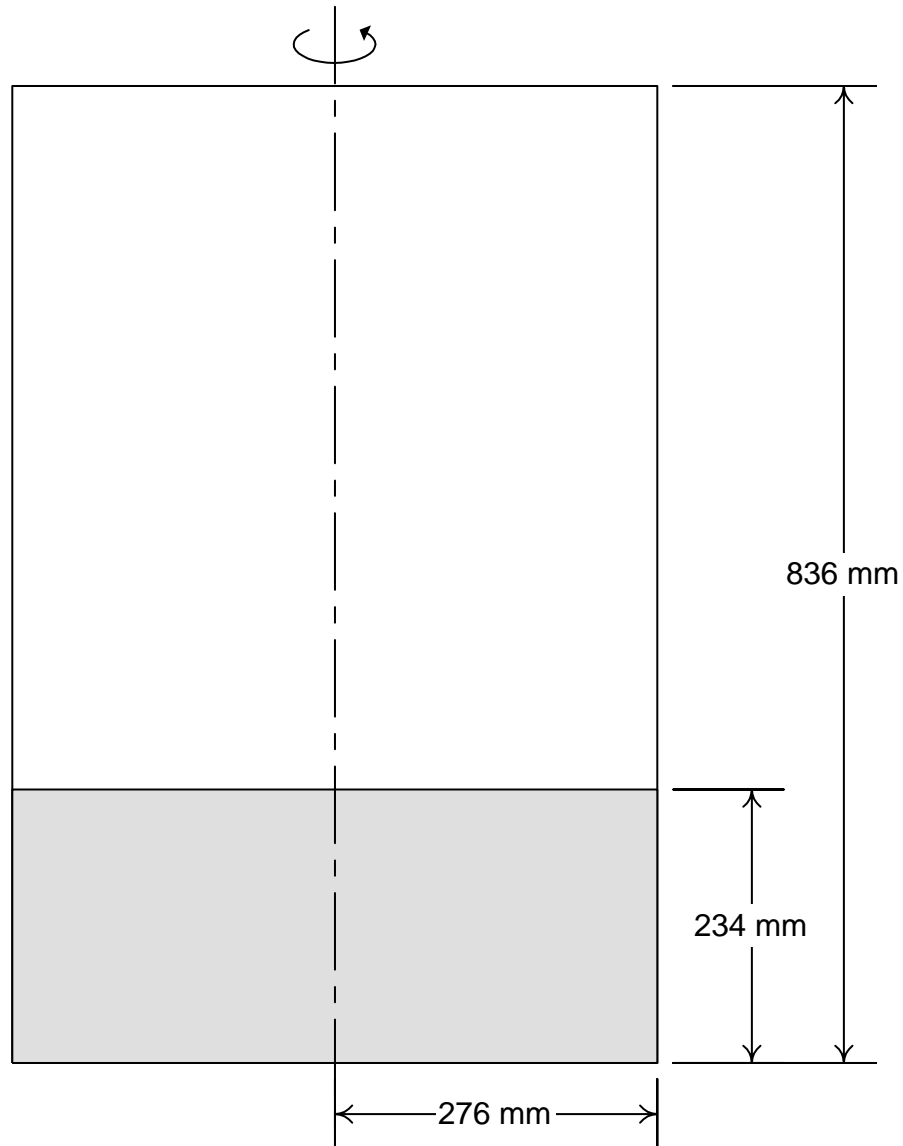
#### 4. Oak Ridge Y-12 Plant, 16 June 1958

*Uranyl nitrate solution, U(93), in a water collection drum; multiple excursions;  
seven significant exposures.*

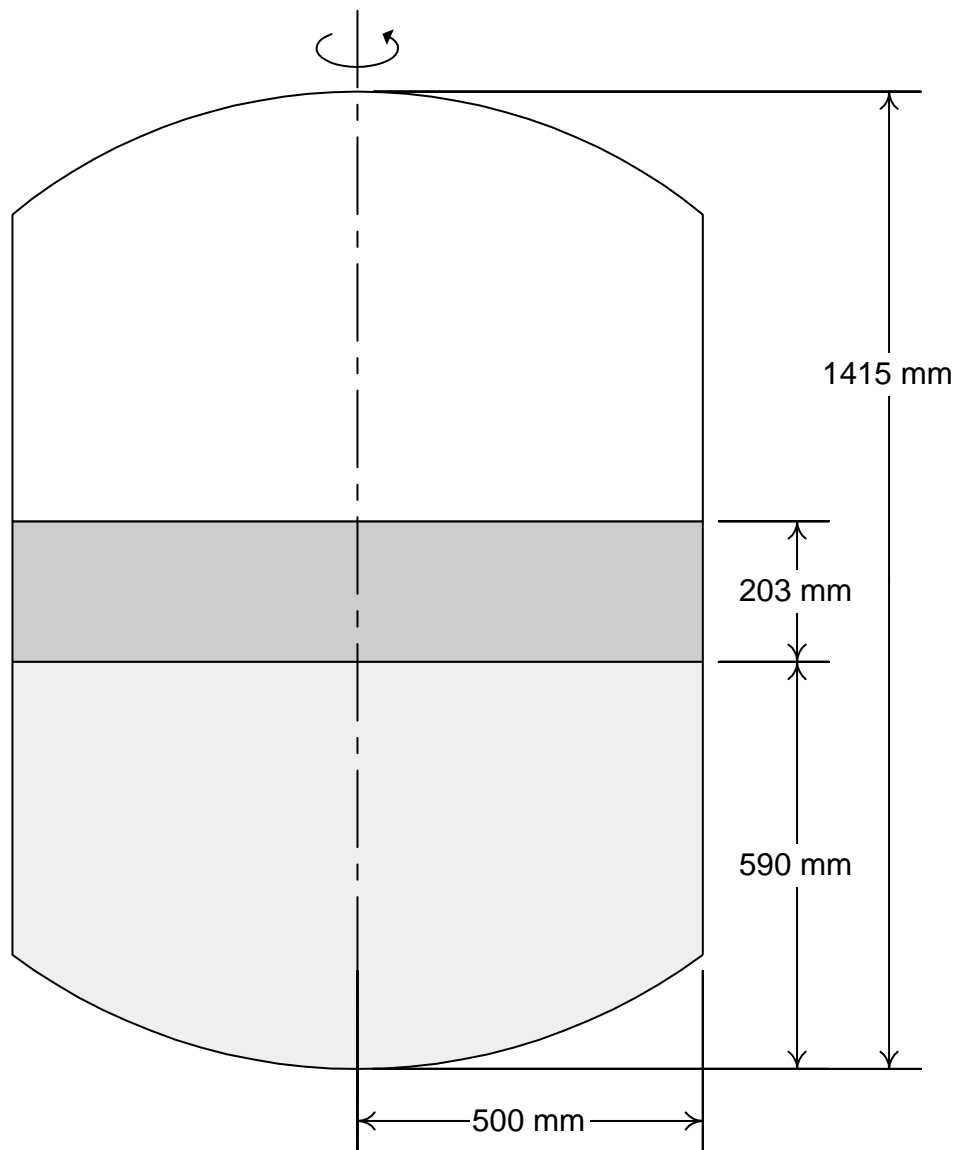
## 5. Los Alamos Scientific Laboratory, 30 December 1958

*Plutonium organic solution in an organic treatment tank; single excursion; one fatality, two significant exposures.*

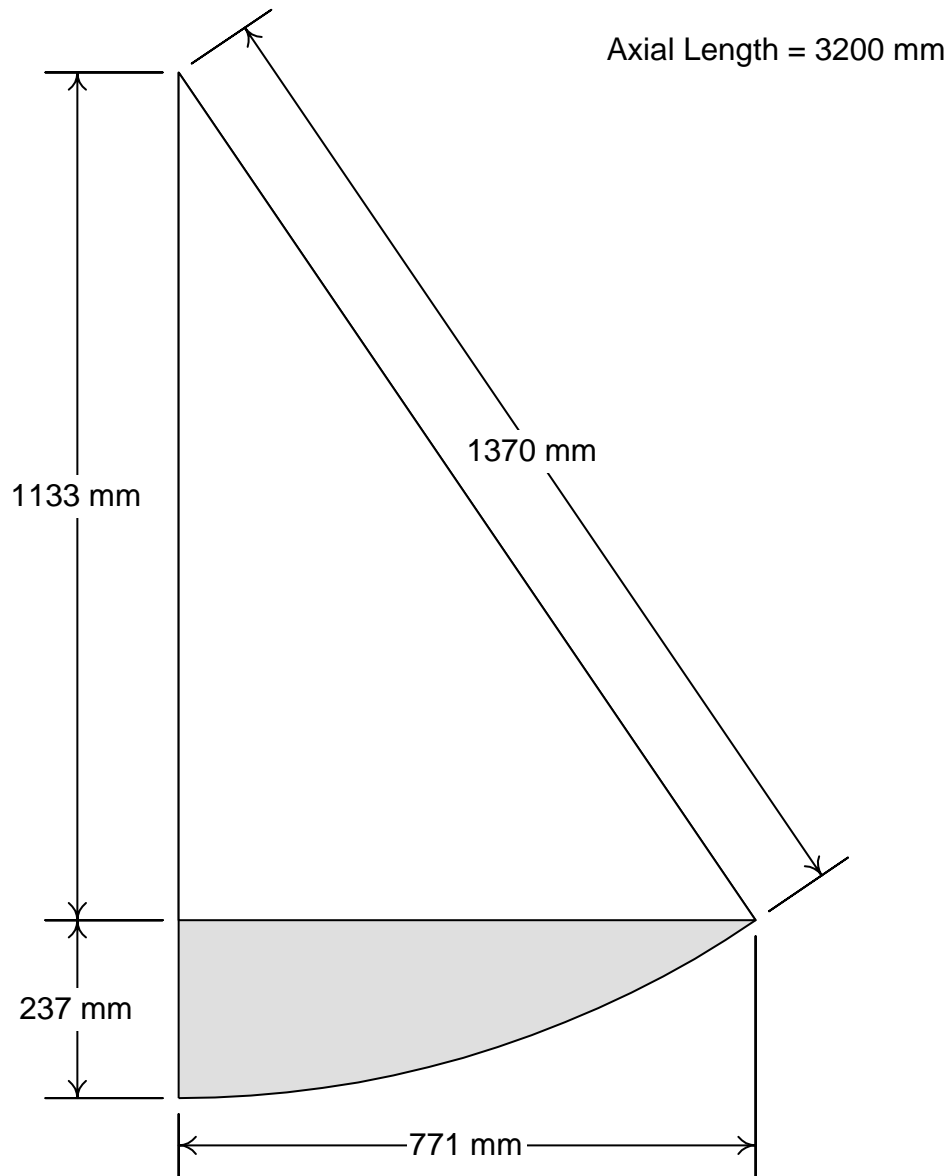
## 6. Idaho Chemical Processing Plant, 16 October 1959

*Uranyl nitrate solution, U(91), in a waste receiving tank; multiple excursions;  
two significant exposures.*

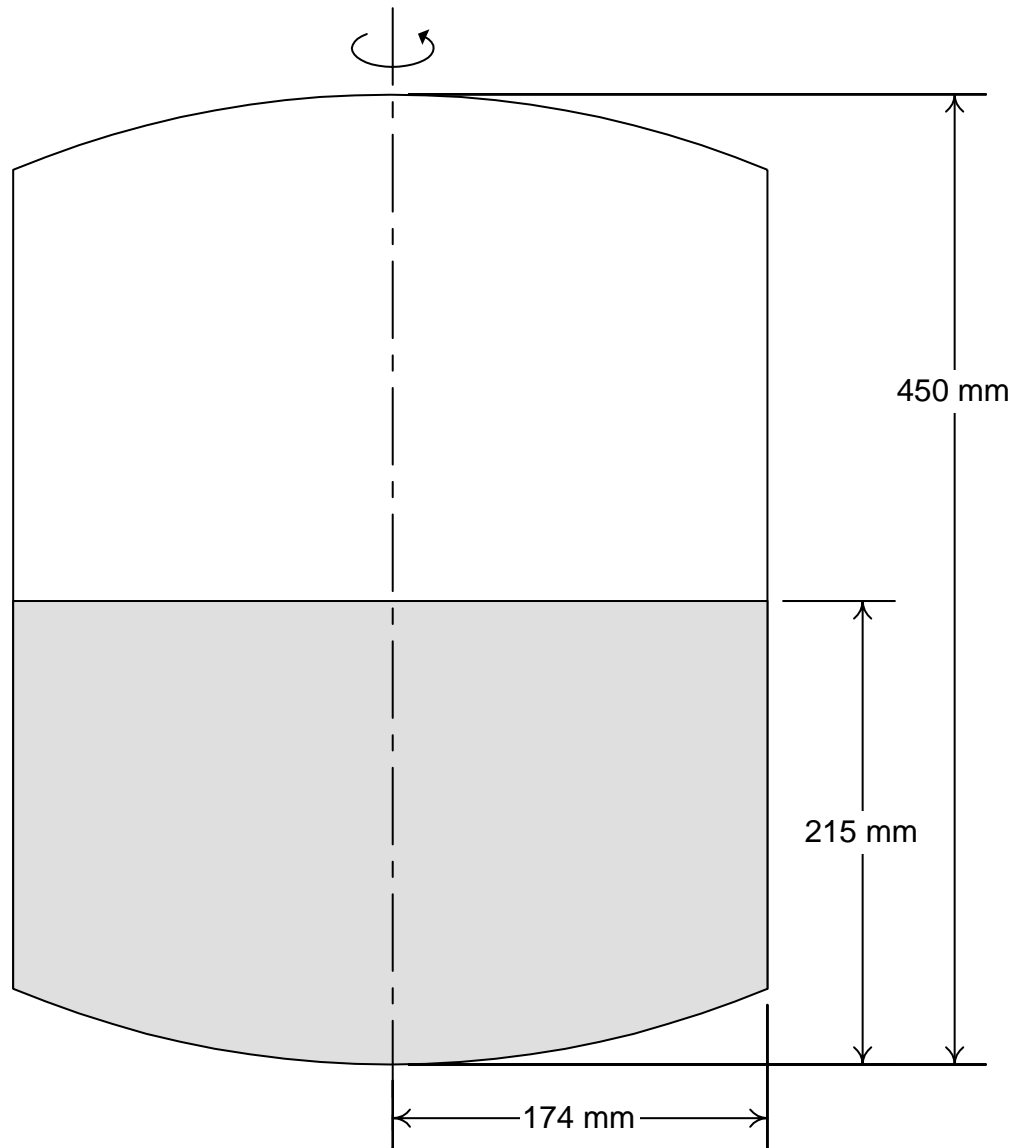
## 7. Mayak Production Association, 5 December 1960

*Plutonium carbonate solution in a holding vessel; multiple excursions;  
insignificant exposures.*

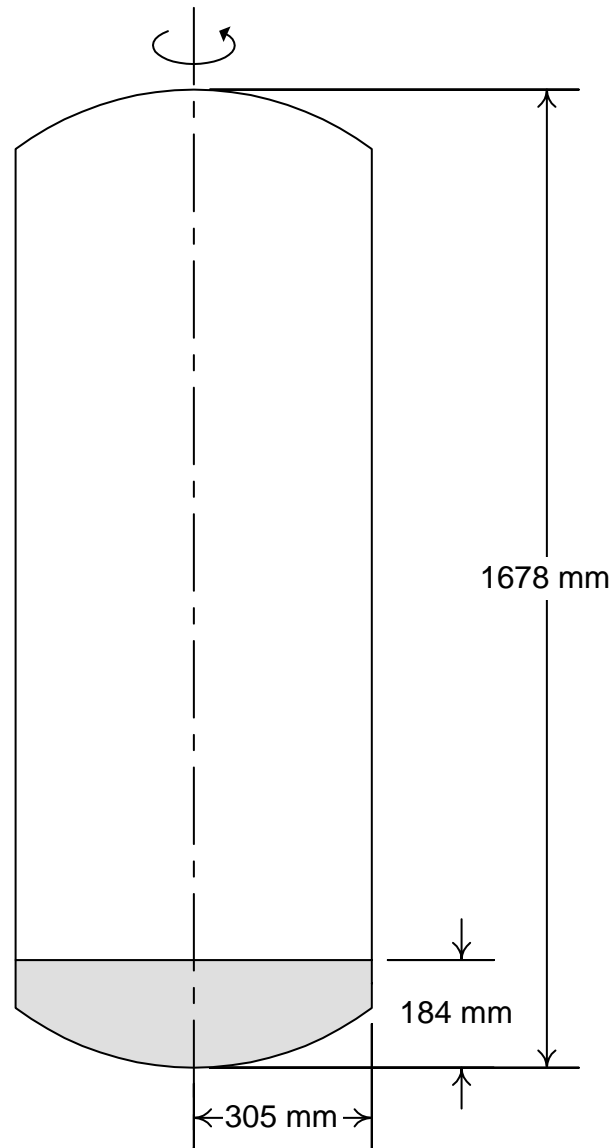
## 8. Idaho Chemical Processing Plant, 25 January 1961

*Uranyl nitrate solution, U(90), in a vapor disengagement vessel; multiple excursions; insignificant exposures.*

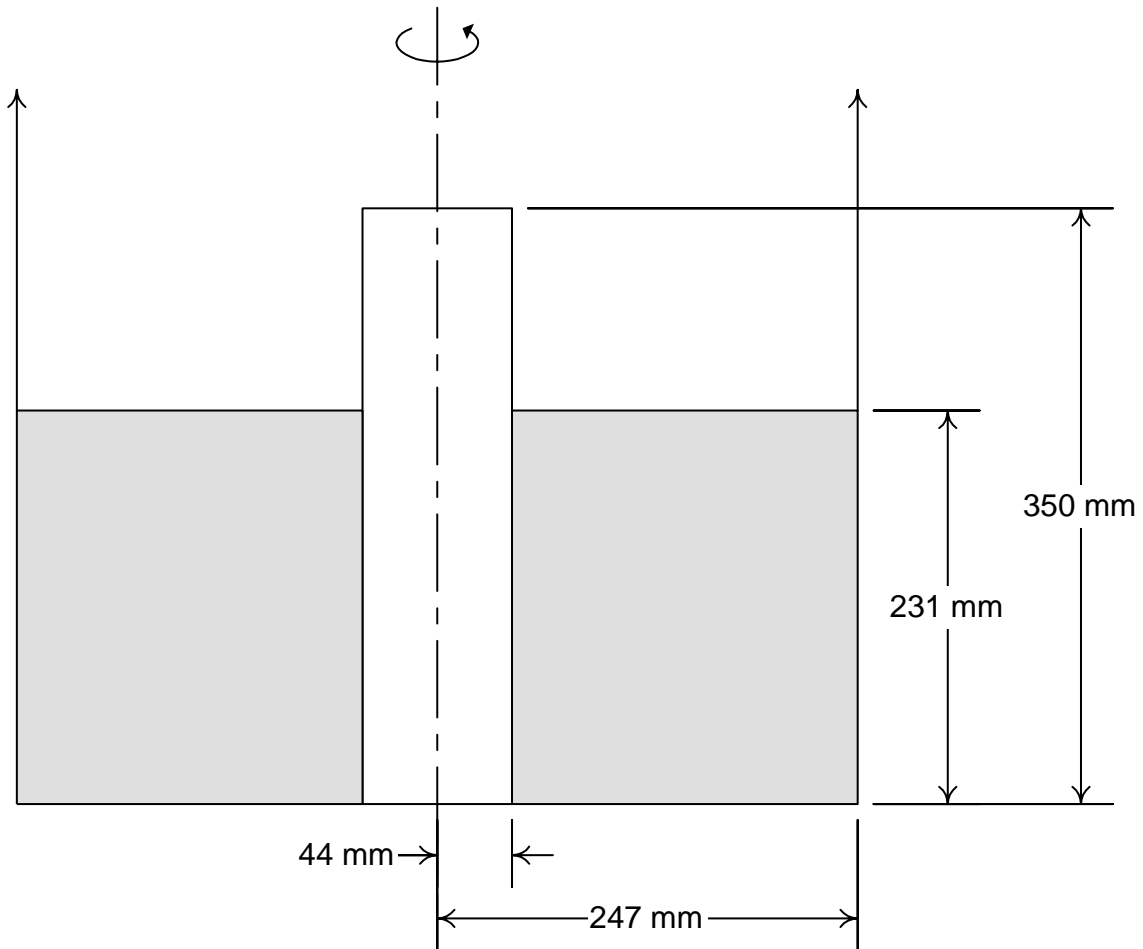
## 9. Siberian Chemical Combine (Tomsk), 14 July 1961

*Uranium hexafluoride, U(22.6), accumulation in a vacuum pump oil reservoir;  
two excursions; one significant exposure.*

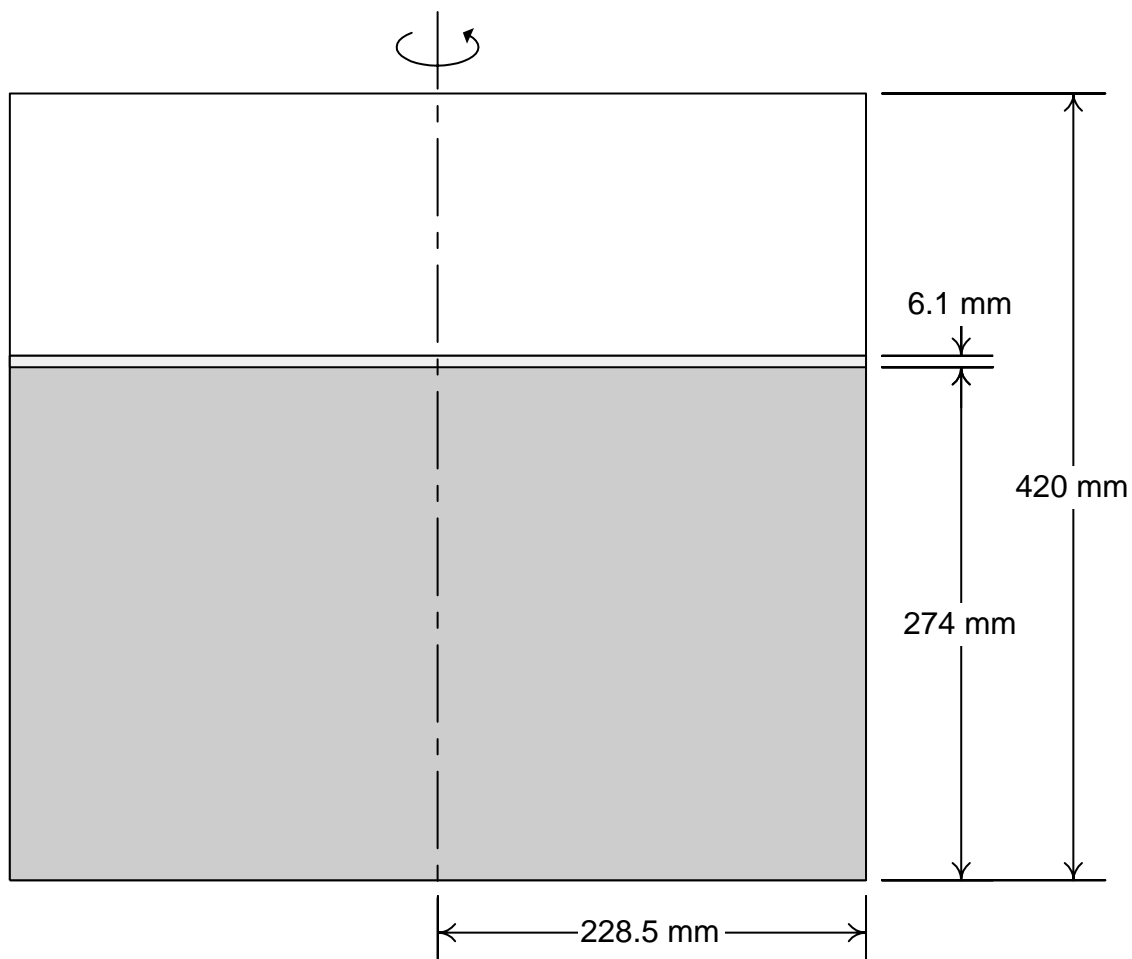
## 10. Hanford Works, 7 April 1962

*Plutonium solution in a transfer vessel; multiple excursions; three significant exposures.*

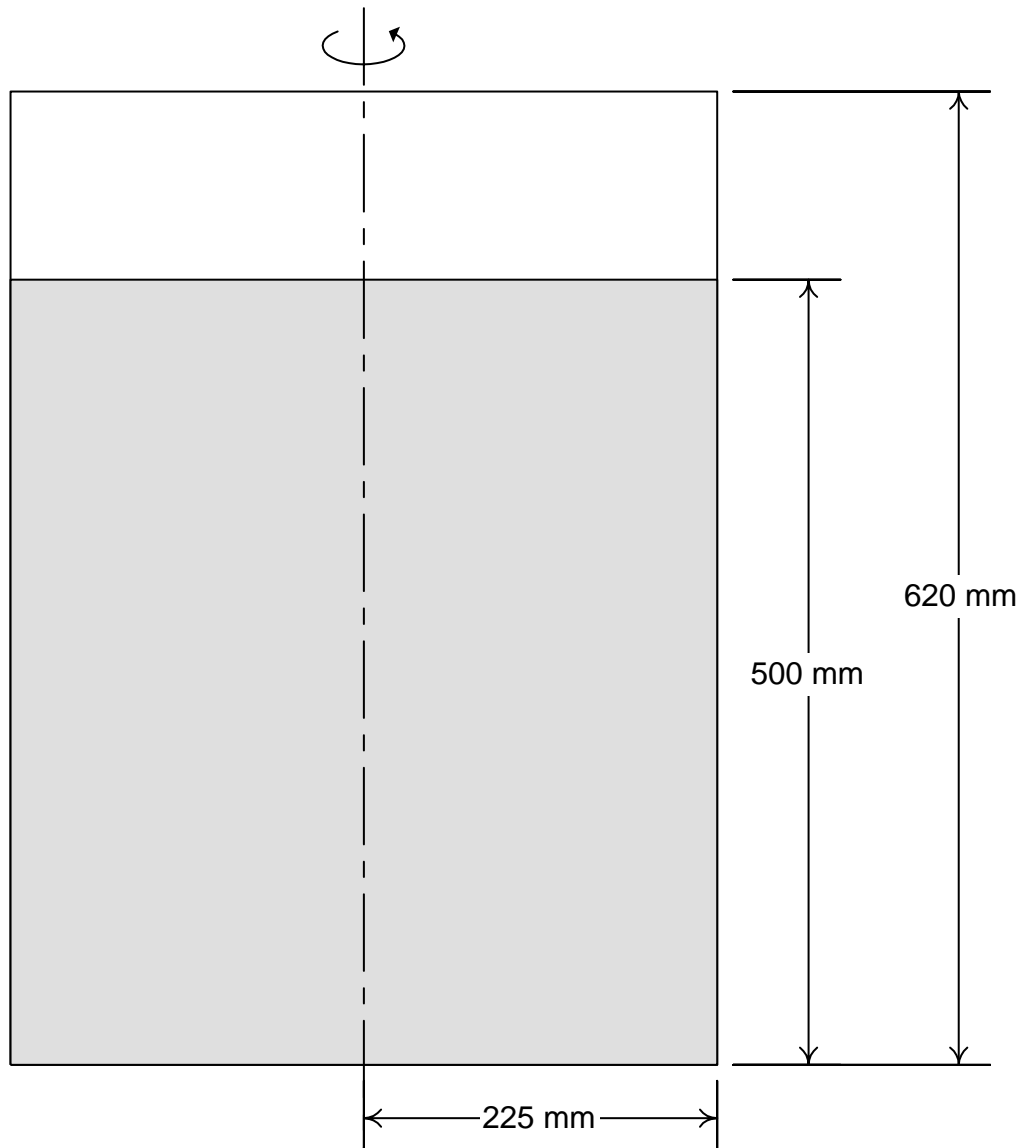
## 11. Mayak Production Association, 7 September 1962

*Plutonium nitrate in a dissolution vessel; three excursions; insignificant exposures.*

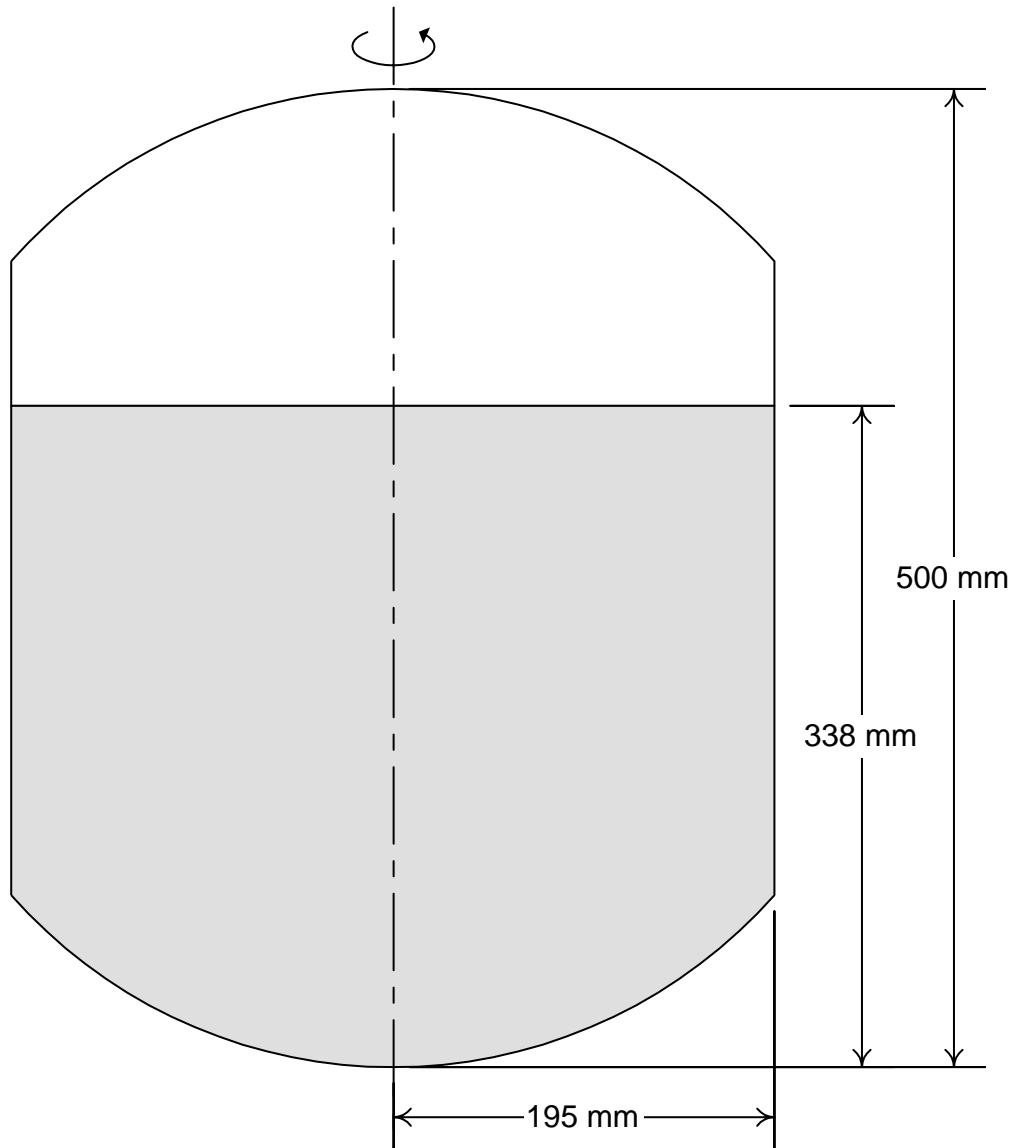
## 12. Siberian Chemical Combine (Tomsk), 30 January 1963

*Uranyl nitrate solution, U(90), in a collection vessel; multiple excursions;  
insignificant exposures.*

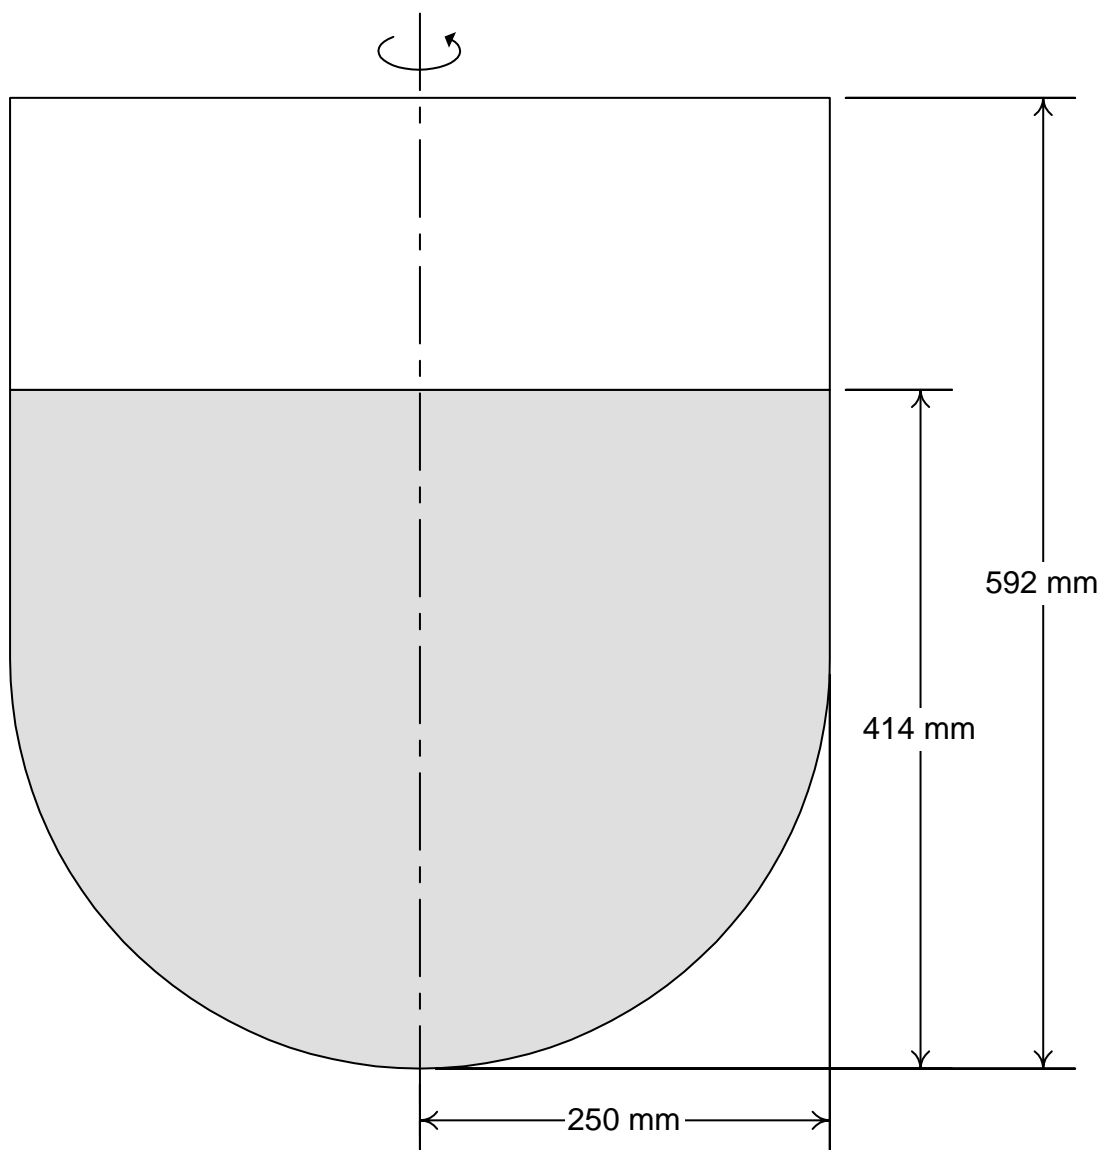
### 13. Siberian Chemical Combine, 2 December 1963

*Uranium organic solution, U(90), in a vacuum system holding vessel; multiple excursions; insignificant exposures.*

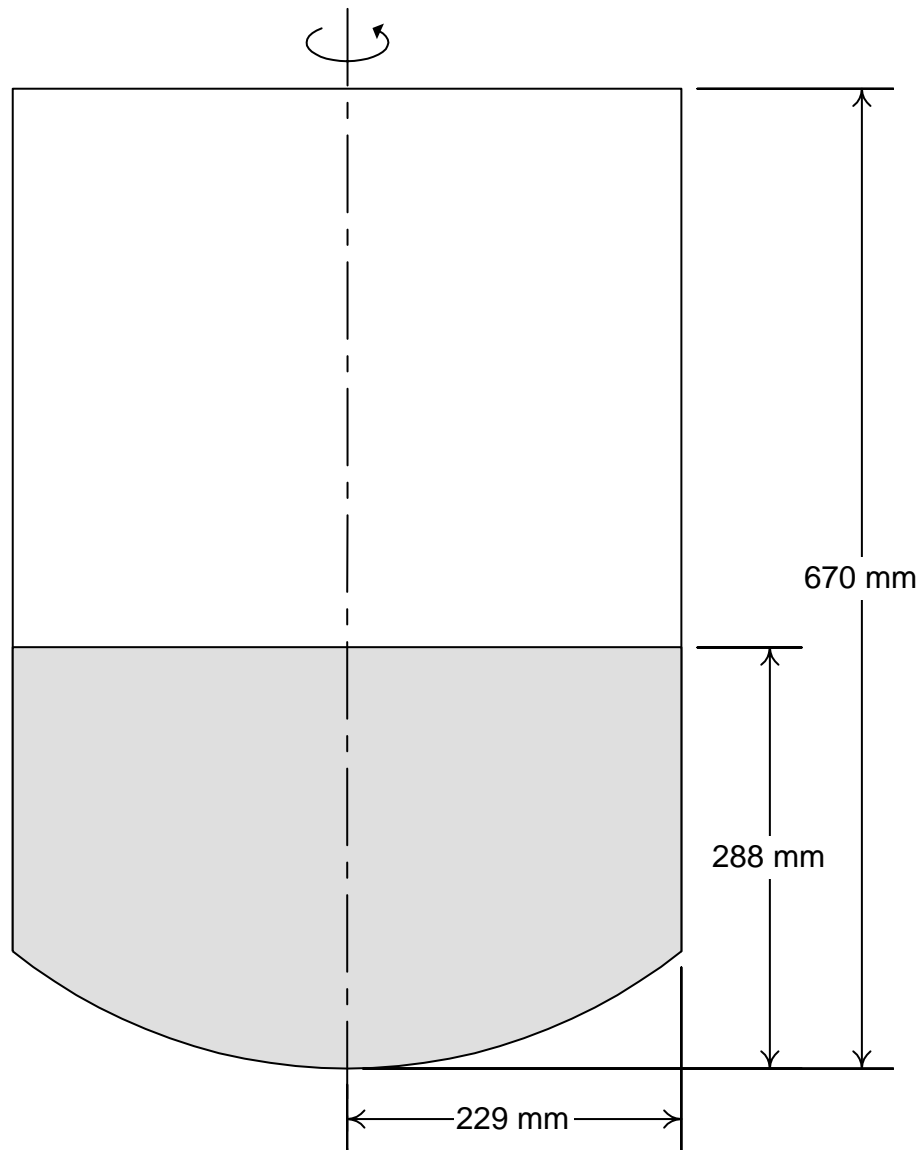
## 14. United Nuclear Fuels Recovery Plant, 24 July 1964

*Uranyl nitrate solution, U(93), in a carbonate reagent makeup vessel; two excursions; one fatality, two significant exposures.*

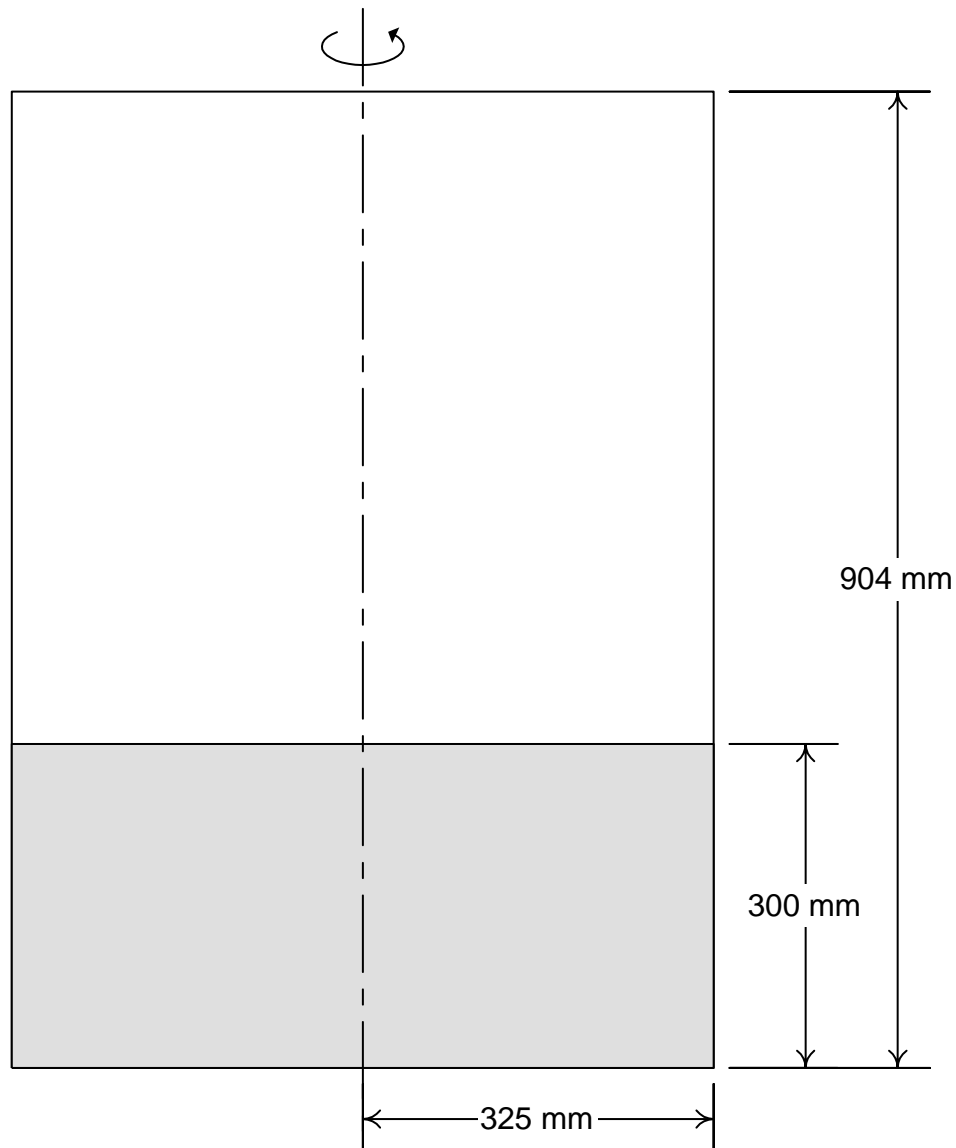
## 15. Electrosta Machine Building Plant, 3 November 1965

*Uranium oxide slurry, U(6.5), in a vacuum system vessel; single excursion;  
insignificant exposures.*
