LA-13638

# A Review of Criticality Accidents

2000 Revision

**Issued: May 2000**

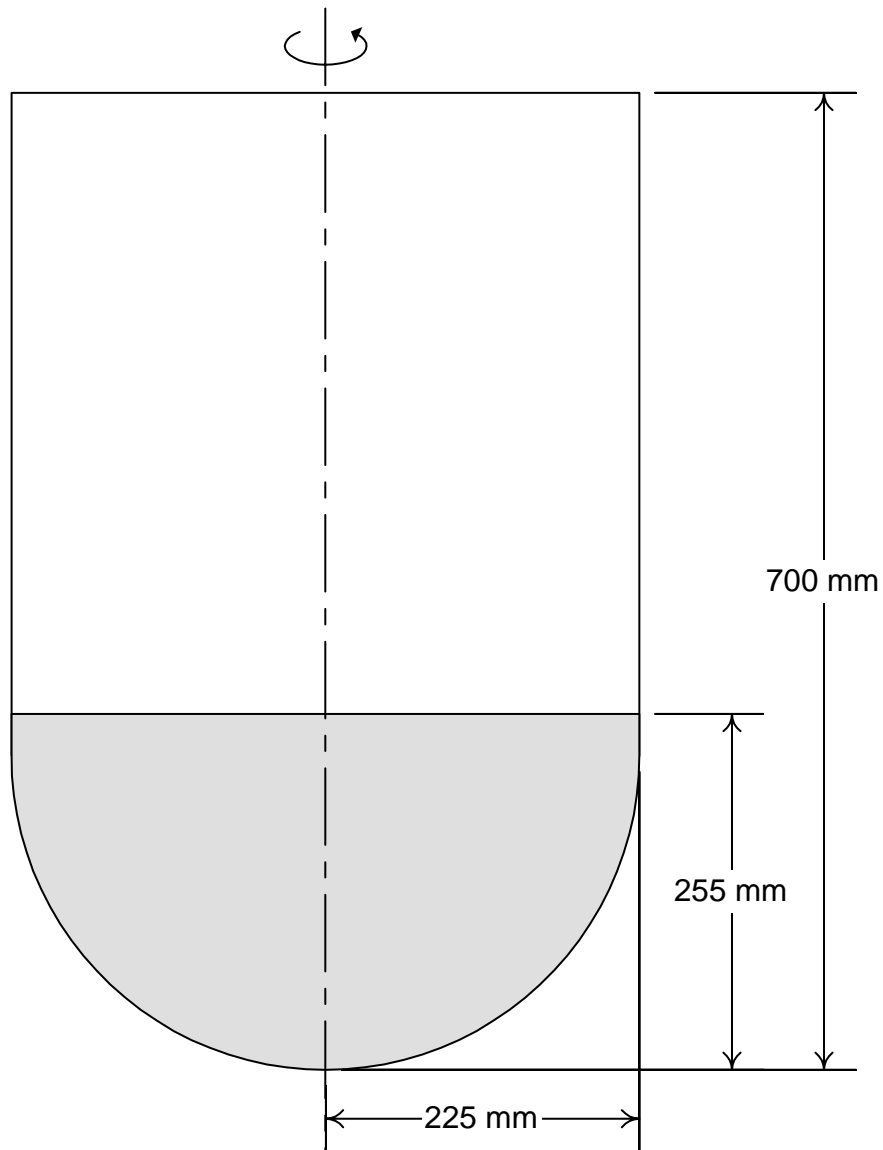
## 16. Mayak Production Association, 16 December 1965

*Uranyl nitrate solution, U(90), in a dissolution vessel; multiple excursions;  
insignificant exposures.*

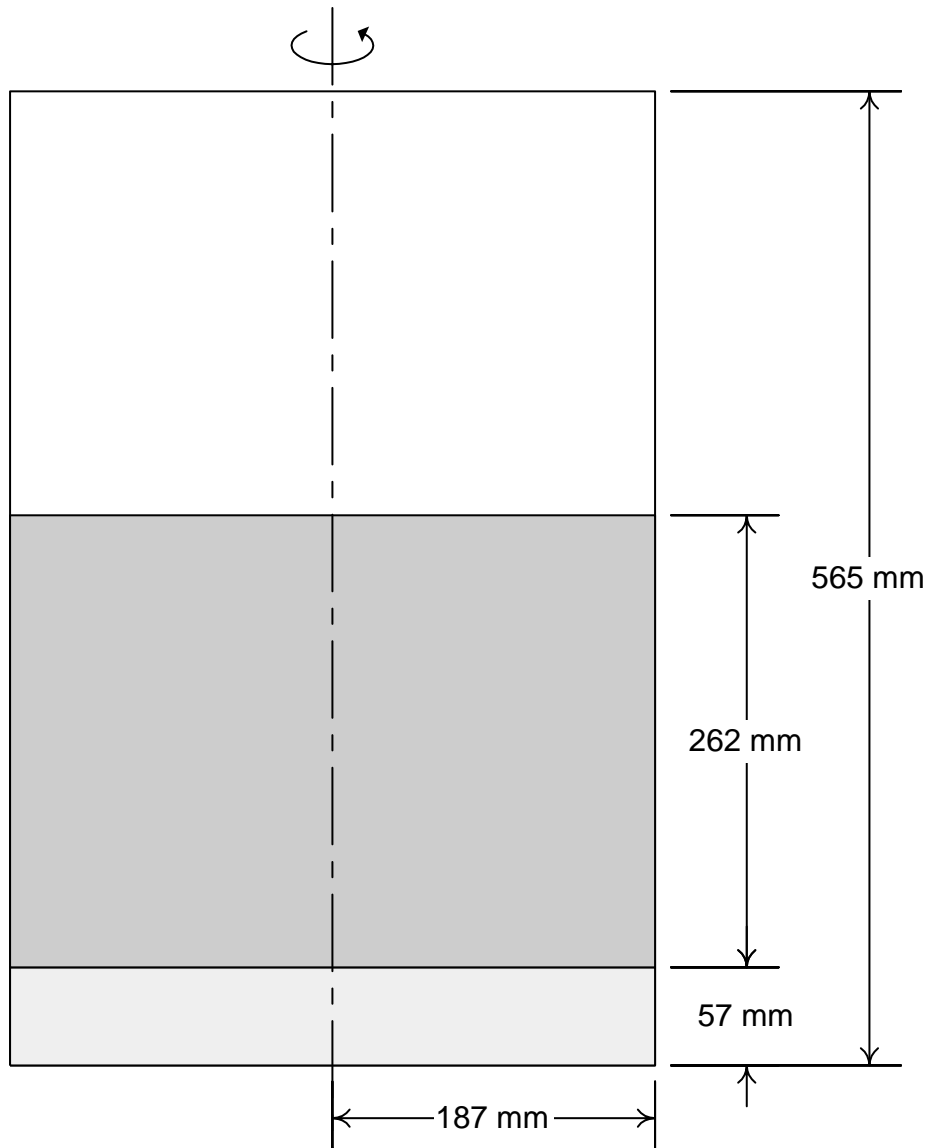
## 17. Mayak Production Association, 10 December 1968

*Plutonium solutions (aqueous and organic) in a 60 liter vessel; three excursions; one fatality, one serious exposure.*

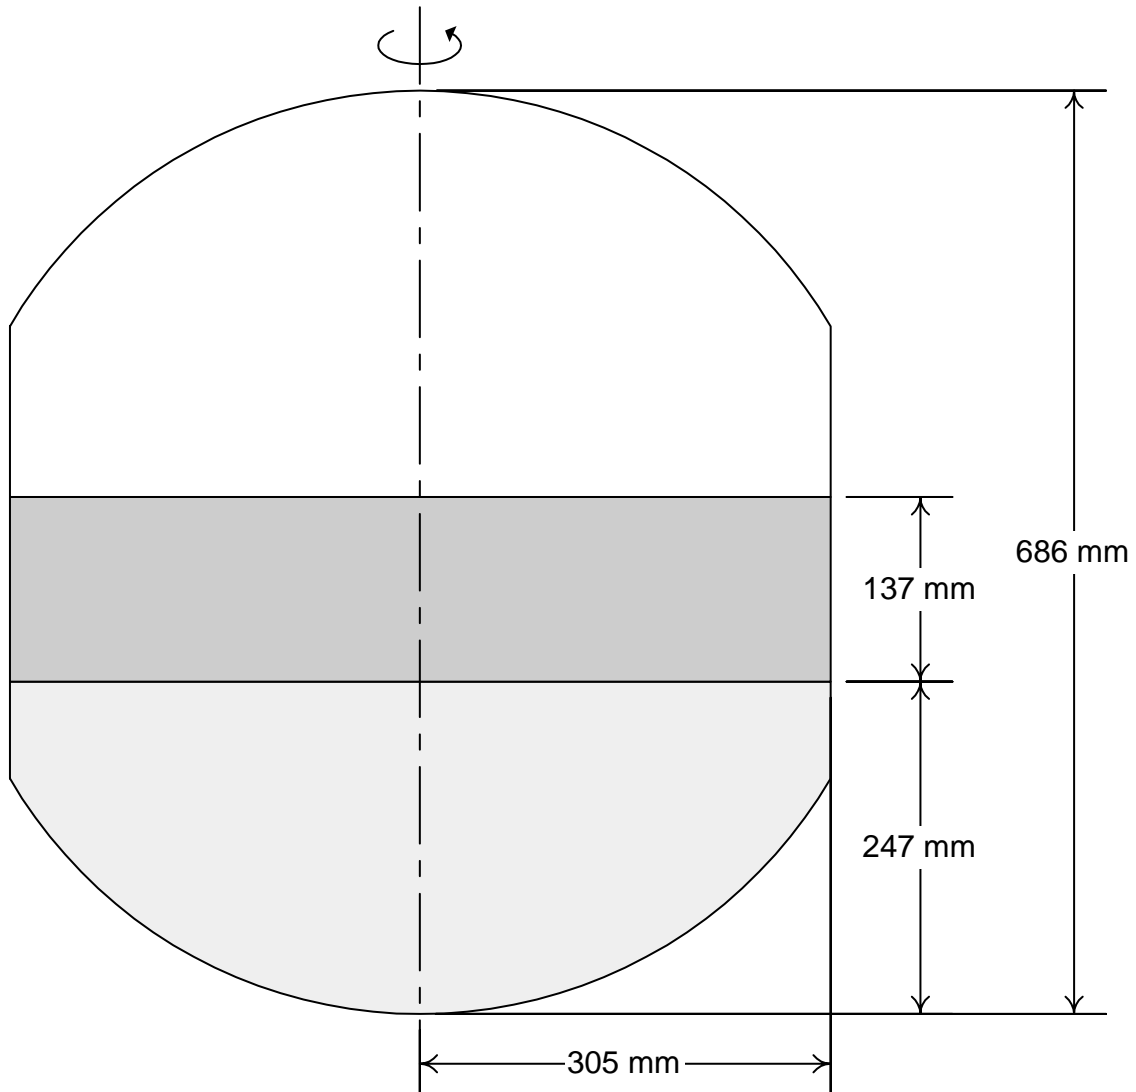
## 18. Windscale Works, 24 August 1970

*Plutonium organic solution in a transfer vessel; one excursion; insignificant exposures.*

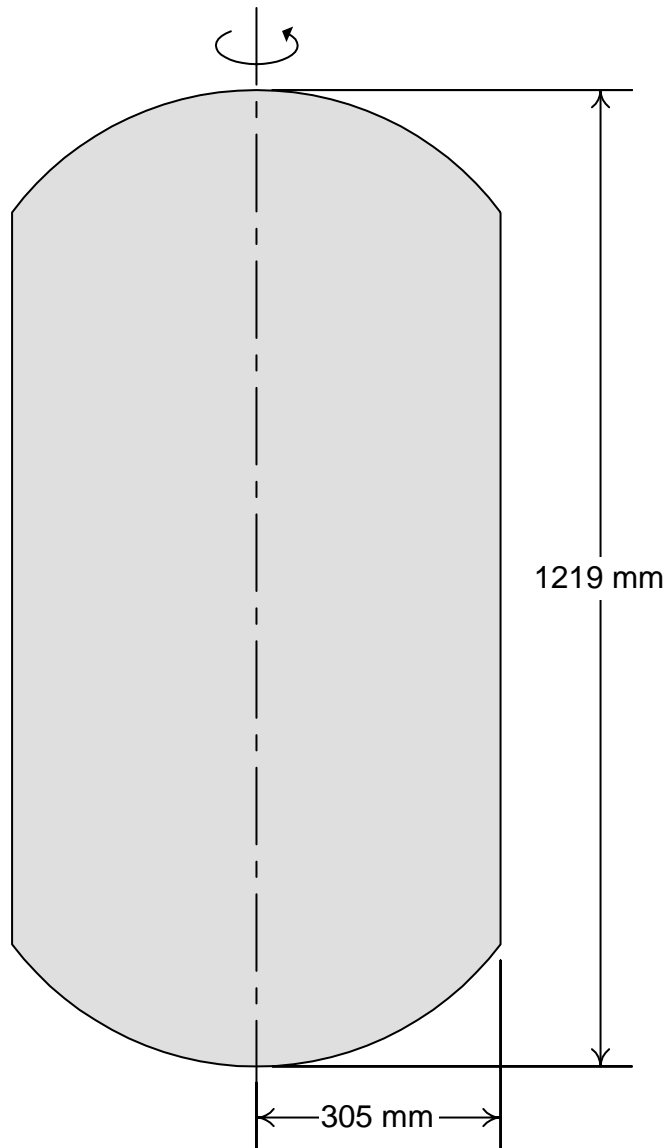
## 19. Idaho Chemical Processing Plant, 17 October 1978

*Uranyl nitrate solution, U(82), in a lower disengagement section of a scrubbing column; excursion history unknown; insignificant exposures.*

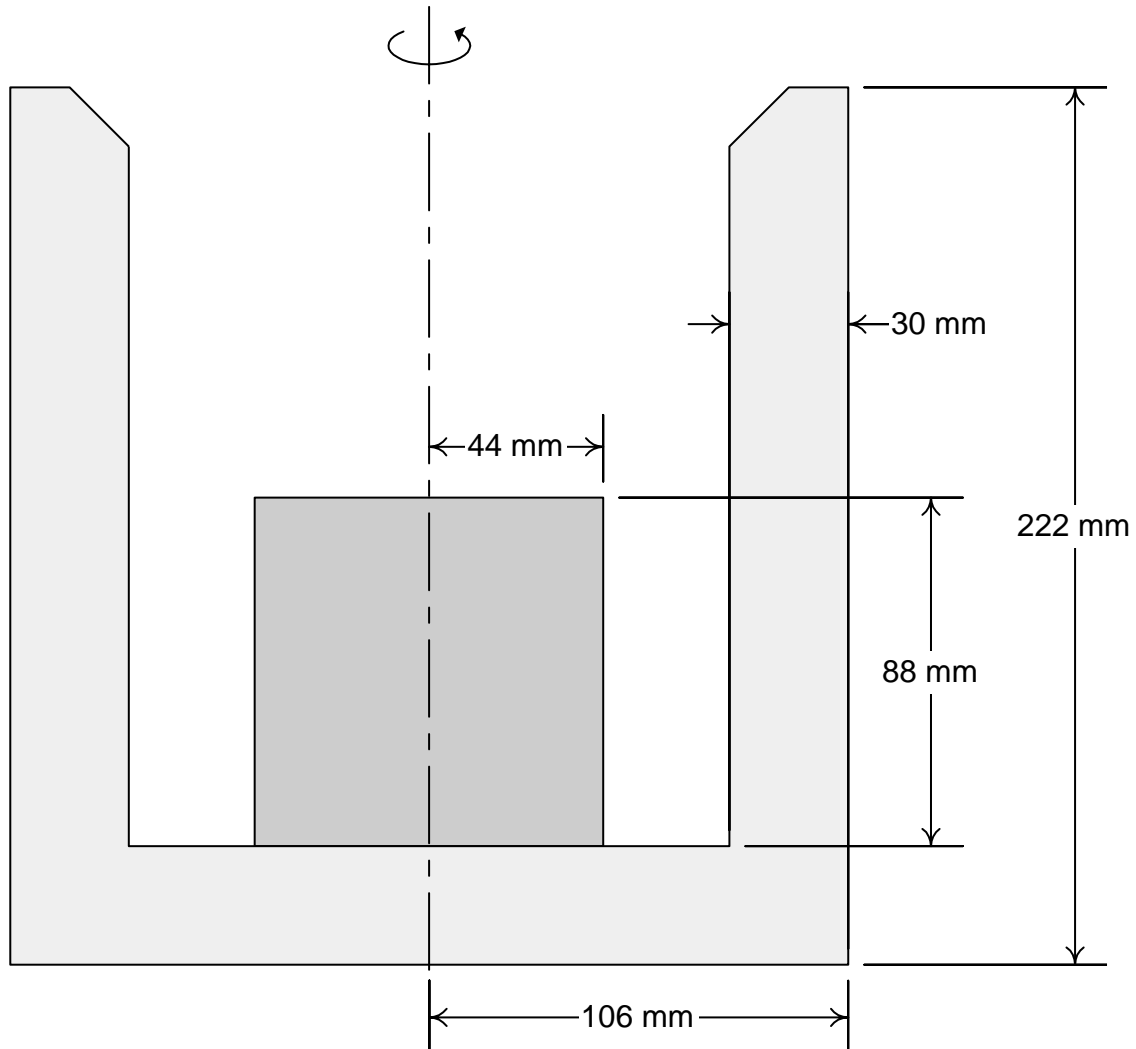
## 20. Siberian Chemical Combine (Tomsk), 13 December 1978

*Plutonium metal ingots in a storage container; single excursion; one serious exposure, seven significant exposures.*

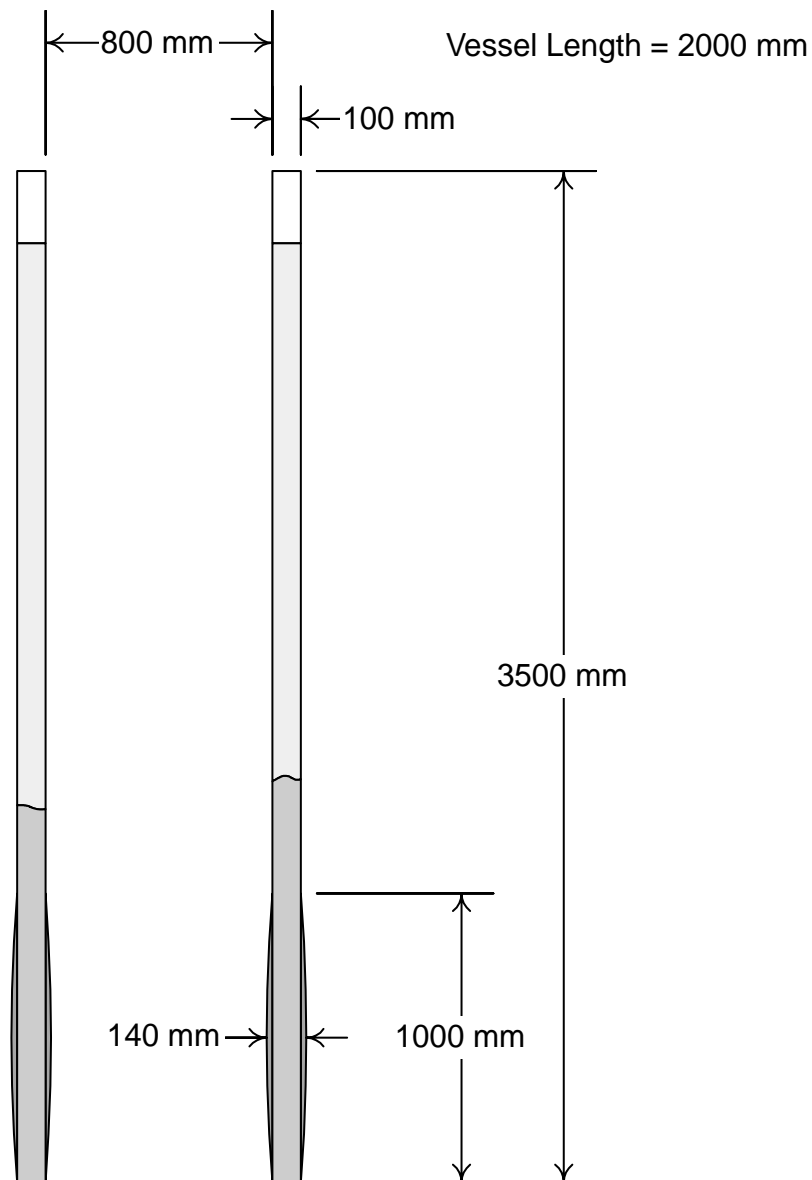
## 21. Novosibirsk Chemical Concentration Plant, 15 May 1997

*Uranium oxide slurry and crust, U(70), in the lower regions of two parallel vessels; multiple excursions; insignificant exposures.*

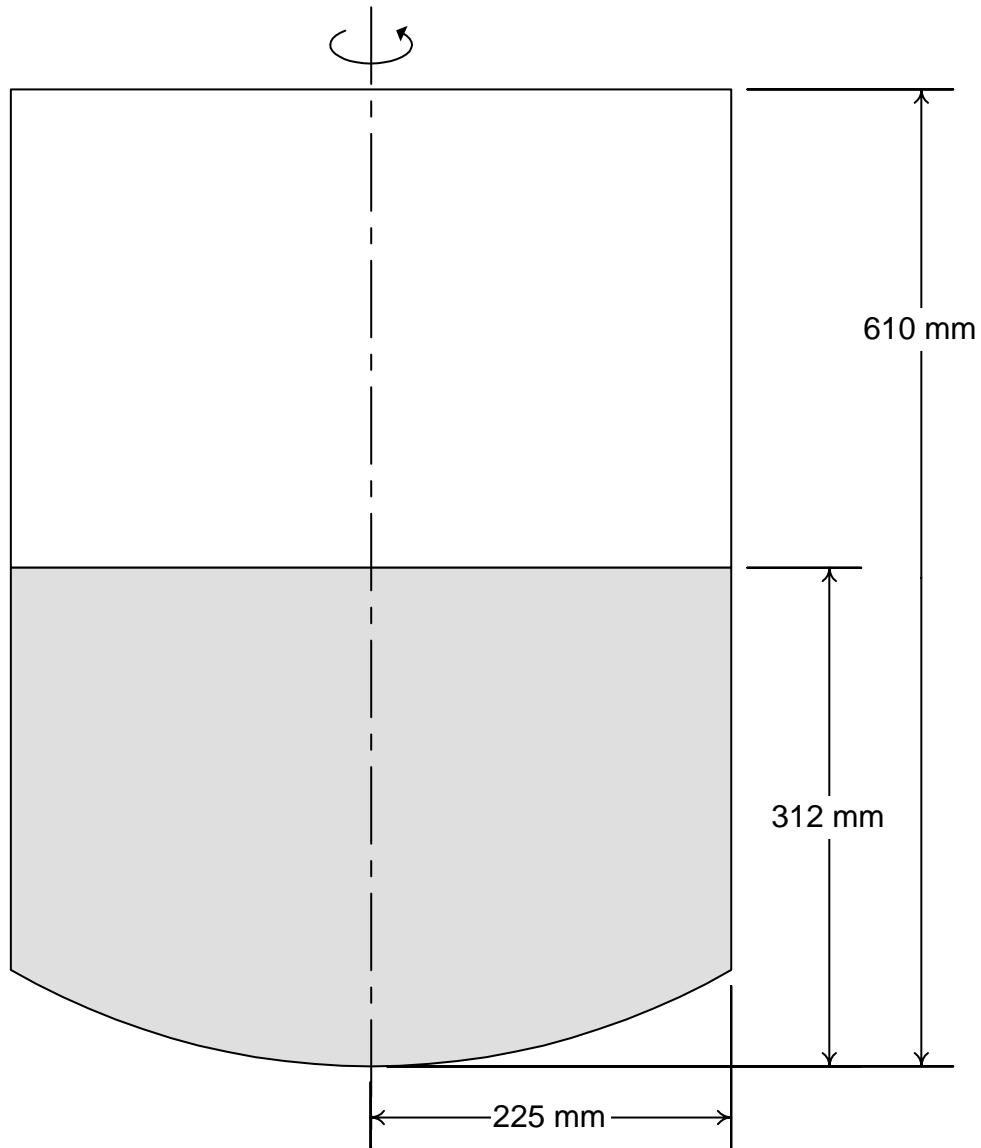
## 22. JCO Fuel Fabrication Plant, 30 September 1999

*Uranyl nitrate solution, U(18.8), in a precipitation vessel; multiple excursions;  
two fatalities, one significant exposure.*
