UNITED STATES
NUCLEAR REGULATORY COMMISSION

SUBJECT: NRC SPECIAL INSPECTION REPORT - INDIAN POINT UNIT 2
STEAM GENERATOR TUBE FAILURE - REPORT NO. 05000247/2000-010

IR 05000247-00-010, March 7 thru July 20, 2000; Consolidated Edison of New York, Inc.; Indian Point Unit 2; Special Team; steam generator tube failure, visual, eddy current inspection, technique qualification, corrective actions.

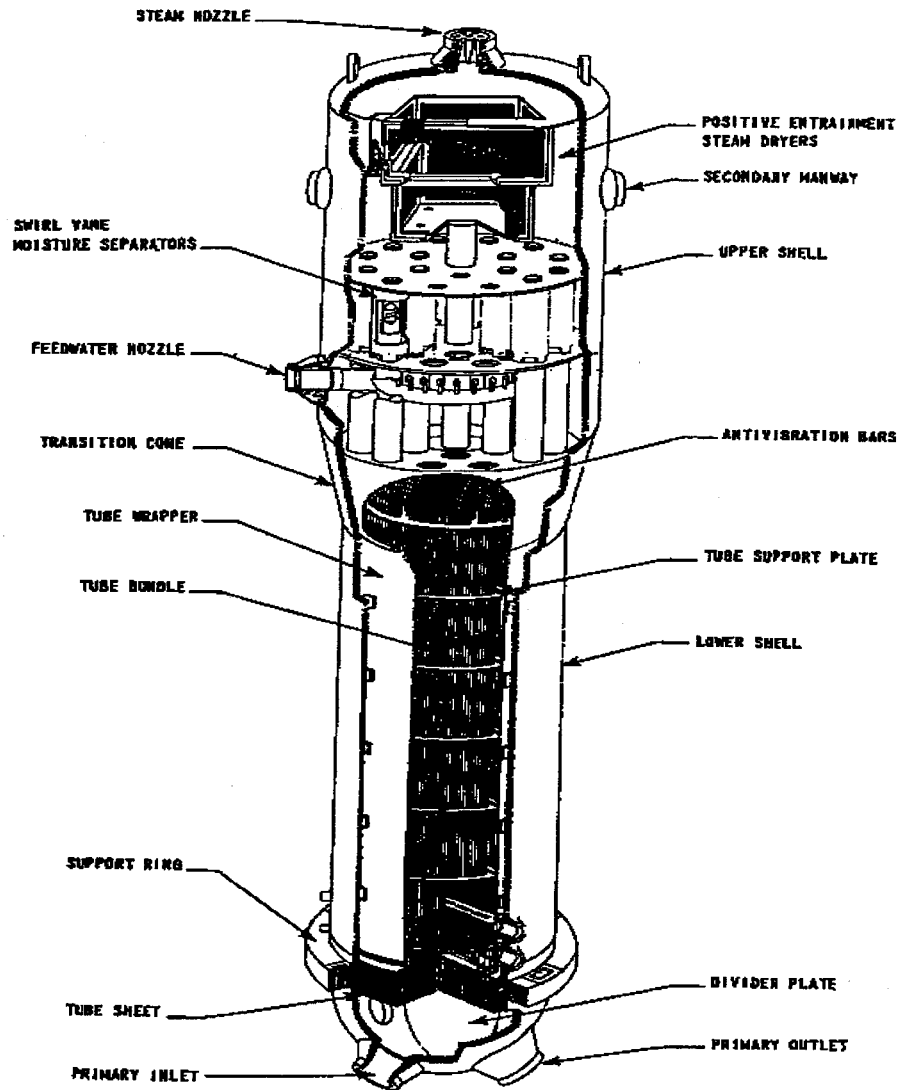
REFERENCED FIGURES 1 THROUGH 19
 Figure 1 - Westinghouse Model 44 Steam Generator

Indian Point 2 is a four-loop pressurized water reactor, meaning that there are four SGs, one per loop, that transfer heat from the reactor coolant system (RCS) to the secondary water. This heat causes the secondary water to boil, and the resulting steam is used to turn the turbine, which turns the electrical generator. Figure 1 shows a Westinghouse Model 44 SG, like those in use at Indian Point 2. The four SGs are identified as SG 21 through SG 24.

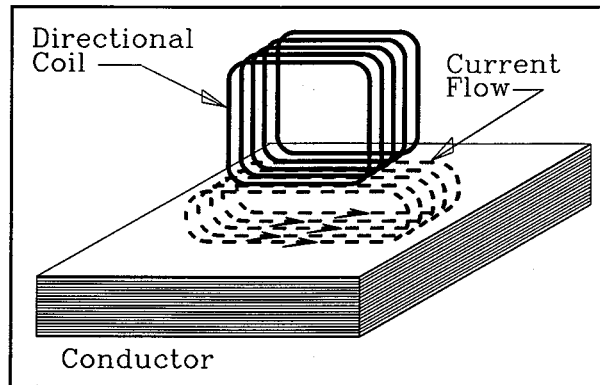
Figure 2 Directional pancake probe

Single coil probes as shown in Figure 2 will induce the eddy current in only one direction, which is a compressed mirror image of the current in the coils. Defects that are perpendicular to the eddy current flow, interrupt the eddy current flow and the probe coil voltage will be affected. Specially designed ECT probes can classify defects as axial cracks, circumferential cracks or both.

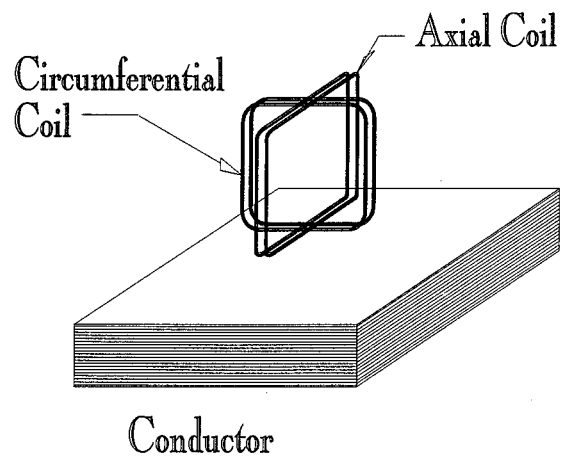
Figure 3 Plus Point probe

The Plus Point probe consists of two coils wound at 90 degrees to each other, as shown in Figure 3. The coils are mounted on a shoe that rotates as it passes through the tube to allow a complete examination. The turns of the two coils are interleaved so that both are effectively the same distance from the surface of the tube. The coils are connected in a bridge circuit, as shown in Figure 4, and the voltage difference between the two signals is amplified. The two coils allow the scanning for both axial and circumferential defects. The mid-range Plus Point probe used during the 1997 examination is a multifrequency probe, operating at 10, 100, 300, and 400 kHz.

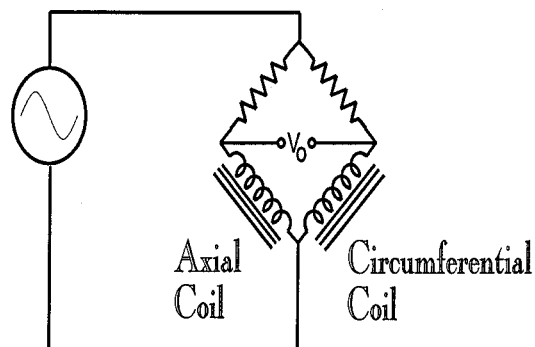
Figure 4 Difference signal from axial and circumferential coils are amplified
