# WESTERN NUCLEAR, INC.

**RE: Radon-222 Flux Measurements on the Sherwood Tailing Impoundment Surface After Final Cover Placement.**

# **EROSIONAL STABILITY OF TAILING IMPOUNDMENT SWALE FOR AS-BUILT CONDITIONS**

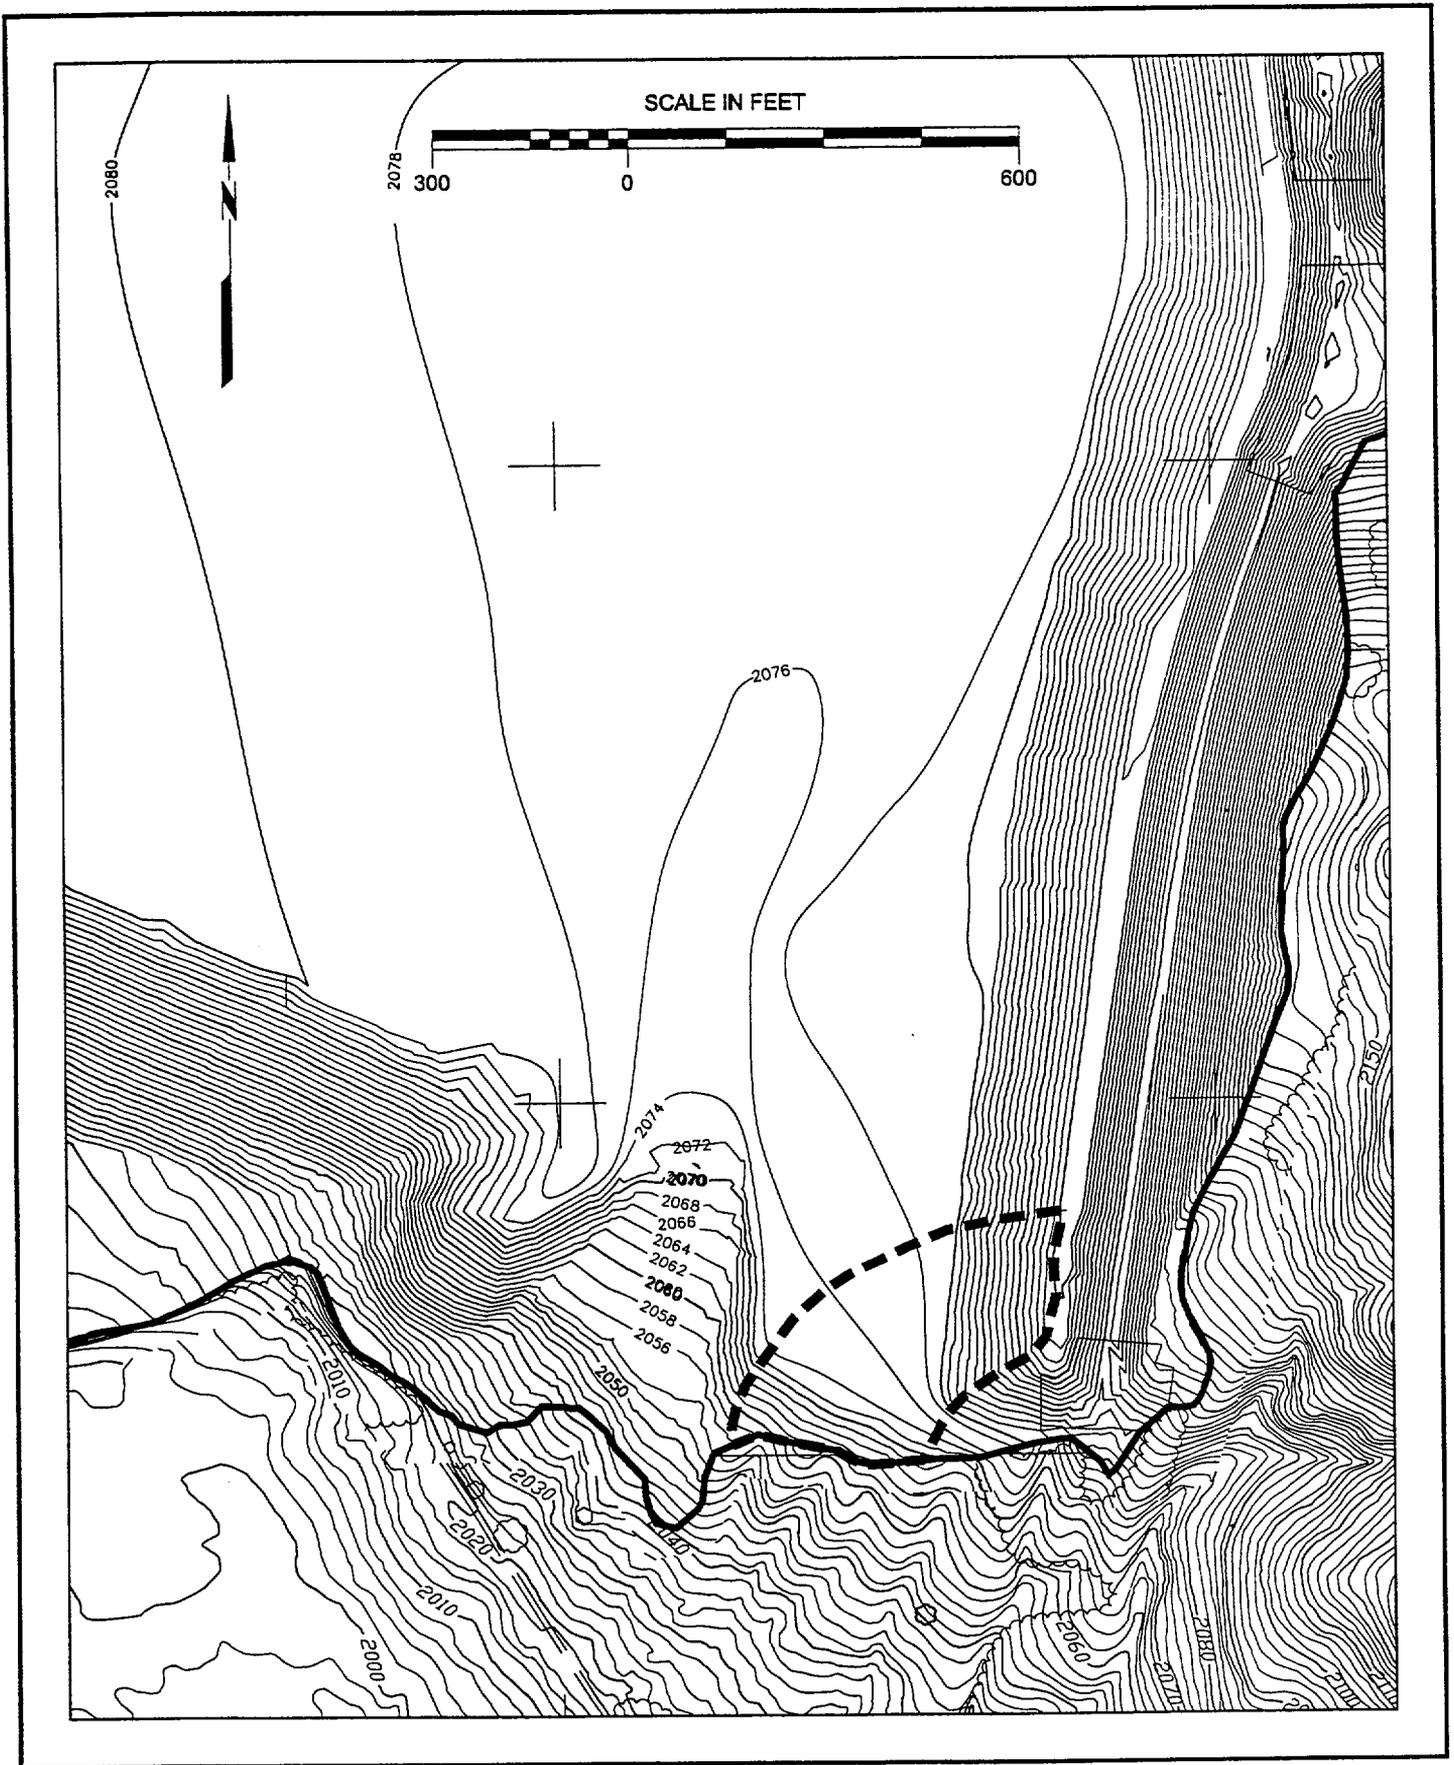
**FIGURE 1**

There is a small area (approximately 3 acres) between the swale outlet and the margin, as shown on Figure 1, that drains to the south. This drainage configuration is consistent with the original design. As the regraded gentle slope transitions into the steeper natural topography, a small amount of gullying and general erosion is apparent. This erosion will not, however, impact the reclaimed tailing impoundment. Any head-cutting would be limited to the small drainage basin, which is at least 700 feet from the edge of the reclaimed tailing surface. Additionally, quartz monzonite bedrock is at or near the surface for much if not all of this small drainage basin and therefore any gullying would be limited to a depth of only a few inches.
