RESPONSE TO FREEDOM OF INFORMATION ACT (FOIA) / PRIVACY ACT (PA) REQUEST

June 12, 2000

SUBJECT: RESOLUTION OF DEGRADED CEQ FAN ROOM WALL

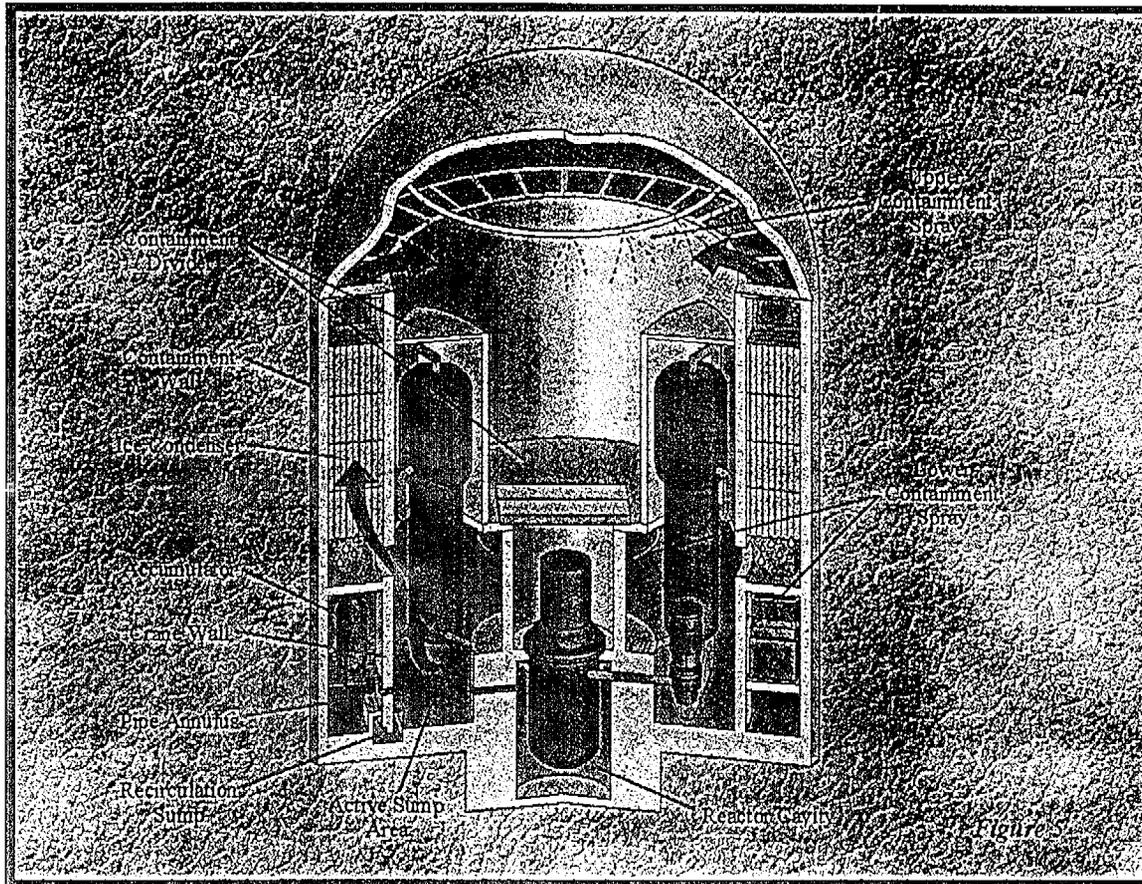
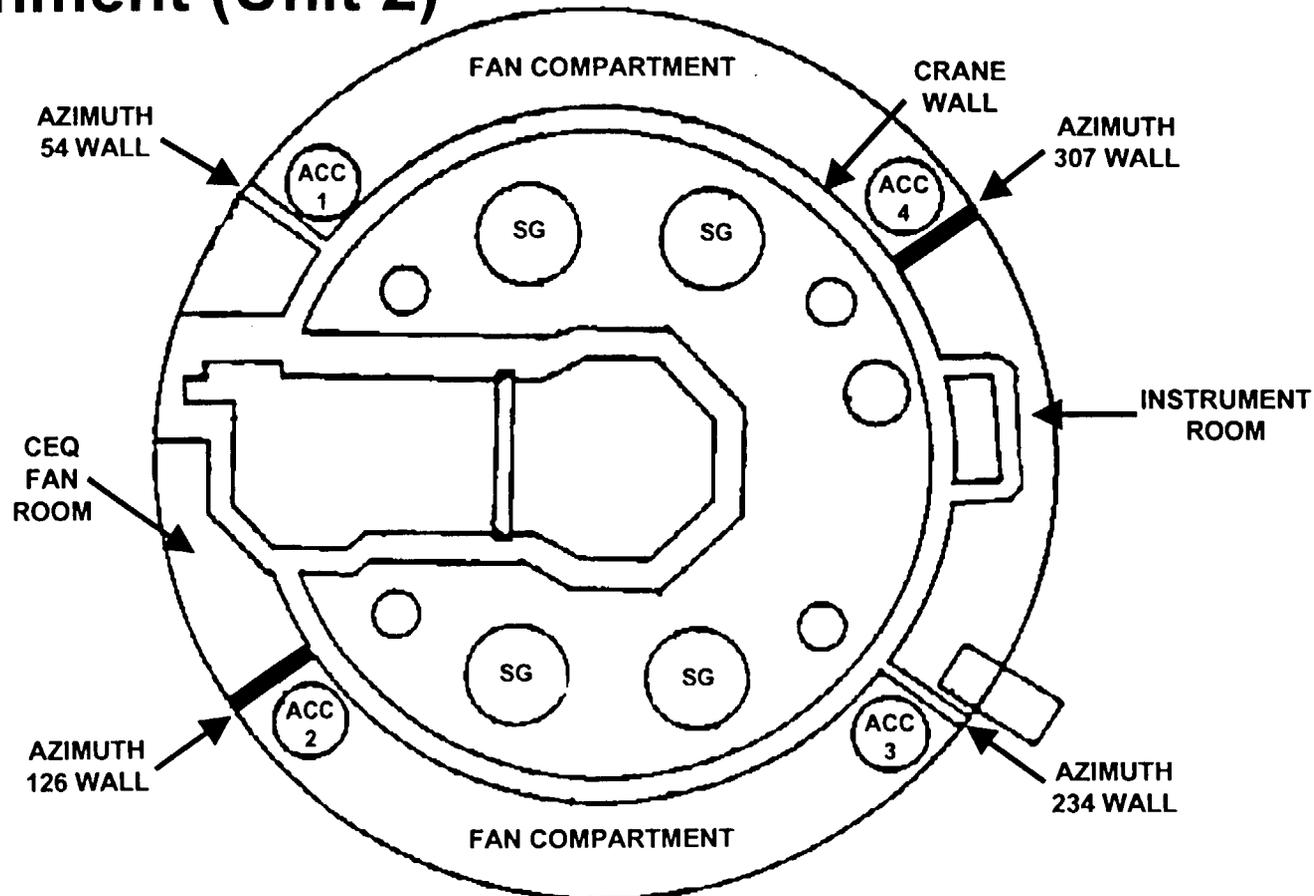
Background: Diagram of Containment Subcompartment Walls

- **Spalling Discovered During System Readiness Reviews**
 - Grout discovered during repair

- **Vertical Rebar Cut at Top of 126° Wall**
- **Cuts Required for Installation of Ice Condenser Anchorage**
- **Excavation Determined Extent of Condition on 126° Wall**
- **Issue Limited to 126° Wall**

- **Asbestos Blanket Found at Top of 126° Wall During Excavation**
- **Likely Used for Cutting of Embedments - Then Left Behind**
- **Embedment Cutting Limited to 126° Wall**
- **No Asbestos Found in 307° Wall**

- **Performed Field Investigation and Confirmation of Rebar Depth and Location**
- **Tested Cores of Existing Grout (Unit 2 Wall at 307⁰)**
- **Excavated/Missing Grout Replaced with High Strength Grout**
- **Verified Concrete Strength from Construction Records**
- **Determined Wall Structural Capabilities**
- **Assessed Extent of Condition**
