# Integrity Assessment for Reactor Vessel Head Penetration Nozzles at B&W-Design Plants

Presented by  
S. Fyfitch  
Framatome ANP

## Oconee Unit 1 & Unit 3 Reactor Vessel Head Leakage

Cracking of RV Head Penetrations  
Due to Primary Water Stress  
Corrosion Cracking (PWSCC)

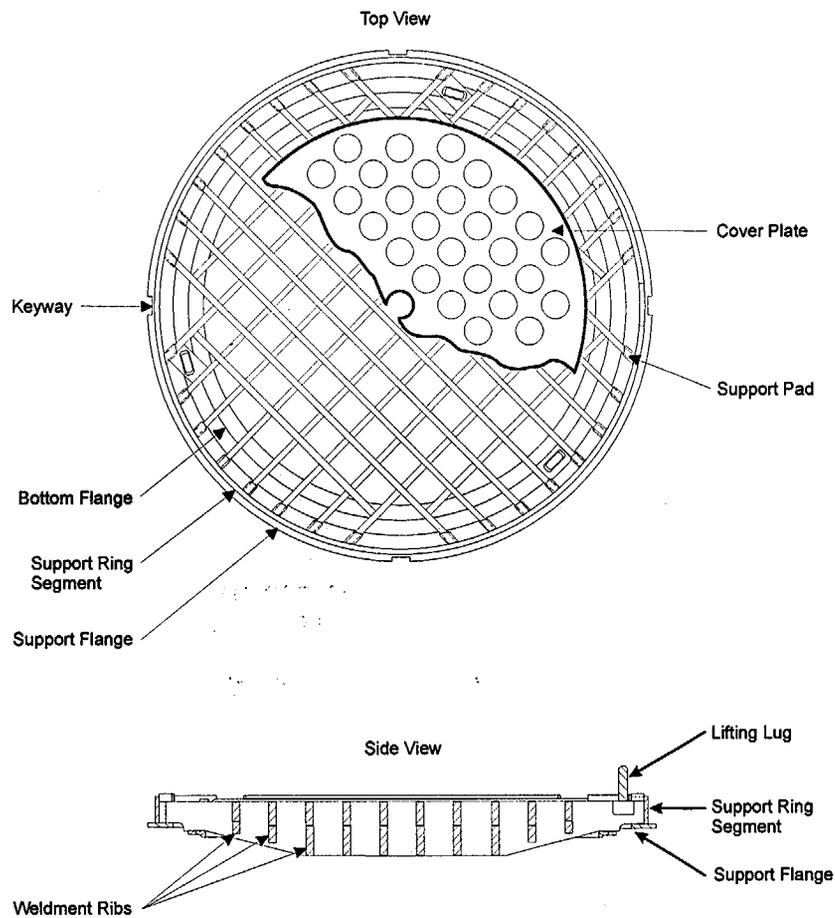
### Plenum Cover Assembly.

- Circumferential cracking of CRDM nozzle below the weld could link with two or more axial cracks and form a loose part.
- A loose part could potentially be transported to three places:
  - Onto the plenum cover plate
  - Through the RCS piping and into the steam generator
  - Into the column weldments

- Deposited onto the plenum cover plate
  - No impact on safety or plant operation
- Transported through the RCS piping and into the steam generator
  - No safety concern
  - Potential equipment damage (S/G tube ends)
- Transported into the column weldments
  - Potential safety concern
  - Could preclude complete control rod insertion
